Record of Conservation Works at St. Columba's, Swords, Co. Dublin

CMF 2022

Introduction

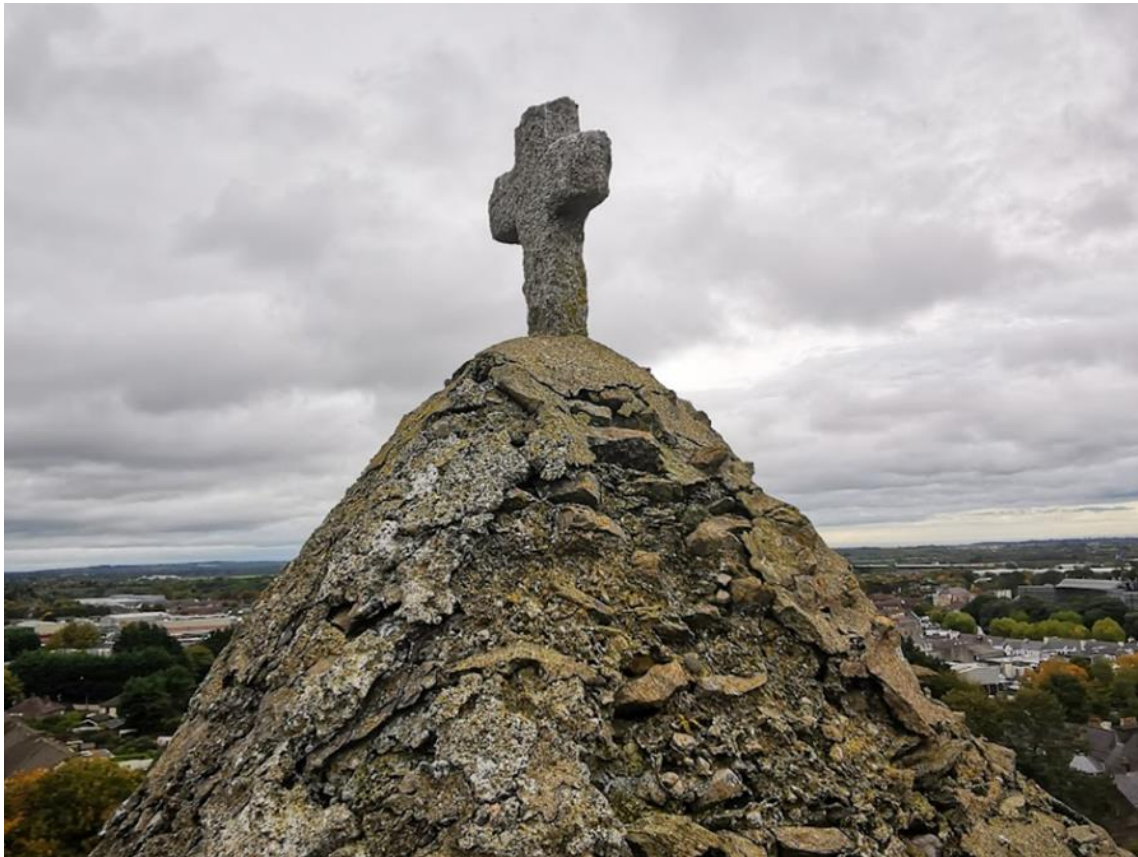
The scaffolding was erected and in use by the third week in August and work on the roof of the round tower commenced immediately. This had been in very precarious condition and was in urgent need of repairs.

Round tower roof prior to conservation

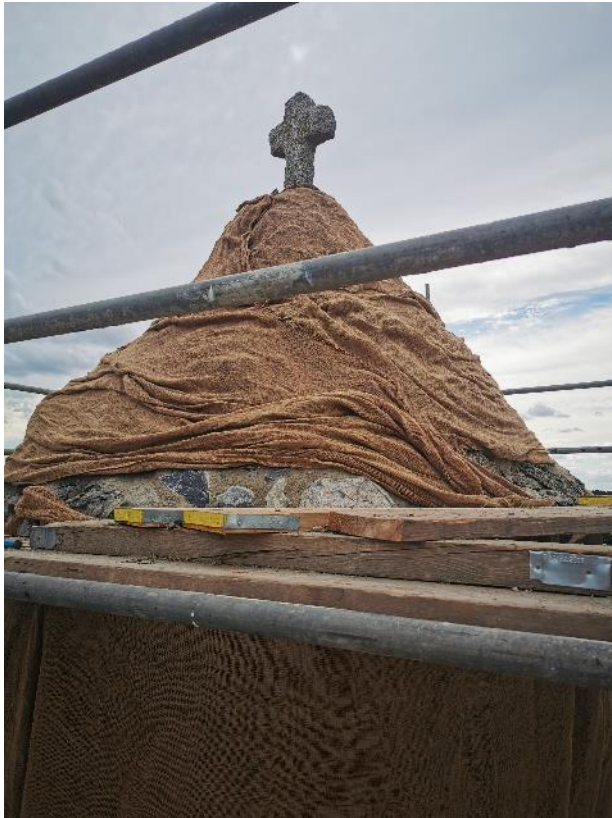
Roof with completed works covered in sacking; the cross has been stabilised

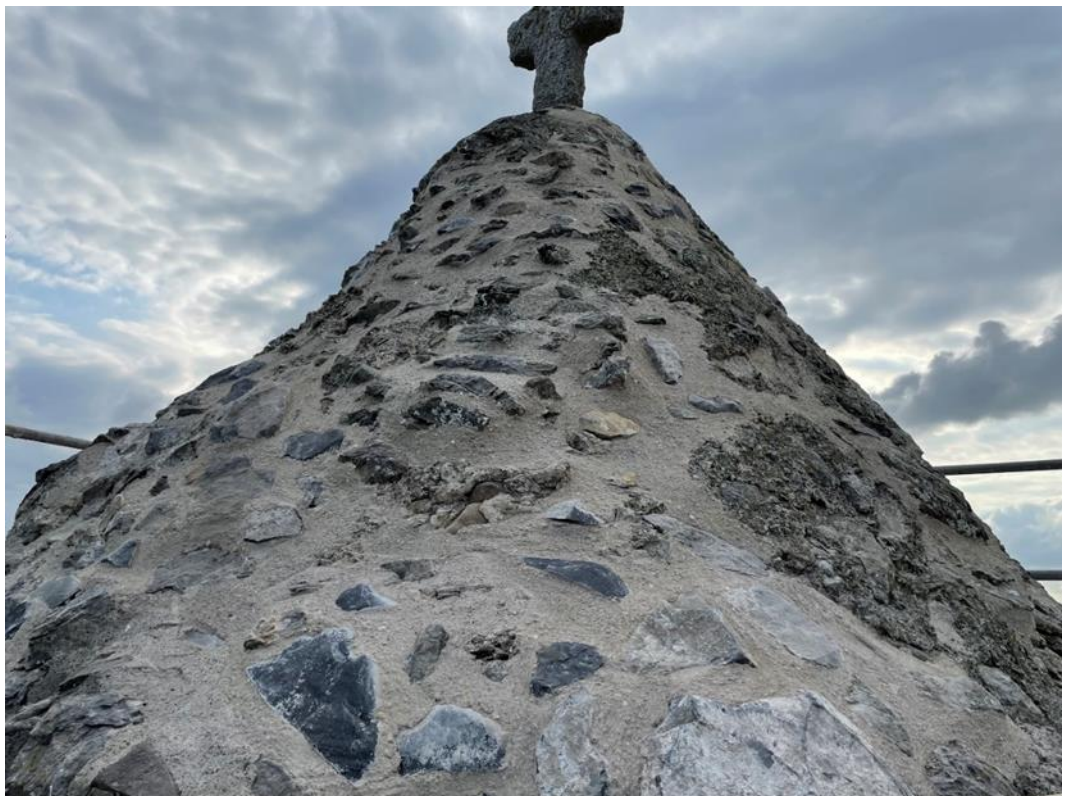
Completed work on the roof

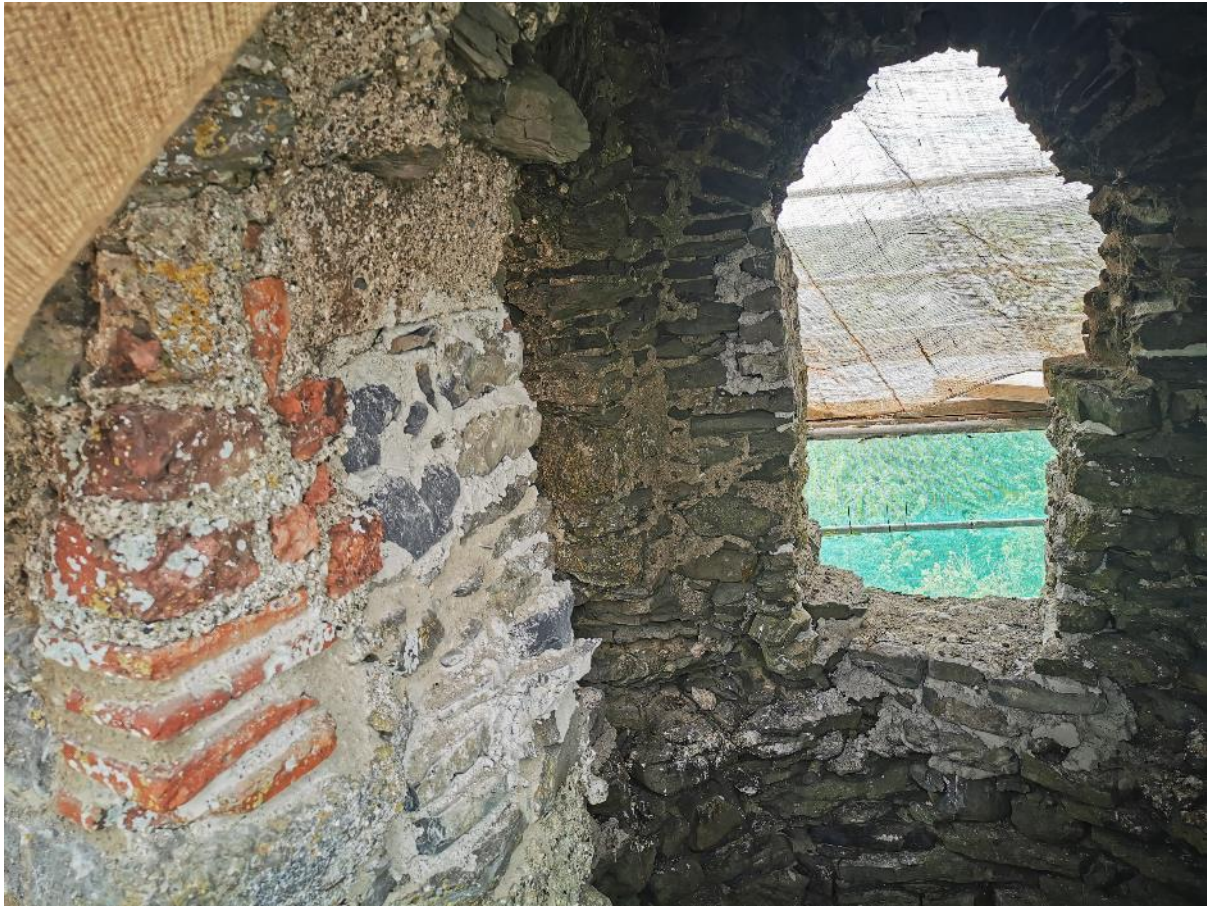
The columns framing the window openings at the top of the round tower were in very poor condition and mortar had weather out of the joints of the entire upper level of the wall in the interior. Work commenced in tandem with the re-pointing of the exterior to re-build and stabilise the columns.

Repairs in progress on the east and west windows; looking through to the west window from east

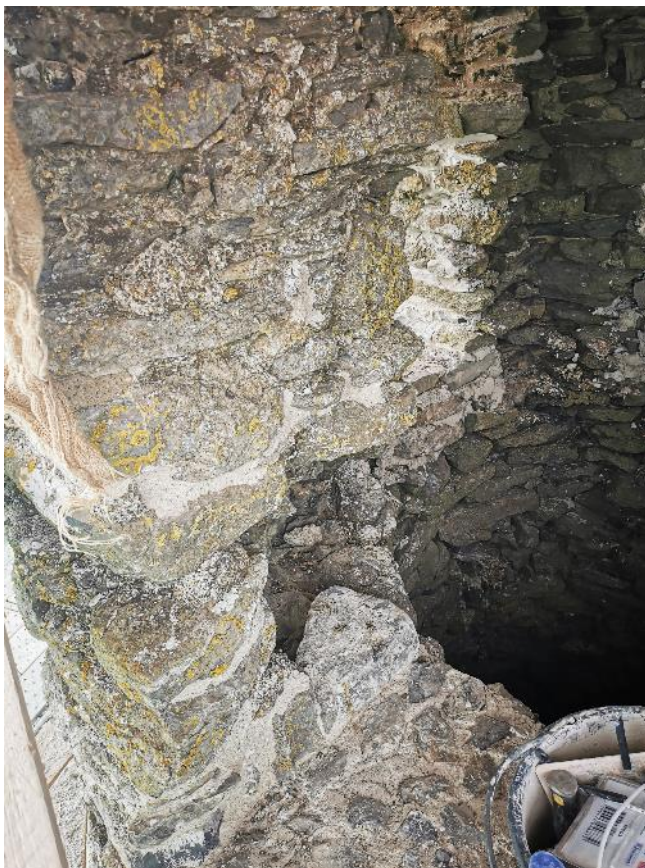
The south window was missing several stones at the base of its west side. Consolidation works began on the parts that could be reached from the scaffolding, at a later stage the interior was planked, and the work completed.

Looking from SE at the west side of the window with re-pointing in progress on the exterior.

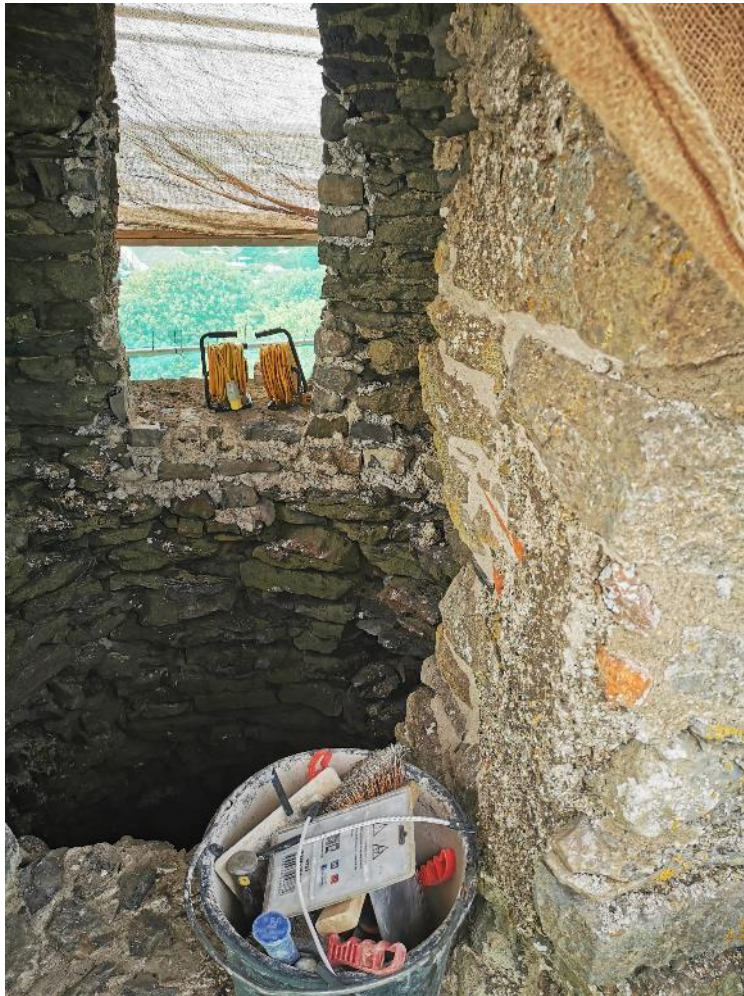
Looking north at the re-built and re-pointed sill and upper part of the wall beneath the north window

The north window also had been in poor condition, especially the area of the sill which was in a very precarious state. This required consolidation.

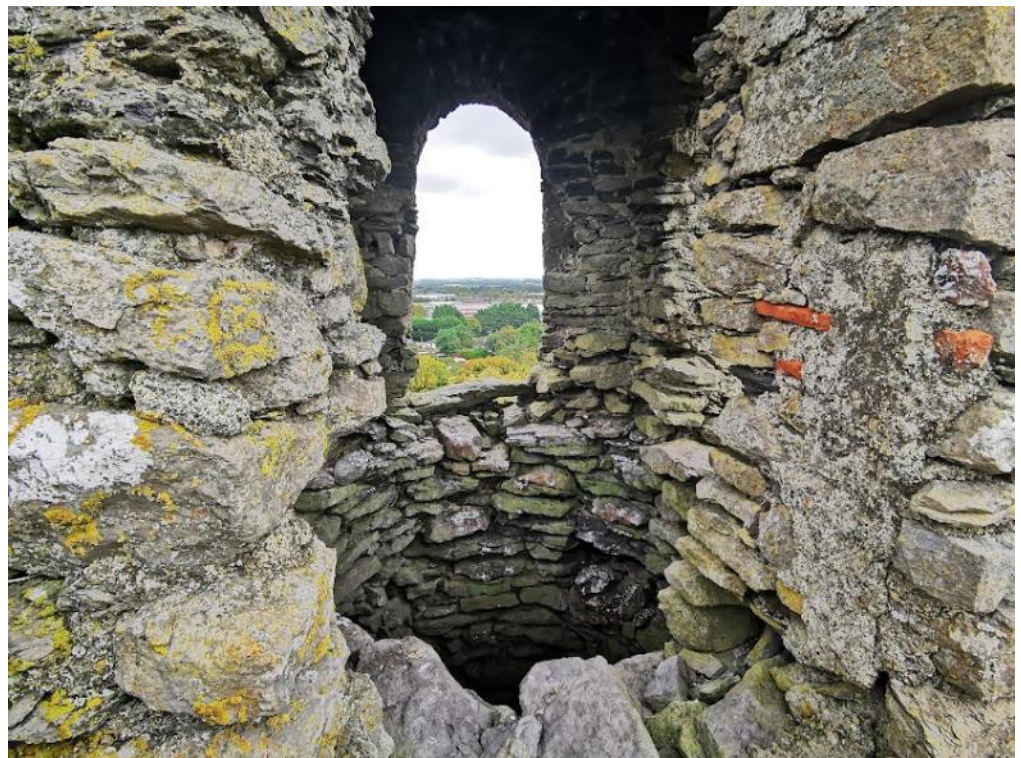
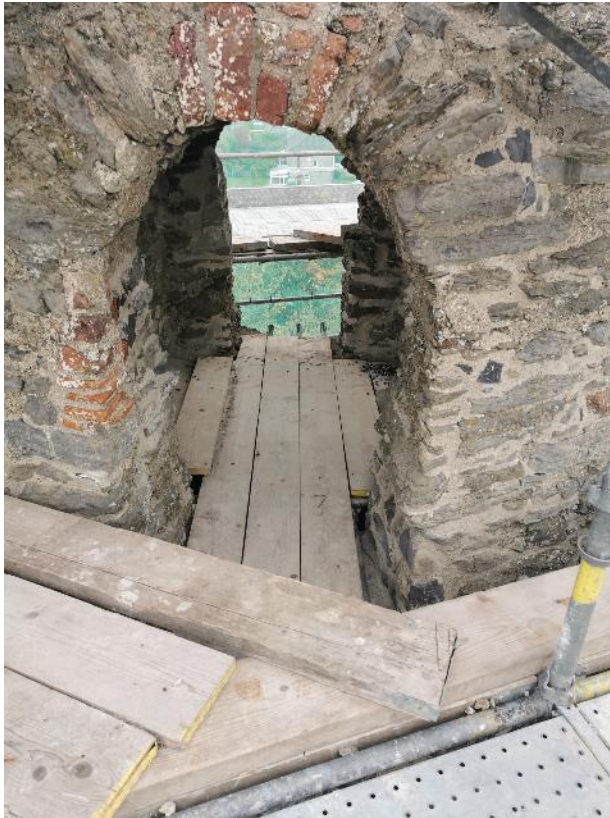
The sills of both windows were consolidated and re-pointed and the contrast is evident between this and the next photograph showing before and after images of the work carried out. The re-pointed right hand (east side) of the south window and the re-pointed north window can be compared with their 'before' condition.

View of the north window prior to conservation works

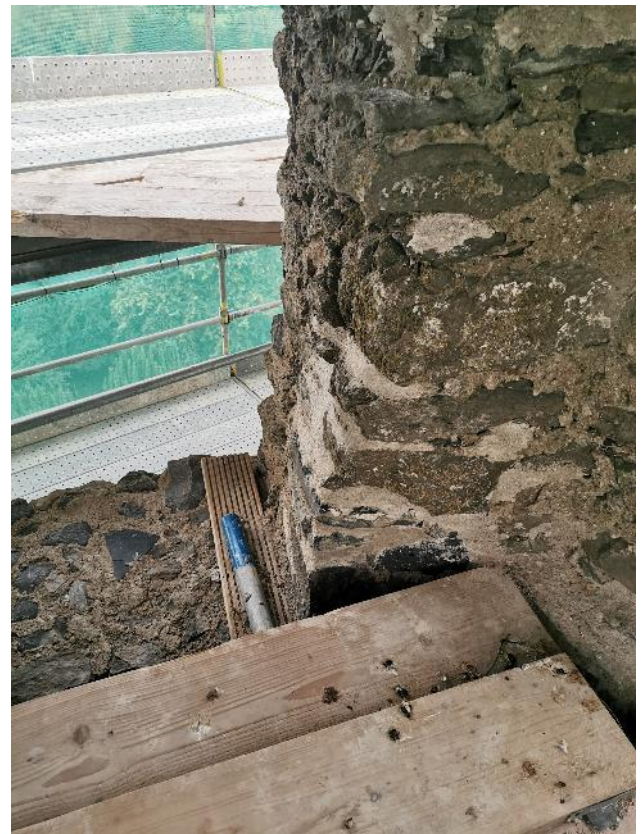
View of the east window looking through to the west window showing work in progress

All four window columns were re-built where

needed, stabilised and re-pointed.

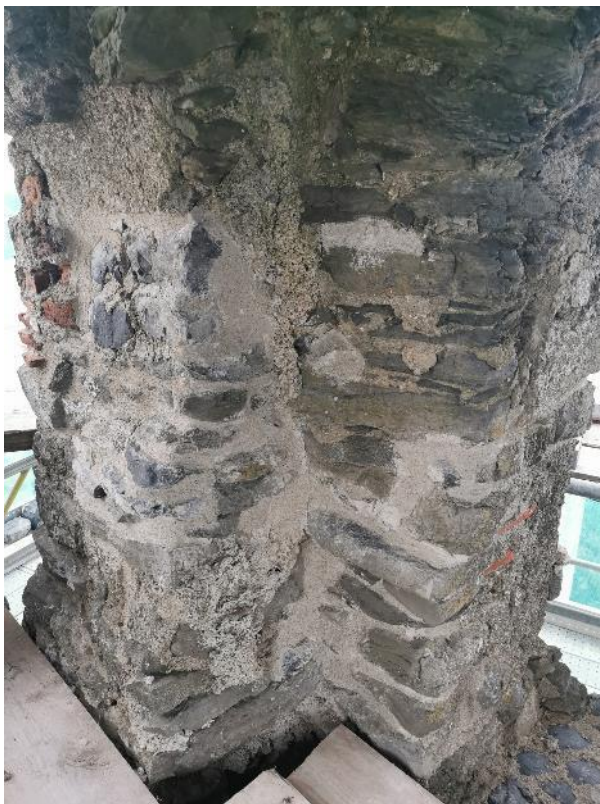
The re-pointed and repaired base of the SW corner

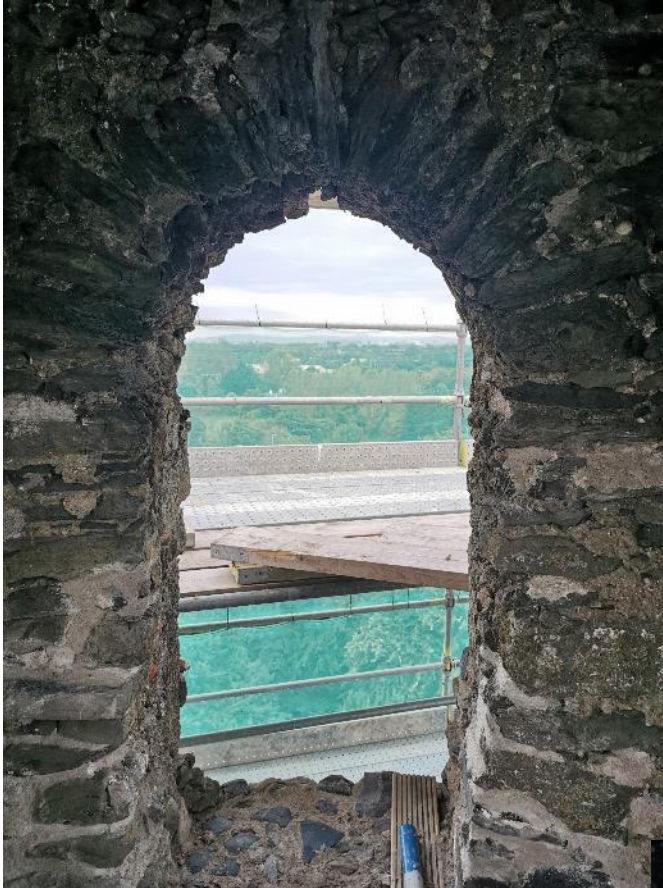
View looking SE at the interior of the wall between the East (left) and South (right) windows

Extensive repair and re-pointing was needed throughout this area.

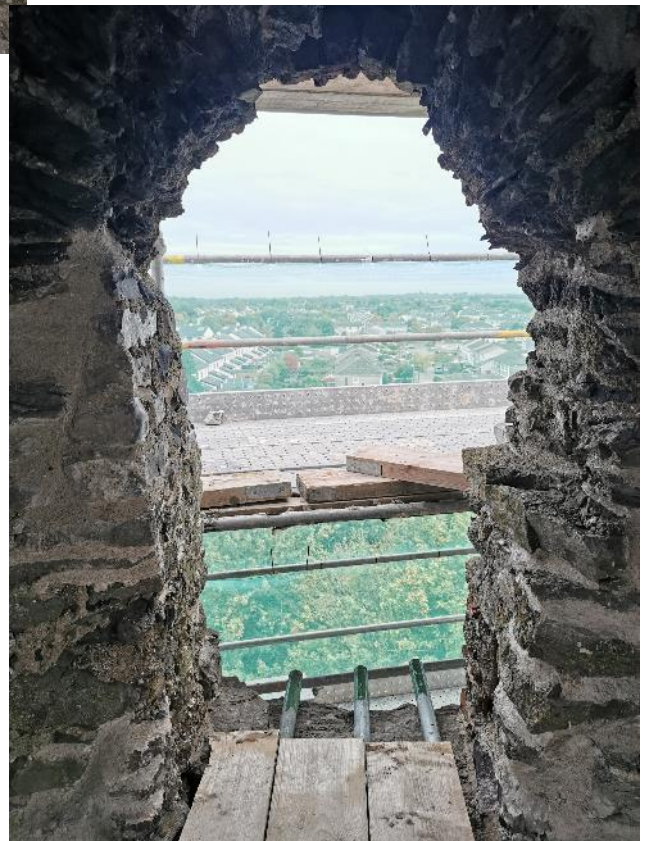
In some instances the upper arches were still reasonably intact, as in the south window which from that point of view was the best preserved. By contrast, the west window, below, showed a distortion of its original shape which could be rectified only by a certain amount.

Looking S through South window

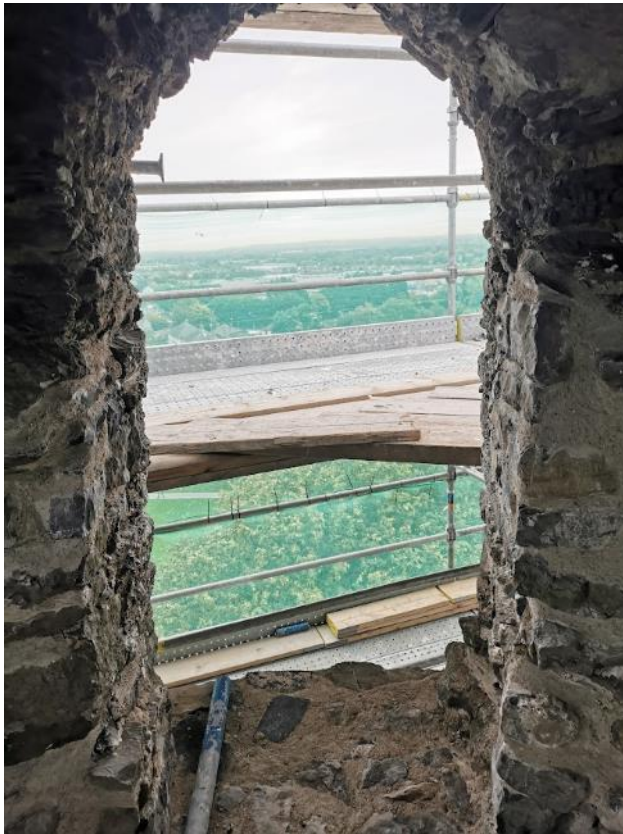
The west window by contrast with the south is much more distorted in shape

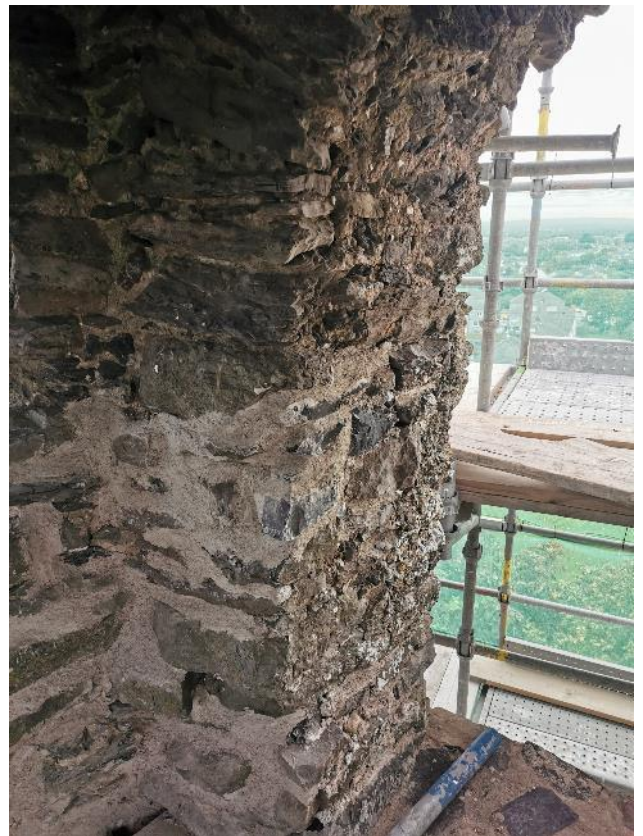
The NW corner showing the re-pointing of the lower half. The sill has also been conserved

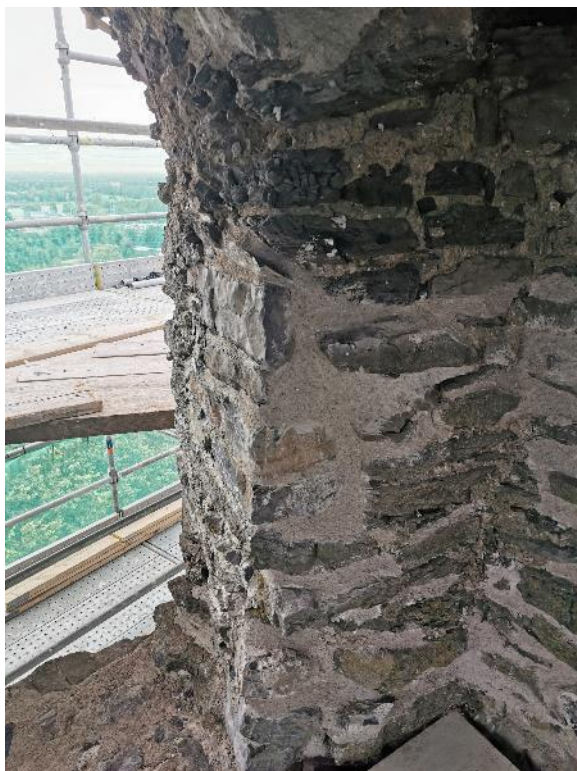
The NE corner after conservation

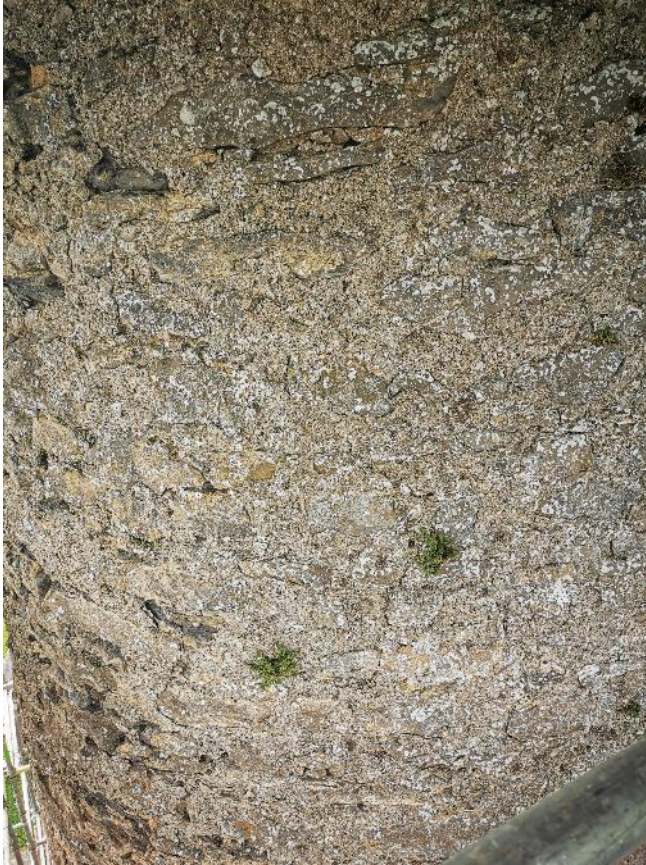
The upper three floors of the round tower were indicated for this work, and this was duly carried out. A line of wind-scouring had been noted on the tower in the 2021 report. This appeared to dissipate higher up, perhaps the taper of the tower reduced the distance sufficiently between the two towers to negate the effect of the W and SW prevailing winds.

View of the south-east section of the tower prior to conservation with portion of possibly wind-scoured area at bottom left

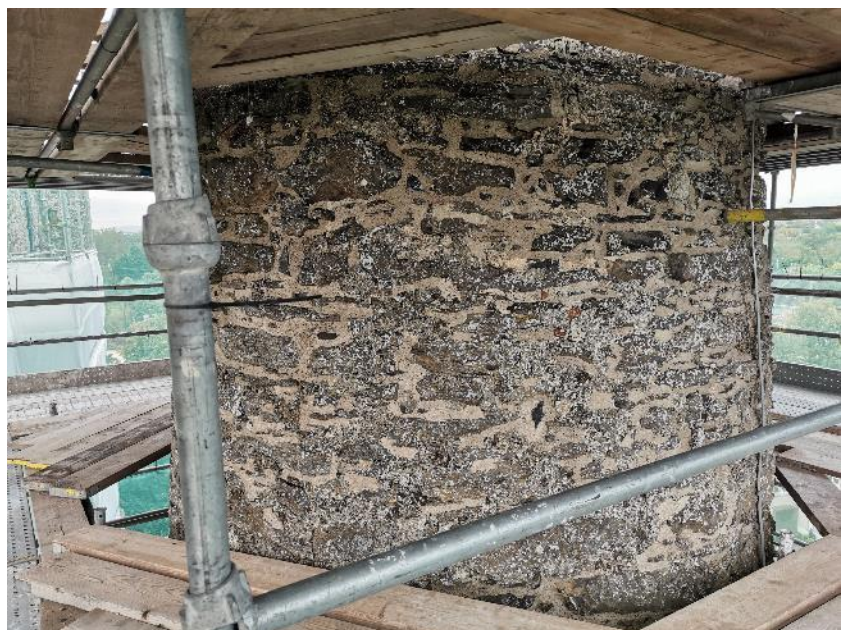
View of the fifth floor, exterior of the tower showing re-pointed joints. Note the presence of small pieces of brick within the existing render

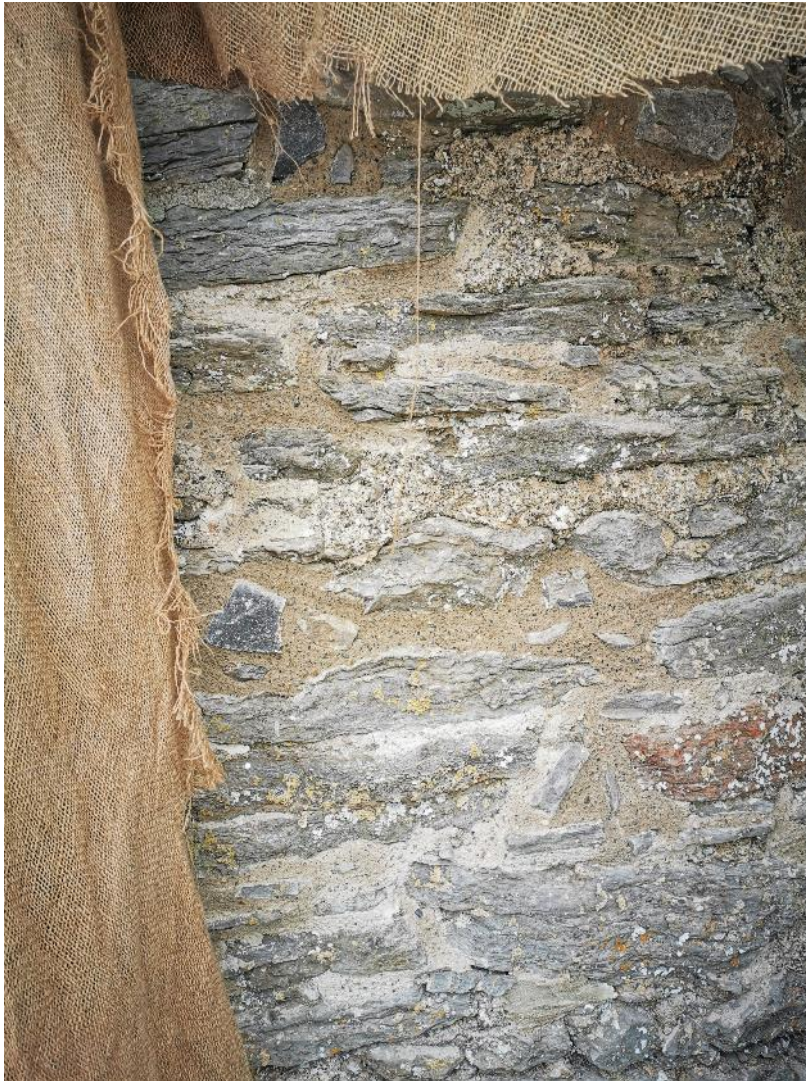
Close-up of a section of re-pointed wall

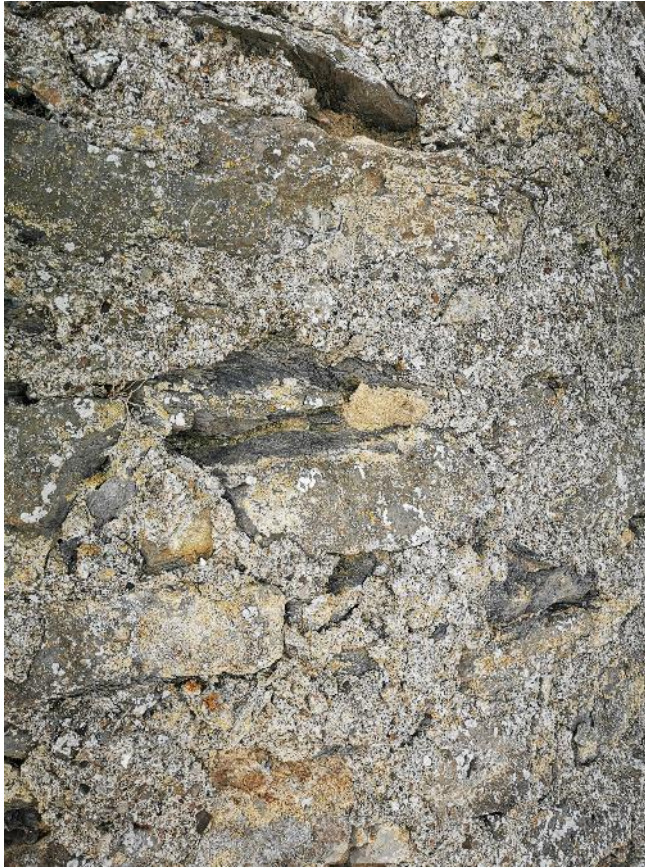
Possible example of different pointing/render mortars on the exterior wall of the tower, note the buff coloured piece in the centre contrasting with the grey render around it

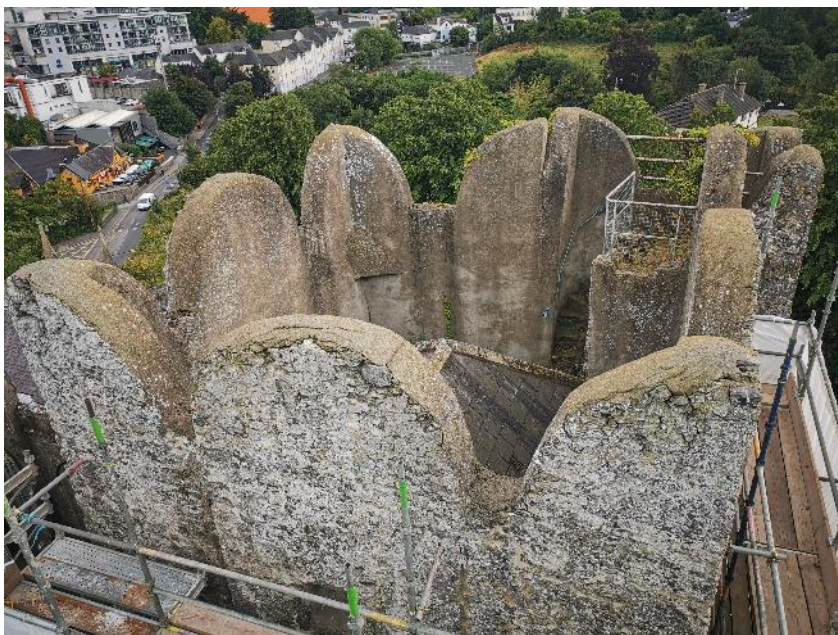
The render is quite patchy, but obviously may have been replaced in the past 30 years.

View looking south at the north wall of the Church Tower showing the crenellations

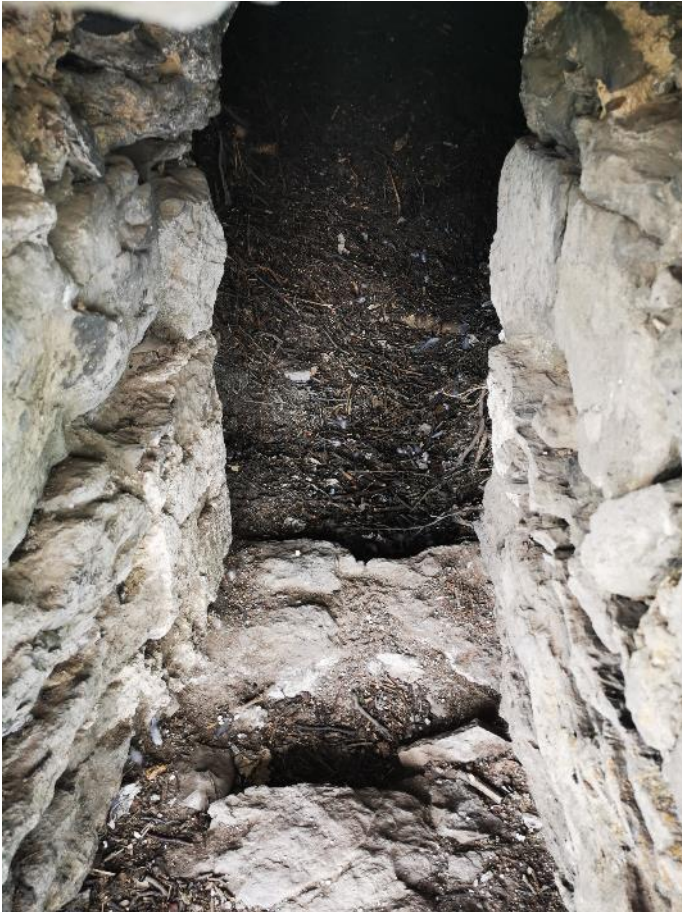
The accumulation of nest material evident at the south window level within the round tower, that is the fourth floor level was removed after several attempts. The depth from the south window sill level to the floor level marked by an incomplete wooden floor level was approximately 0.6m (John Lonergan pers comm). The corresponding relationship of the windows to the existing floors could not be ascertained with any confidence as the process of abseiling the interior of the tower and removing the accumulated debris was hazardous and didn't lend itself to much careful observance of such details. Some photographs and a short video were made by the individual doing the work but the overall quality is fuzzy and not much can be seen.

Looking in the South window at the accumulation of birds' nesting material; this picture was taken after several bags had already been removed
