*Managing Fingal County Council's  
Archaeological Resource*

Christine Baker  
Field Monument Advisor

March 2012

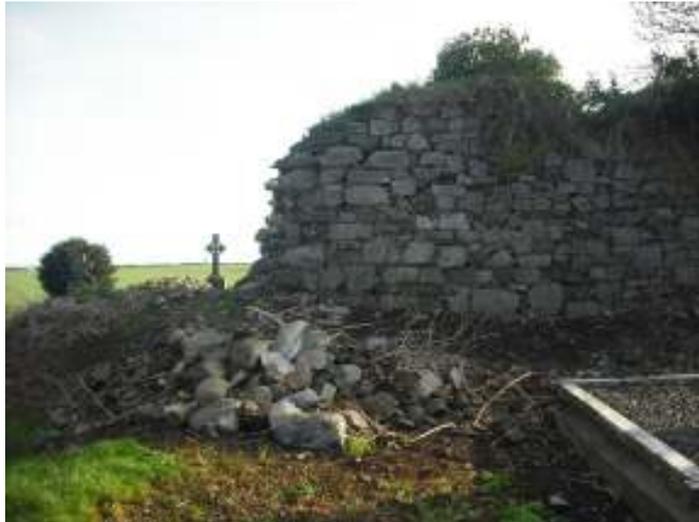
Vegetation on structures, and graveplots is also an issue. The root action of ivy destabilises masonry and can cause collapse once removed. The remaining gable of Grallagh church is an example. The removal of ivy has caused collapse of parts of the wall.

*Vegetation removal & resultant collapse, Grallagh Church*

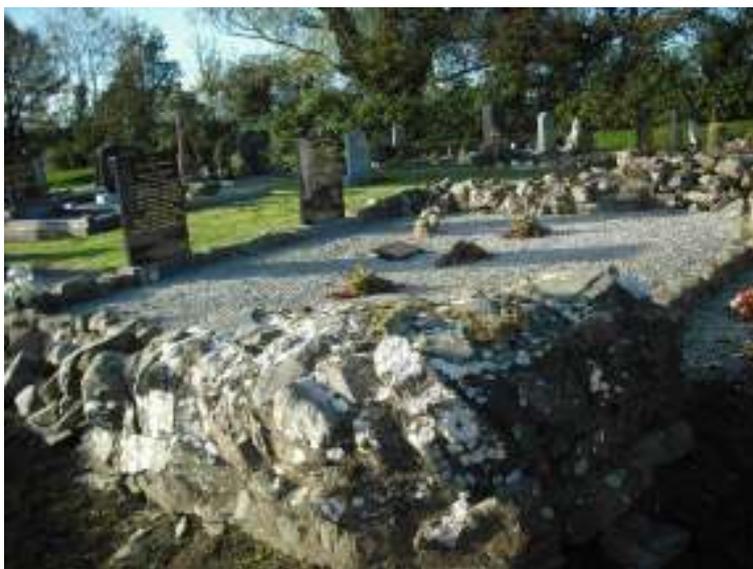
**FMA Report:** While some mounding is still visible, the chancel & nave described in the RMP records not discernible. NW corner of church extant and appears to have been stabilised (6.5m EW x 2mNS x 3m h.). NE (2m NS x 3mEW x 0.75mh.) and SE (1.50m x 2m EW x 0.60m h.) corners also extant but have been added to with stone and cement to form the limits of the Dunne family plot 1948-2006

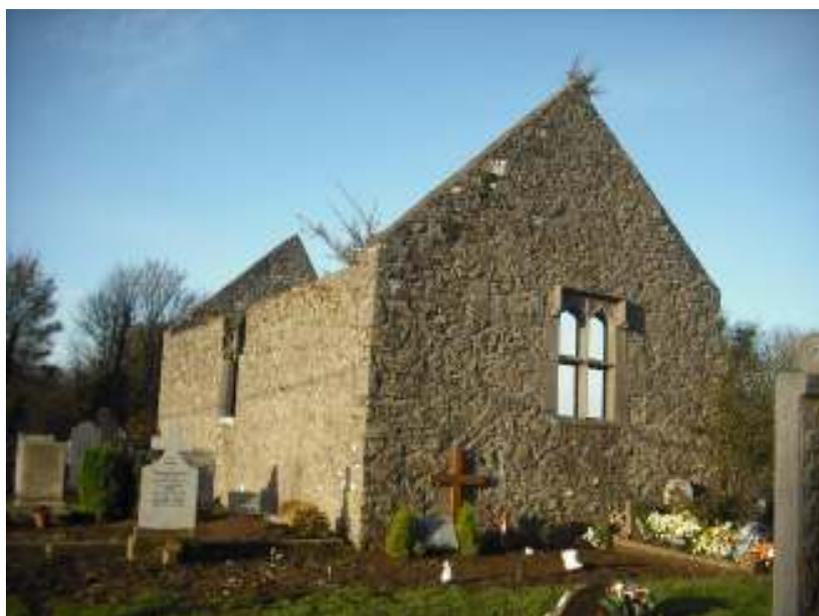
**FMA Report:** Located on high ground on Eastern approach to the village, SE of the Black Castle. Double ogee-headed window in eastern gable. Shield in sill. Plaque above northern door. Proportions of the upstanding remains are all wrong-supposedly the northern wall never built. Cross in interior. Light vegetation growth along tops of walls.

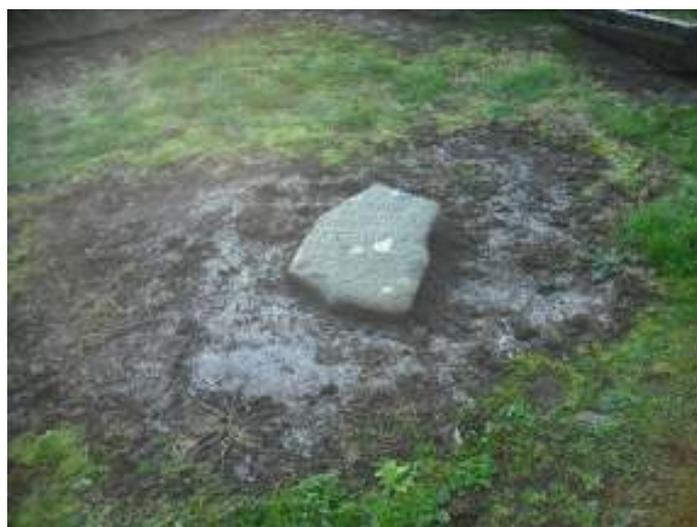
**FMA Report:** Graveyard bound by high wall with entrances to south-east and along western perimeter. Road to the south and laneway to the west. High ground and slopes down to north where there has been a graveyard extension. Mix of burial markers. Large open area 'sunken' to the NW of the church. Extensive use of weedkiller has created large muck patches.

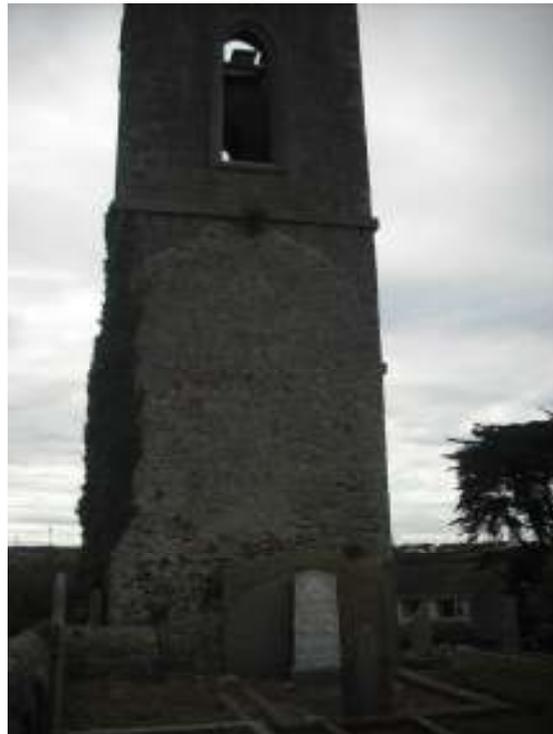
**FMA Report:** Remnant of a building on the E gable of the bell tower. Arch partially visible behind the Ronaldson grave. Remnants of old redbrick and stone in the vicinity and fragments of medieval floor tile found in the Caffrey grave 37m ENE of the bell tower.

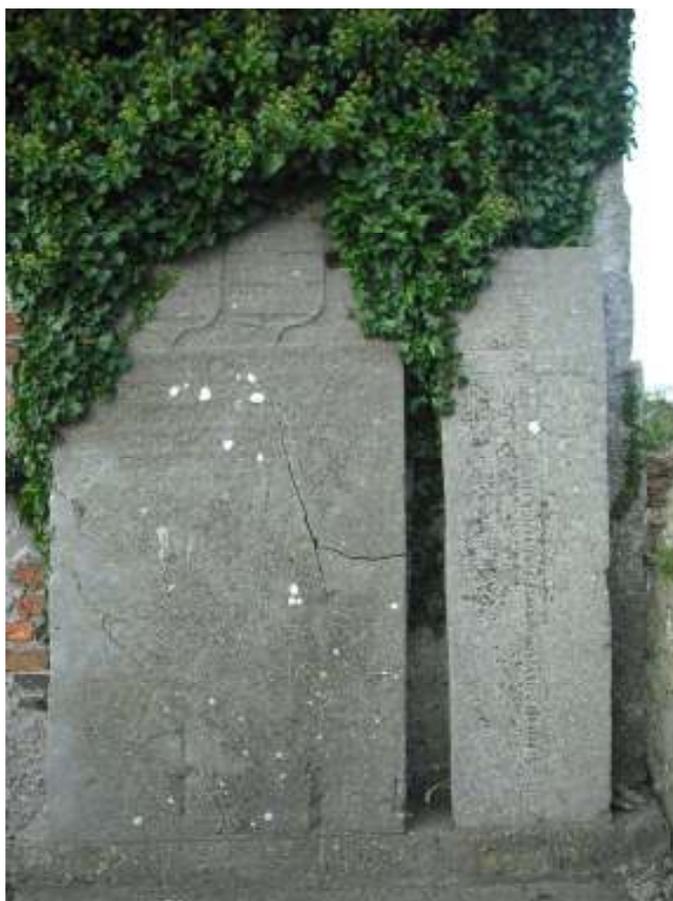
**FMA Report:** Peter Mann (e)1520. Located to set in concrete against S wall of bell tower. Some lichen growth and weathering but in relatively good condition. Peter Mann one of the last priors of Holmpatrick. Stone slab with cross inscribed *Hic Jacet Petrus Mainn Olum Prior Huus Dominus Cuis Anximae Propicitur deus qui Obit Anno Christi MVXX*. Translated by Rev. William Carrigan CC 1907.

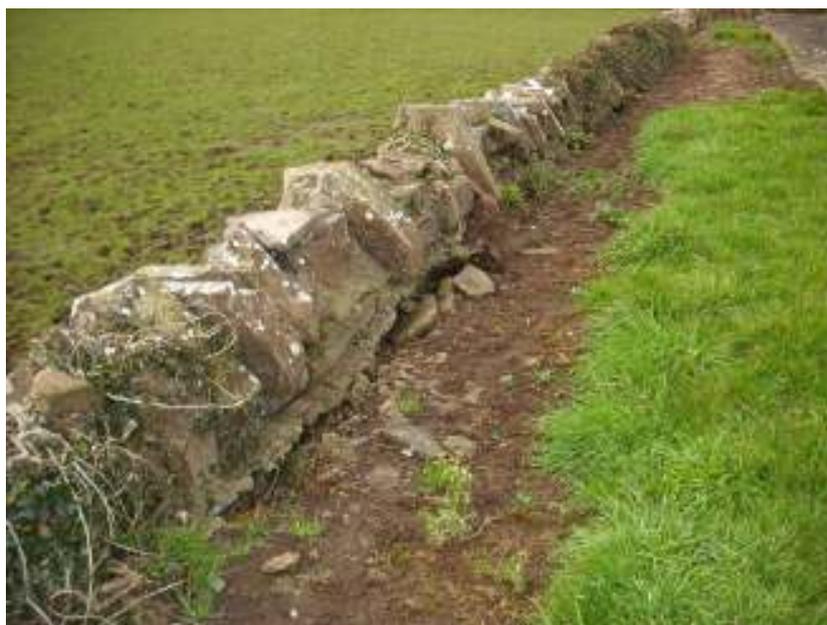
**FMA Report:** Graveyard defined by stone wall, square in plan. Significant drop to surrounding land to W and S. Interior perimeter path. Possible architectural fragment to Se corner of graveyard adjacent to Smith grave. Overall mix of gravestones 18th century-modern. Remains of stone wall/building immediately N of graveyard wall-may have reused stone from Church. Use of weedkiller has created muddy expanses between concrete path which is very cracked in place and the graveyard wall which is showing evidence of mortar wash out.

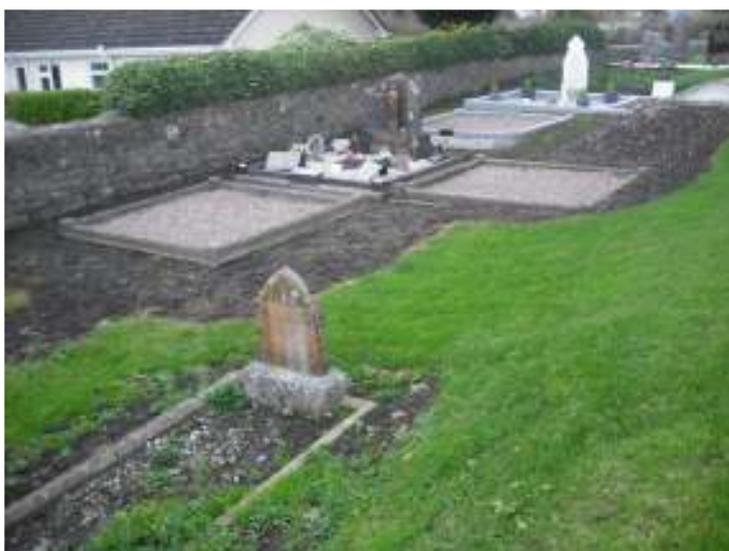
**FMA Report:** Vast swathes of the southern area of the graveyard has been denuded through the use of weedkiller. There is evidence of significant skeletal remains exposure. The Echlin tomb was vandalised and repaired. The graveyards is the scene of littering and anti-social behaviour.

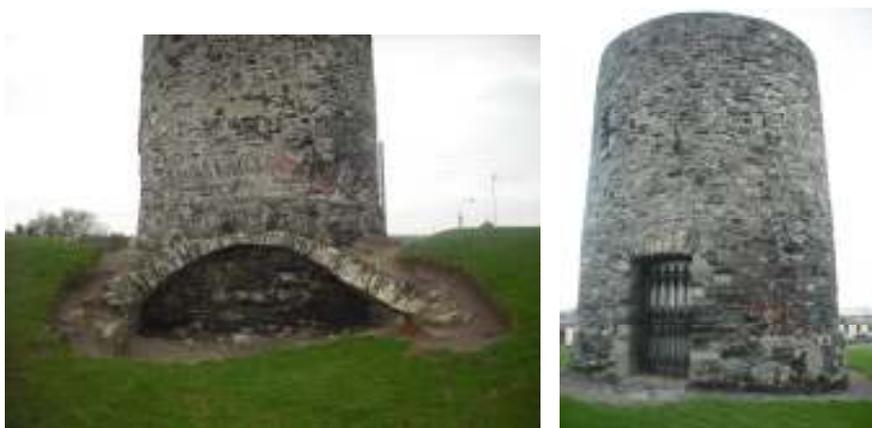
**FMA Report:** Located on high point of landscaped open space-Chapel Green. Vault arch to the SE has been stabilised-now used for drinking. Door ways secured by ornate metal gates-wooden floors long gone. Quite a bit of graffiti on structure and gates. Windmill still a focal point for the 'yoof'. Graffiti at person height on two sides. Metal doors have been placed on the interior of doors since last visit. Removal of green at E door-sand apparent. Lots of litter in the vicinity.

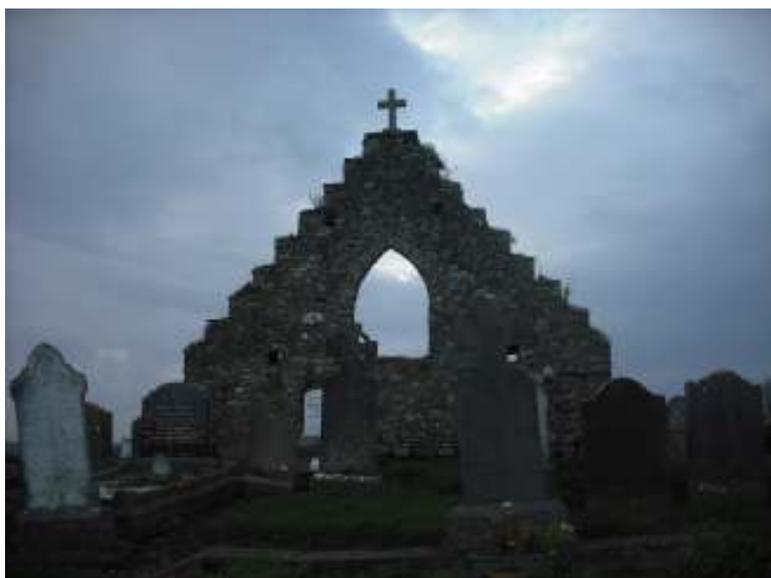
**FMA Report:** Vegetation growth on the top of the church wall. Wash out of mortar along the base. Some cracking evident.

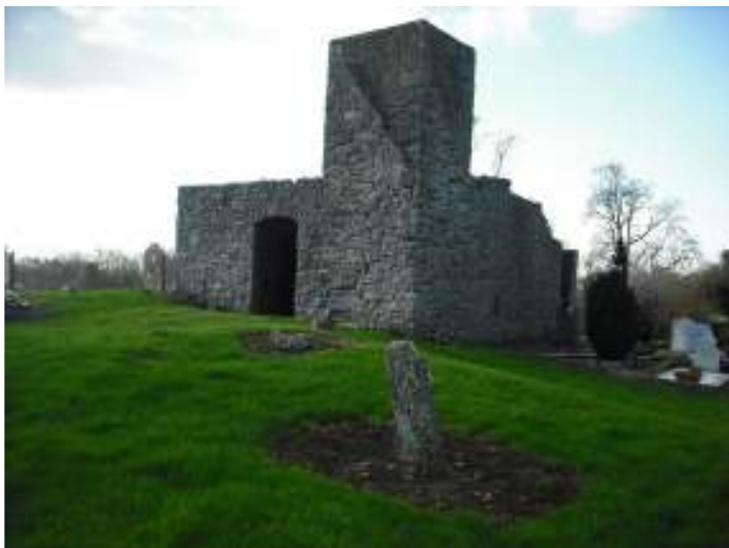
**FMA Report:** NE tower surviving-has been stabilised and rebuilt. Stairwell surviving in SW comes out on top of barrel vault. Internally vault used for dumping of graveyard detritus. Extensive views. Tree growth on top of vault. Some mortar wash-out around base of structure.

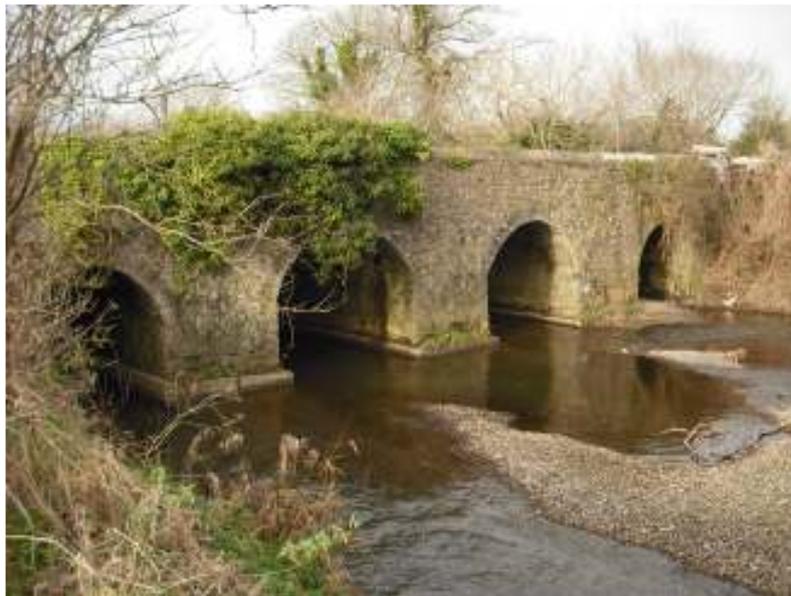
**FMA Report:** This was the Old Coach road. Some repairs to E facade of bridge-bad ribbon pointing. Capping is becoming loose and overgrown. Proposed that Metro North be carried across the bridge but project currently suspended. Some graffiti.

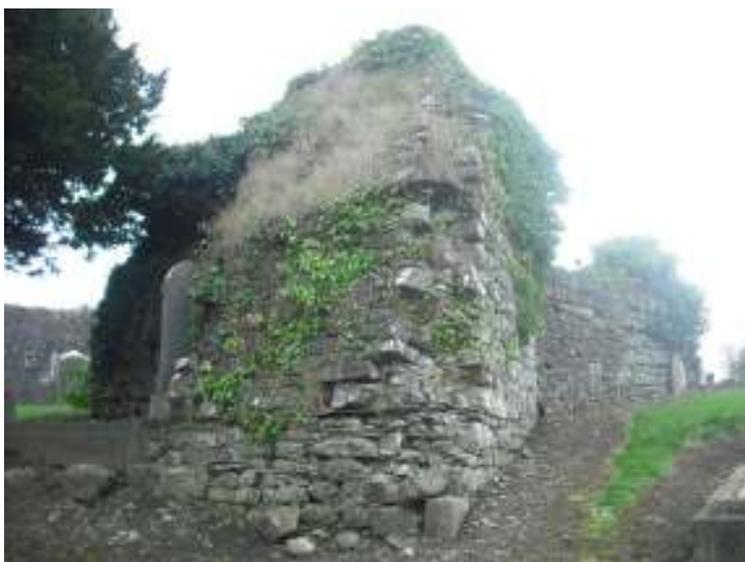
**FMA Report:** West end of 'old church' survives. The north-west and south-west corners are extremely overgrown with ivy with the top of walls overgrown with grass. Mortar wash-out has damaged the structural stability of the church.

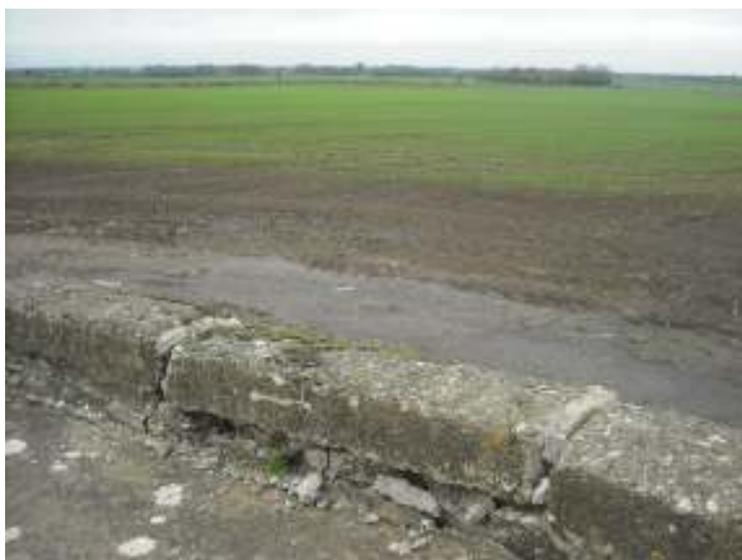
**FMA Report:** Subrectangular graveyard adjacent to curve in Ward Road. Would probably have been circular/oval in plan before improvements. Entrance pillared and gated to E. Majority of headstones extremely modern 80s to present- three older to Se of church. Located within a tillage field with new N2. Difference in ground level from interior of graveyard to surrounding tillage field. The graveyard walls have deteriorated and show signs of collapse.

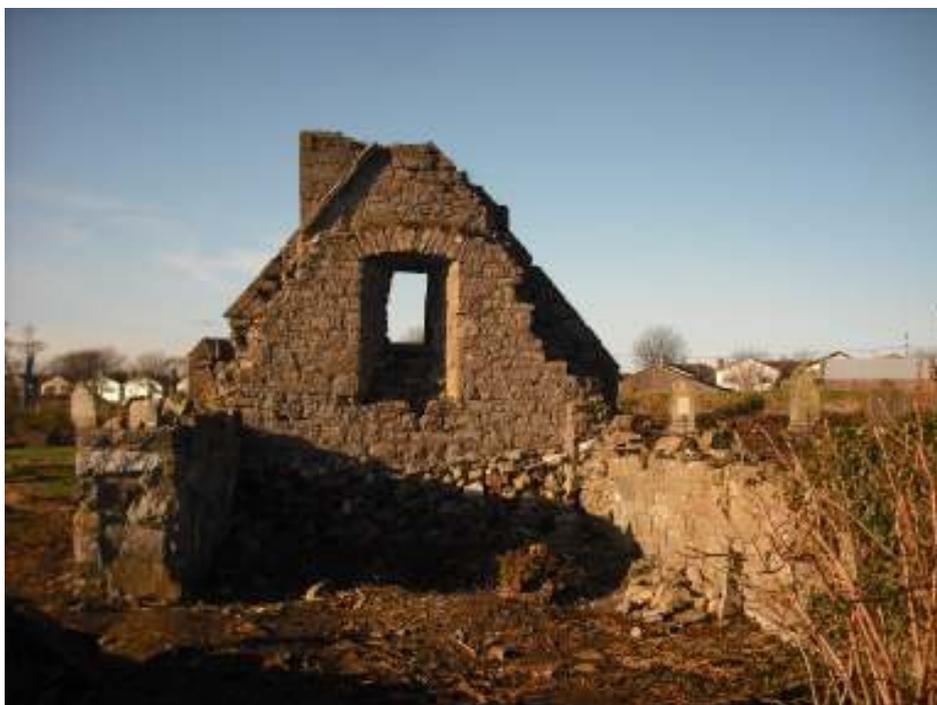
**FMA Report:** At the request of John Longeran of the local Lion's Club who had undertaken 'improvements' to the church and graveyard at the behest of the local priest site was inspected in the company of Sean Kirwan and Martin Reid of the NMS (May 2010). The 'improvements' had taken the form of the following: 1. All ivy had been ripped from the walls of the church-thus destabilising the

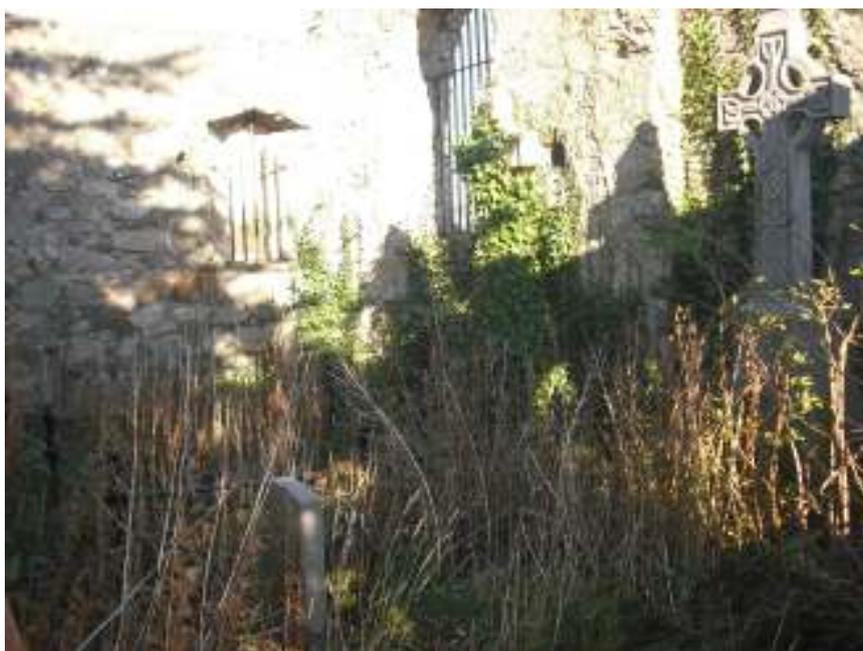
**FMA Report:** Located on high ground within large square graveyard bordered to S by road and sea. Church has been extensively ribbon pointed-concrete infill and metal railings to W where the gable is absent. Some graffiti but only on the concrete. Internal vegetation growth.

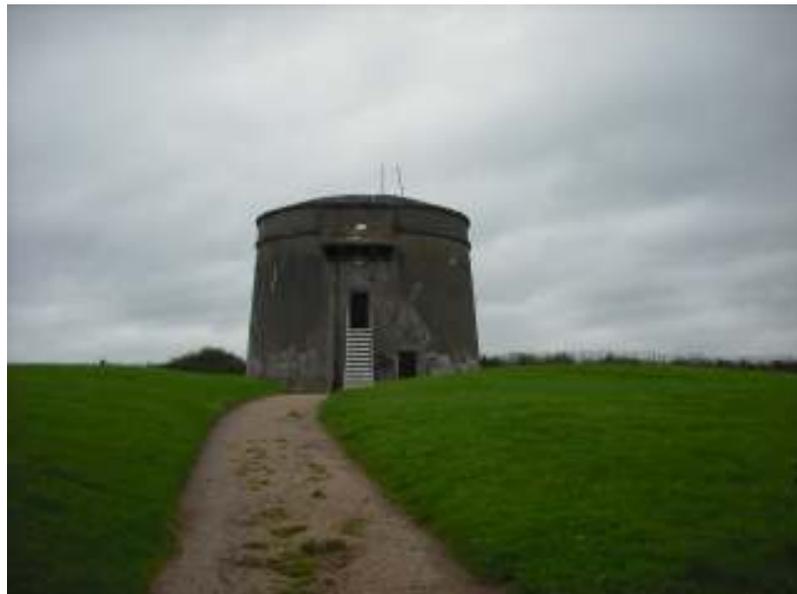
**FMA Report:** Now in use as a communications museum called ‘Ye Olde Hurdy-Gurdy Museum of Vintage Radio’. Entered by stairway to upper floor. Persistent water problem-leaking down into the basement.

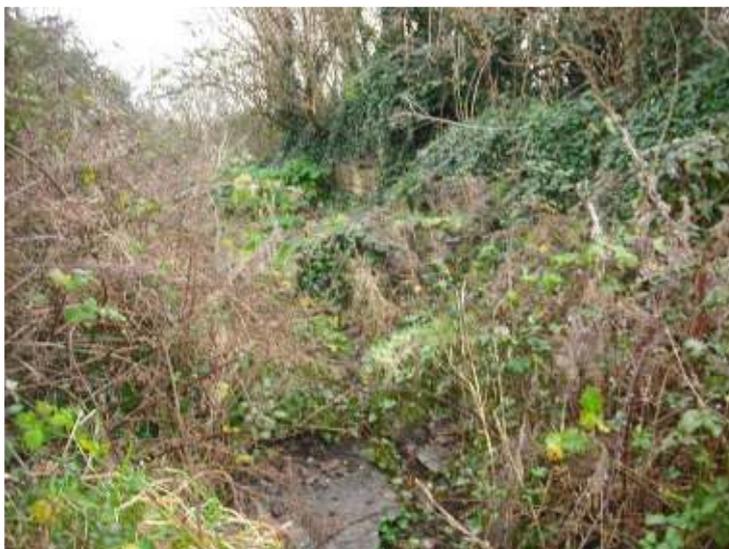
**FMA Report:** St Mologas forms part of the Bremore castle 'improvement' scheme. It will form part of the Conservation Study. It is significantly overgrown since the time of first visit (2007). Gravestones are no longer visible and access to the interior is impossible.

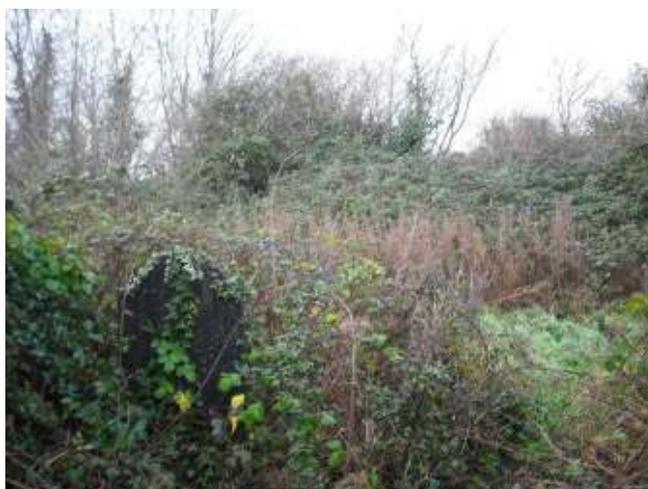
**FMA Report:** It is significantly overgrown since the time of first visit (2007). Gravestones are no longer visible and access to the interior is impossible. Unpublished survey by Balbriggan Historical Society.

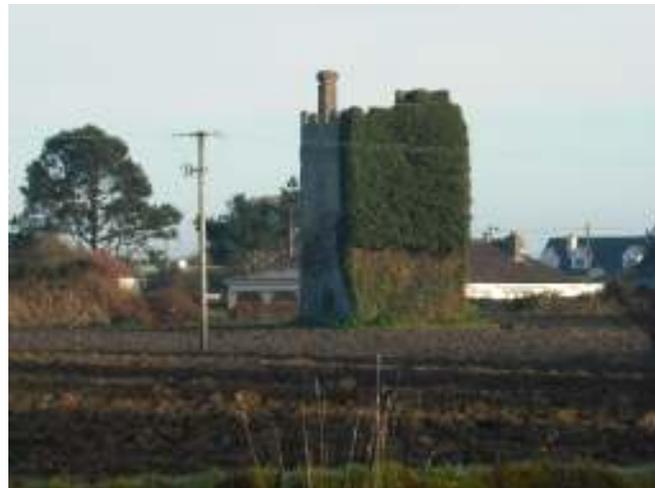
**FMA Report:** Tower is heavily covered in ivy. One chimney stack in precarious position. Evidence for interior collapse within undercroft. Only visible remains of once large complex of buildings- Inquisition of 1541 describes the castle as having divers buildings including a threshing house, hemp yard and haggard. Medieval pottery and worked flint found during site visit. Improvement in the context between visits as access to nearby housing estate had been blocked-cessation of anti-social behaviour in immediate vicinity of tower. On most recent visit the ivy is dying back on the south façade but recent ploughing has been undertaken almost up to the tower walls.

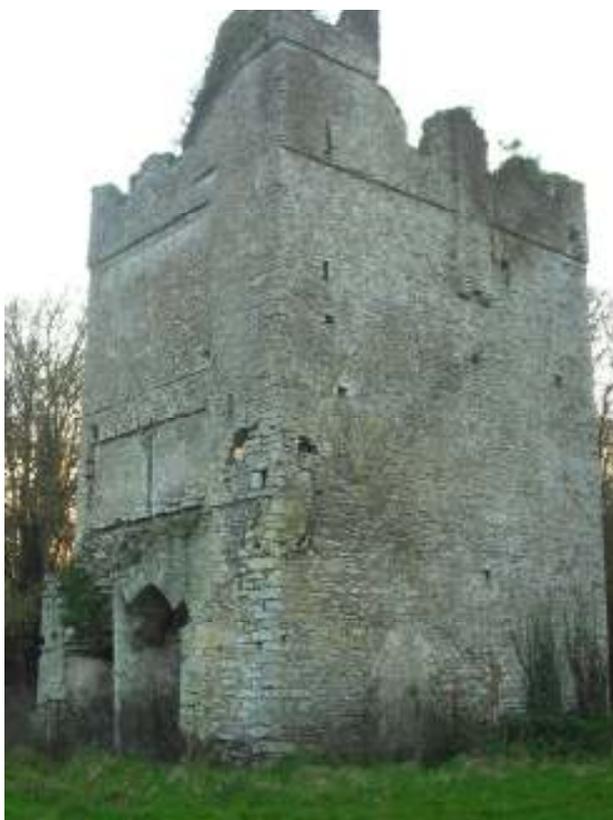
**FMA Report:** Located within S. entrance of Newbridge Demesne, in parkland. Gable of removed buildings visible on E facade. W. facade subject to burning. Damage to SE corner. Also sporadic ivy growth damage. All opes in filled with brick and concrete. Castle had been used as a cattle shelter for many years..residence of the landowners of Lanistown and probably dates from the time of the Bathe family who first possessed the lands in 1376. A 1776 survey shows large single storey residence to E-used into the 19th century when Cobbe family purchased tenants (John Grace) interest in surrounding lands and demolished house in c.1820. John O'Donovan told by Charles Cobbe in 1830s that there were extensive buildings to N and E of castle prior to demolition. Ruins of St Colman's Church which stood near castle seen by O'Donovan. On return visit appearance of ivy having been removed from N & NE corner has uncovered significant damage including area of stairwell. Base of SE corner has significant cracks. The blackened area on the eastern façade is covered in a white substance-could this be a fungus?

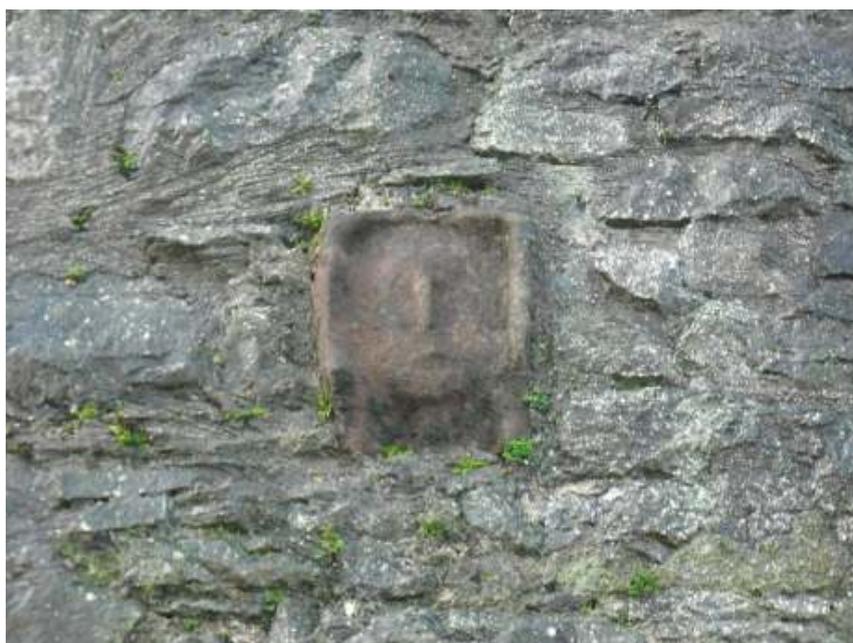
**FMA Report:** This sheela-na-gig has been significantly eroded.
