HSE LANDS, PORTRANE
Preliminary Woodland Management Strategy

**Preliminary Woodland Management Plan
for St. Ita's Hospital site at Portrane**

Architectural Survey (2013)

Feasibility Study

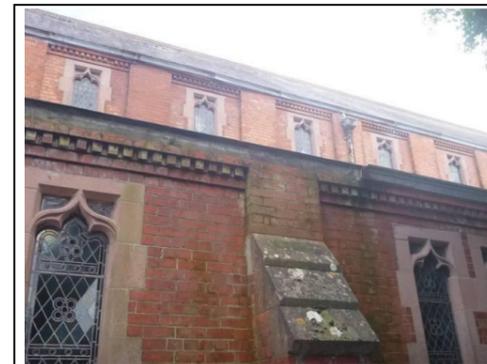
Internally, water ingress due to missing/damaged rainwater goods is apparent. A broken section of guttering along the west elevation of the Catholic Church has led to damage to the internal plasterwork of the church in this area.

Fig.1: Missing section of guttering to church; note algae staining to brickwork where water is running down face of building

3. Rainwater Goods - rainwater goods throughout the complex are in need of repair and maintenance. This is extremely pressing as the lack of satisfactorily working rainwater management is causing problems for many of the buildings. If not addressed, these problems will continue to escalate. Maintaining the water-tightness of the buildings is extremely important when ensuring the long-term safeguarding of the buildings.

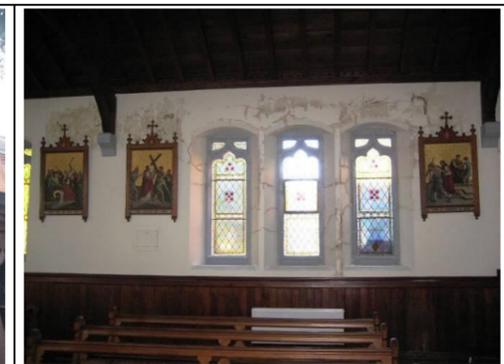
Fig.2: Damage to internal plasterwork where water ingress has occurred as a result of missing section of gutter

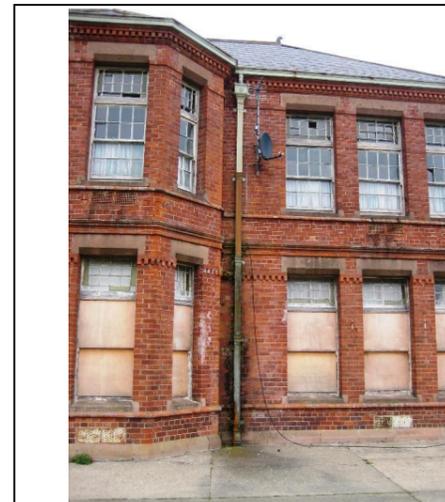
Damp conditions resulting from the presence of moisture in the brickwork form a perfect breeding ground for biological growth and green algae can be seen on many areas of the buildings where rainwater goods have failed. Algae can be unsightly and can also be a contributing factor in other forms of decay as they increase the amount and duration of wetness on the surface of the building fabric, which in turn can also provide nutrients for higher-order plants such as mosses.

Fig.3: Algae staining to brickwork where downpipe is leaking

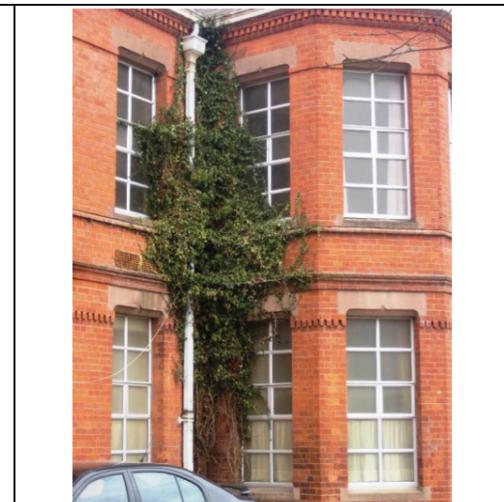
Fig.4: Plant growth to building

Higher-order plants such as ivy, etc are visible throughout the complex, particularly to the northern elevations of buildings and along the circulation corridors. Plants such as ivy and buddleia are particularly destructive as the roots penetrate deep into joints and crevices. As the roots grow, they force gaps to widen and open up the core of the wall, or even the interior of the building, to water penetration.

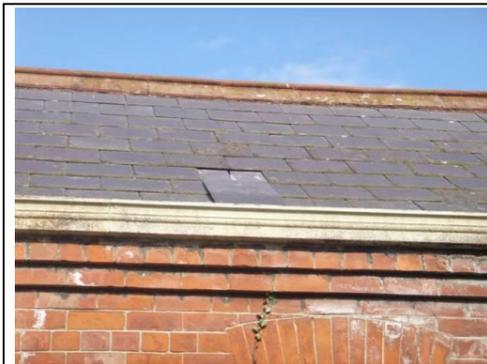
Missing/slipped roof slates are also an issue to some of the disused buildings. Roofs are the first line of defence in preventing rainwater entering a building to work properly, they must be intact. Any slipped or missing slates should be attended to as a matter of urgency to prevent water ingress and subsequent damage to the buildings internal fabric. Similarly larger areas of slipped slates can result in birds/bats entering the attic spaces and creating more serious problems.

Fig.5: Slipped slate to store building

4. Roofs - roofs should be inspected for missing/slipped slates, lost or broken ridge tiles and any such instances found should be repaired. The maintenance of the roofs is extremely important in ensuring the long-term protection of the buildings. Areas of slipped slates were noted to the Dining Hall and the Nurses' Accommodation. However, given that all inspections were carried out from the ground, it is likely that other buildings show instances of roof damage.

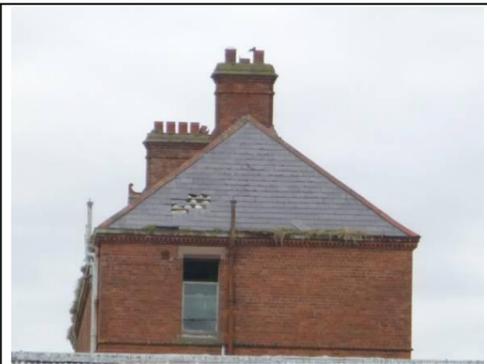
Fig.6: Missing section of slates to Attendants' Building; note vegetation growing in gutter
