Core Hole Investigation Steel Sheet Pile Survey - Supplement Skerries Pier

Project Title:	Core Hole Investigation
Location:	Skerries Pier
Document No:	21-018/UI02

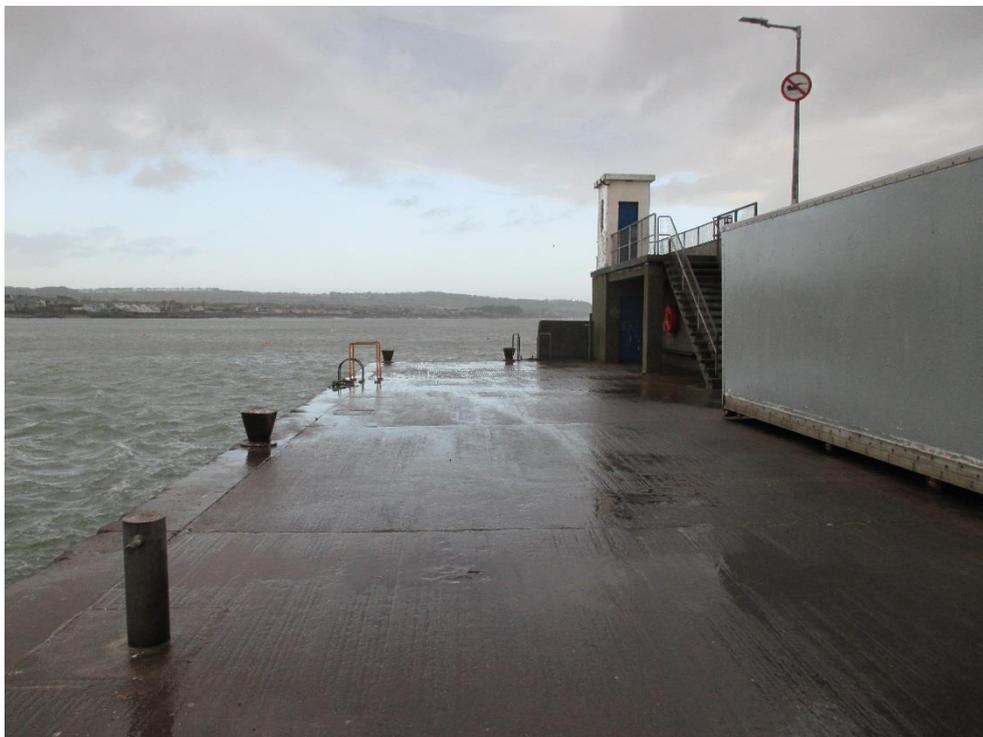
There is no subsidence or significant cracks anywhere on the piled section of the pier that was accessible.

Fig 4.1.1 - General Deck Concrete Slab Condition

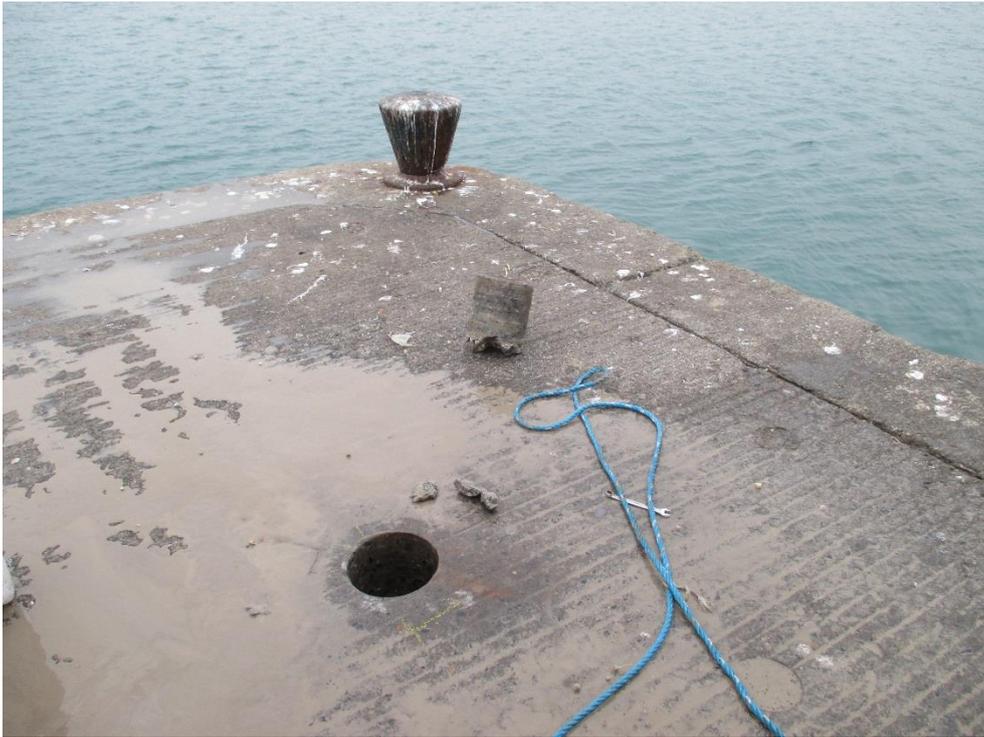
The concrete slab that forms the deck was found to have a nominal thickness of 200mm. The concrete is in good condition with no significant defects noted.

Fig 4.1.2 - Typical Concrete Condition

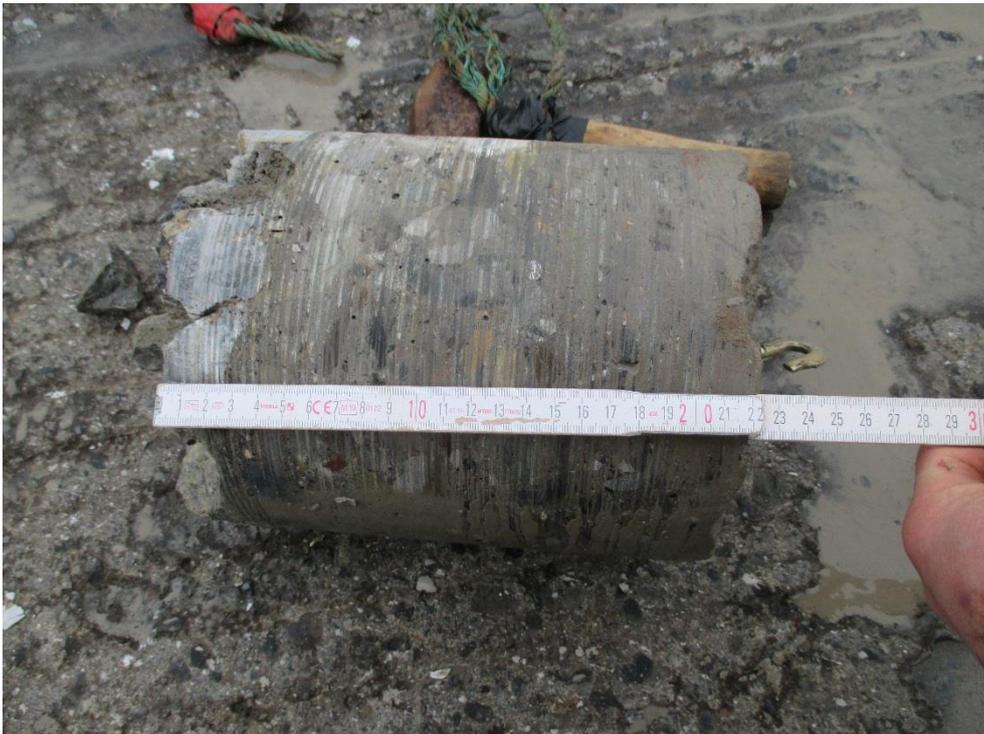
Fig 4.1.3 - Concrete Slab Thickness

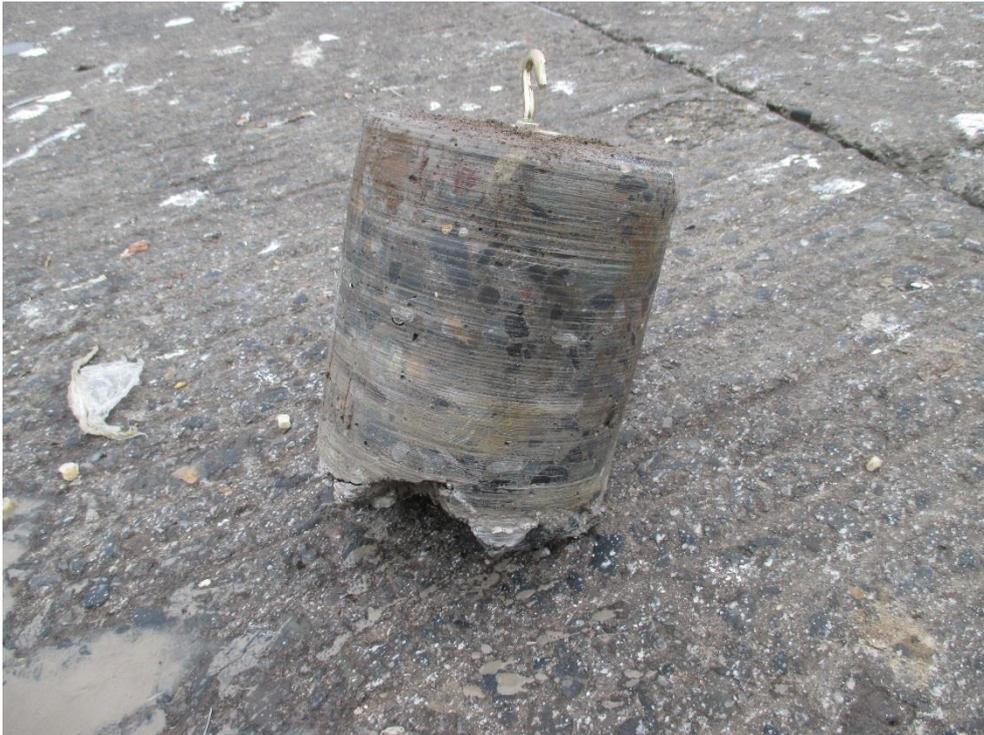
Fig 4.1.4 - Typical Core Section Removed

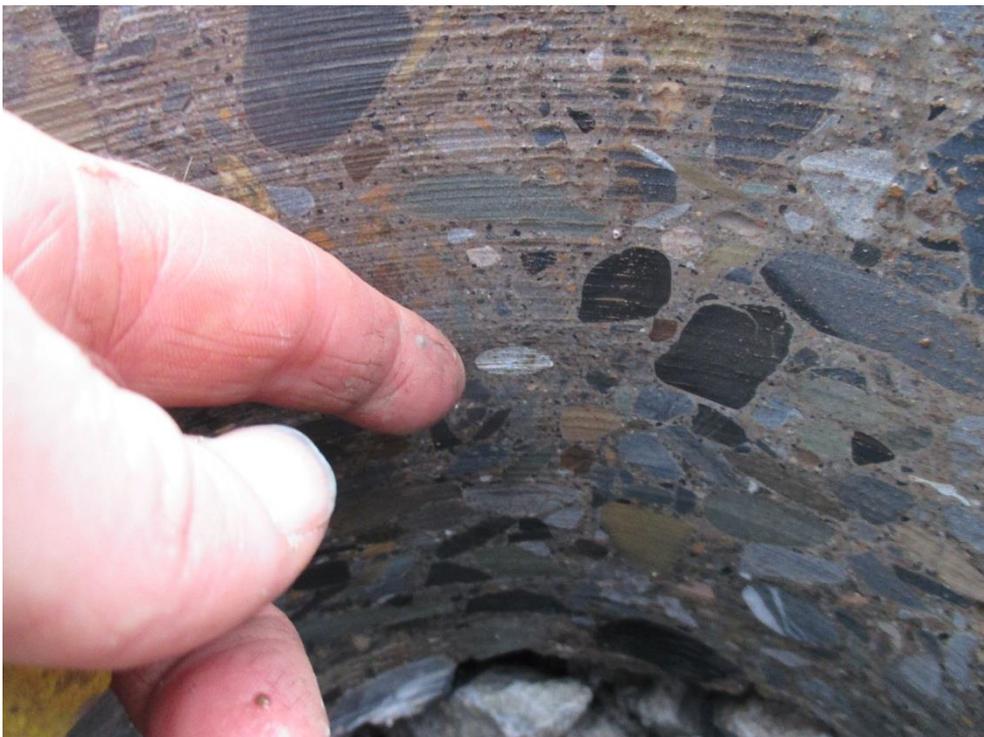
Steel reinforcement mesh was found within the cored holes which appeared to be a mesh sheet of approximately 8mm. The steel was in good condition with no corrosion visible within the core hole. The mesh is located in the middle of the slab thickness.

Fig 4.1.5 - Steel Mesh Reinforcement Visible in Slab

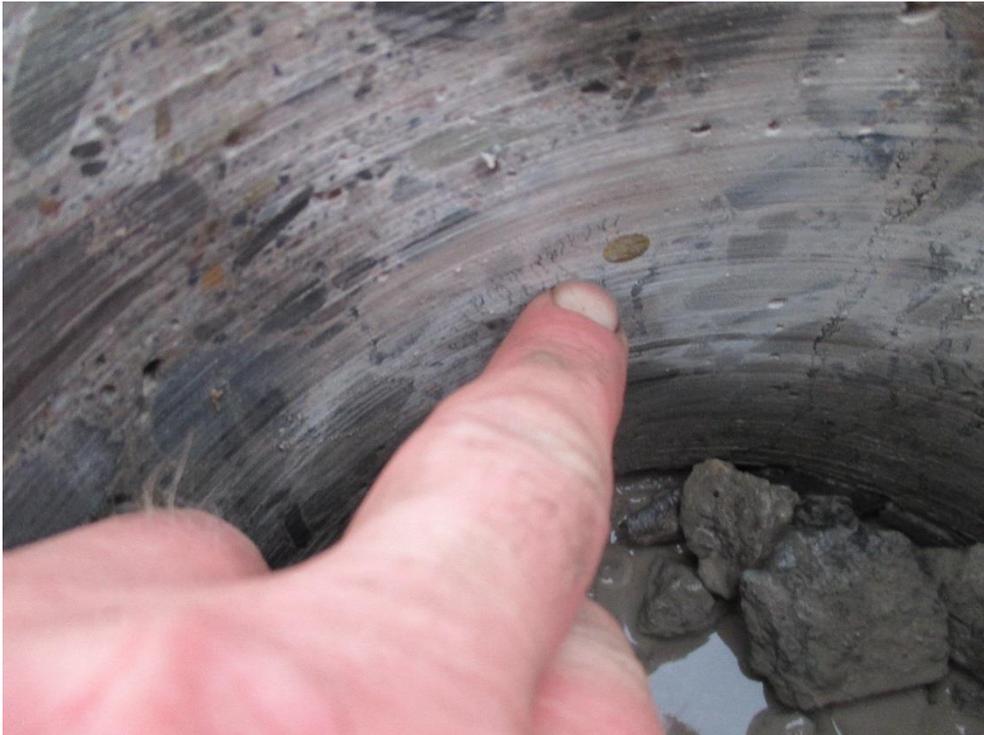
Fig 4.1.6 - Steel Mesh Reinforcement Visible in Slab

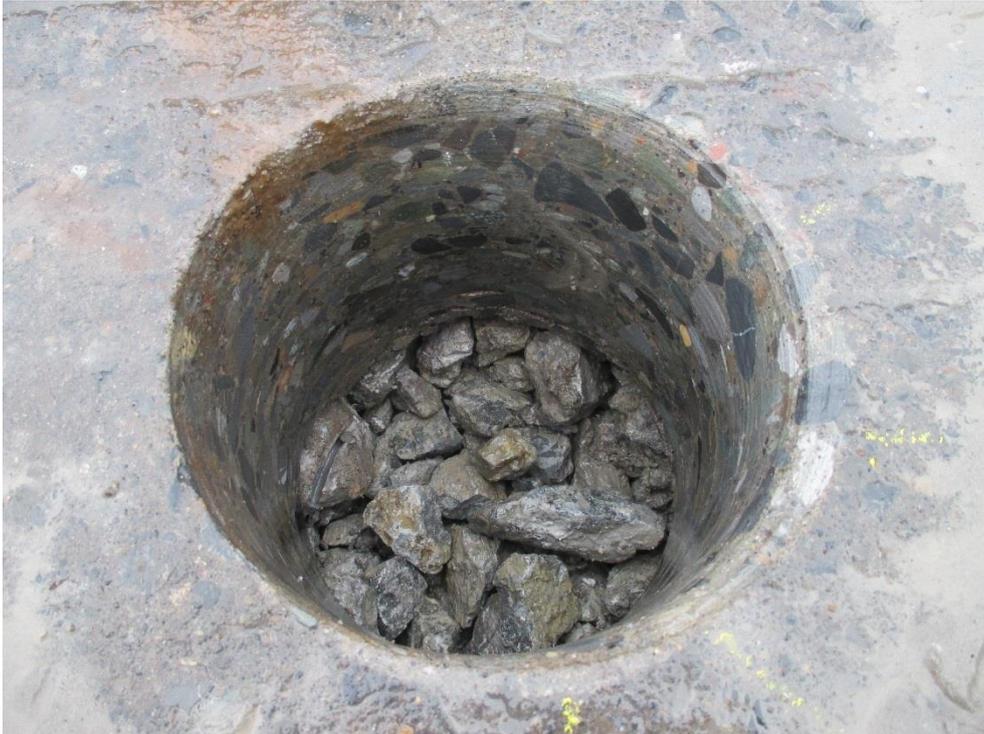
Hole 1

The fill material varied slightly between the investigation locations with a smaller stone and fines material present, particularly at locations 4 & 5. Hole no. 1 has a slightly larger stone with no fines material visible. There was no evidence that material has washed out so this could just be variations in the fill loads during construction.

Fig 4.2.1 - Fill material within hole No. 1

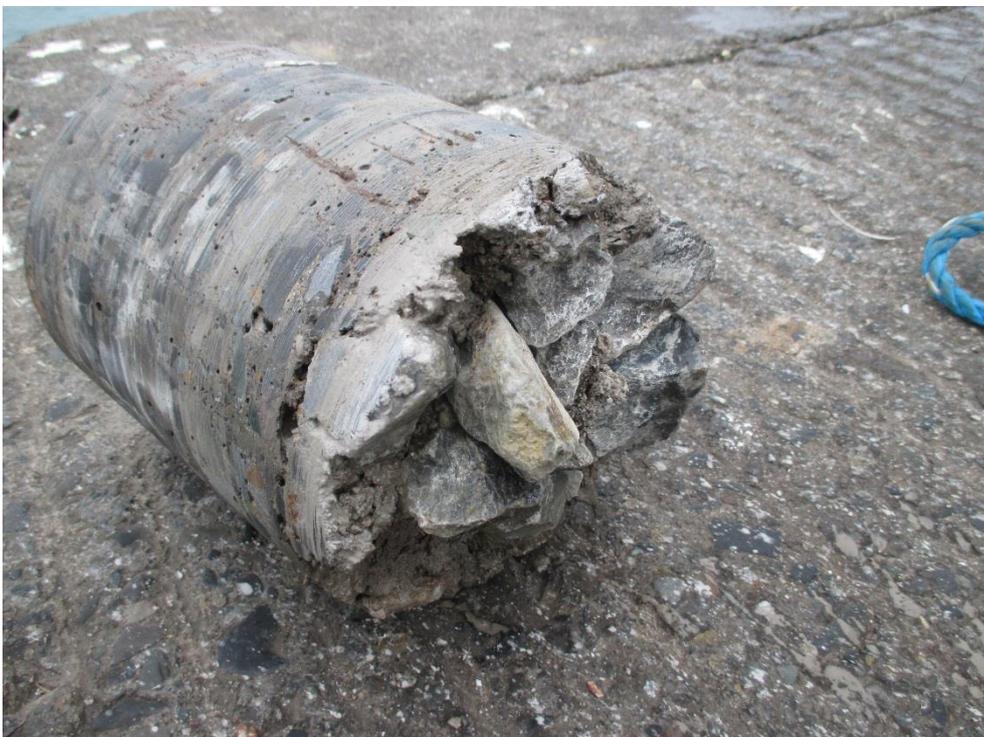
Fig 4.2.2 - Core section removed

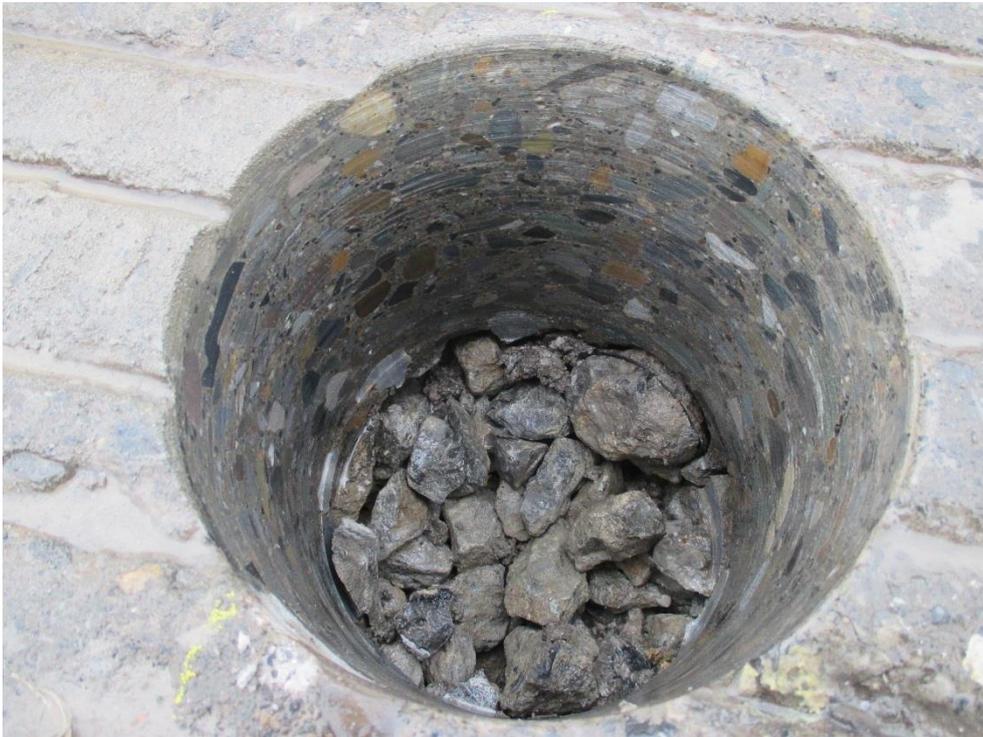
Hole 2

Fig 4.2.3 - Fill material within hole No. 2

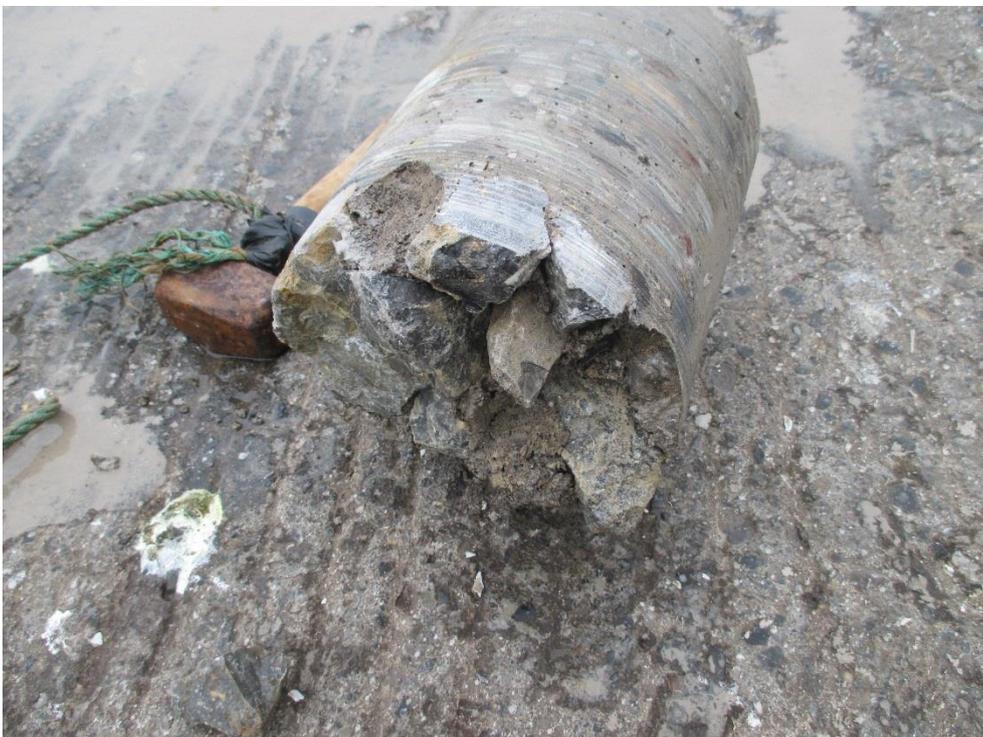
Fig 4.2.4 - Core section removed

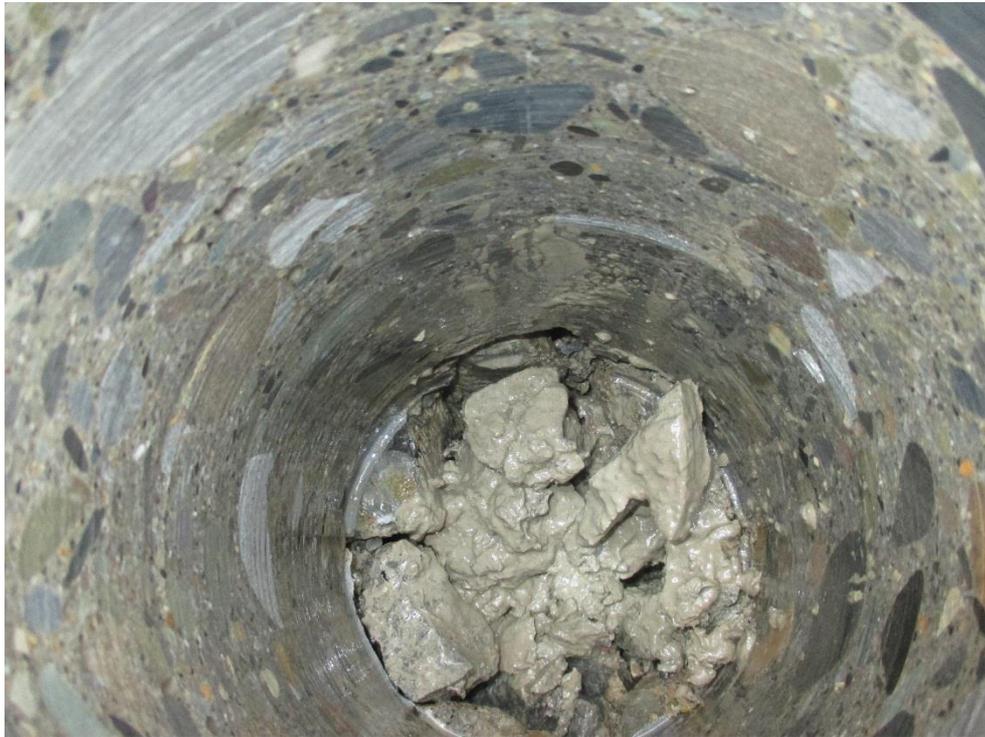
Hole 3

Fig 4.2.5 - Fill material within hole No. 3

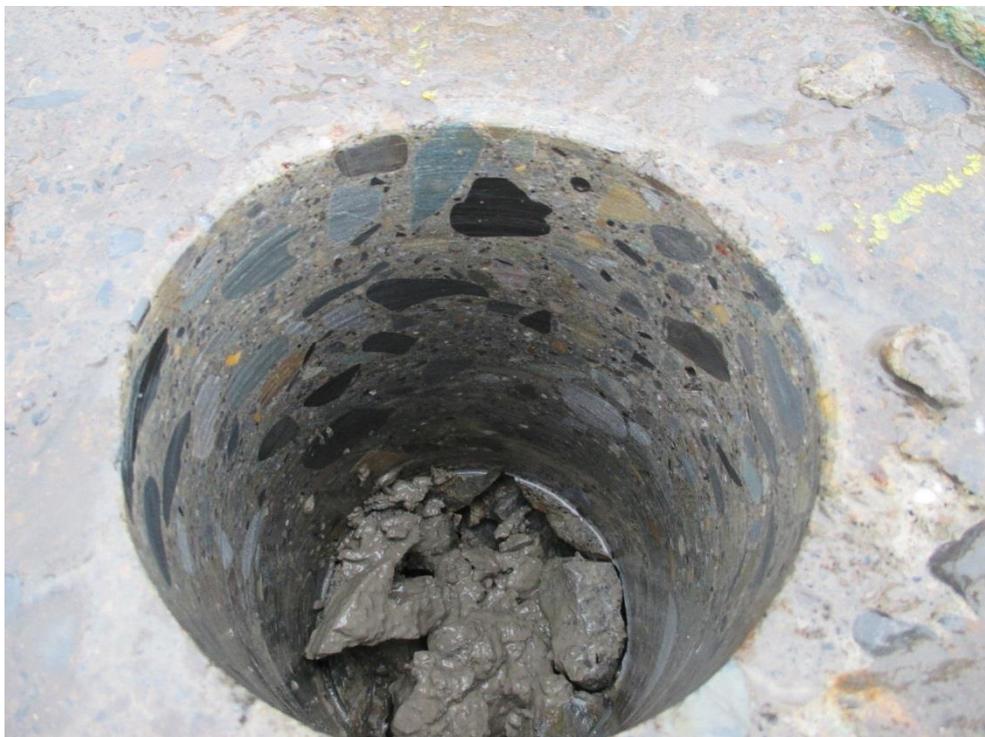
Fig 4.2.6 - Typical Slab Condition (Hole No. 3)

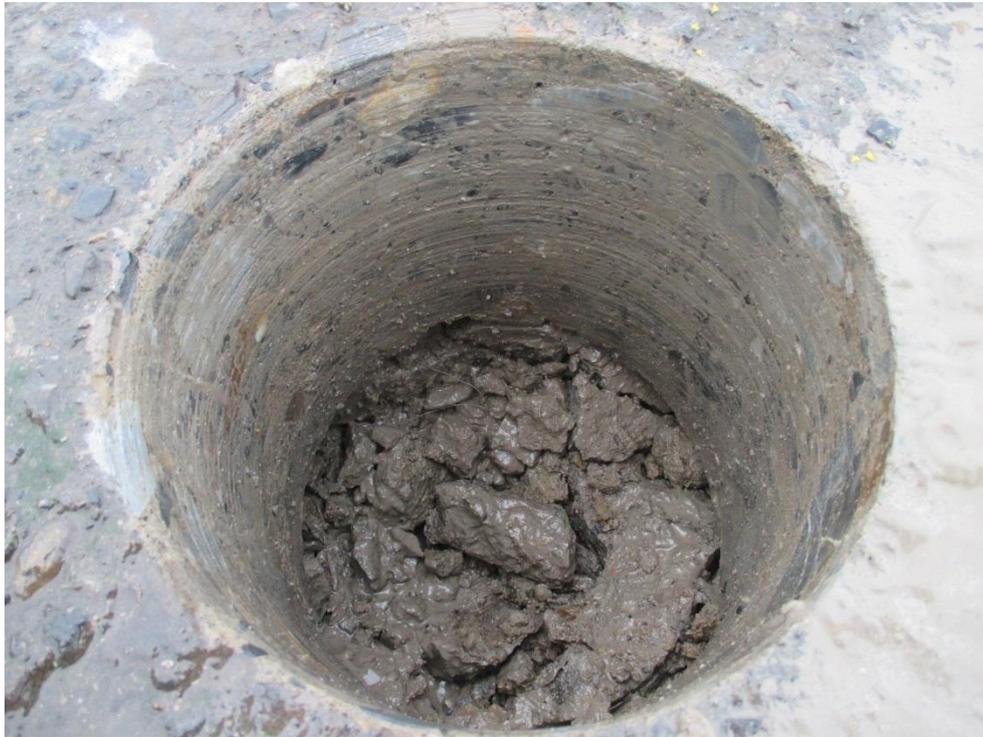
Hole 4

Fig 4.2.7 - Fill material within hole No. 4

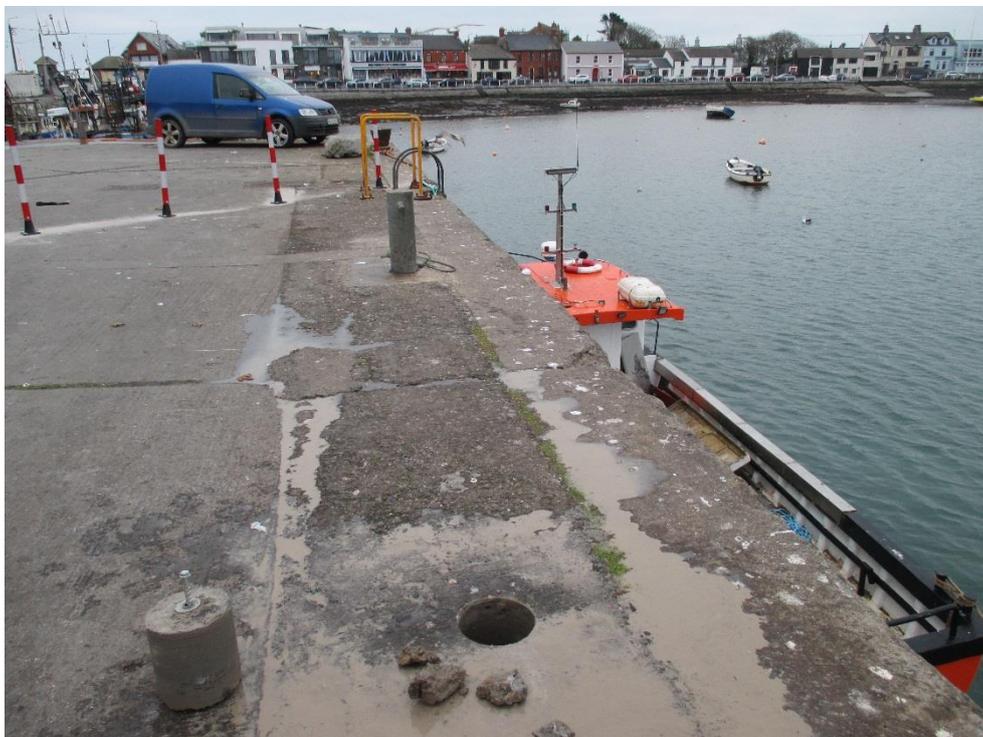
Fig 4.2.8 - Hole No. 4 location and removed core

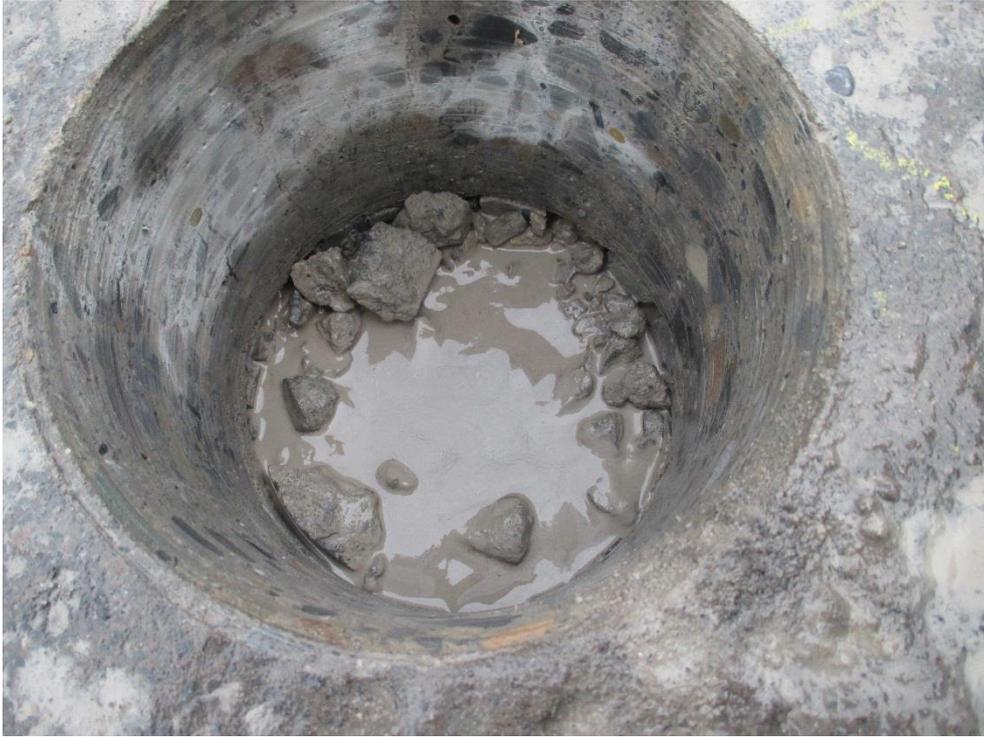
Hole 5

Fig 4.2.9 - Fill material within hole No. 5

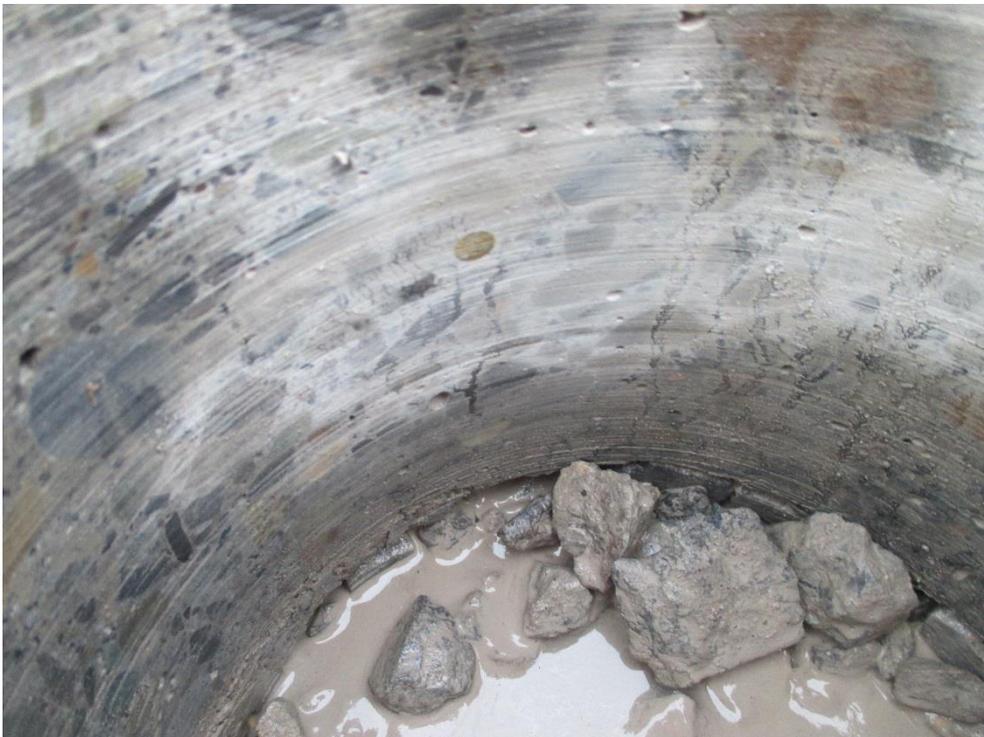
Fig 4.2.10 - Mesh Reinforcement visible within Hole No. 5
