# Record of Conservation Works at St. Columba's, Swords, Co. Dublin

CMF23-1-DF001

Finola O'Carroll

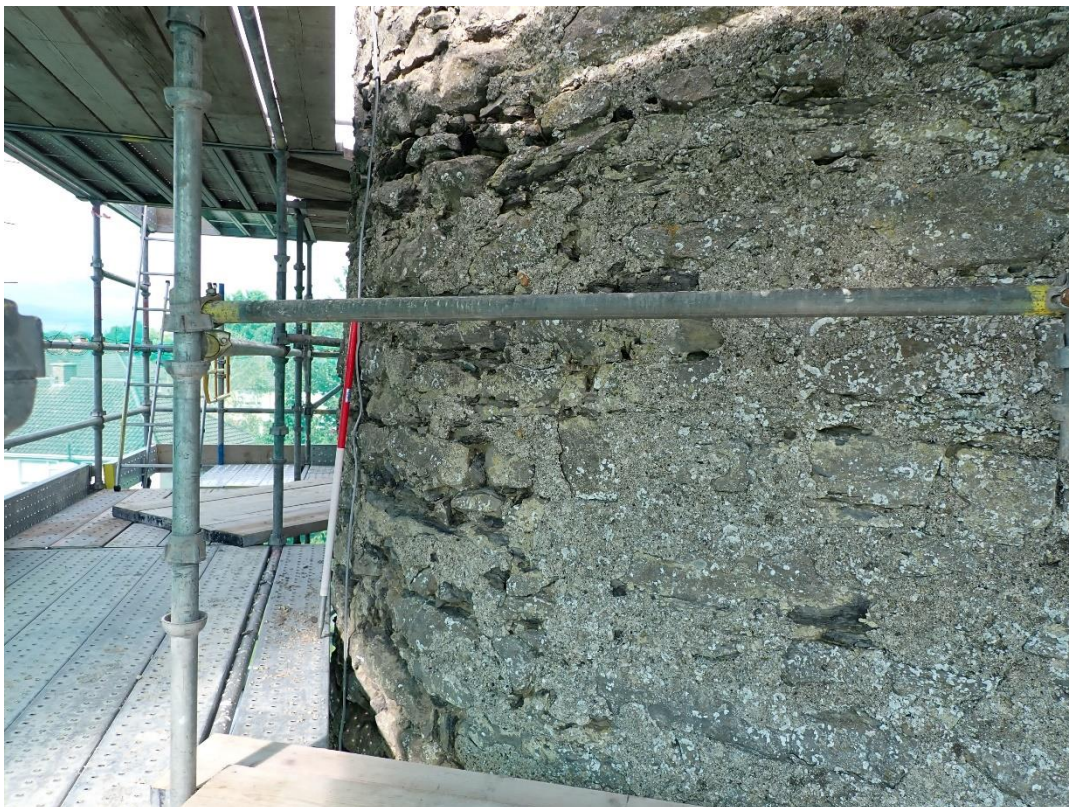
The southeast side had been noticeably scoured by the effect of the prevailing winds channelling between the two towers though the upper third or more of the tower was less affected. This resulted in the noticeable loss of mortar from a strip running from the ground level to a point over halfway up the tower, with deep erosion of the mortar from the affected area.

Plate 2: View looking west along the southeast side of the tower showing the effect of wind scour

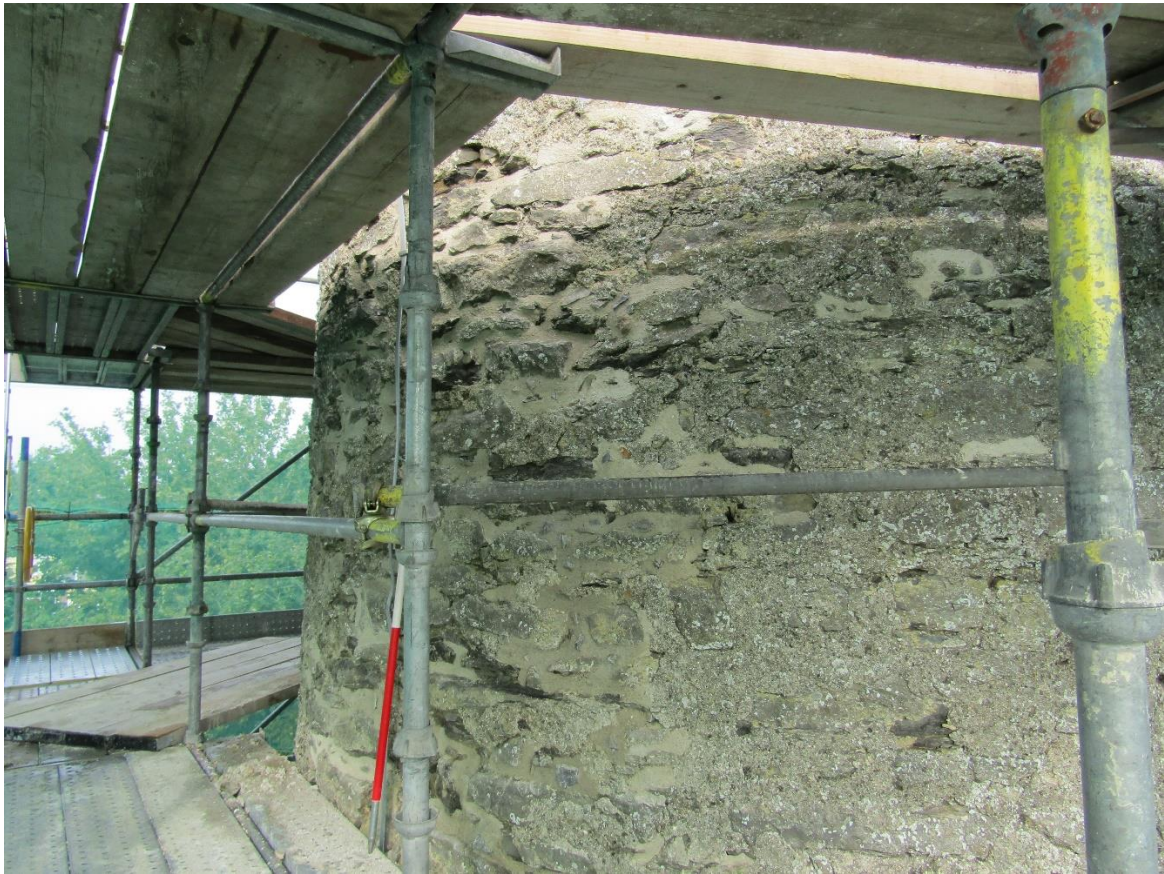
Plate 3: The same section after re-pointing

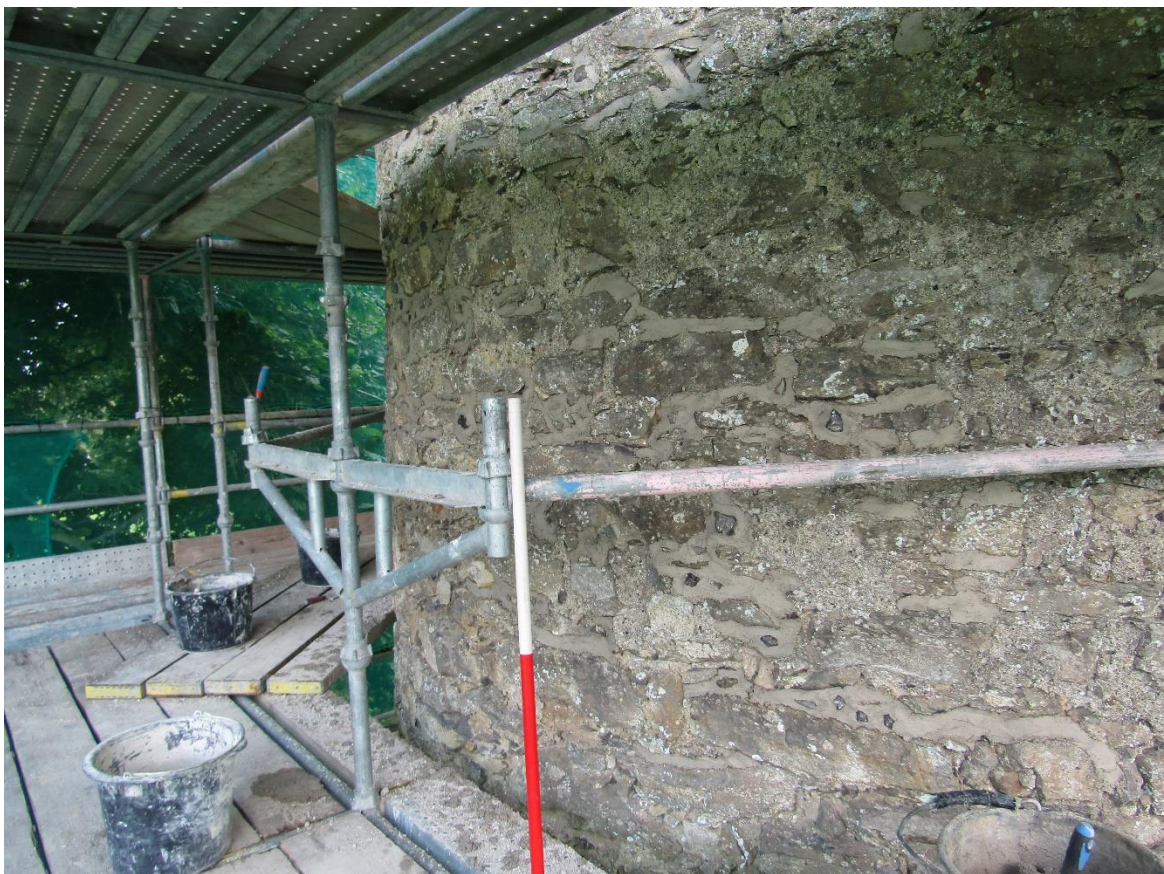
Plate 4: the northwest side next level down with deep gaps being filled.

In places the mortar loss was such that pinning stones had to be added in with the initial mortar infill before finishing.

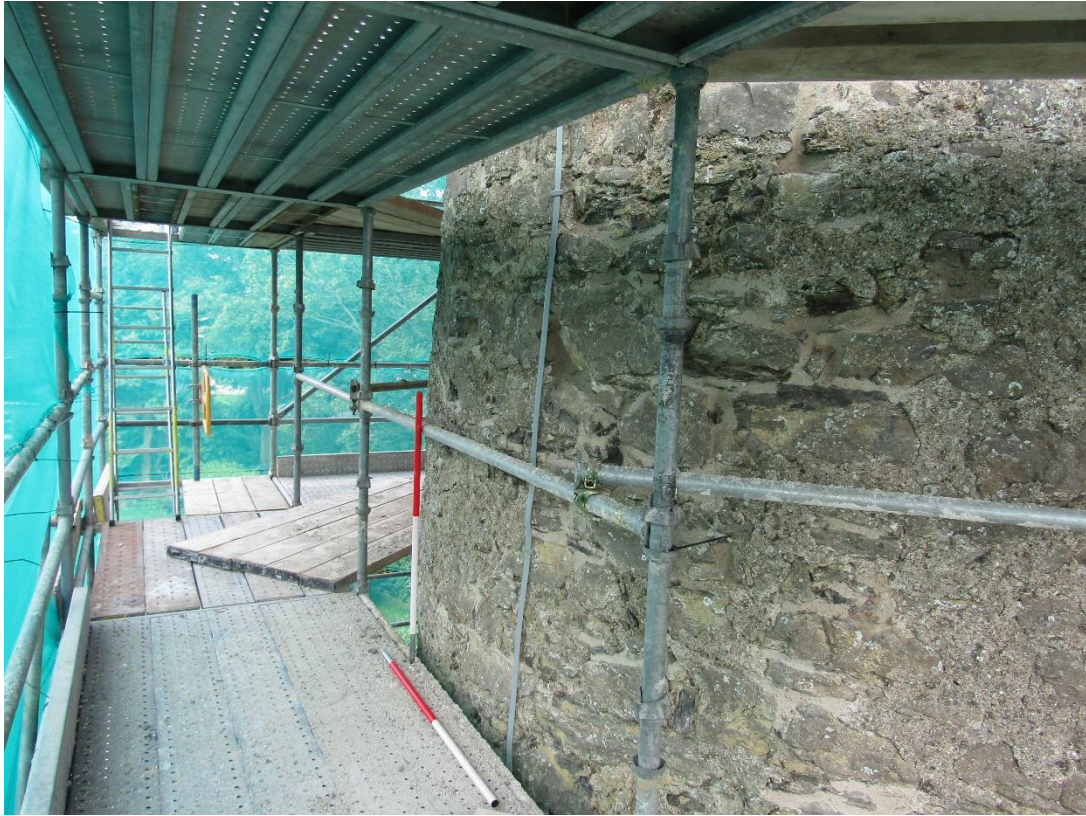
Plate 5: the southwest side after re-pointing

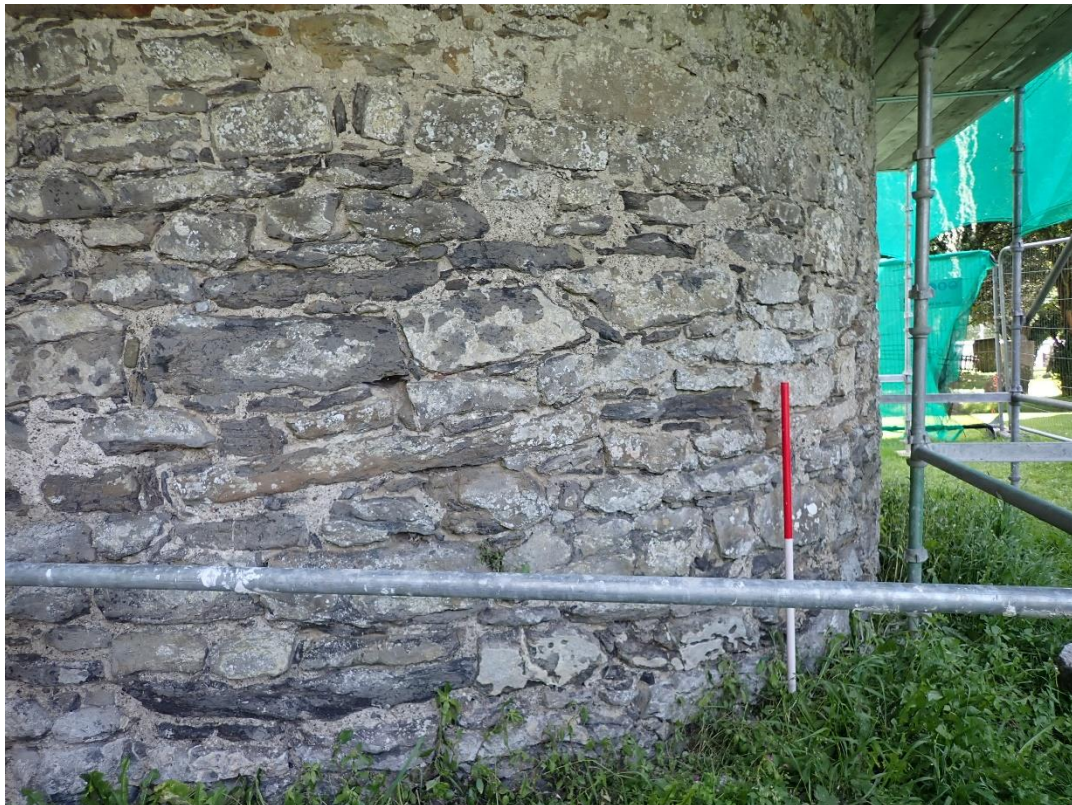
Plate 6: the northwest side at ground level before work was completed.

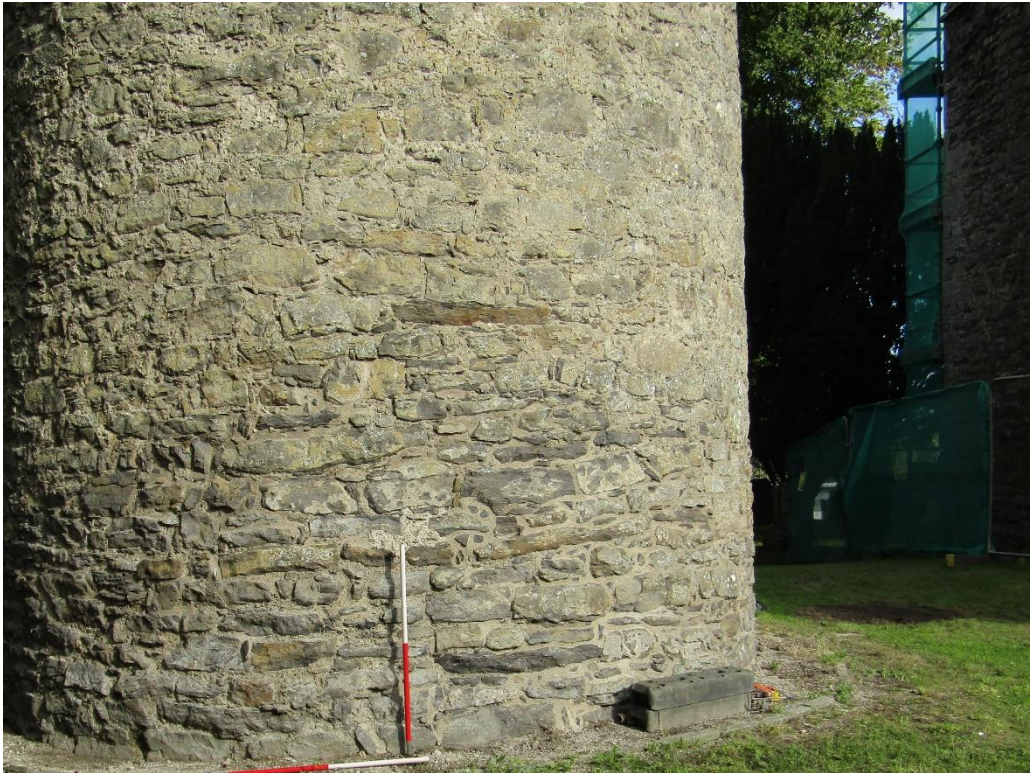
Plate 7: the same side after work was completed

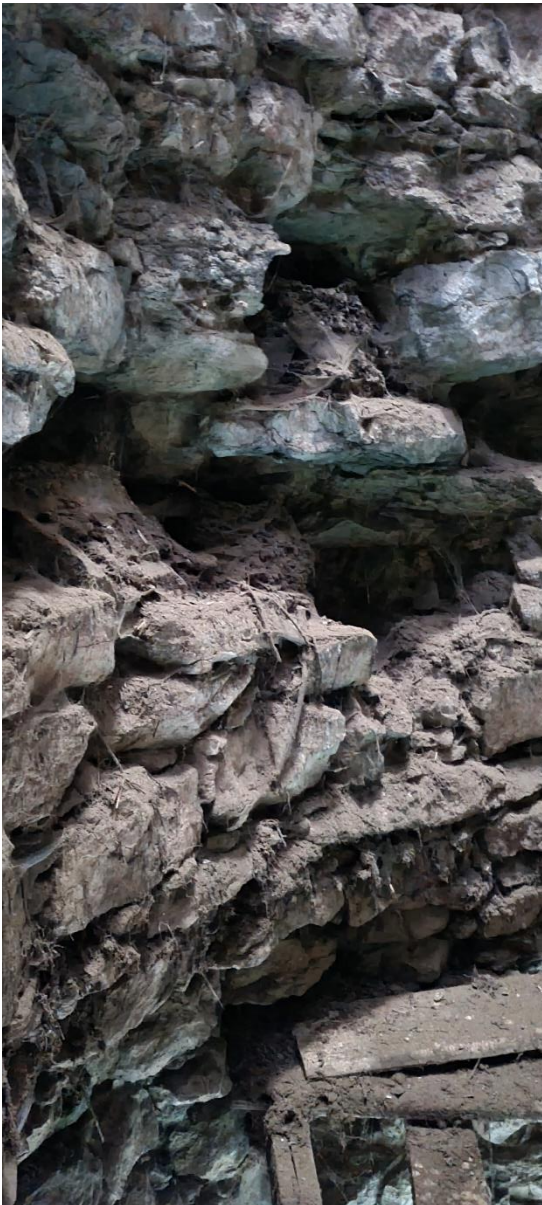
Plate 9: view through the north window at the condition of the wall on the east side.

This limited examination suggests that there is considerable mortar loss from the interior of the tower, and quite probably significant stone loss also. It is however possible that the stone loss seen in Plate 9 is in fact the position of the original floor level at that point, and that the timber floor remaining in situ was placed in an incorrect position. But, when looking below this level it can be seen that apparent stone loss there cannot be explained this way, as the area where stones are missing is too close to the corbels of the so-called treasury floor to be another level.

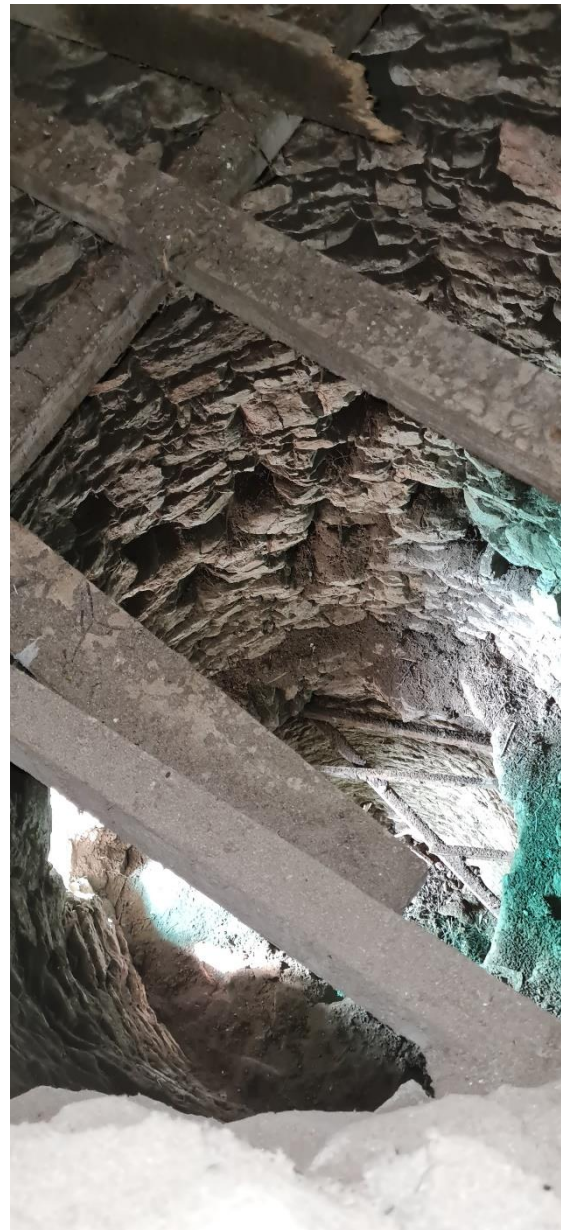
Plate 10: View from the north window looking down. The east window is left below, and the apparent stone loss is from above the corbels of the first floor.

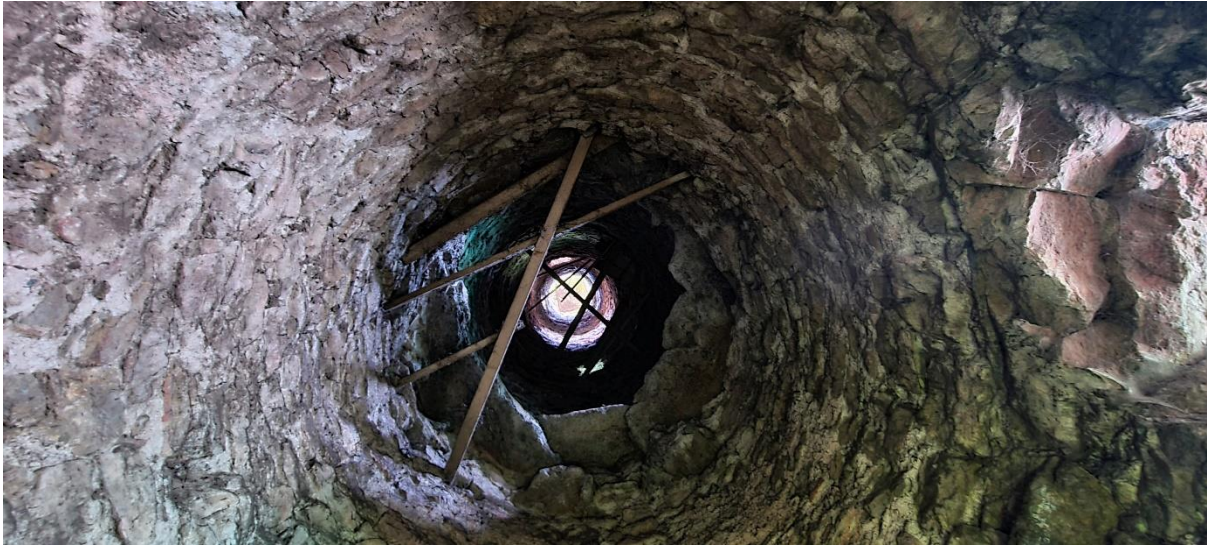
The condition of some of the stones in the lowest level also suggested that they had been affected by heat. This was especially noticeable in the interior lintels of the doorway. However, information from Mr. Eric Wolfe suggests that this may have been caused by a fire which occurred sometime in the 1990's when nesting material which had accumulated within the tower was set on fire. He stated that the fire smouldered for several days.

Plate 11: view looking up the tower from the basement; the inner lintels of the door are visible on the right and appear to be heat affected

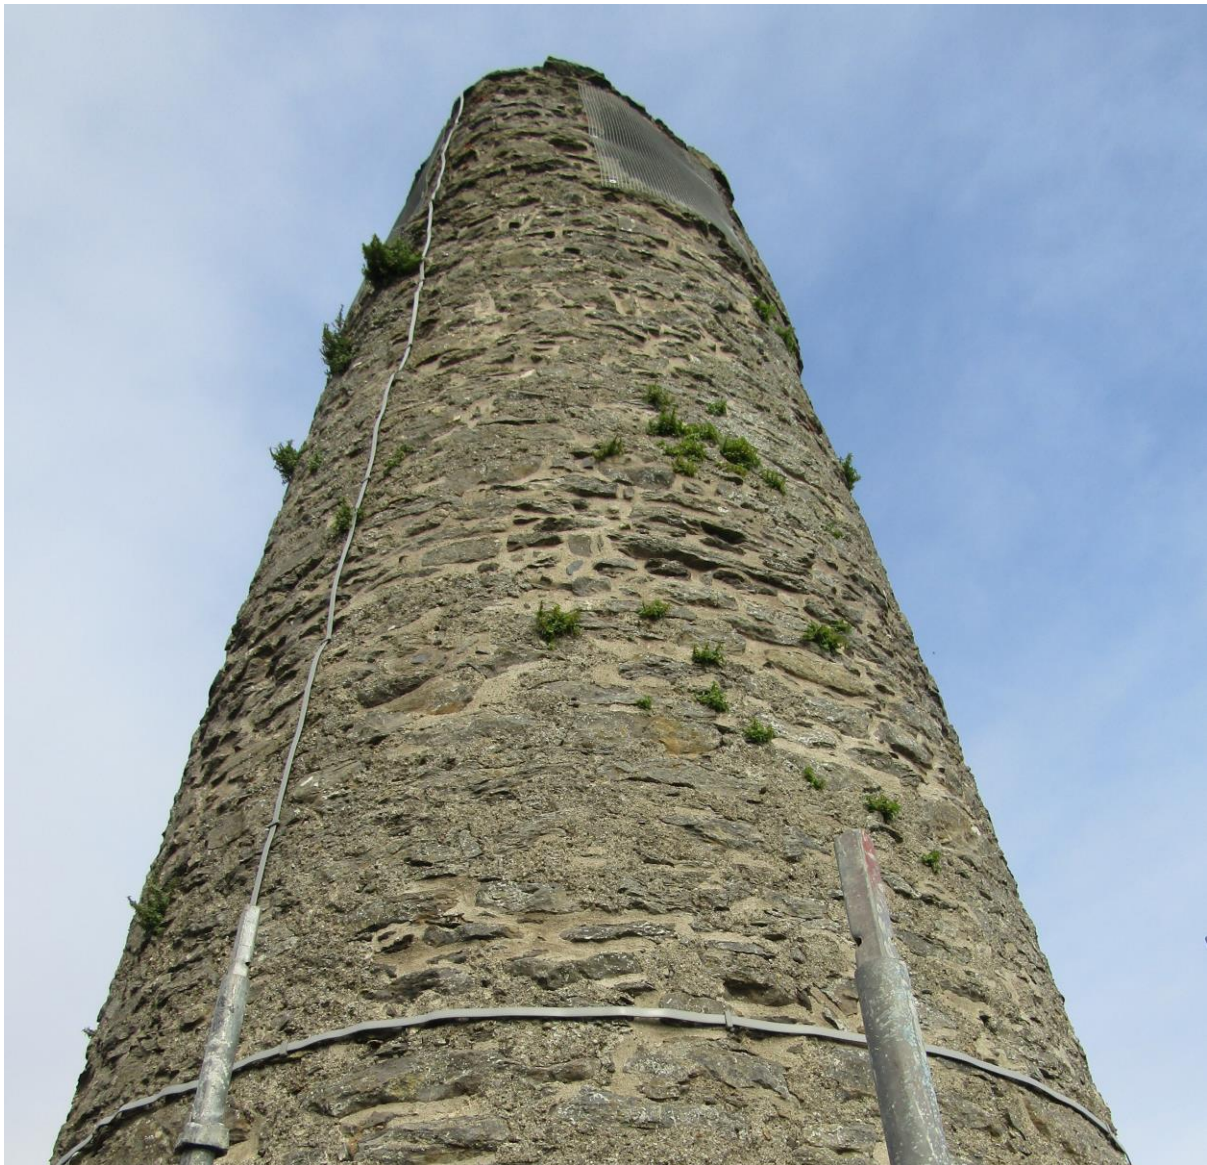
Plate 12: view looking NW at the upper floors of the tower showing some vegetation re-growth

It was noted that there has been some re-growth of the vegetation on the tower since the upper levels were cleared last year. This doesn't appear to be affecting the areas which were repointed, but it's not entirely clear if this is so.

The conservation works have hopefully ensured the ongoing preservation of these monuments. The re-growth of vegetation on previously conserved parts of the round tower, and on the north face of the belfry tower will need to be monitored. The interior of the round tower is concerning, both because of the clear erosion of mortar from the joints and the lack of clarity about how the original floors were fixed into the walls.

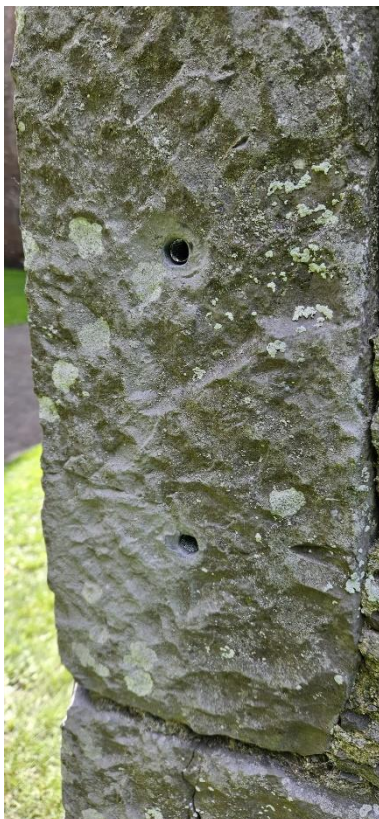
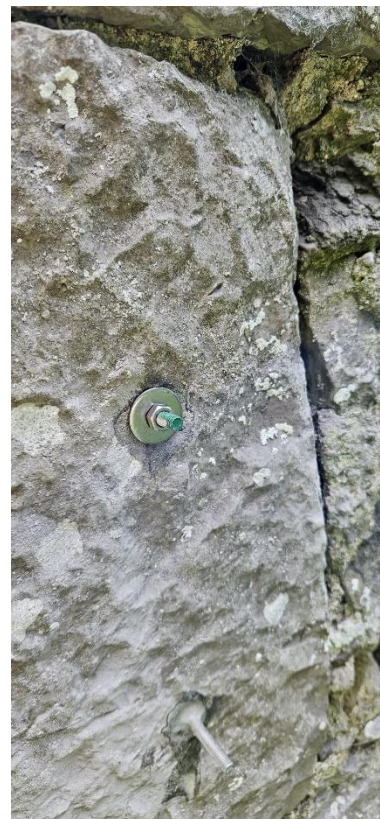
Plates 13 and 14: hole drilled for bar, and bar fastened with washer and nut. See also frontispiece.

Once the work on the exterior of the round tower was completed the scaffolding was taken down and re-erected at the belfry tower. Prior to this the repairs to the lower quoins at the northeast corner were undertaken, using steel rods, mesh sleeve, and a chemical agent to hold the bar which was then threaded into a nut at either end.

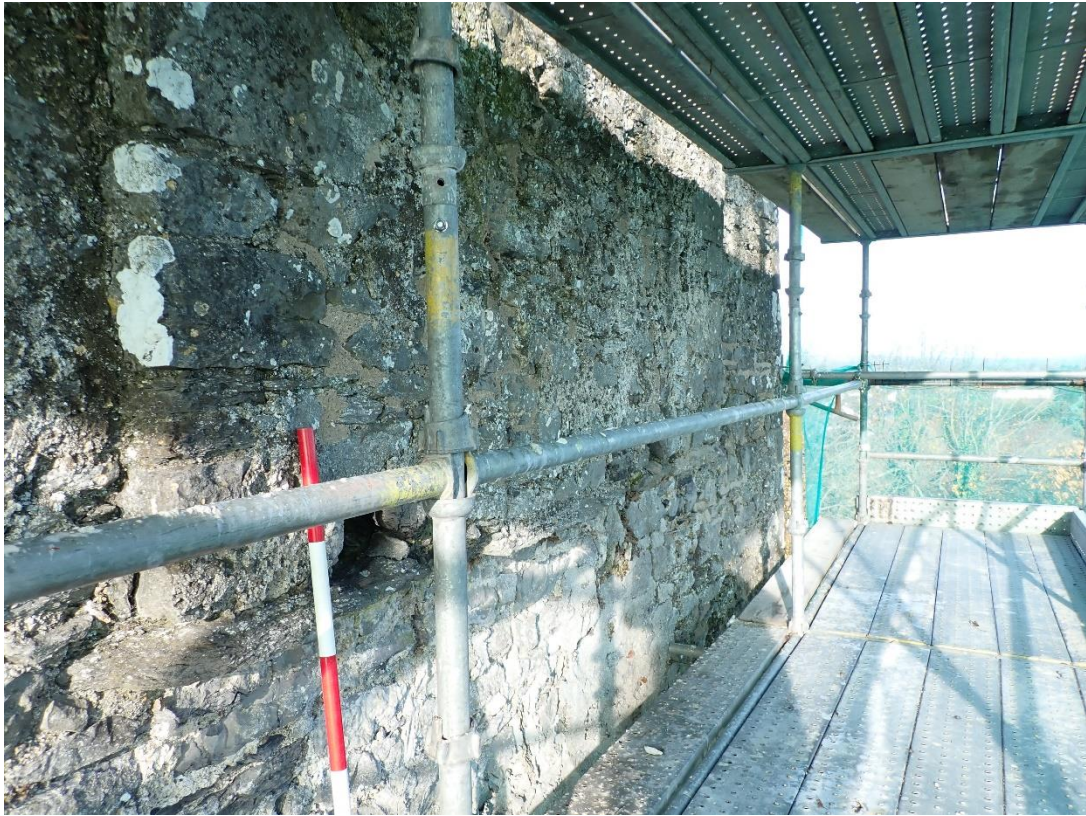
Plate 15: East face, base of projecting parapet, east face after vegetation removal and re-pointing

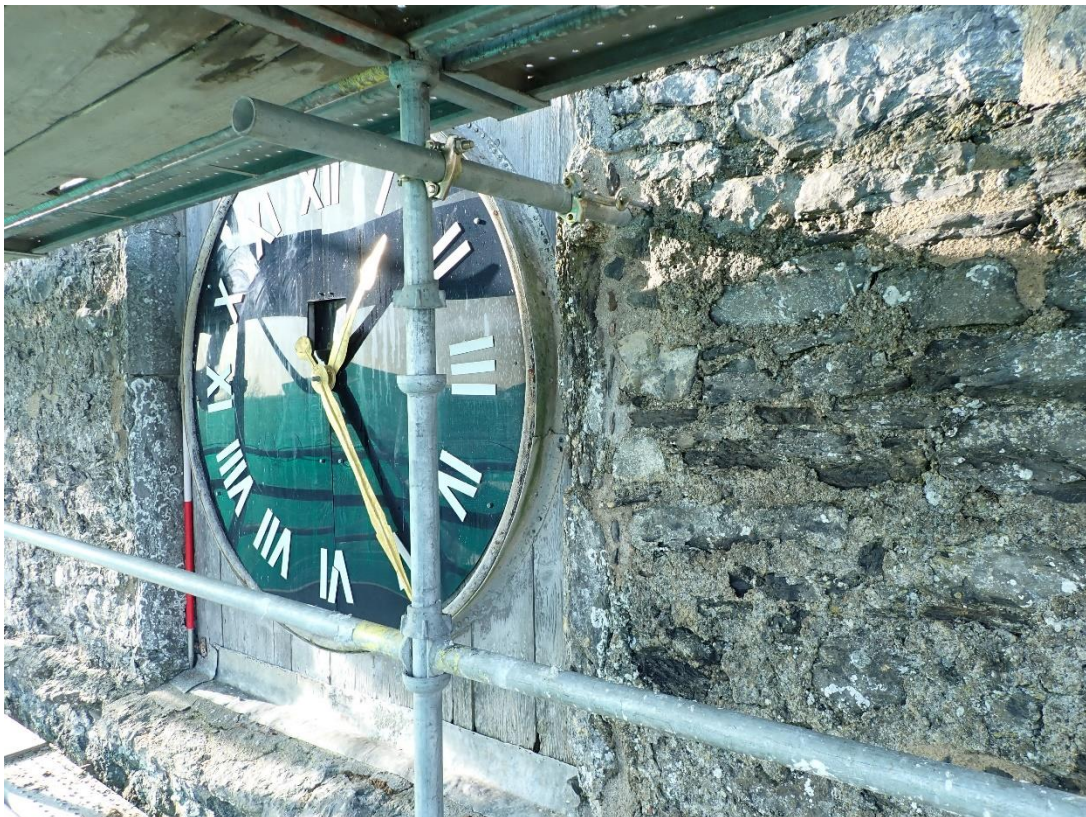
Plate 16: East face, repairs to string course beneath clock

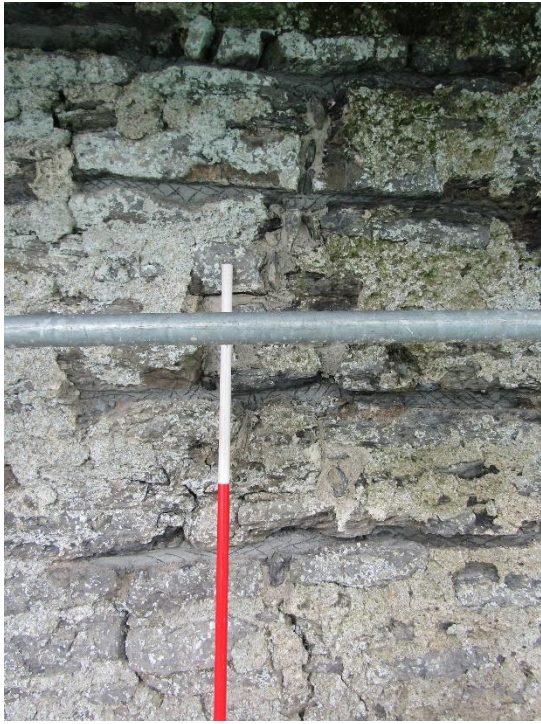
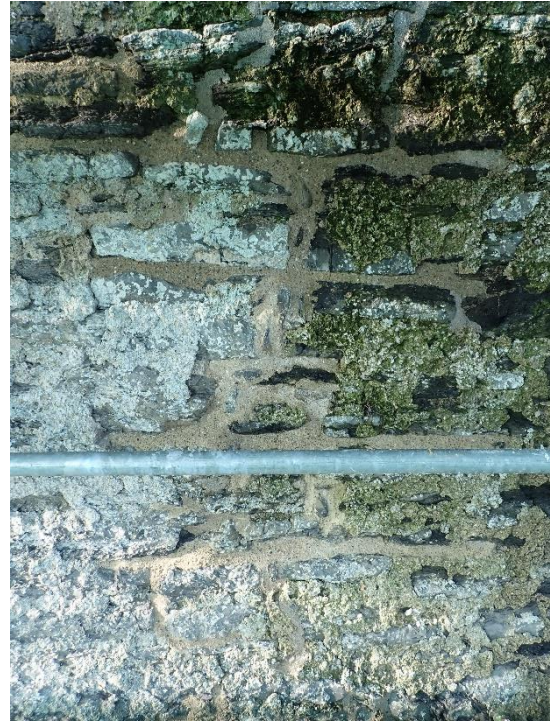
Plates 17 and 18: East face, crack below clock being stitched, filled and then pointed.

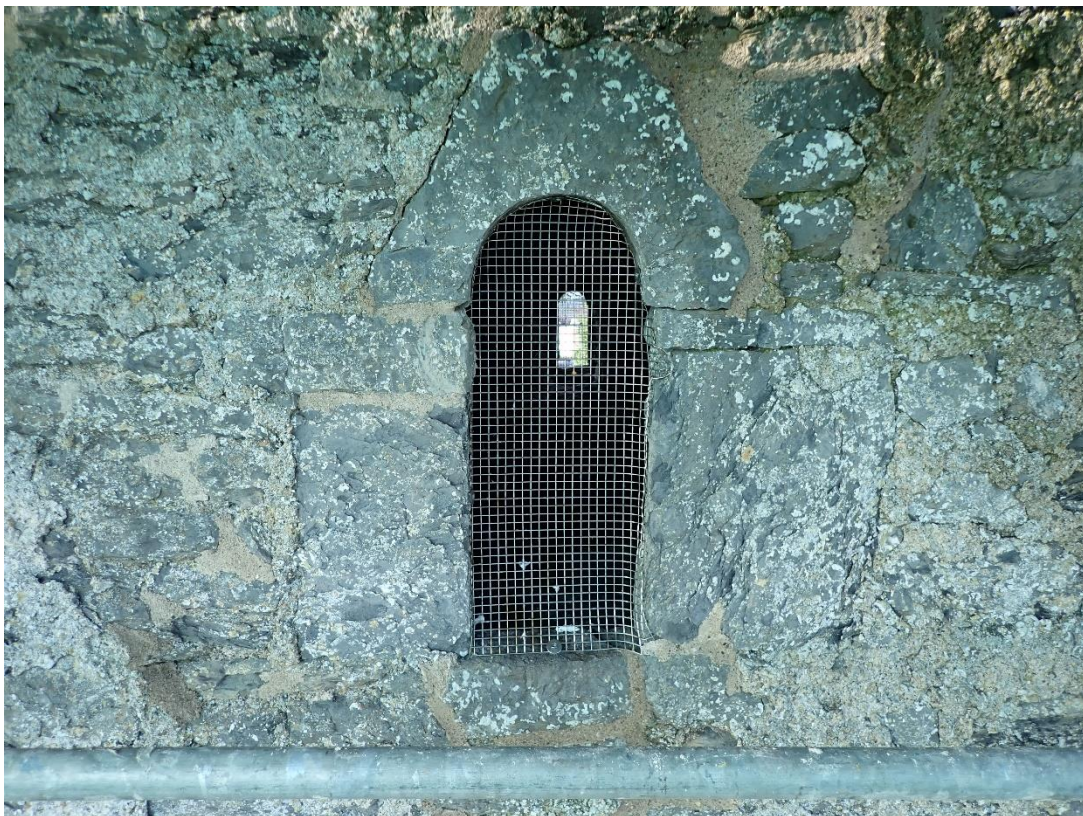
Plate 19: East face, round headed window with mesh grille inserted and re-pointing of surrounding stonework.

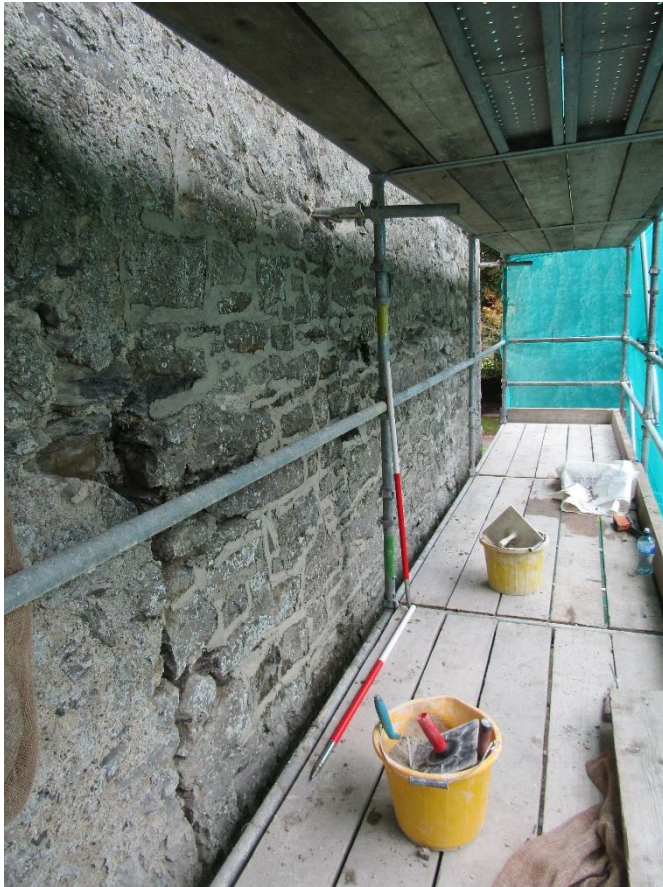
Plate 20: East face, crack at south side prior to repair.

Re-pointing continued down the wall, and when the larger crack was reached that had to be fully packed and then repointed.

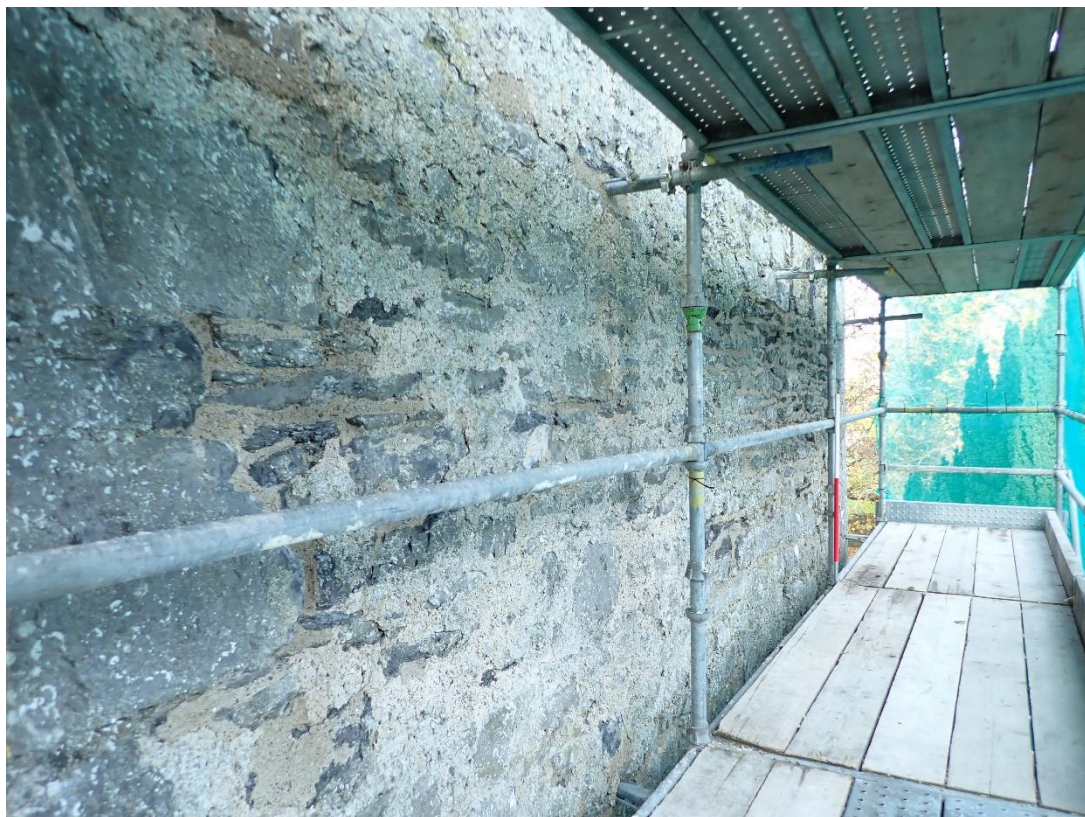
Plate 21: East face, crack at south end after repairs

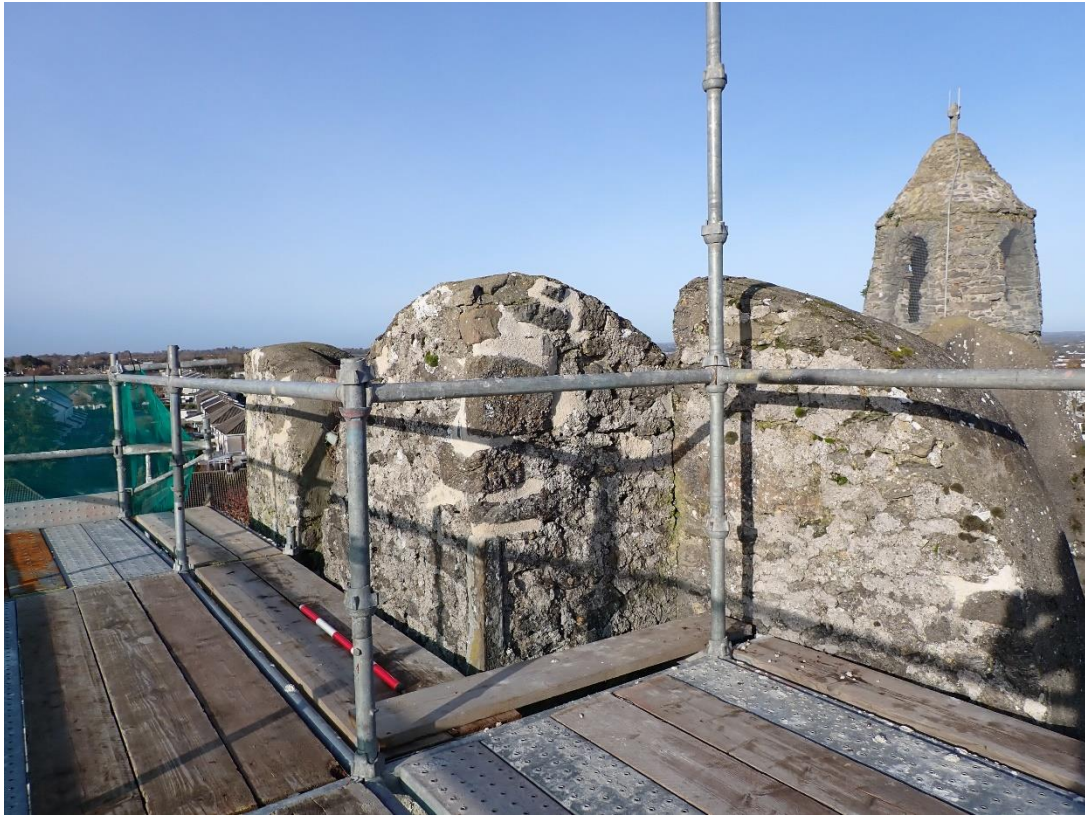
Plate 22: South face, re-pointing of the crenellations at the angle of the projecting stair tower.

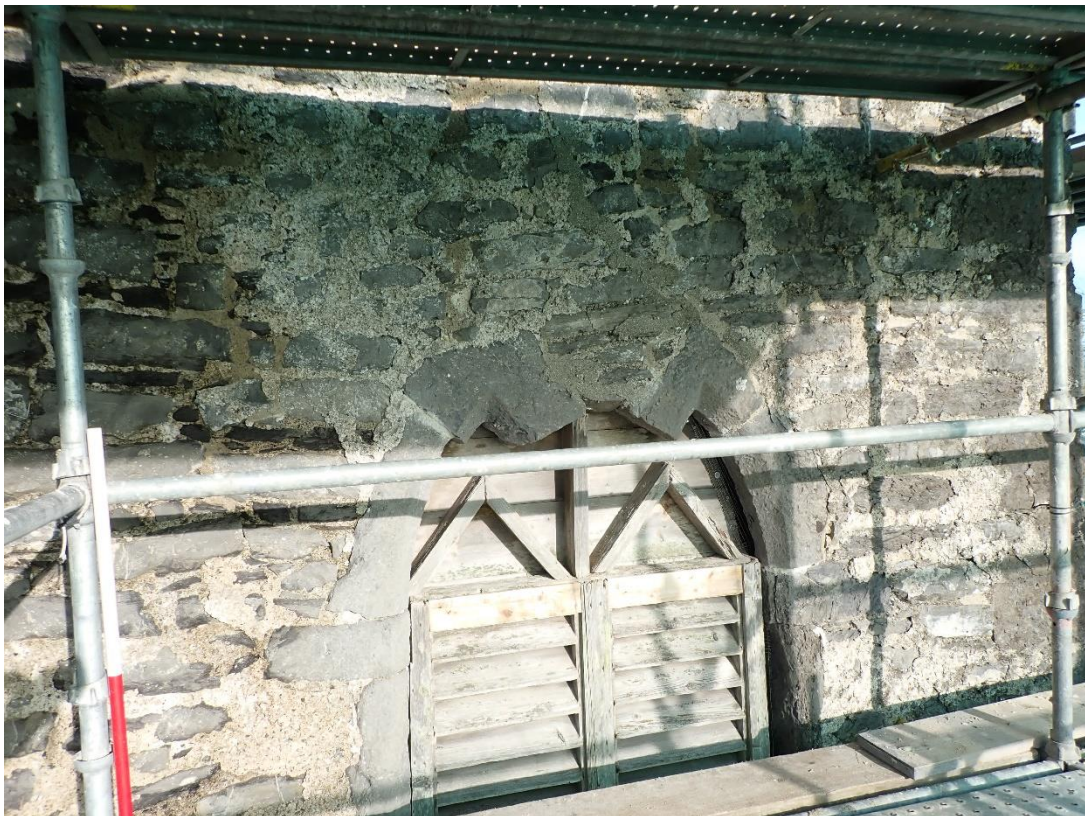
Plate 23: South face, arches above window after stitching with steel bars.

The window in the south face has had its tracery broken out and the remaining pointed arches in the frame were in danger of collapse. These have been stitched and stabilised. The ends of the bars are visible.

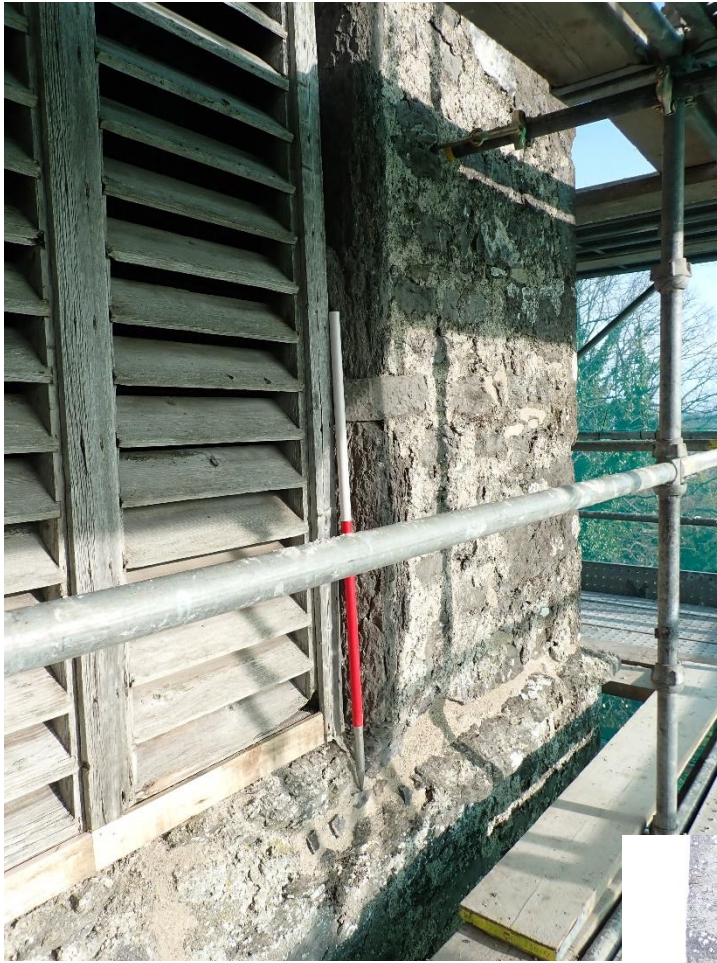
Plate 24: South side, replacement wooden sill and repointing of the string course at the base of the window.

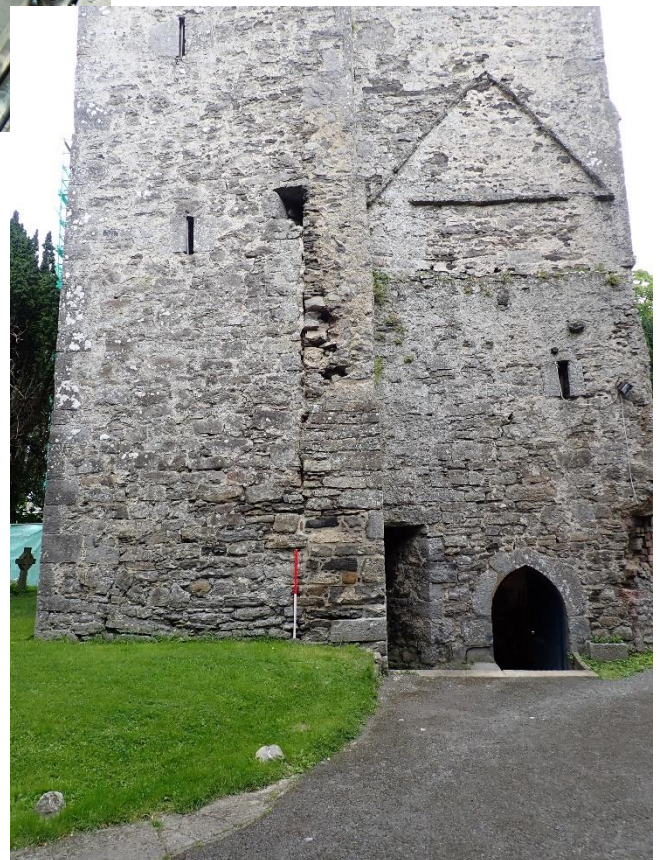
Plate 25: South face prior to conservation, note the area of the join of a former wall.

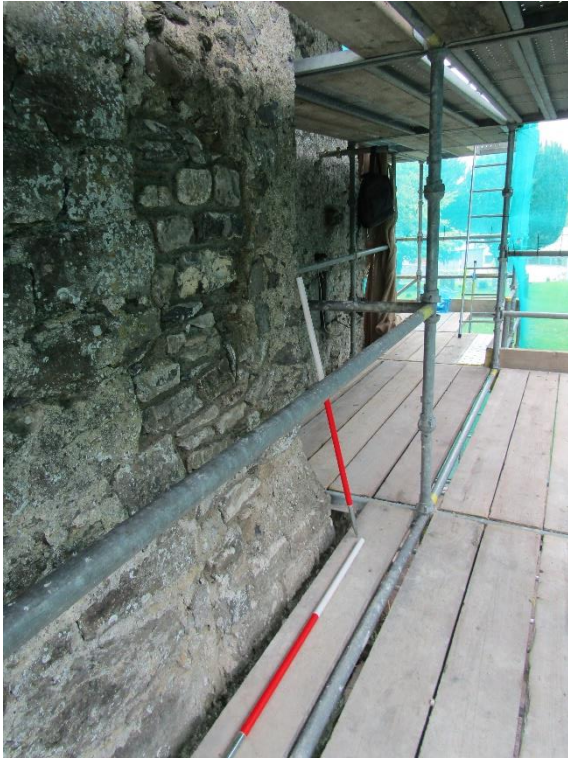
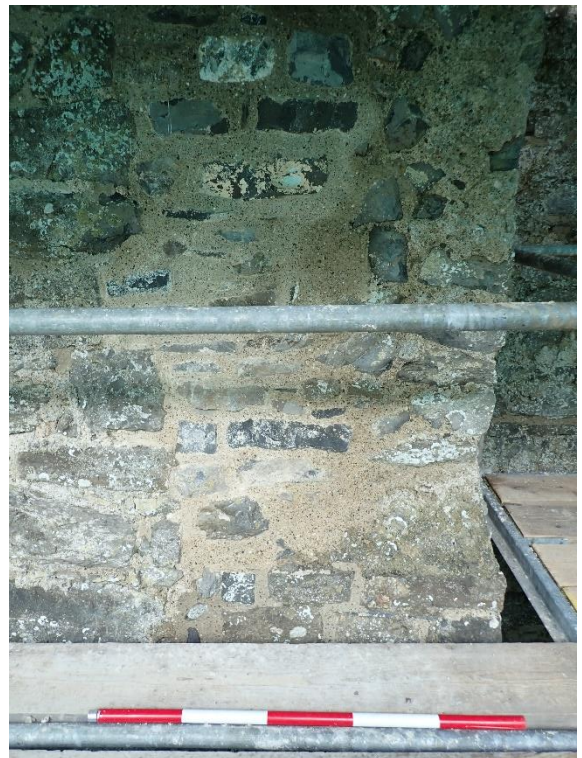
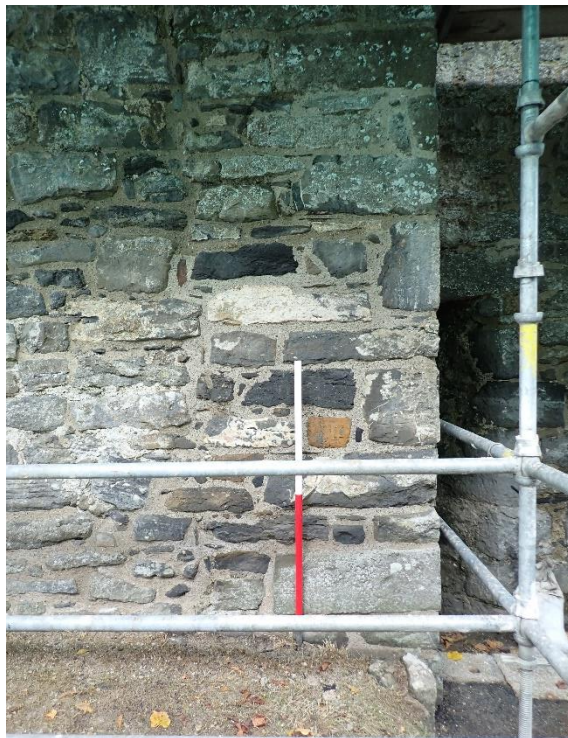
Plates 26-28: South side, repairs to the masonry join. Preparatory work, (Plate 26) followed by final pointing (Plate 27) and lower level, Plate 28.

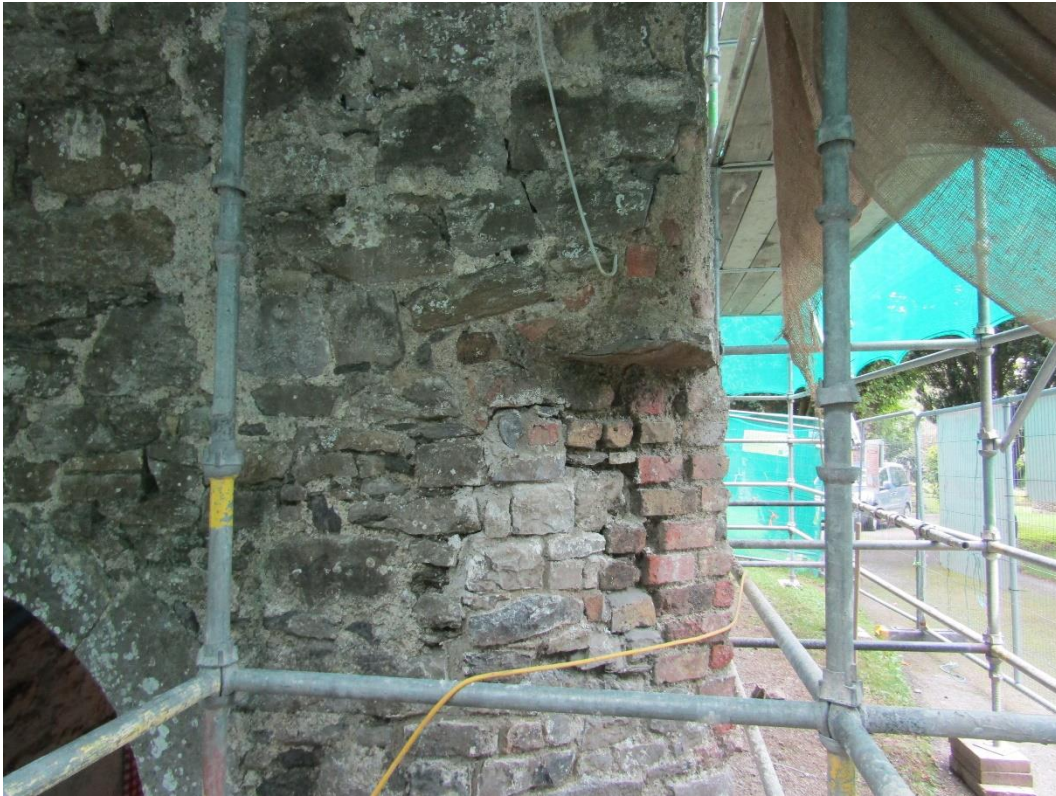
Plate 29: Southeast corner, brick facing on cut out corner, before repair.

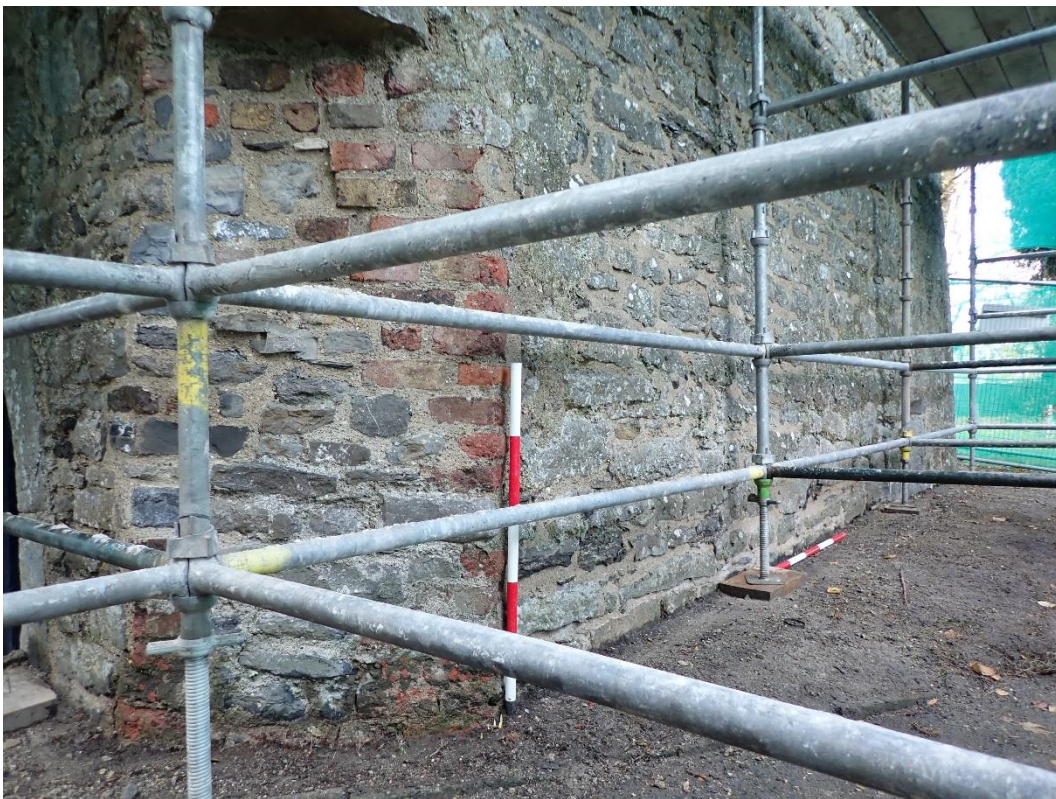
Plate 30: Southeast corner, repairs and re-pointing work completed.

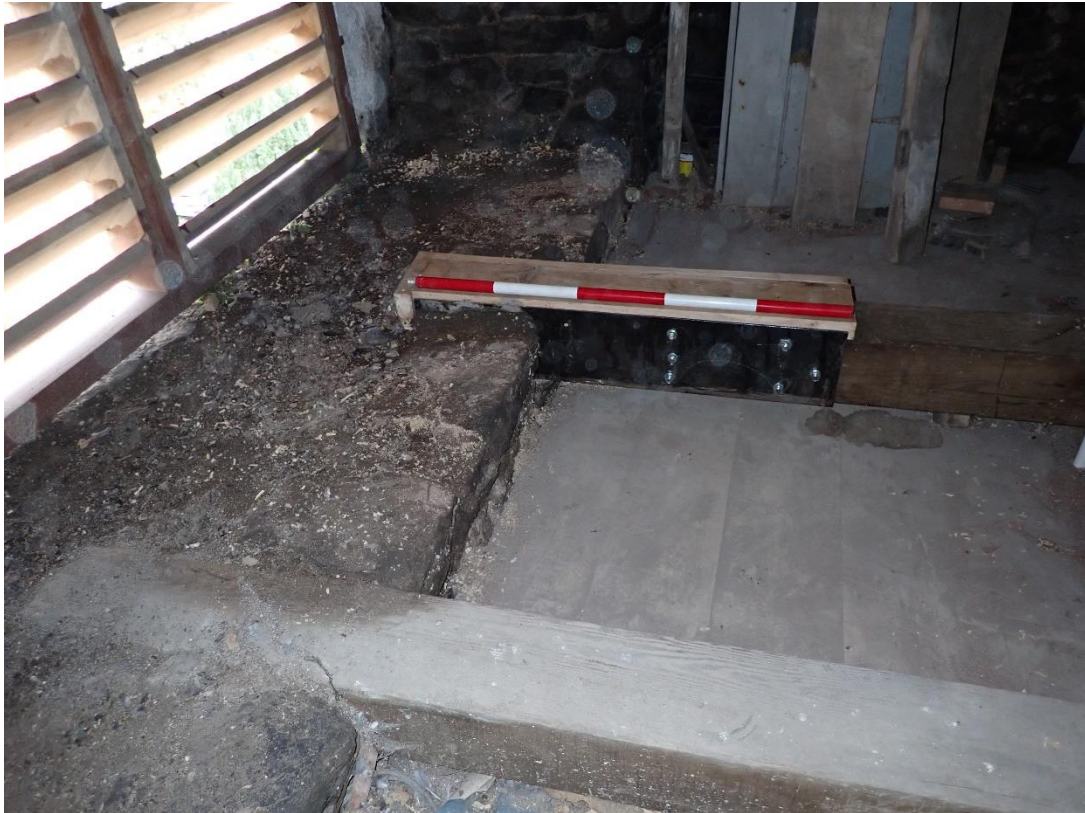
Plate 31: Interior, steel shoe in place to repair the end of one of the beams supporting the bell.

A steel shoe was made to join a new piece of timber to the original beam to replace the section on the wall ledge where it was decaying. The shoe had been made deeper than required and filled with a plank of timber.
