**Tower House
at
Glebe South
Balrothery, Co. Dublin
Archaeological Oversight Report**

CMF23-1-DF003

RMP No. DU005-057006-

License No. 23E0833

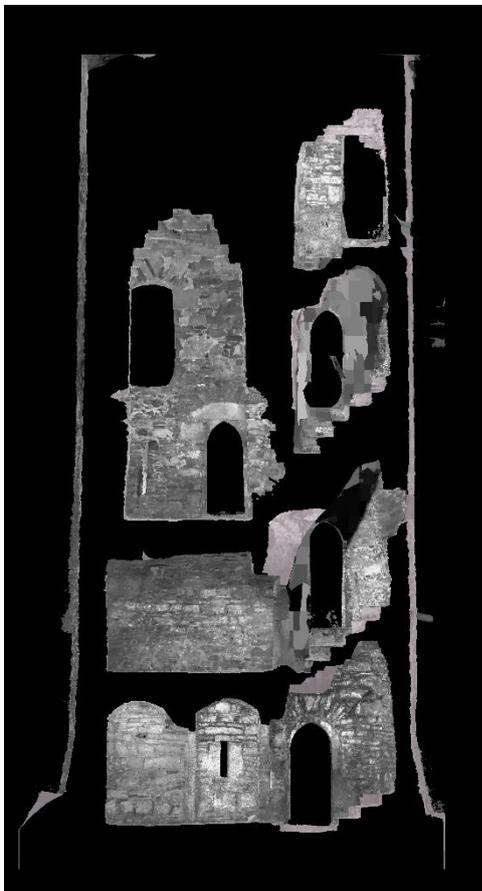
During and after the removal of vegetation and humus from the roof above the caphouse and small room it became apparent that the corbelling seen in the ceilings of both of those structures continued seamlessly to form the roof / platform above. The roof surface is composed of overlapping massive limestone flags, sloping from south down to north and from east down to west (Figure 1, plan of roof; Figure 2, profile). The differences in height between the two ceiling levels is seen in the image captured as part of the surveys conducted in 2022, but the depth of flagstones used to make up the corbelled ceilings to roof / platform level must be at least 0.6m.

Plate 1: Cross-section through the west end showing the heights of the corbelled ceilings, stairs to right (Image from Tír 3D)

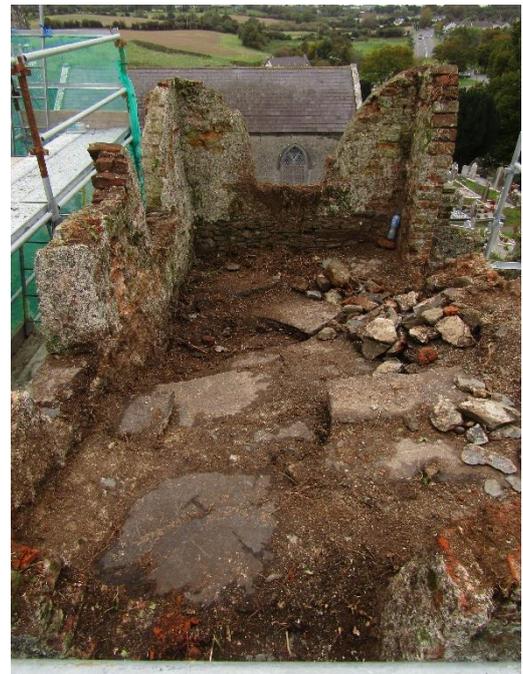
Plate 2: View looking north from above the stairs, showing the flagstones being uncovered

The roof is 2.23m E/W by 4.55m N/S. It drops about 1.10m from south to north (Plate 2) and 0.6m from east to west at the north end, and about 0.3m at the south end (Plate 3). Previously, two openings high up on the west wall had been interpreted as rainwater goods, although they were at very different levels (O'Carroll 2022, p. 16). At the north end an opening 1.78m below the sill in the crenel is visible on the exterior of the west wall, but before the humus was removed

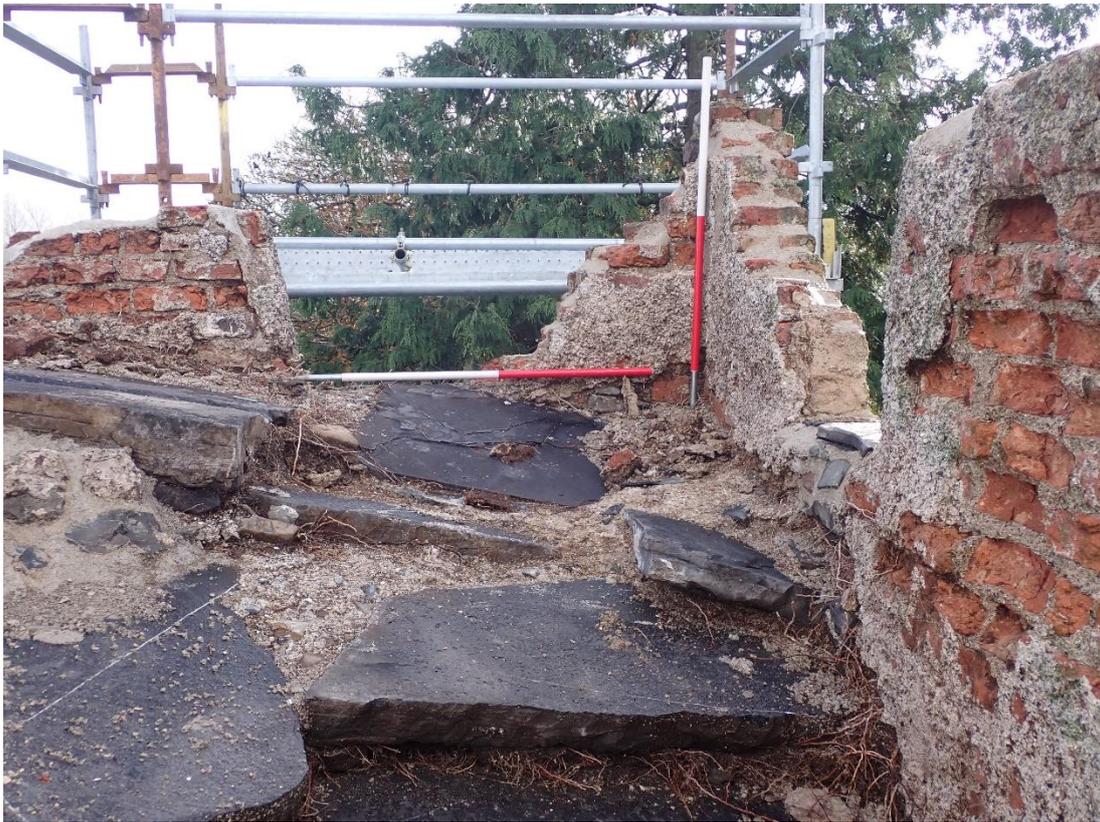
Plate 3: View to south of roof showing flagstones sloping from east to west and from south to north

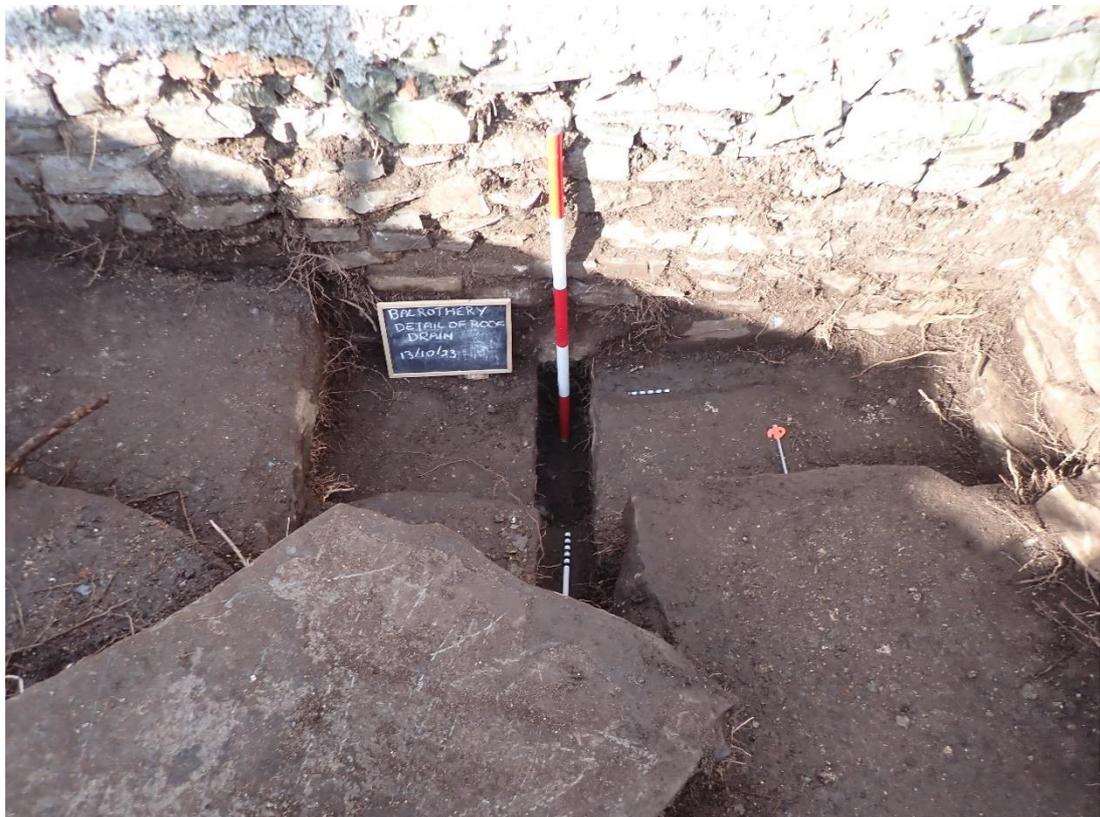
Plate 4: View to west of drain feature with groove on the north (right) side indicated by a scale bar and the second internal step in the drain indicated by another scale bar

After cleaning a drain formed by a gap in the flagstones at the northern end was exposed (Plates 4 and 5; Figure 1). This extends through several layers of stones so that it is 0.32m lower than the adjacent flags at the west end (Plate 4). The drop from the sill of the crenel to the flagstone is 1.36m at this point and beneath the parapet itself the drain drops another 0.12m. There are two more steps in the drain, one 0.4m from the west wall and a second 1m east of that. A large flagstone at the lower NW corner (Plate 5) has been replaced inaccurately, and originally covered the channel. It is correctly shown as a dashed outline in Figure 1.

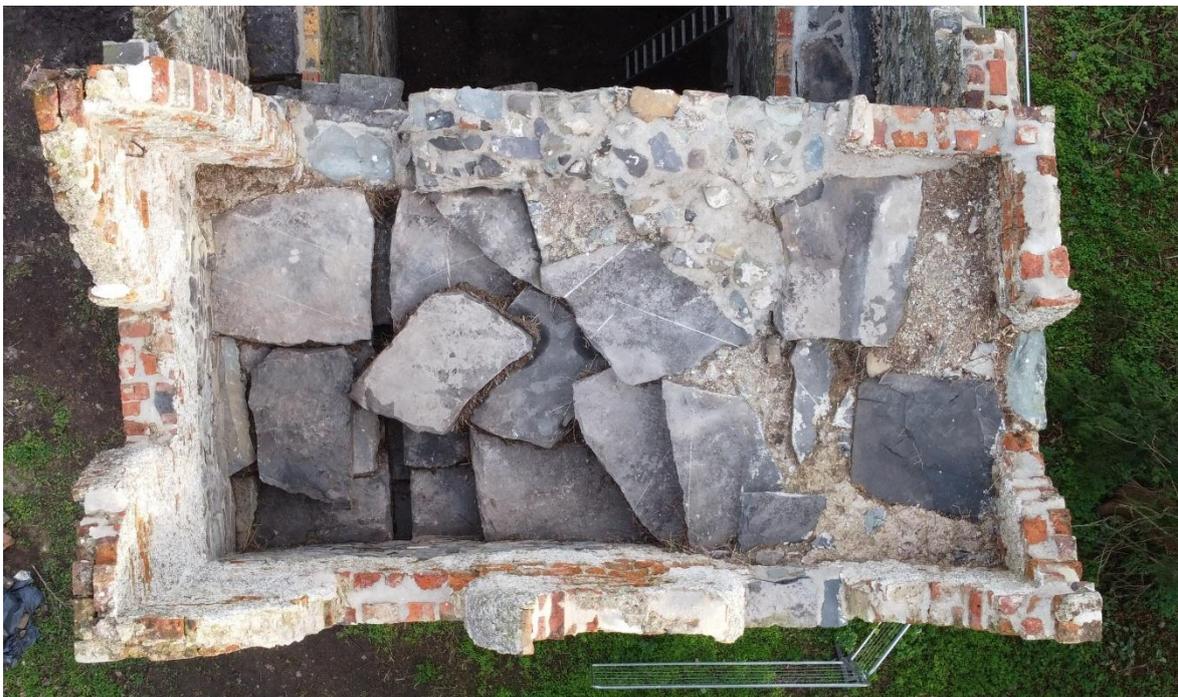
Plate 5: aerial view of the roof after cleaning and conservation, north is to the left

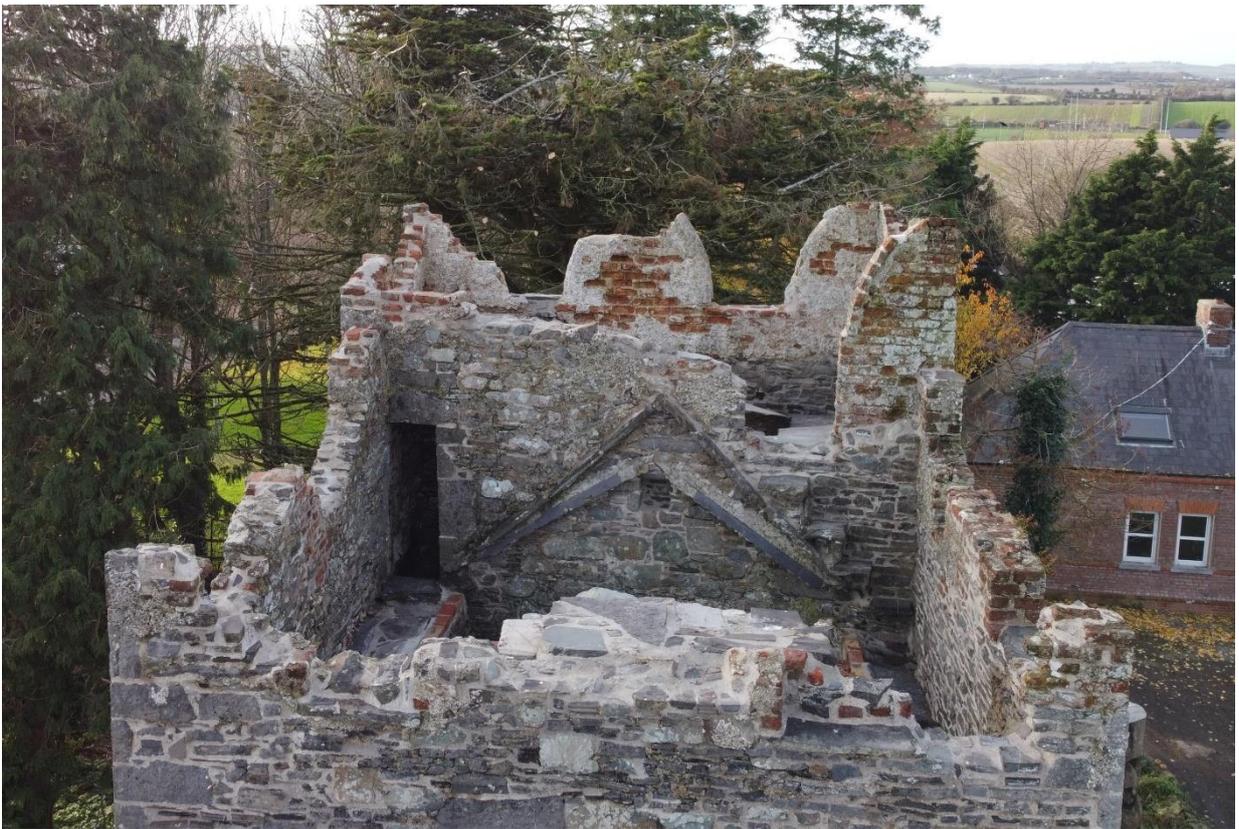
Plate 6: View looking west at the rooftop level, showing brick crenellations in varying states of preservation, and the two different roof scars on the internal west wall, after conservation.

The larger space within the tower house would have been covered by a pitched roof running E/W. On the interior west wall there are traces of two rooflines, one above the other (Plate 6, see also Plates 7 and 8). The higher roof line consists of the remains of limestone flags between 4 - 7cms thick, butted together and running at a steeper pitch than the lower roof. The lower pitched roof is of slate and immediately beneath the apex is a recessed rectangular niche, possibly to take a roof beam. The distance between the apex of the lower and the upper roof is about 0.65m. Running along the north face of the upper flagstone roofline are a series of four

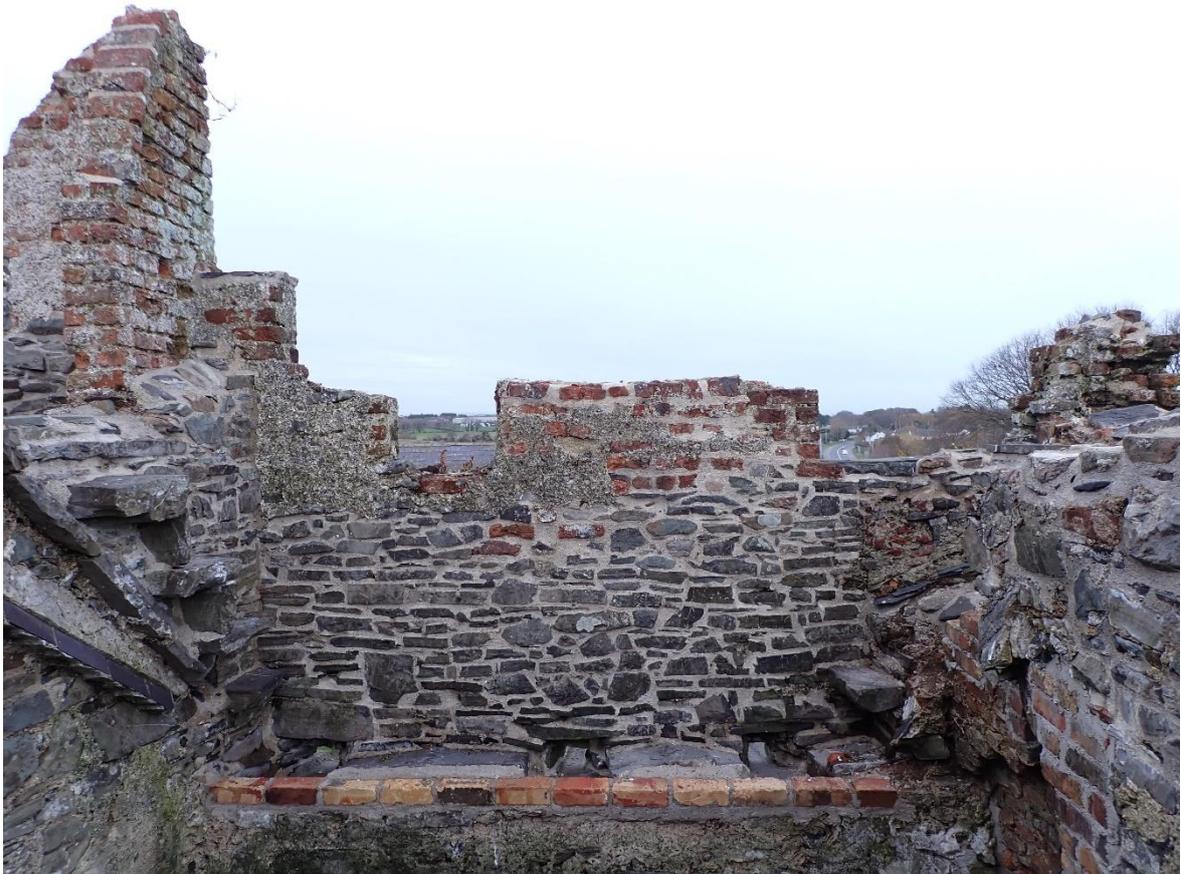
Plate 7: Looking north at the parapet above the wall walk. Steps to higher roof are on the west (left).

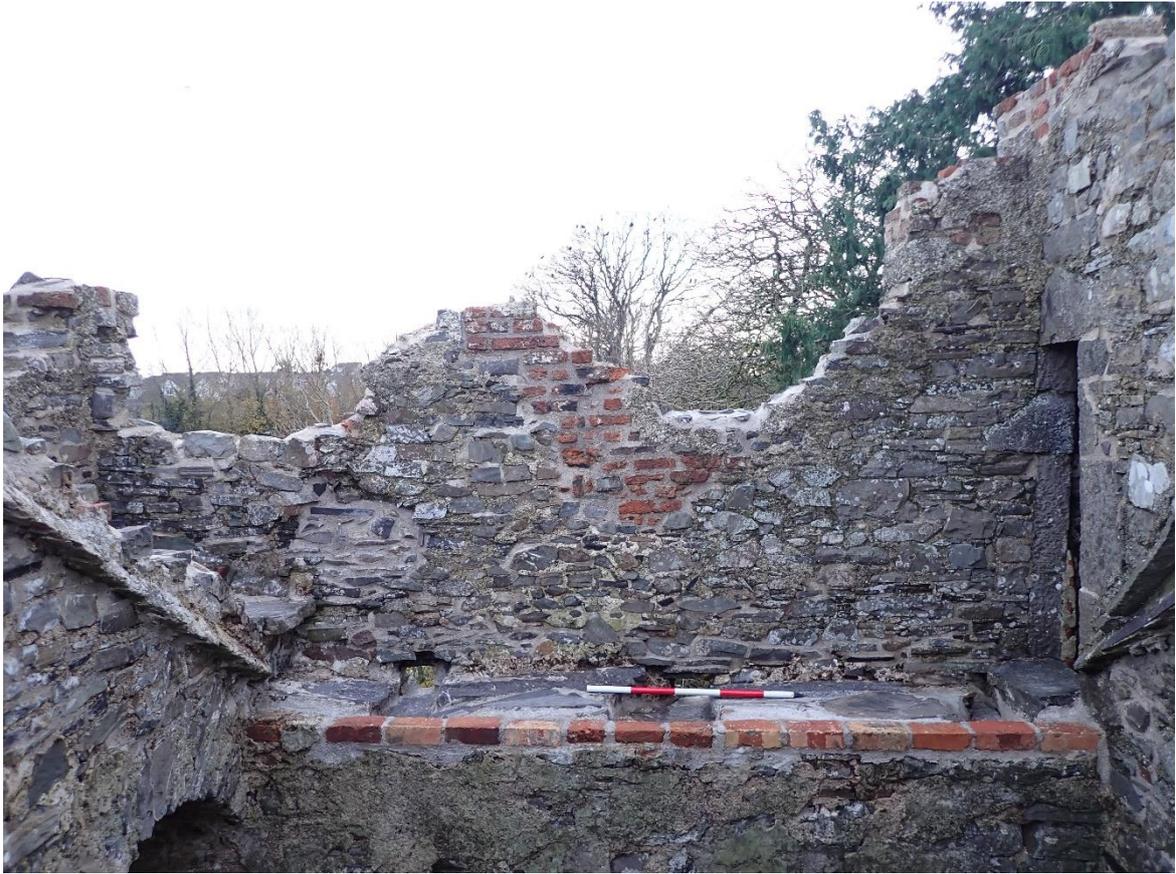
Plate 8: Looking south at the parapet with remains of the brick crenellations, and infill of brick

On the opposite side the wall walk is similar, but less well preserved (Plate 8). The water chutes have been broken on the exterior (Plate 11). On both sides there is an additional chute at the east end, but higher than the others, (Plates 11 and 13). This must have drained water from the higher wall walk at the east end. There is a possible fourth chute at the east end, north side beneath the higher one, now blocked by brick (Plate 13). An opening was infilled during conservation, and it would be at the correct height for another chute had the walk extended beneath the later modifications.

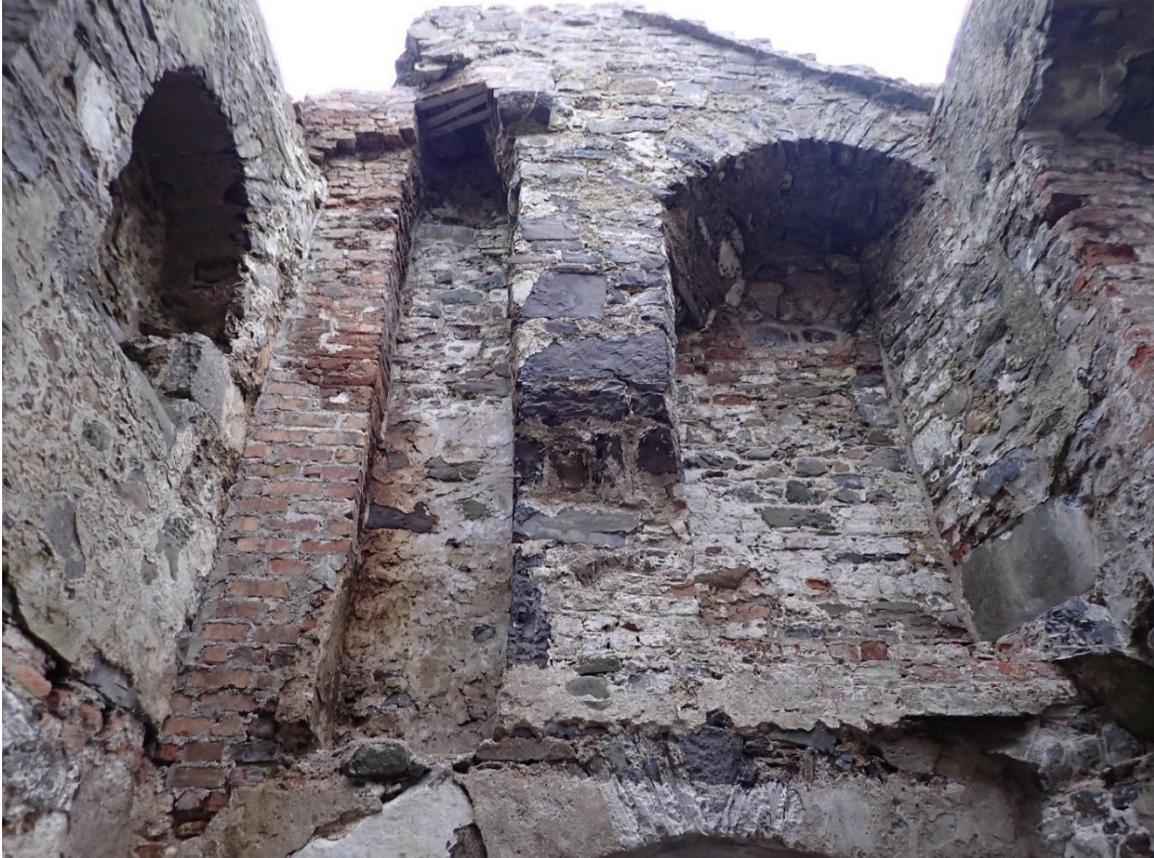
The lower slate roof is the only roof scar visible on the interior east wall (Plate 9). The present height of the centre of the east wall is too low to accommodate the higher ridge point seen on the west side and is just about high enough for the slate roofline.

Plate 9: Looking up at the interior face of the east wall, with roof scar, chimney flue, supported brick arch beside flue, central buttress and window opening visible.

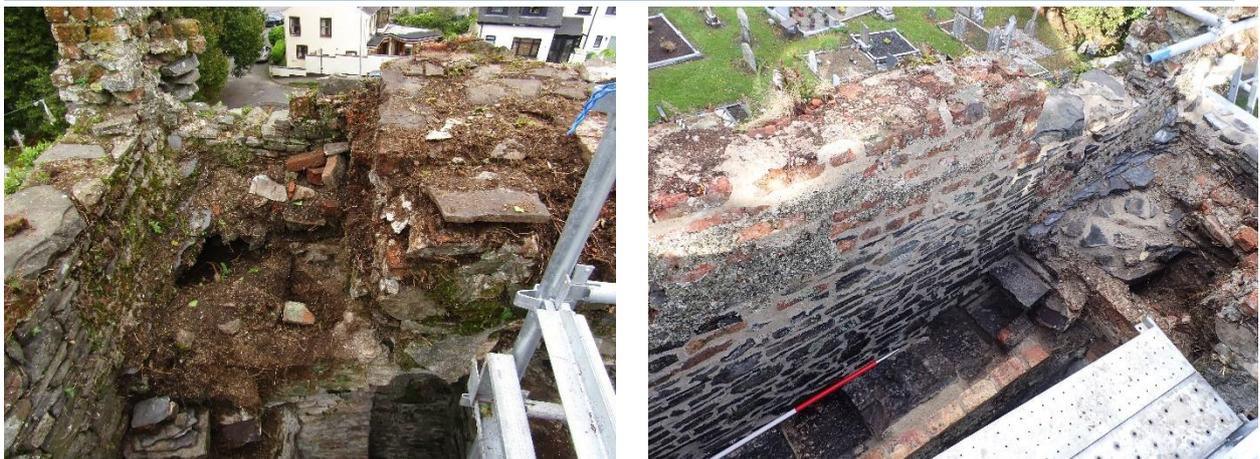
On the north side the slate line is not visible at all, and it is likely that the collapse evident in that area from the chimney has impacted the survival of this feature. There is a separate roof scar running E/W and sloping down to the west set into the north wall. This suggests that the space between the chimney and the north wall was slated (Plate 10).

Plate 10: Slate line in NE corner, before and after conservation

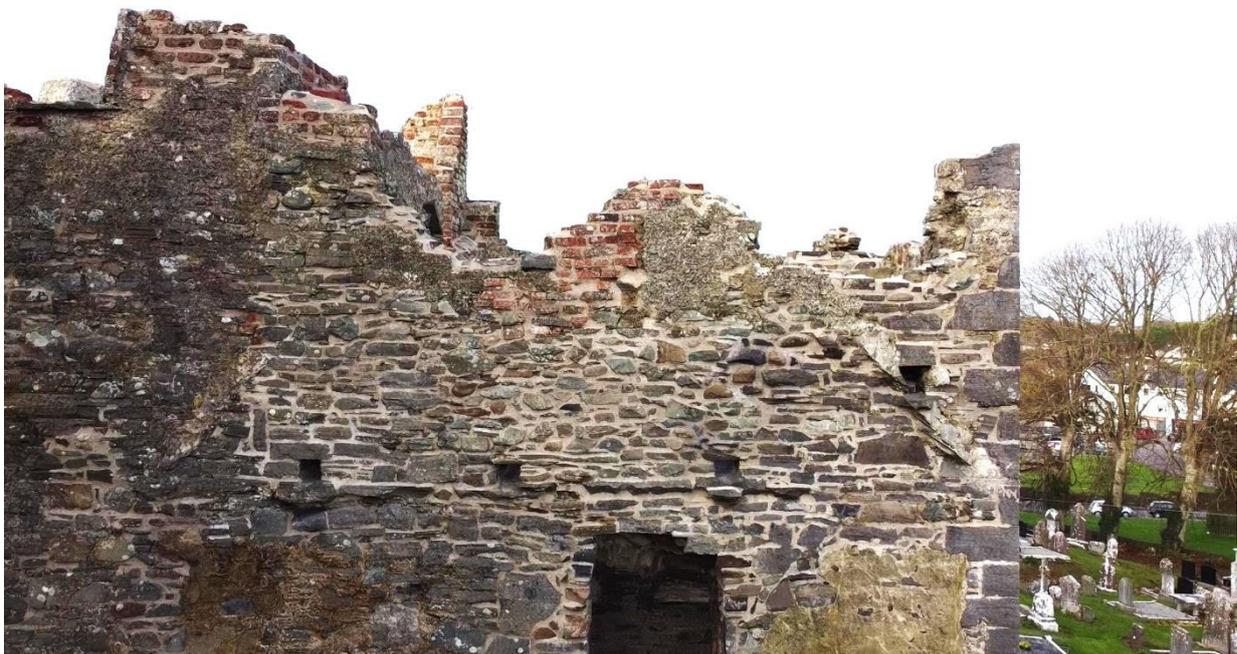
On the exterior of the south wall just below the parapet the remains of a roof scar can be seen clearly on the east side, and there is a possible matching line on the west. The pitch is such that it suggests that the apex would have been to the top of the battlements (Plate 11). As there is no visible sign of a scar above a certain point it is possible that the roof was in effect a partial lean-to / hip roofed structure over a relatively shallow attached building. The question of its form, phasing and impact on existing features will be discussed below.

Plate 11: View of south wall showing roof scar to east (right) and possible scar to left.

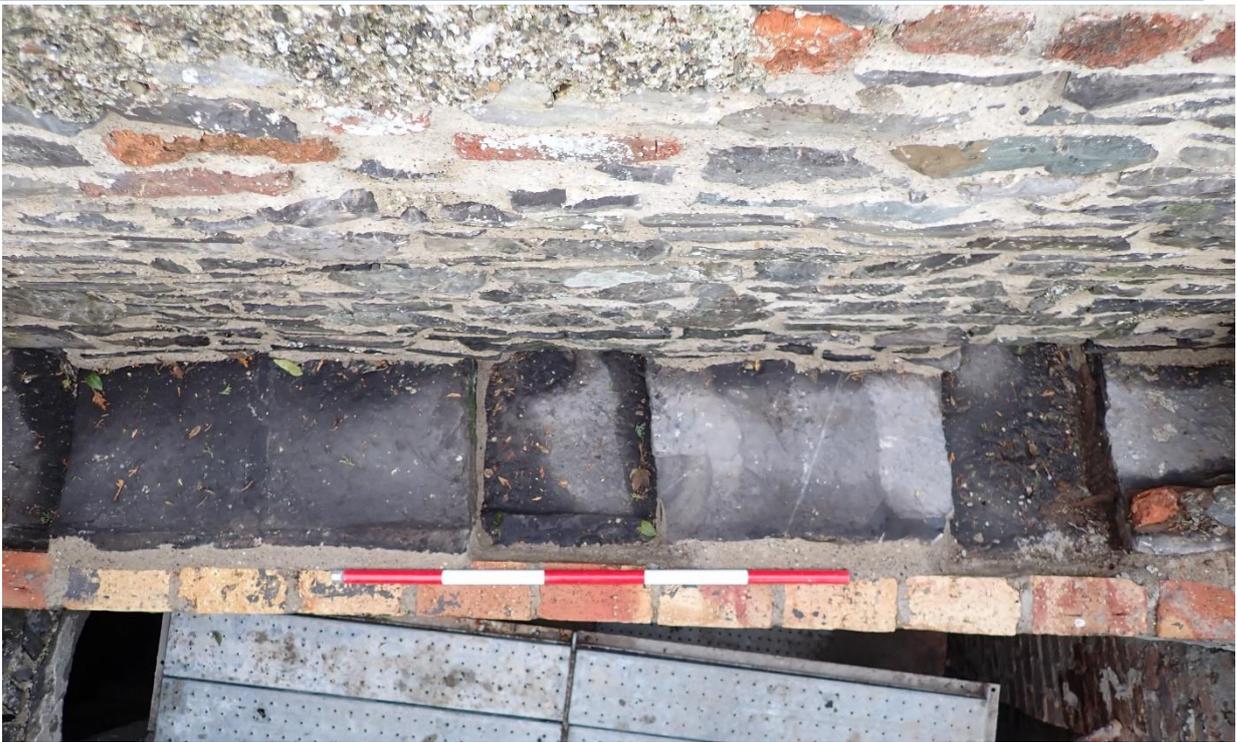
Plate 12: Wall walk on the north side during conservation. The ranging rod sits on replaced brick.

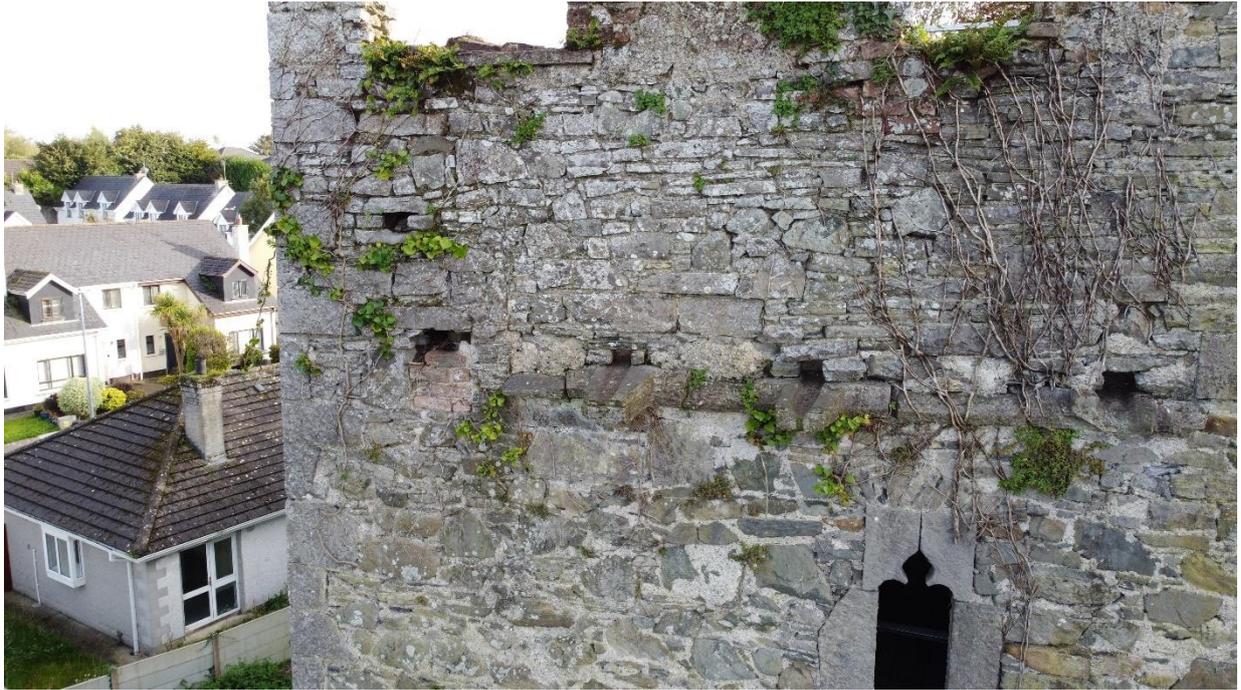
Plate 13: View of the north wall showing the rainwater goods, with one possible addition at the east end and a higher one above.

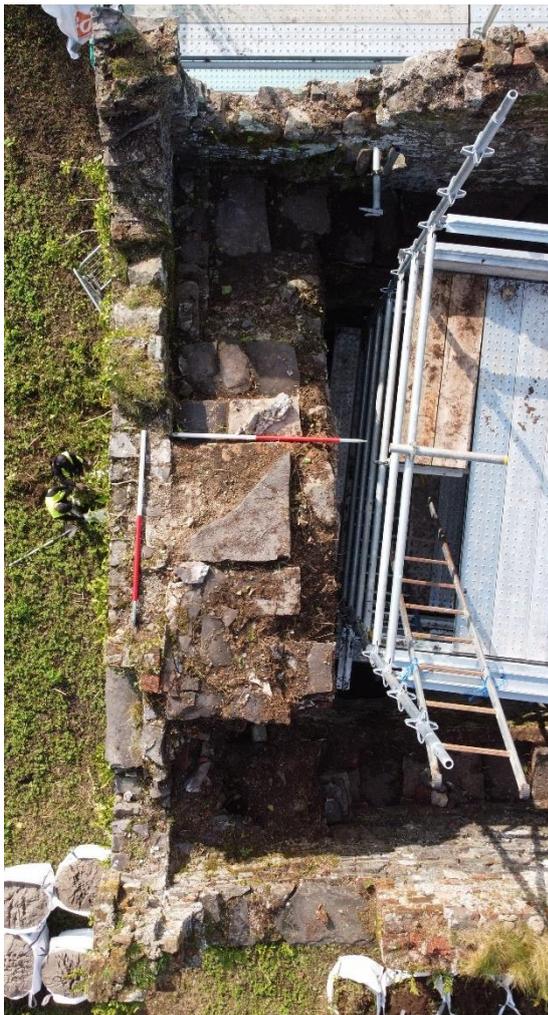
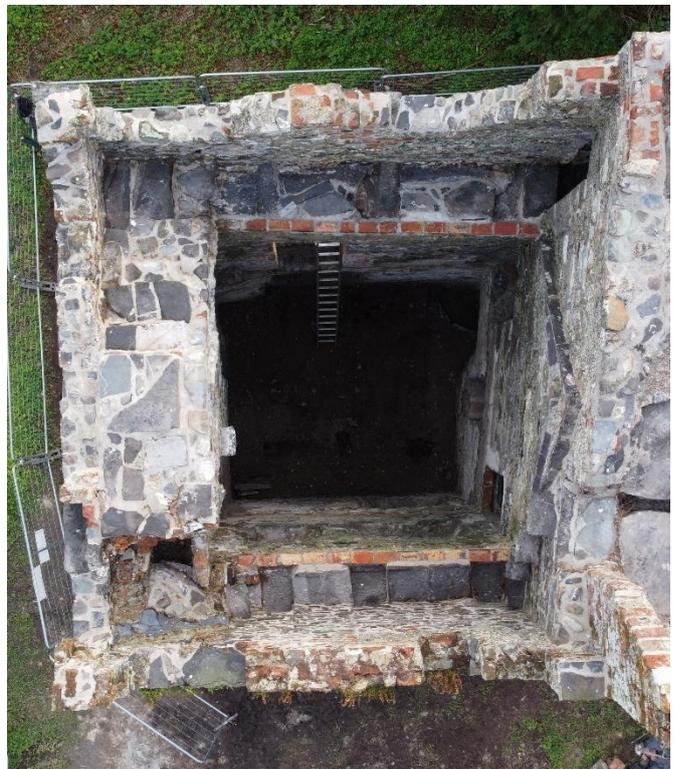
At the east end the wall walk rises to a flat central platform. A large slab had broken and has been repaired by the addition of further slabs (Plates 14 and 15). While there are definite steps on the south side of this, on the north the insertion of the brick chimney has disrupted the original form of this section.

Plate 14: aerial view of the east wall top prior to conservation. North at bottom

Plate 15: aerial view of the eastern part of the tower after conservation. Chimney visible in NE corner

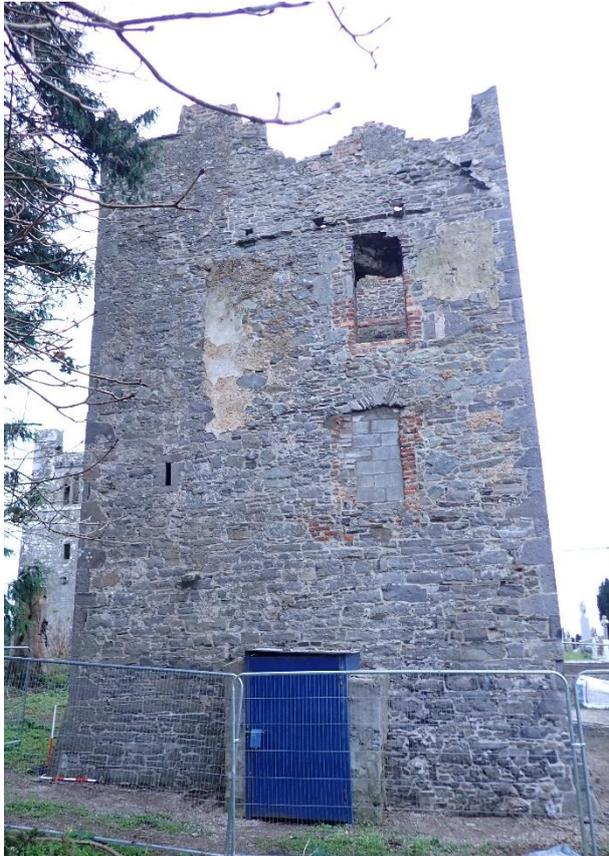
Plate 16: South wall after conservation. Note roof scar and conserved plaster.

Conservation works including re-pointing and pinning an unsupported window arch on the second floor were carried out. The removal of the vegetation exposed a previously unseen arrow loop on the east side of the enlarged window on the second floor (Plate 16). This is located at the base of the window. Areas of plaster to either side of the opening were cleaned and conserved.

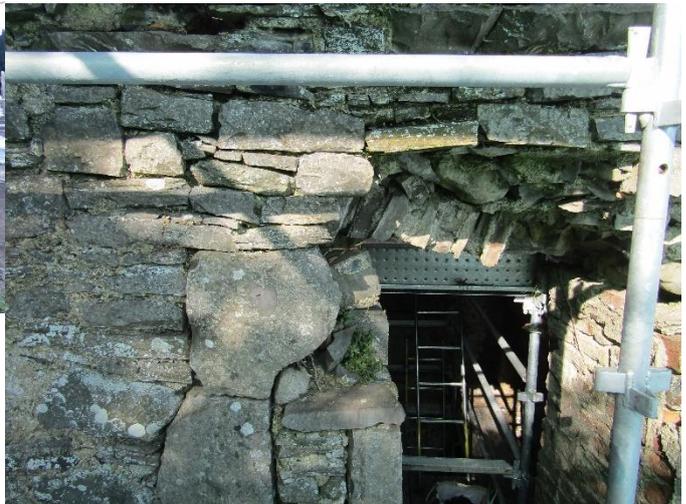
One side of an ogee-headed window remains at the west side of the second floor opening, and the arch above needed to be pinned. This is the original arch from the ogee window which was later considerably enlarged.

Plate 17: Detail of second floor opening with half an ogee headed window on the west side.

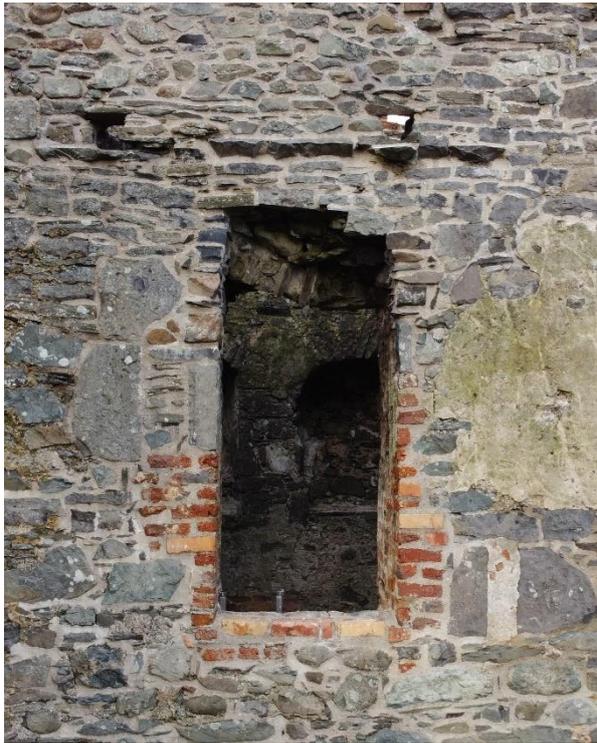
Plate 18: The repointed opening with infilled stonework; the newly revealed window loop is at bottom right

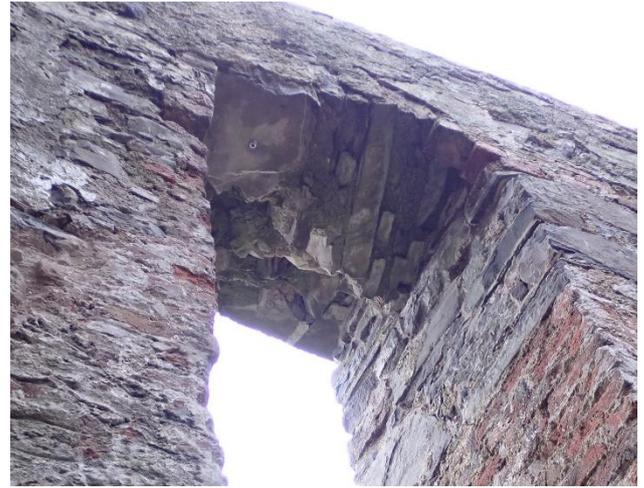
Plate 19: The screw threaded through the unsupported masonry beside the end of the arch

Pinning this masonry required the insertion of a threaded bar through the stones to the east of the arch above the original ogee headed window, presumed to be a single not double light, and fastening it by means of a metal plate on the parapet above, (see Plates 19 and 20). The newly exposed loop beside the east reveal of the enlarged opening is at or below the bottom of the original ogee window, meaning that that in the interior this would have been between 0.5m and 0.6m above the floor level. The arch above the blocked up opening on the first floor is slightly off-centre, the keystone is not in the centre of the opening, suggesting that this also was an earlier opening which was enlarged.

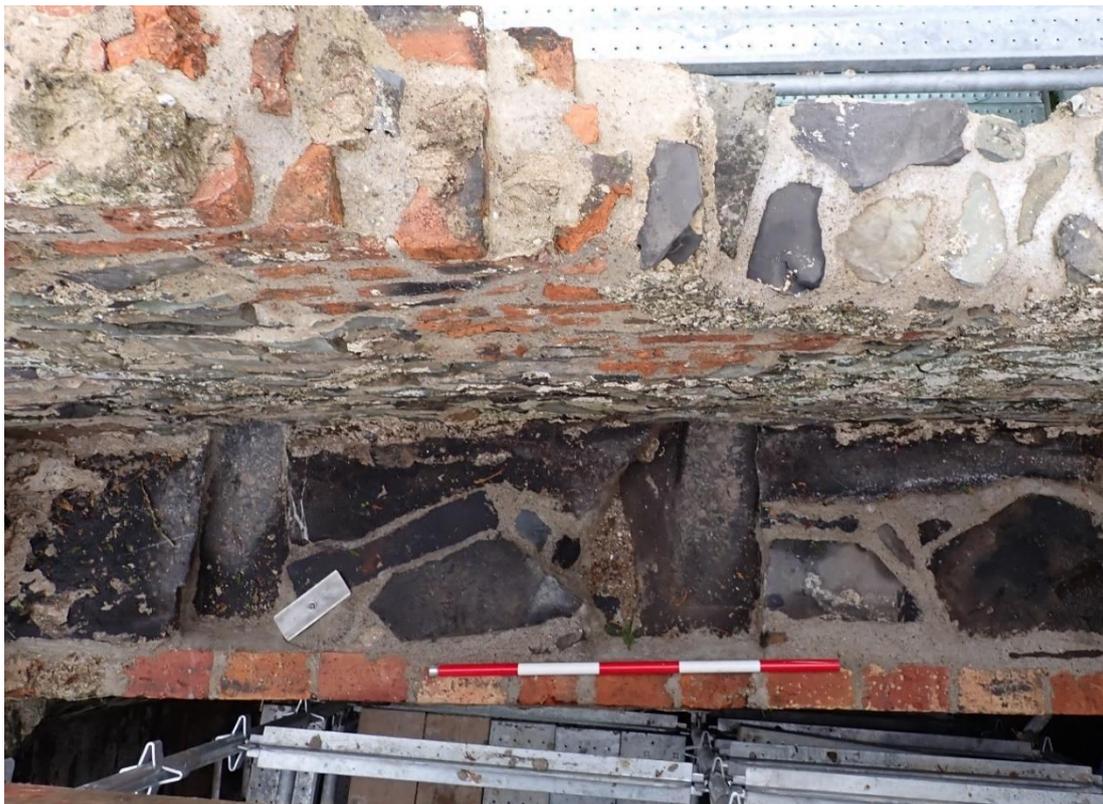
Plate 20: The plate and head of the threaded bar pinning the masonry beside the window arch on the south wall walk

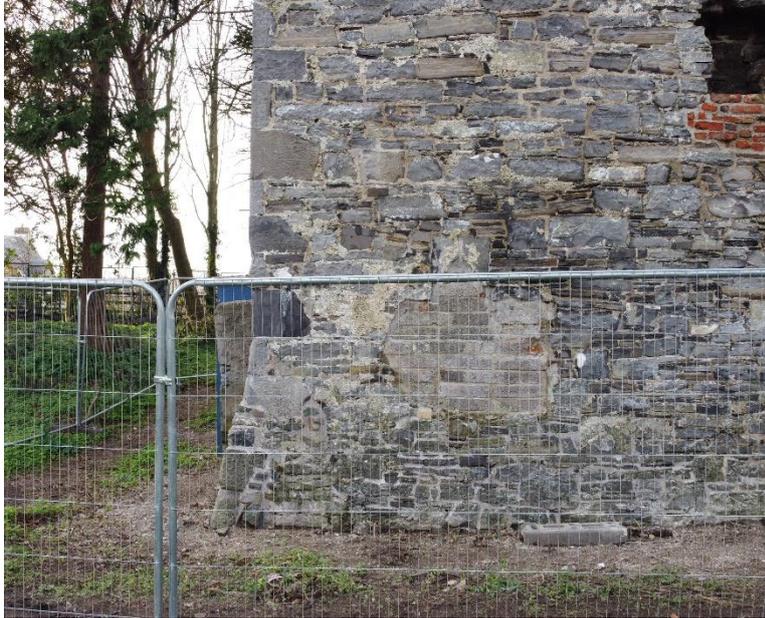
Plate 21: View looking west at the SE corner which has been repaired and consolidated.

Removal of vegetation, re-building of some brick infill, and re-pointing and consolidation were required on the east wall. The quoin stones in the base batter at the SE corner were repaired and repointed (Plate 21)

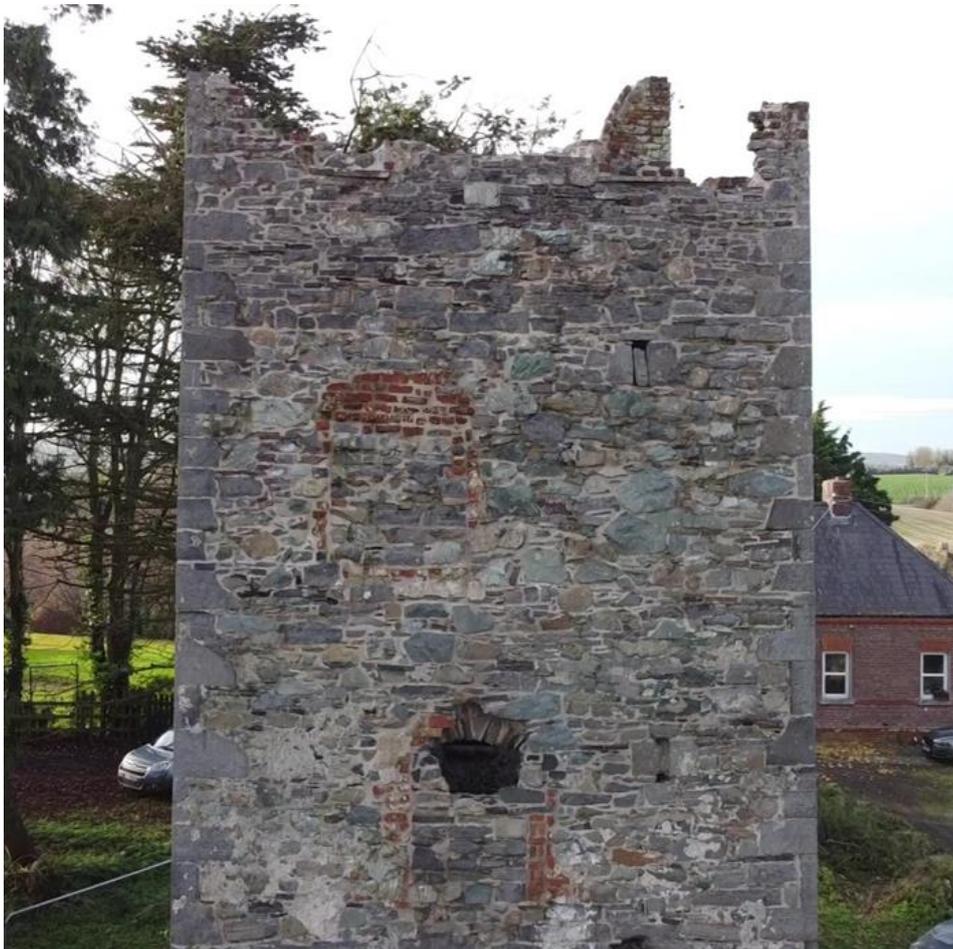
Plate 22: View of the mid-section of the east wall showing the arrow loops, and consolidated brickwork

Cleaning off the vegetation allowed the masonry to be seen more clearly. The position of the loops at first and second floor levels is interesting. Both have been blocked in and are not visible in the interior (Plate 22). The window openings have been consolidated with the hole in the brickwork of the second floor window infilled by matching brick. Cleaning allows the brick reveals to be clearly seen.

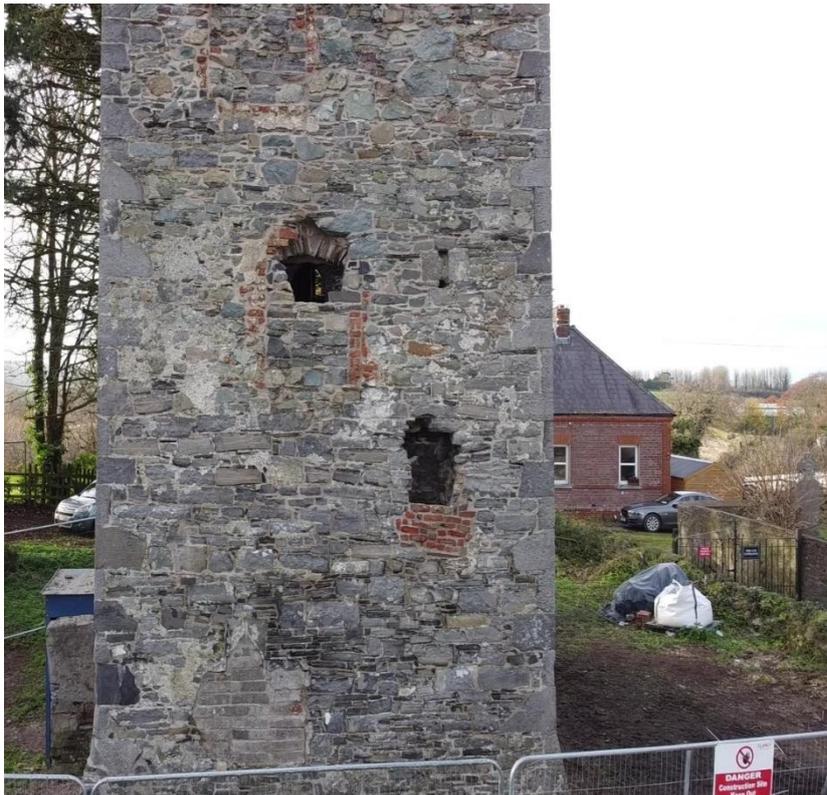
The hole at the north side first floor level which had been partly infilled with brick was consolidated. The damage does not extend into the interior though it may relate to damage to the chimney flue.

Plate 23: Lower section of the east wall exterior showing cleaning and repairs

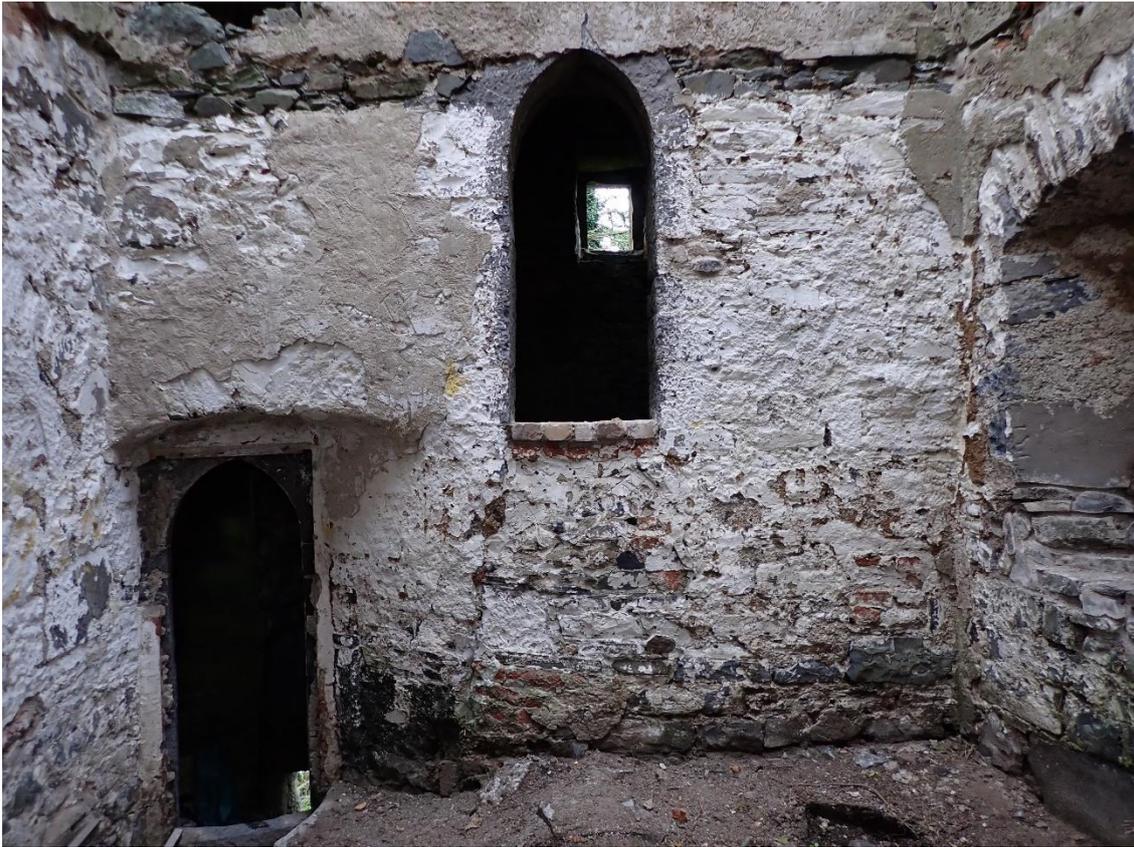
Plate 24: Looking west at the interior wall, entrance to first floor and the entrance to the second floor of the western section.

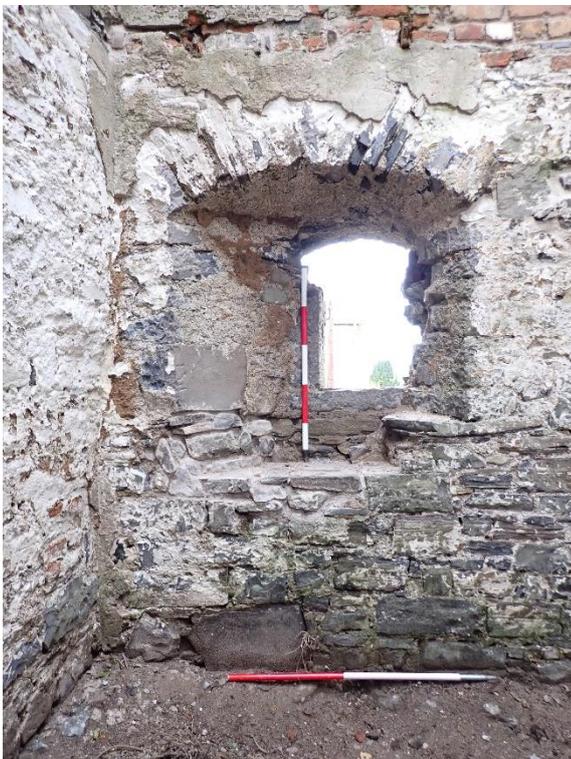
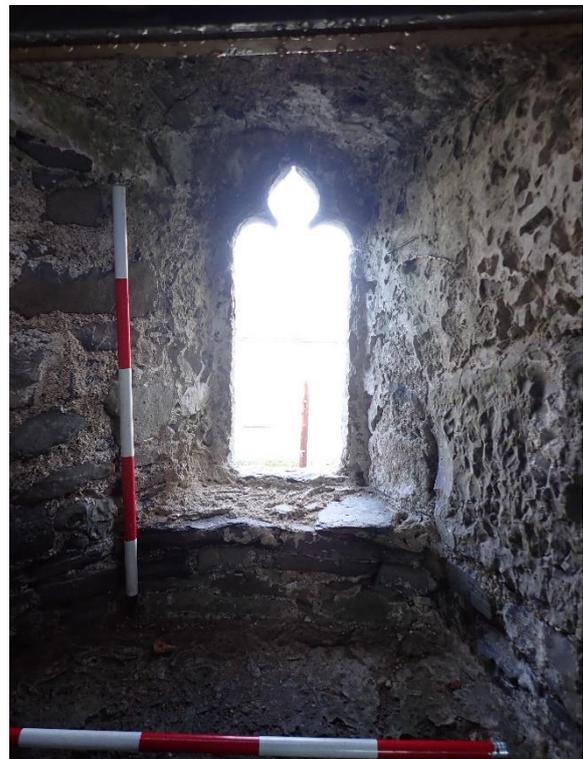
Plate 25-26: Window reveal repaired, first floor level and window area cleaned second floor level, north wall

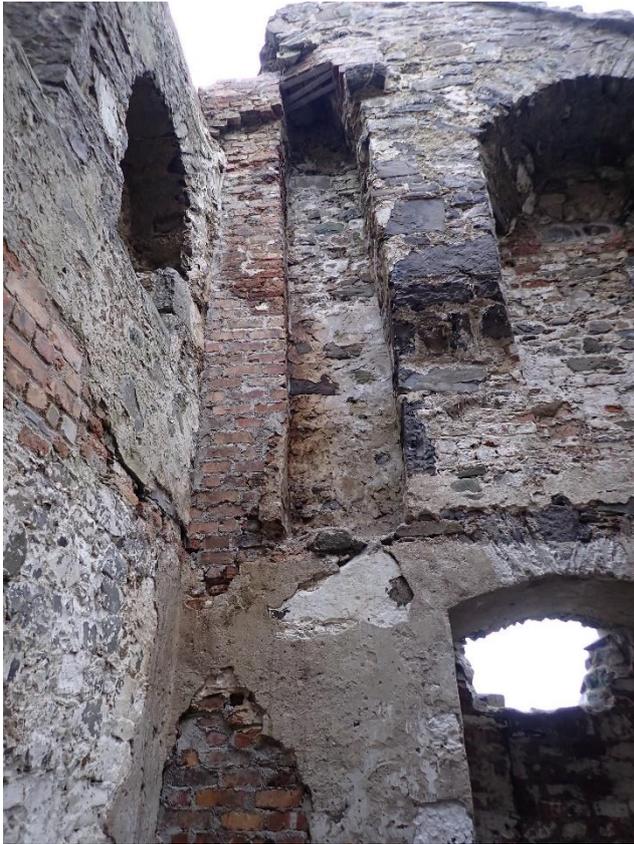
Plate 27: looking upwards along the north side of the east wall, chimney flue repaired and stitched with bar through the cavity

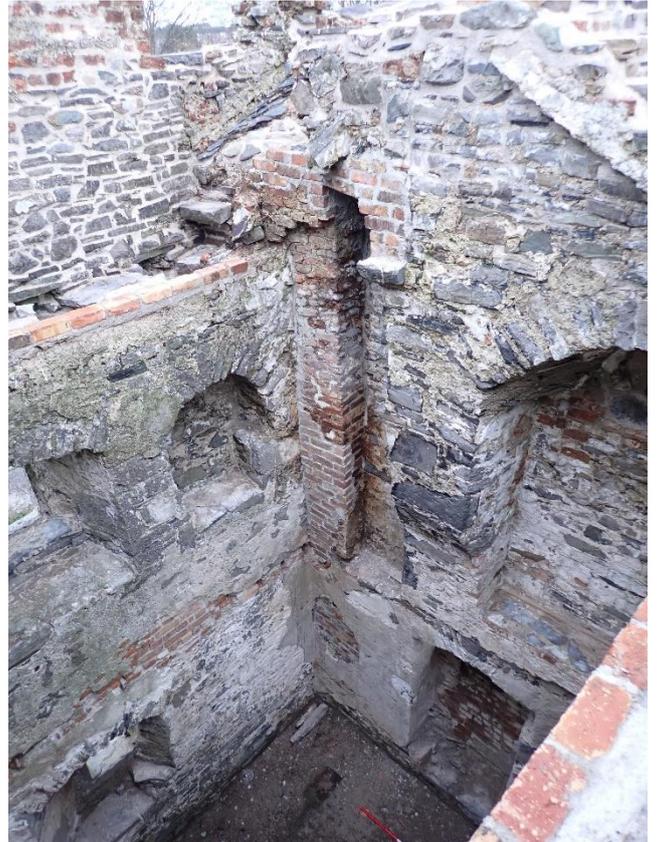
Plate 28: View looking down from the entrance to the wall walk at the NE corner.

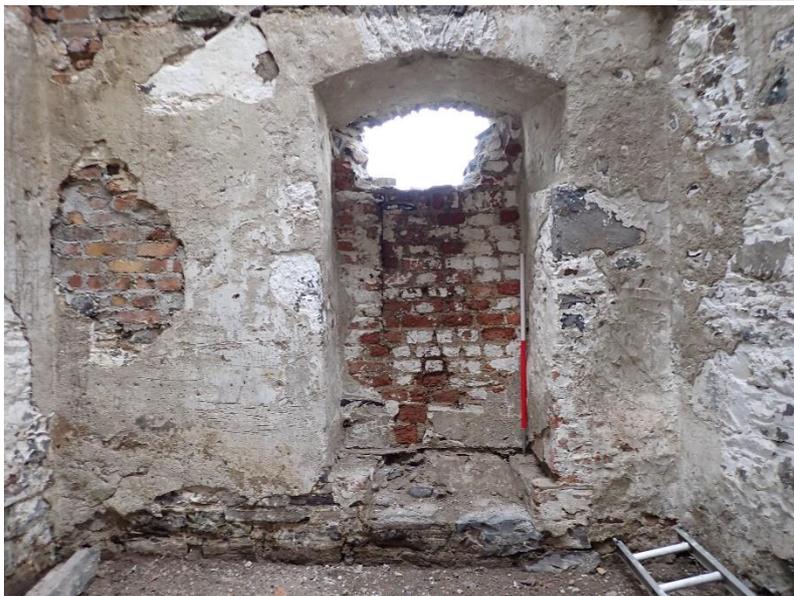
Plate 29: First floor window opening, east wall. Repair to brick to left.
