**Tower House
at
Glebe South
Balrothery, Co. Dublin
Archaeological Oversight Report**

CMF23-1-DF003

RMP No. DU005-057006-

License No. 23E0833

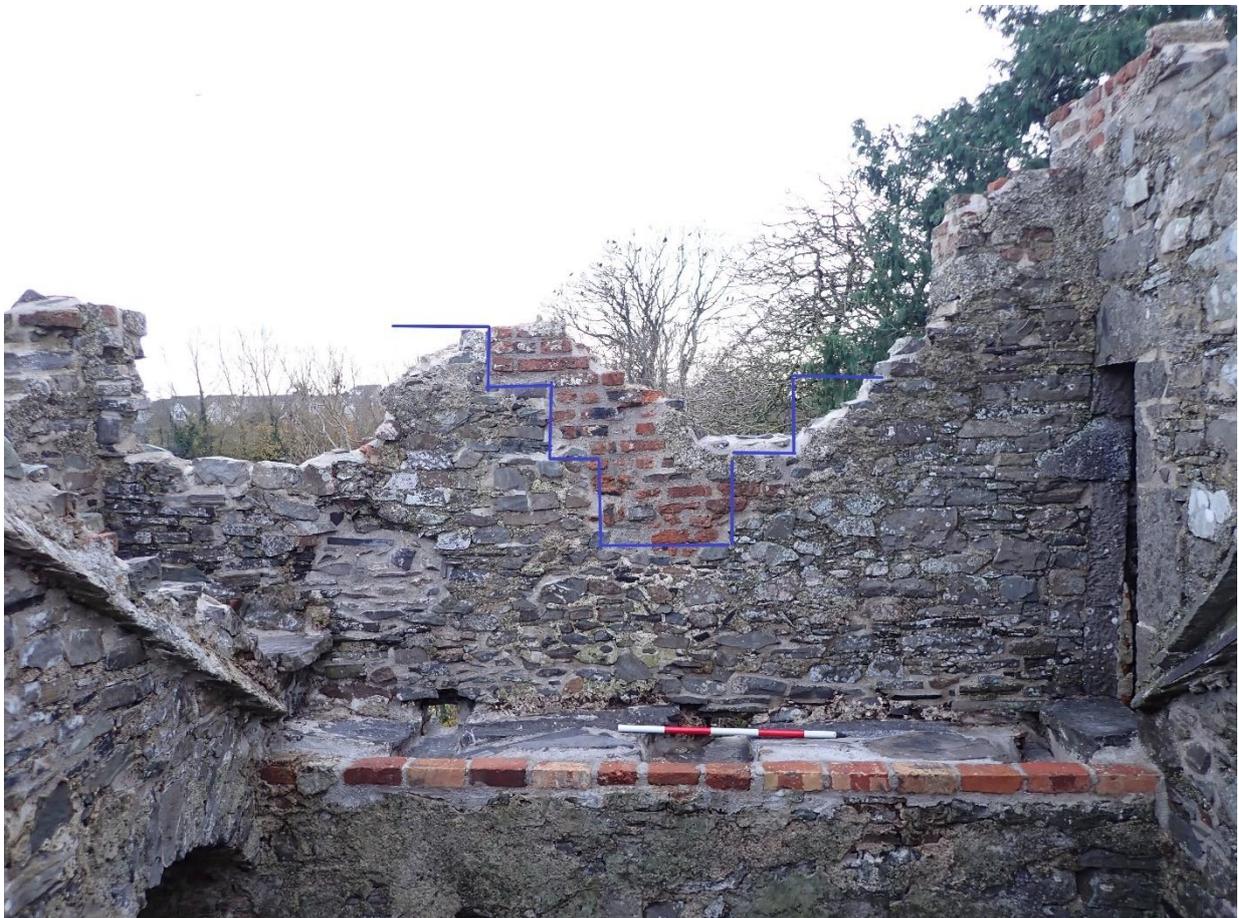
At some time in the 17th century, or later, the tower was heavily modified. The parapets, which seem to have had standard crow's foot crenellations were given a makeover, and high, curved brick merlons were added.

Plate 30: Suggestion of where the original Crow's foot type crenellation can be seen in the south wall parapet.

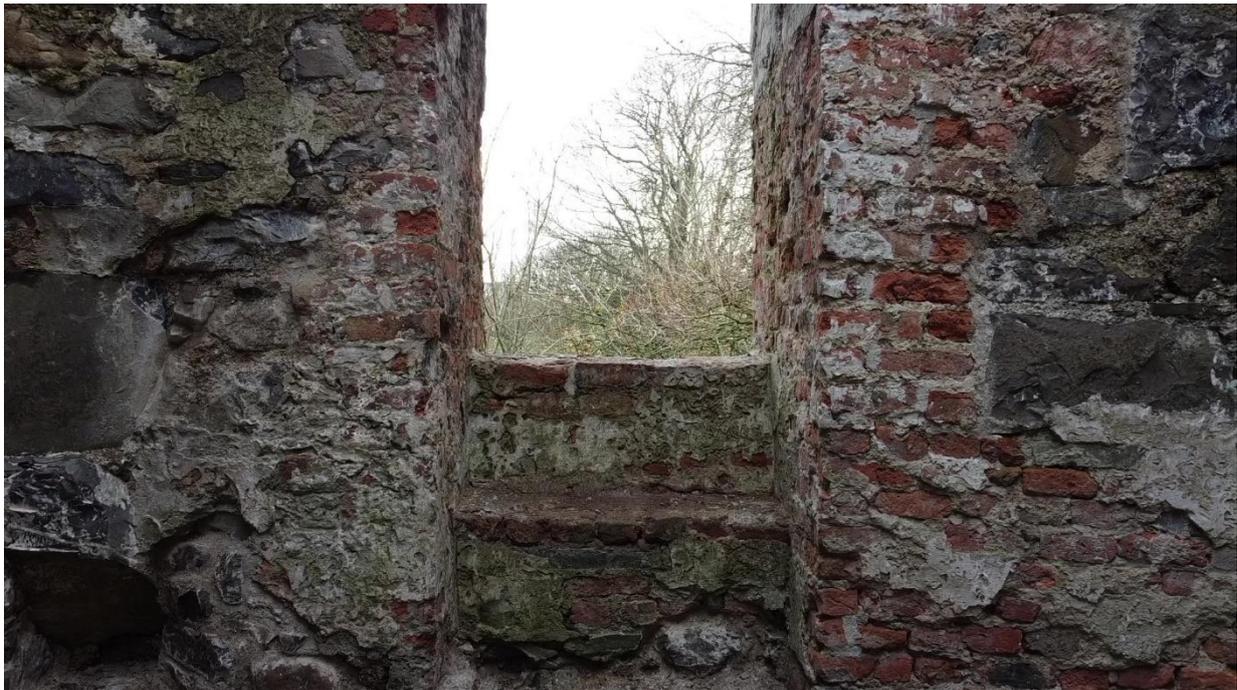
The windows in the south wall, first and second floors, were drastically modified. The upper floor opening has steps leading up to it from the second floor level, (Plate 32), and this suggests that it was used as a door into the adjoining extension. Similarly, the window on the first floor may also have been remodelled as a door, and this suggests that the extension may not have had internal stairs although it was the full height of the tower house.

Plate 32: steps leading up to the remodelled window, second floor, south wall.

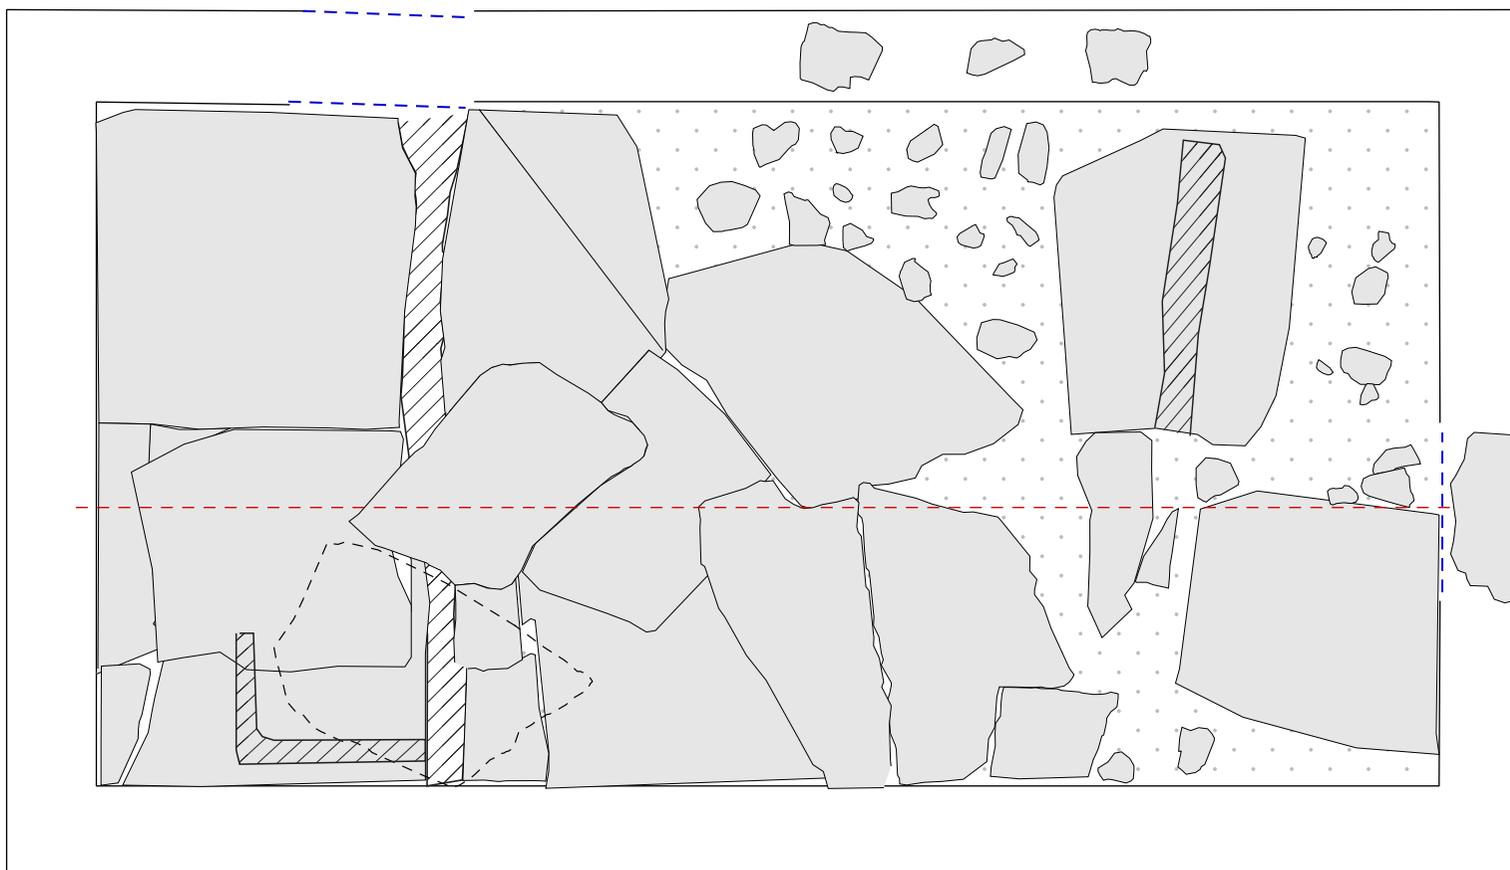
Figure 1: Plan of rooftop

After cleaning a drain formed by a gap in the flagstones at the northern end was exposed (Plates 4 and 5; Figure 1). This extends through several layers of stones so that it is 0.32m lower than the adjacent flags at the west end (Plate 4). The drop from the sill of the crenel to the flagstone is 1.36m at this point and beneath the parapet itself the drain drops another 0.12m. There are two more steps in the drain, one 0.4m from the west wall and a second 1m east of that. A large flagstone at the lower NW corner (Plate 5) has been replaced inaccurately, and originally covered the channel. It is correctly shown as a dashed outline in Figure 1.

The flagstones are massive. They range in size from just over 1m x 1m to about 0.8m x 0.6m and from 10 – 16cms thick. The flagstones directly in the NW corner (see Figure 1) has a groove chiselled into it to funnel rainwater into the channel beside it. In the south end a similar, larger groove has been worked into the surface of the large slab in the SE side, (Plate 5; Figure 1) and it is likely the slab west of it would similarly have had a groove in it, but this is obscured by mortar.

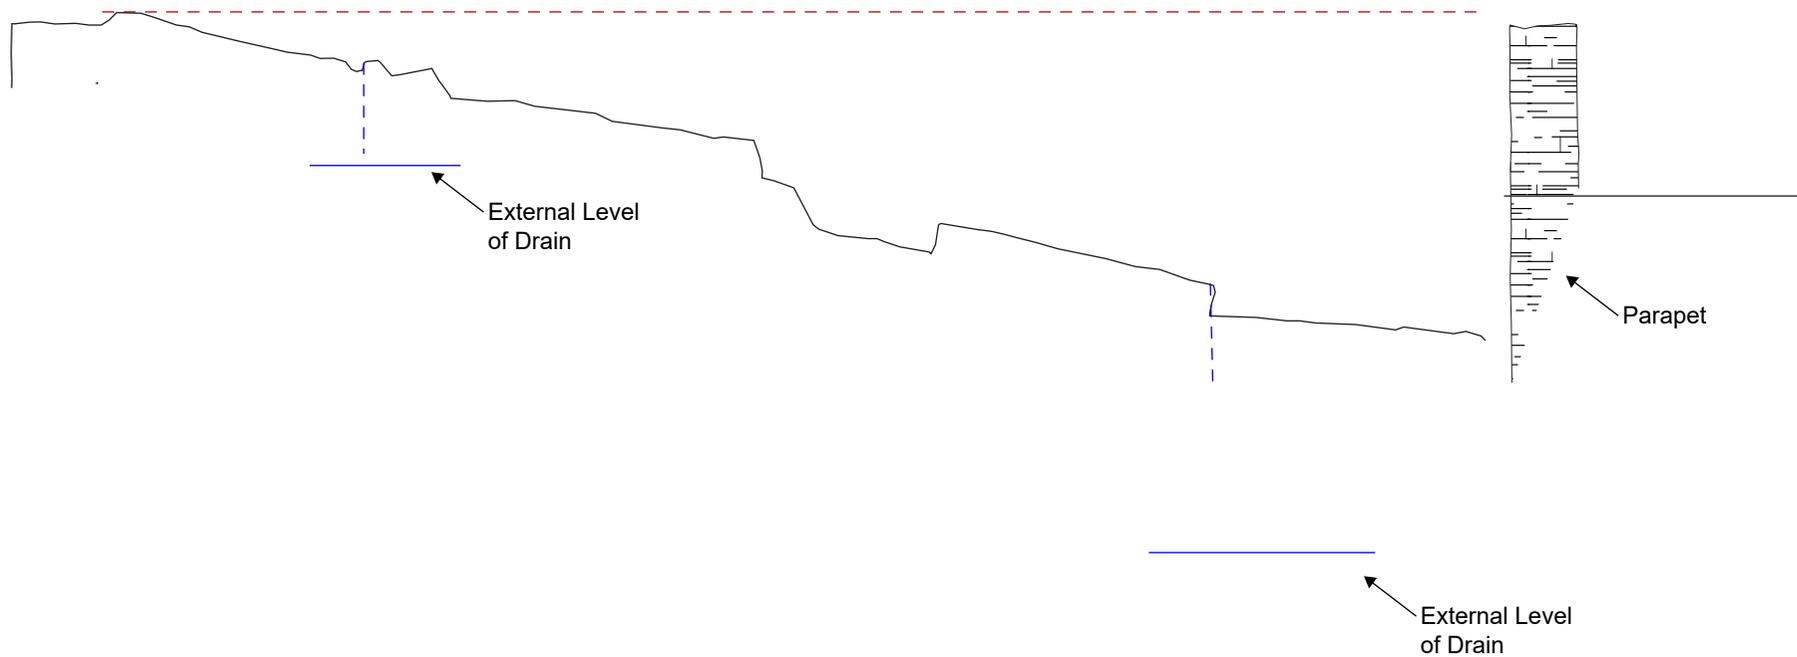
Figure 2: E-W profile of roof at the west side

The only complete example is that in the NE corner of the flagstone roof. It stands 1.80m high and is only one brick deep, about 23cms along its eastern side, but on the north the lower third is the stone parapet which carries around the whole roof beneath the brick. The total height above the flagstones of the crenellation in the opposite NW corner is 2.30m, but this is missing some bricks at the top. At the south side the sill of the crenel is actually at roof level (Plates 3 and 5; Figure 2).
