Conservation Management Plan

**Mulhuddart Church (St. Mary's)
Church Road
Buzzardstown
Dublin 15**

Community Monuments Fund CMF23-2-DF001

05 March 2024

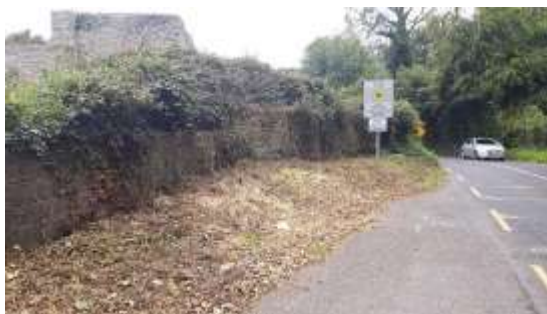
West wall is formed of approx 50m length of random rubble stonework with an additional section at the north end approx 12m long in blockwork. The boundary wall varies in height above adjacent ground between 1000mm and 2000mm depending on the ground contours. The condition of the wall is hard to currently discern and further vegetation control is required.

West wall, partially cleared Autumn 2023. Note poor sightlines to south.

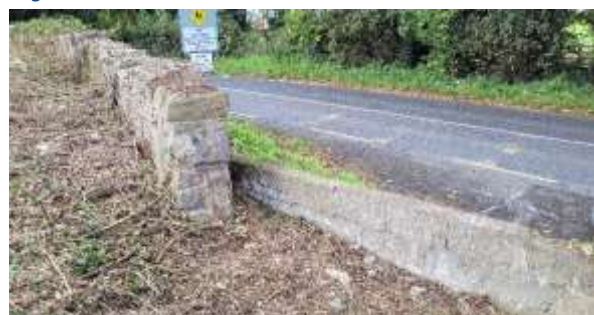
The north blockwork section is fragile and at risk of falling. The metal gate is serviceable with some repairs and repainting. However, because of the presence of the road and lack of good sightlines reuse of such would need to be carefully considered.

West wall contains a mix of stone and block.

- viii) Stabilisation or replacement of 12m long section of blockwork wall to the north end of the west boundary where at risk of falling. This could potentially be replaced with a fence. Note this is likely outside of the works package to the monument.
- ix) Repairs to approximately 16m length of west boundary wall to form exemplar for rest of boundary wall works.
- x) Control of all vegetation growing out of and at the base of the rest of the boundary walls (approx 150m) to be carried out winter 2023-24 and again winter 2024-2025. Any vegetation that is entrenched in the wall should be cut to the face of the wall and then the cut stem treated or if greater diameter than 30mm drilled and plugged with EcoPlug.

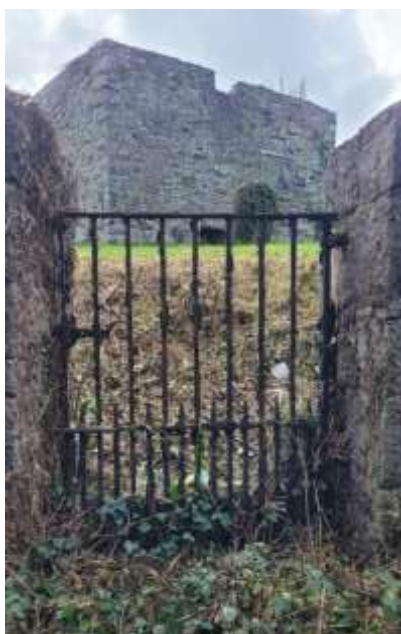
Gate through west wall.

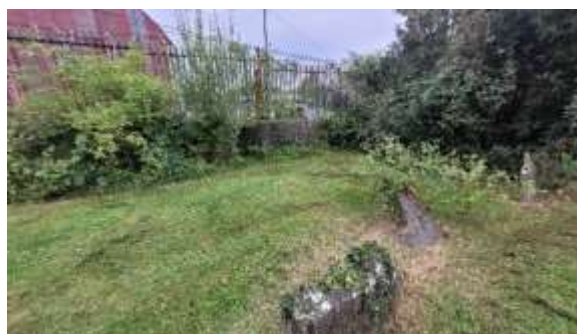
The east and south walls are approximately 60m and 56m long respectively and formed of low rising masonry in a combination of random rubble and later block and brickwork the majority with cement top flaunching. These elevations are also secured with galvanised steel palisade fencing to separate the graveyard from the yard beyond

East and South walls are low rise masonry with palisade above. much overgrown

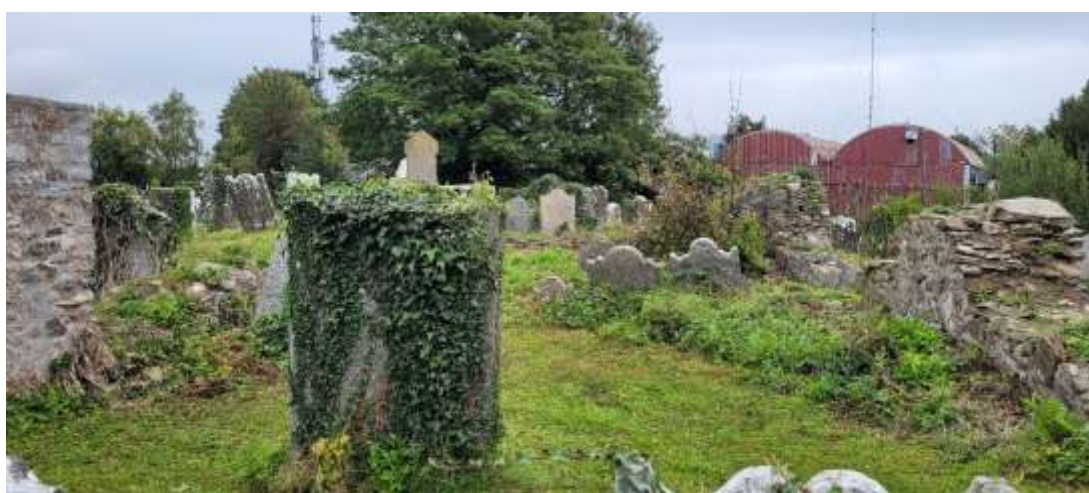
The rest of the nave walls are in a very poor state and have attracted some poorly conceived repair attempts which are now failing.

Nave looking east. Note poor definition of the walls excepting the west end of the north wall seen to the left-hand side of the picture.

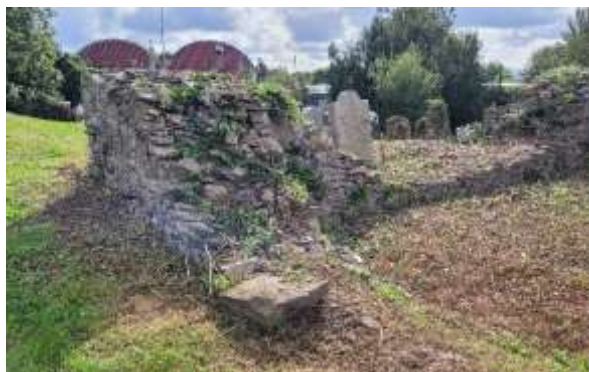
Northeast corner of nave in urgent need of stabilisation.

A total of approximately 30m length of wall is of loose falling masonry. There is approximately 5m below ground to the west end of the north wall. There are the remains of two buttresses to the east end, these can be seen on the Berangerer drg from 1777 ref fig 15. They are in a similar condition to the adjoining nave walls.

- vii) Stabilisation works to approximately 30m length of 1m thick nave walls. This will involve exploration of ground immediately to base of walls to retrieve all loose fallen stone and allow discovery at wall bases. Works to walls themselves will require digging out of any plant root systems; local dismantling and rebuilding; deep repointing and re-flaunching 30m length.

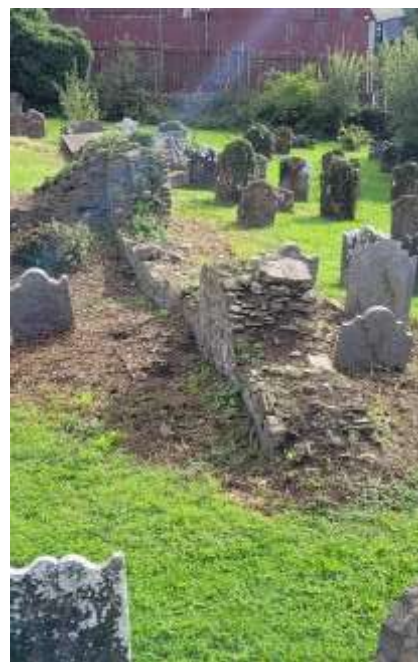
East end of south wall lacks definition and there are no upstanding remains to the western end.

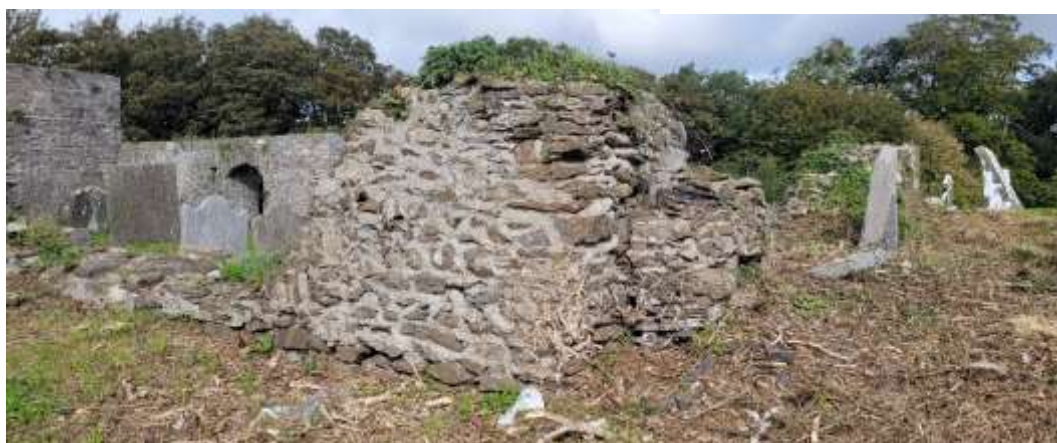
Poorly conceived repairs to southeast corner. Note buttressing stonework to right hand side in fragile condition.

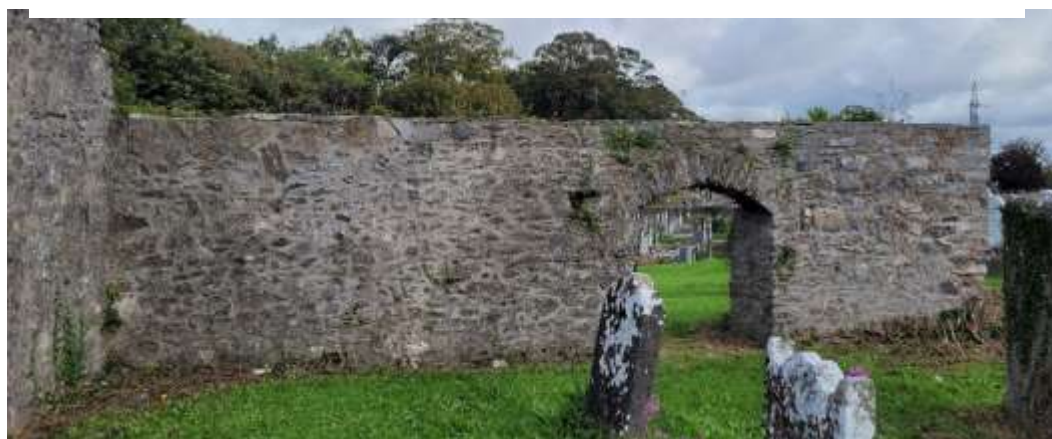
West end of north wall of nave in relatively stable condition.

- i) Re-flaunching; repointing and localised repairs to west end of north nave wall.
- ii) Soft capping to parts of Nave walls if desired depending on appreciation of the walls and longer-term management philosophy.
- iii) Surface interpretation of the nave floor depending on findings from 2024. This could be a gravel surface on geotextile or left to grass.
- iv) Tower walls - depending on findings of any investigation through tower wall surfaces in phase 1 works this structure could be re-interpreted. This is likely to require further reporting and detailed specification coming out of those findings and is beyond the remit of this reporting.
- v) Repointing to the tower north, west and south walls if not carried out Phase I.
- vi) Repointing of east wall of tower and all internal walls under vault.

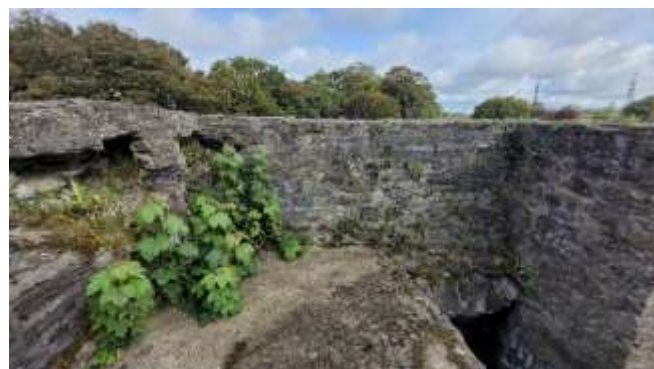
Tower vault top looking north.

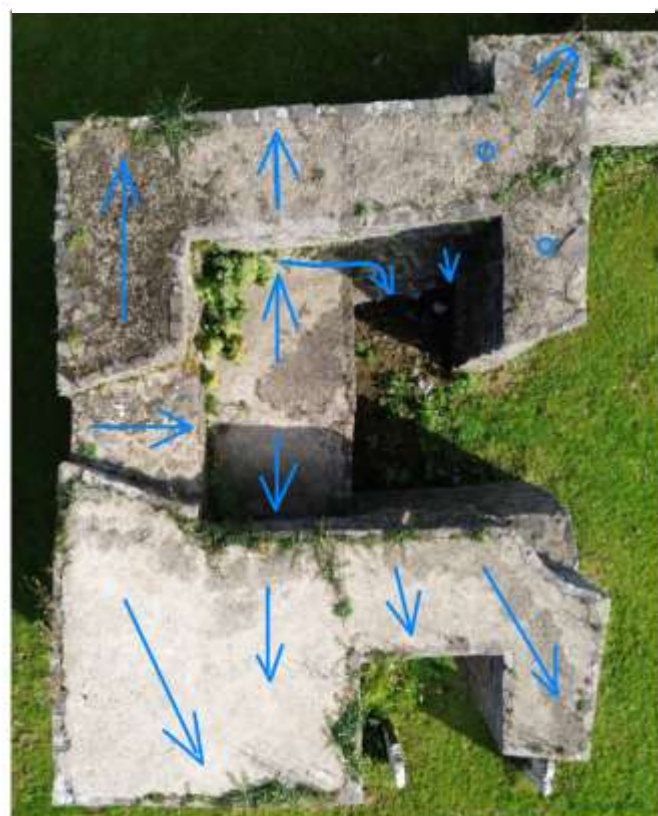
Top of Tower showing falls in flaunching.

- ii) Repair of all the internal faces of the upper-level walls above the tower vault.
- iii) Re-flaunching of the tower walls tops and repairs to the vault flaunching.

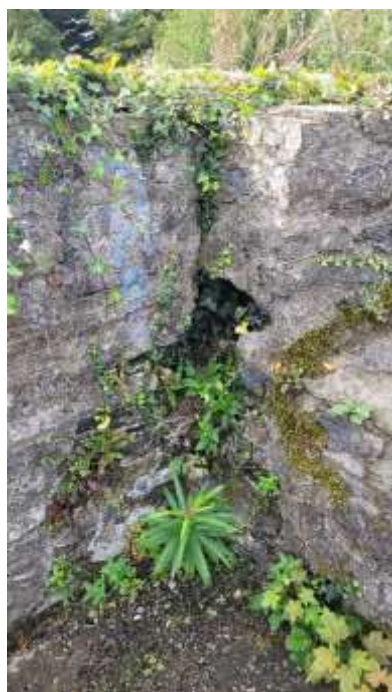
Southwest internal corner above vault.

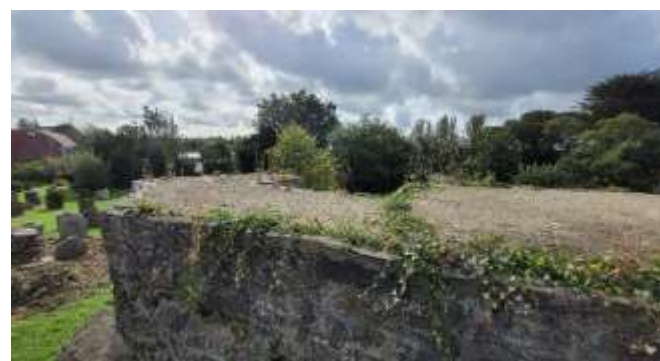
The southern section appears to better flaunch and is showing less signs of water migration through the stonework. The first-floor arch only survives in part. The maintenance of the top surface of this is crucial for the long-term survival of the arch masonry below.

South side of tower top, flaunching generally intact and to outward falls but cracks + edges need attention.

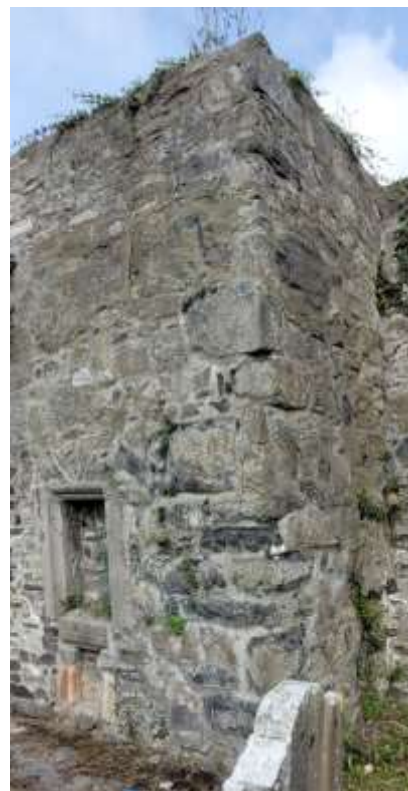
The condition of the tower walls is enigmatic. There are many vertical cracks that appear to tell the storey of the previous iterations. The infill stonework now appears to be unravelling. Picking this apart might lead to a substantial tranche of work and therefore restraining the tower as is should be considered as perhaps a more pragmatic approach.

Vertical cracks to the east side of South elevation.

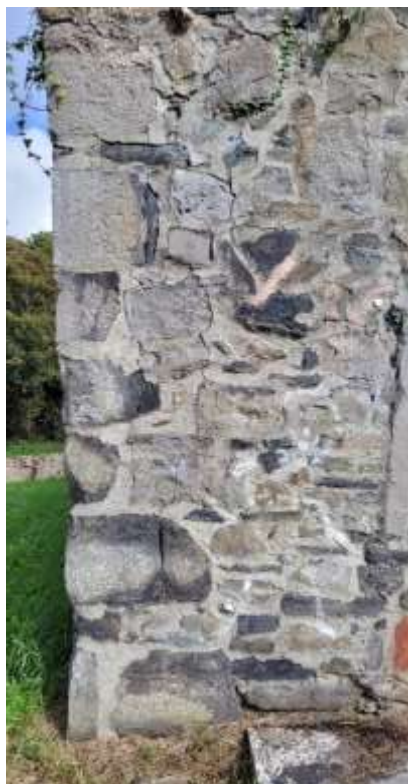
Vertical cracks to west side of south elevation.

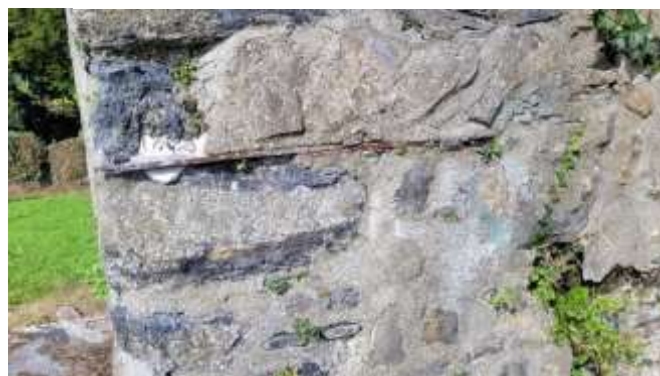
Corroding steel or wrought iron plate embedded in wall.

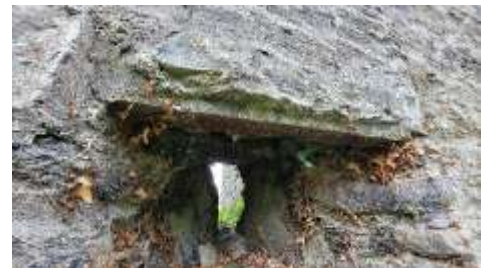
There is a defensive loop lower down to this same west elevation, and possibly similar to the north elevation albeit not visible externally. The head detail to both is nondescript and contains corroding ferrous elements such as rusting steel angles fire damaged to the stonework internally. Both openings need their head details addressing through much of the wall thickness.

Ground level defensive loop.

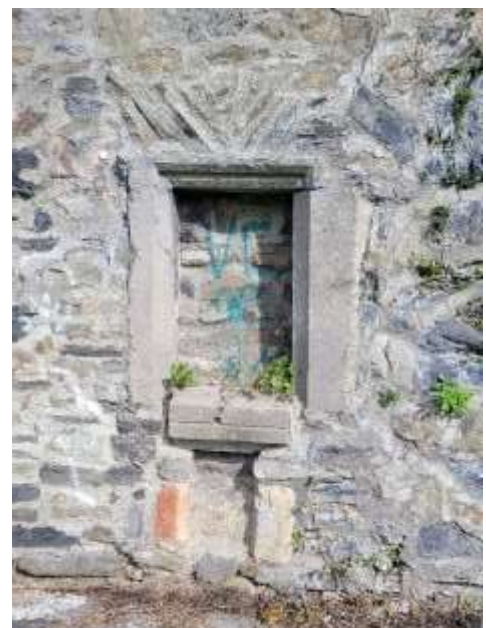
The previous window opening to the south elevation is now blocked up and although having to do little structural work the well-being of these carved stone elements needs addressing.

Window south elevation of Tower.

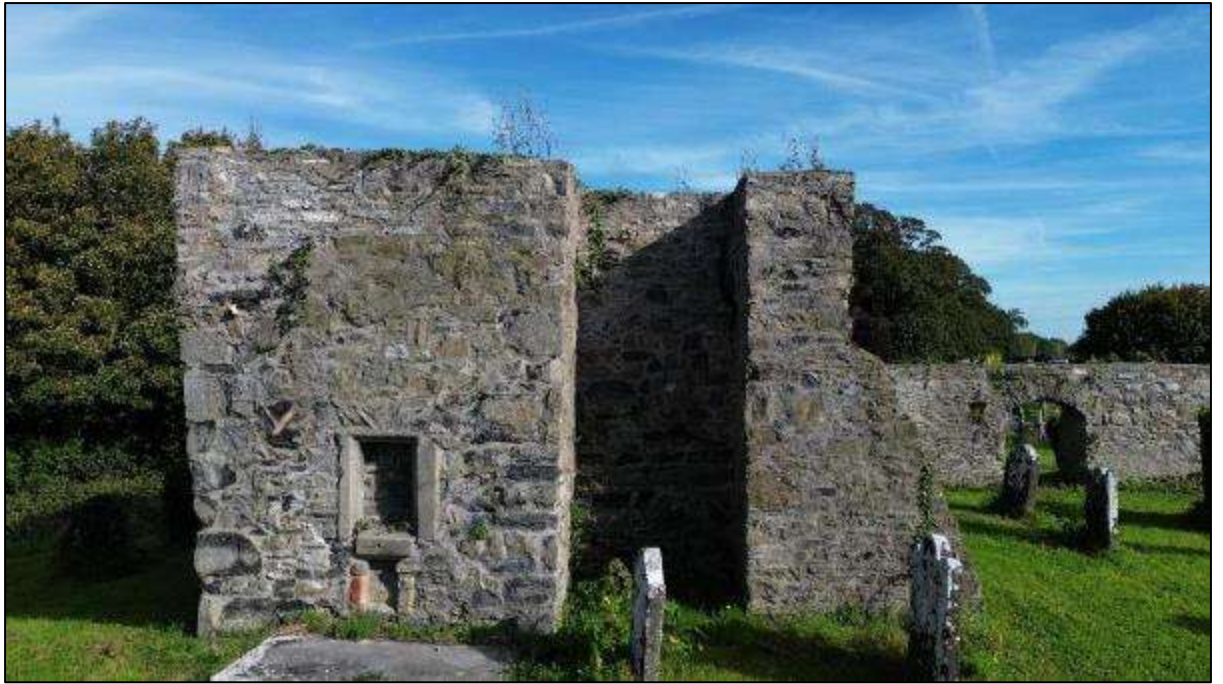
Southern elevation (Plate 10)- the extent of the modern repair with the late twentieth century strap pointing which afflicts much of the tower and church has served to obscure the location of the entrance doorway which is present in the historic photographs of the tower (Figures 8-10) and additionally it masks where the southern wall of the tower would have met the western wall of the church, to the point where the relationship between the two is no longer apparent. A blocked window ope at waist height in the southern elevation is bordered by some chamfered cut stone blocks, which have been poorly reinserted to the point where the glazing bar holes are facing in an implausible direction (Plate 11), this ope may have illuminated the start of the staircase, which was possibly contained within a mural gallery in this wall, as suggested by the massing (Plate 19).

Plate 10 View of southern elevation of tower, facing north

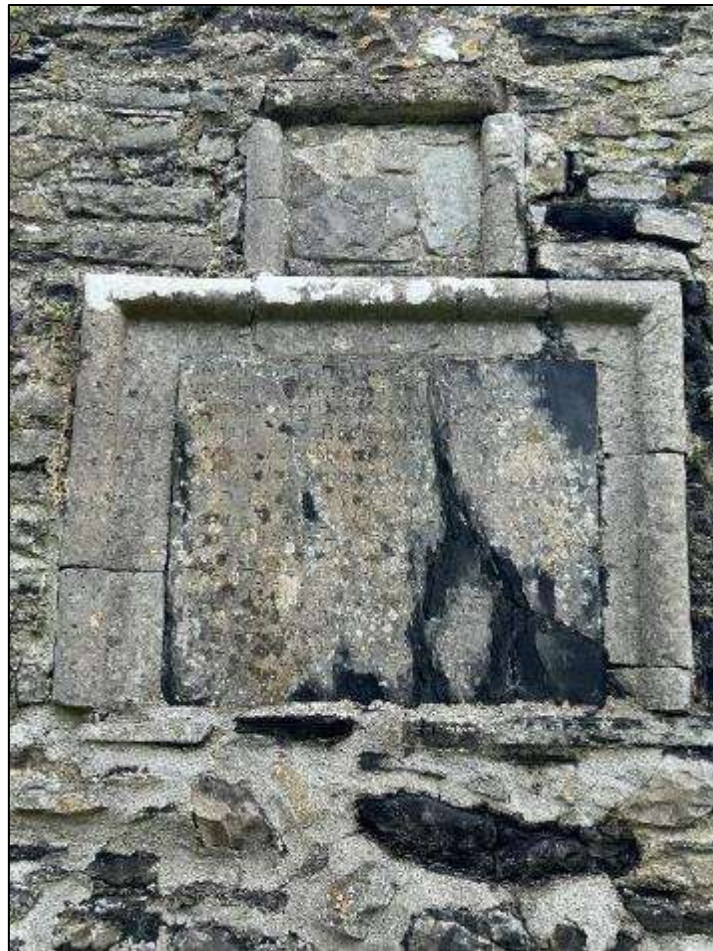
1. The Comins mural tablet (Plate 13) on the western side of the tower is currently suffering from its exposure to the elements. As highlighted by 7L architects (2023) it is stable but its removal for repair would risk further damage.

Plate 13 Close up of eighteenth century mural tablet, facing east

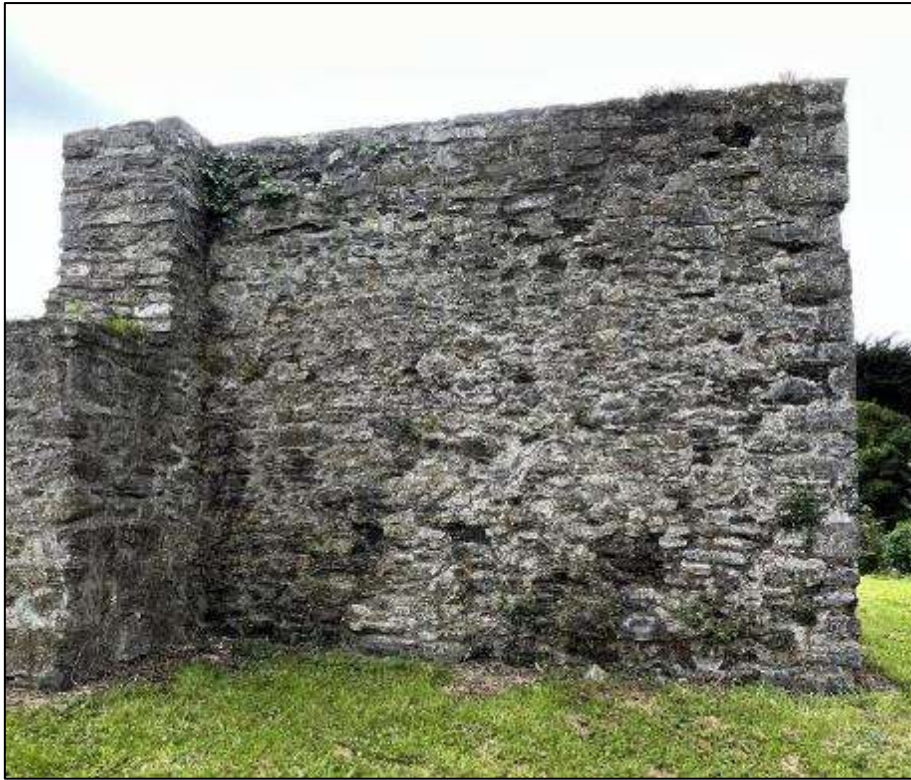
Northern elevation (Plate 14)- No obvious features were discernible in the northern elevation of the residential tower, other than the alternating quoins at the northwestern corner. Again, the elevation shows signs of modern repair with strap pointing, something which serves to mask where the northern wall of the tower meets the western wall of the church.

Plate 14 Northern elevation of residential tower, facing south

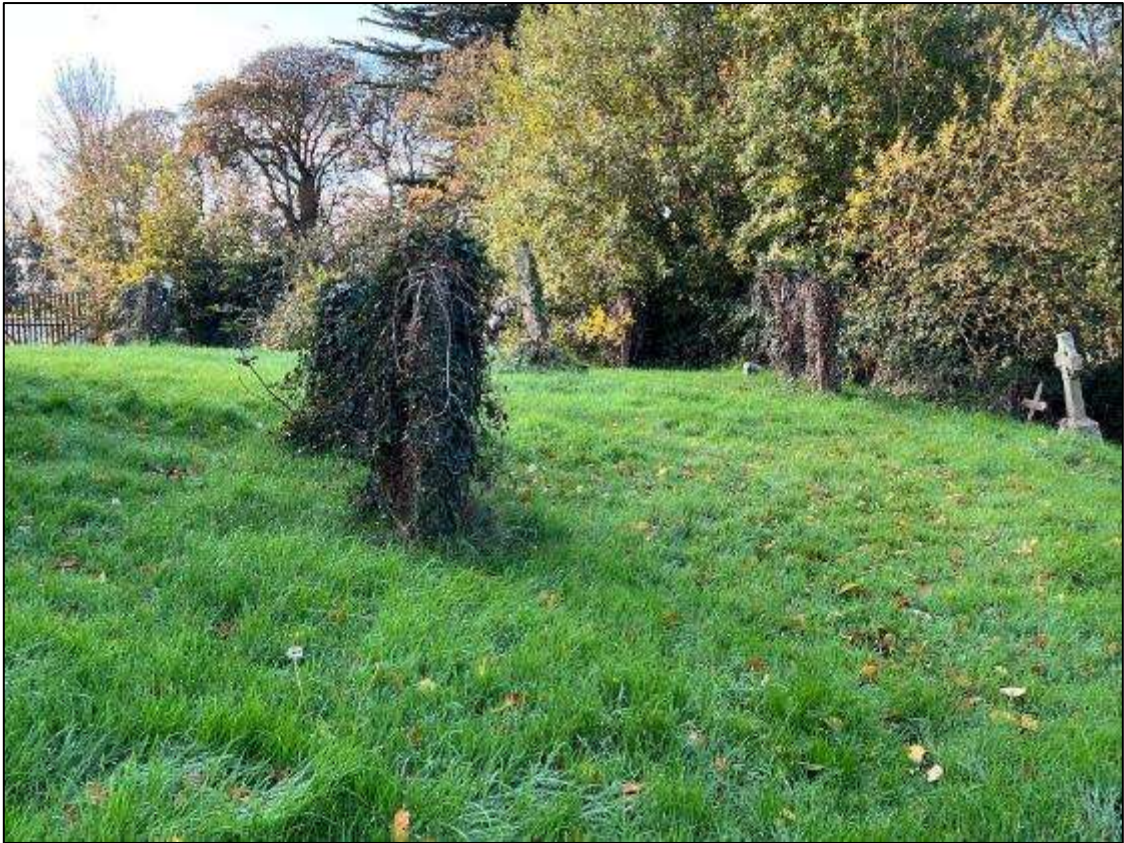
Plate 17 Vegetation overgrowth in southwest corner of graveyard

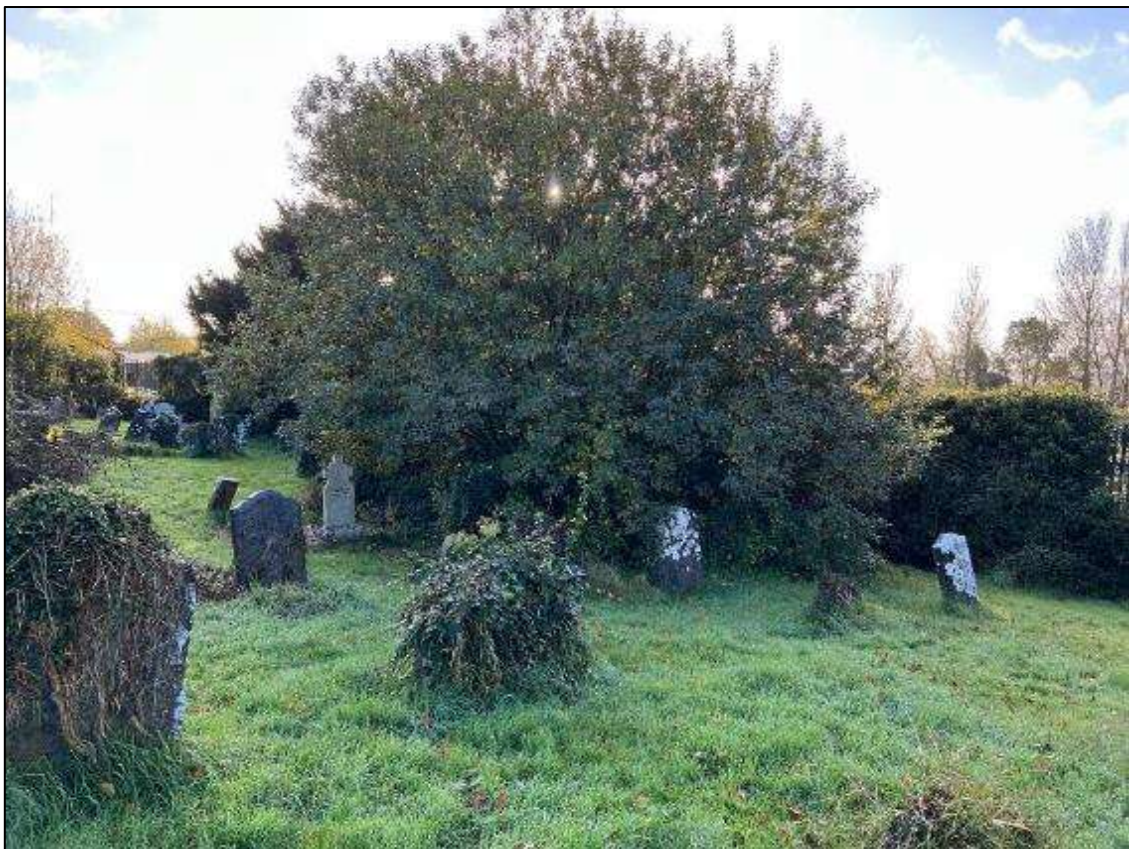
Plate 18 Vegetation overgrowth in southeast corner of graveyard
