Site: Lanistown Castle, DU012-004

Address: Donabate, Co. Dublin

Report on Archaeological Monitoring of CMF Conservation  
Works (CMF24-1-DF004) under Ministerial Consent C00141

Date: 11<sup>th</sup> February 2025

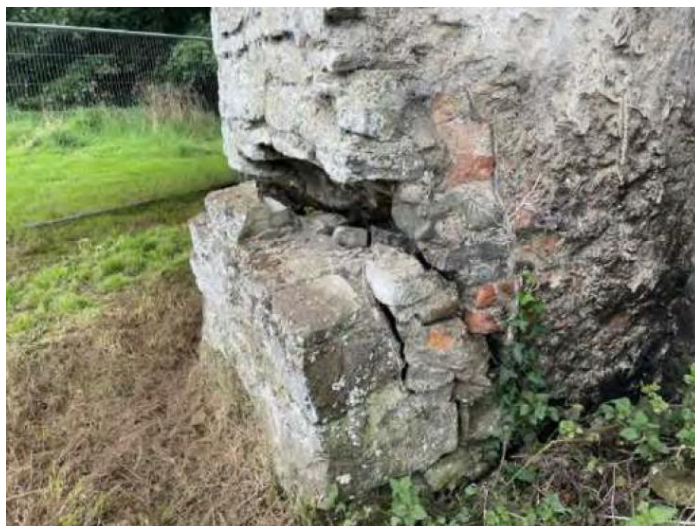
A shallow excavation was carried out to establish the depth of the foundations beneath the southeast corner masonry wall and to ascertain the reason for the subsidence of this feature (Plates 2 and 3). This hand excavation, carried out by the author, removed the sod layer and topsoil to a depth of 0.25m in a cutting 0.5m wide extending south and east from the face of the wall

(Plate 4). It was found that, while the projecting masonry spur or buttress was of a contemporary build with the rest of the castle, there were no below ground foundations to this projection and this is what had caused the subsidence. Assessment of the feature confirmed that further subsidence is unlikely and that the optimum remedial work was the infilling of the fissured masonry with lime mortar and salvaged stone from the site to stabilise the fragment and prevent further water ingress and erosion (Plates 5 and 6).

**Plate 2:** Subsidence in southeast corner wall, facing south

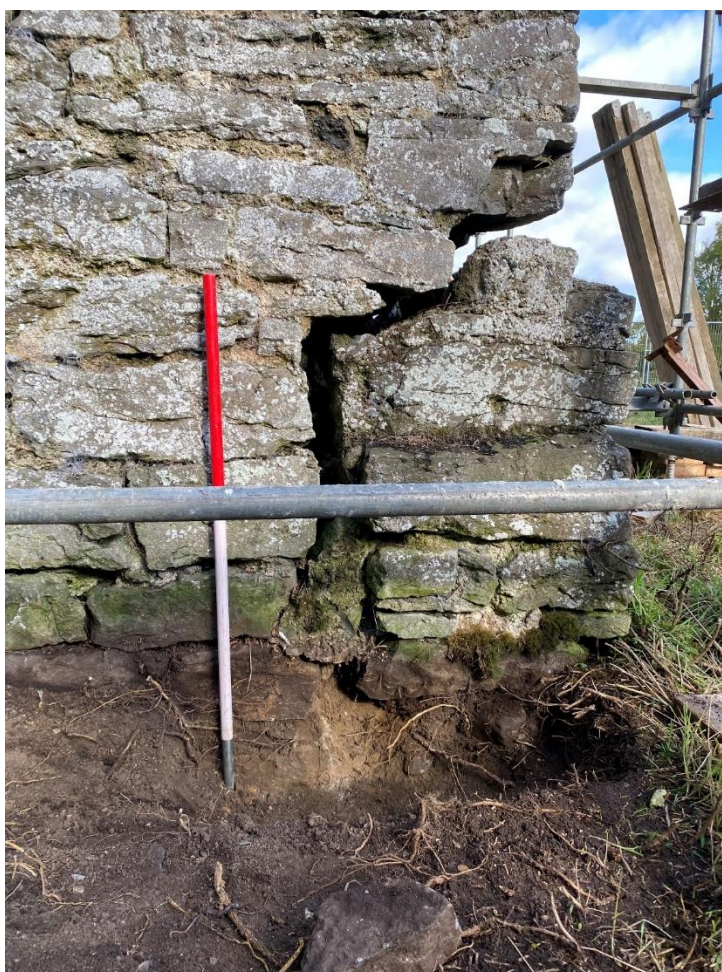
**Plate 3:** Foundation test pit showing no foundation beneath the projecting masonry spur, facing north

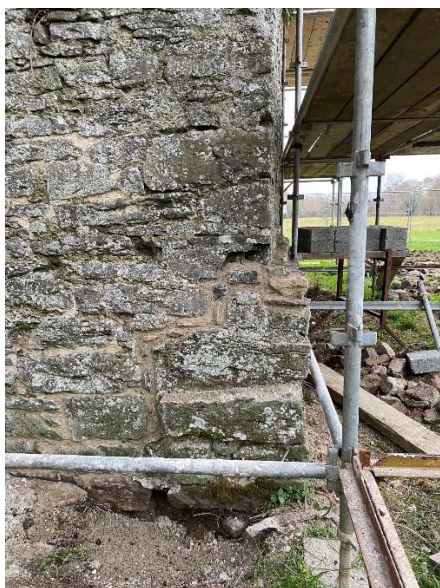
**Plate 4:** Lime mortar repair to projection, facing north

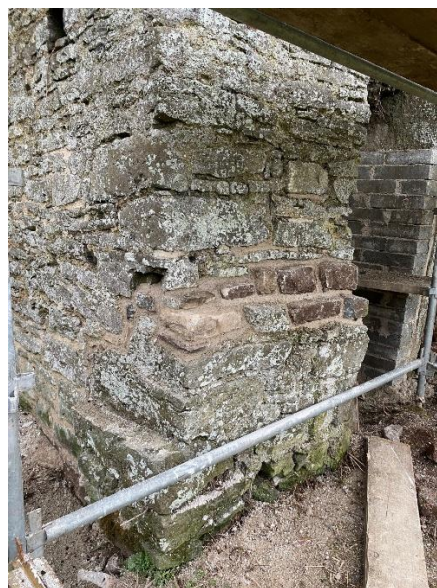
**Plate 5:** Lime mortar repair to projection, facing northwest

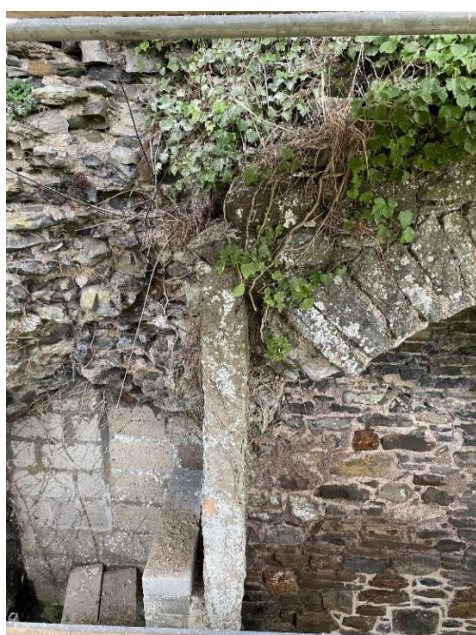
A compromised pointed arch on the eastern ground floor level of the castle has been propped sometime in the 20th century arch by a single-leaf concrete wall (Plates 6 and 7). Scraw and loose rubble and sod was also removed by hand by the author at the base of this wall to establish the nature of the foundation (Plate 8). It was found that the wall sits upon a wide concrete plinth that appears to be c. 0.2m in depth. This concrete wall was reenforced and rendered with a lime harling and the compromised arch was stabilised with infilling of stone salvaged from the site bonded with lime mortar (Plate 9).

**Plate 6:** Single-leaf wall supporting compromised arch, facing west

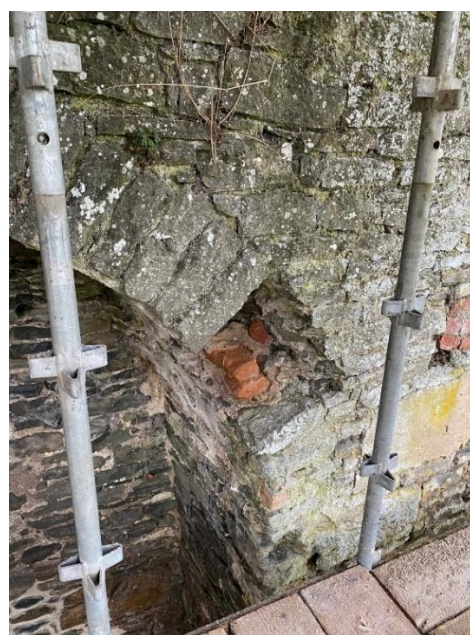
**Plate 7:** Northern side of compromised arch, facing west

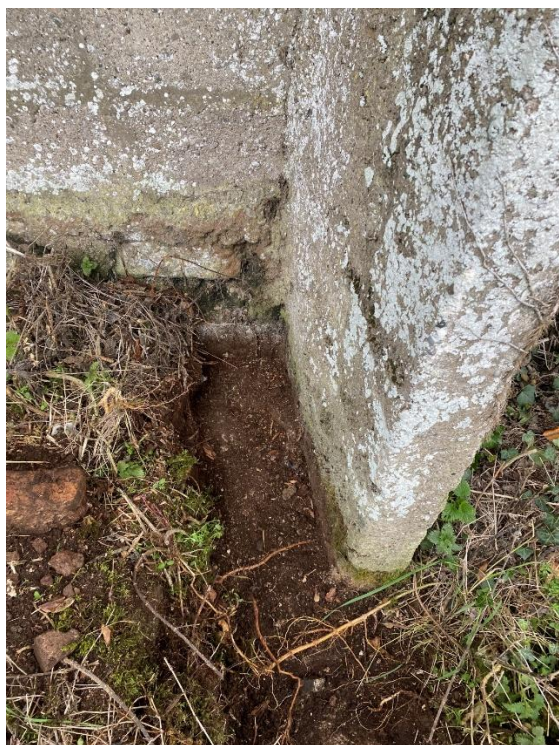
**Plate 8:** Base of single-leaf wall

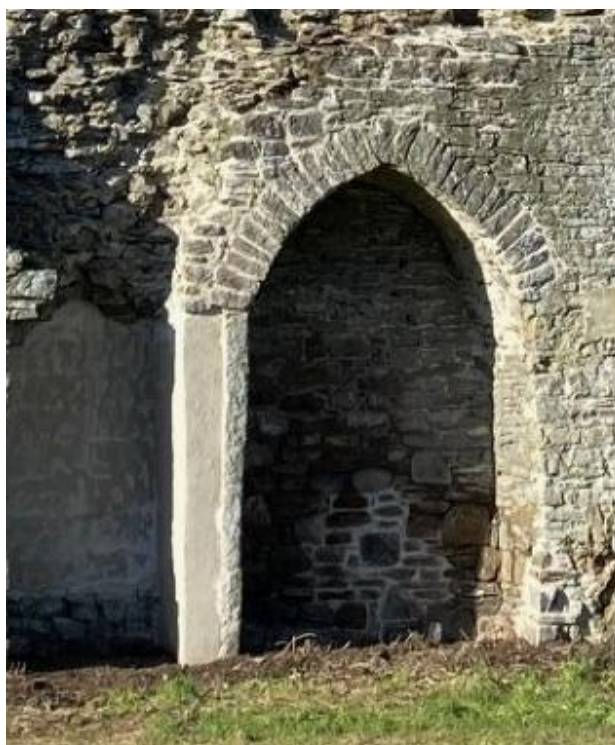
**Plate 9:** Lime mortar harling and repair to arch, facing west

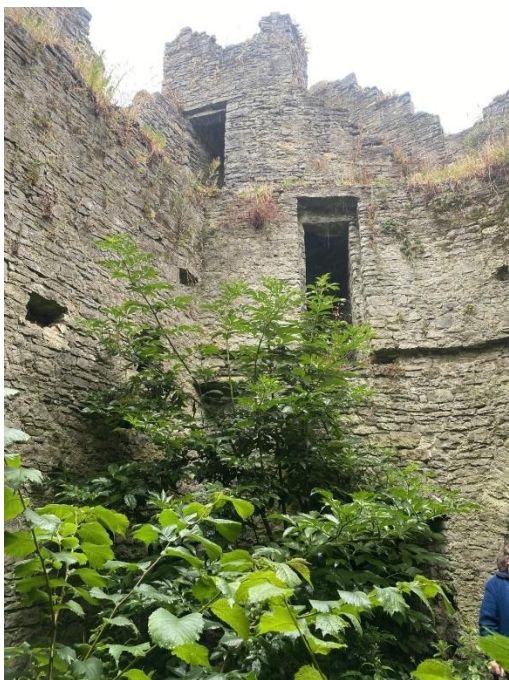
The stone vault covering the ground floor rooms and forming the first floor level in the castle had been open to the elements for a prolonged period of time. During this time a deposit of hummic material had accumulated, providing a fertile environment for plant growth (Plate 10). Significant woody saplings were present at the outset of the project and the conservation works provided for the removal of the plant growth, removal of the hummic material and installation of a layer of compacted puddle clay to be capped by a thin layer of grassed sod that could be easily maintained through regular mowing. The hummic material was removed by hand under archaeological supervision (Plate 11). No artefactual material was encountered apart from a plastic shotgun cartridge and a scalloped edged fragment of tin-glazed earthenware (Plates 12 and 13).

**Plate 10:** Vegetation growth from soil over vault, facing west

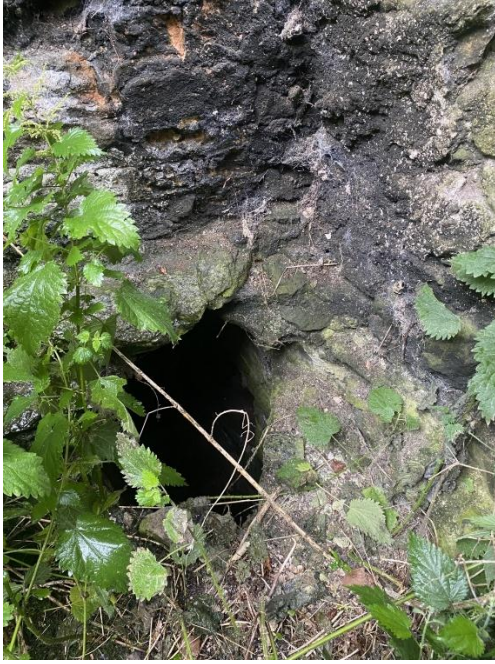
**Plate 14:** Hole prior to conservation, over intramural stairs

Prior to the installation of the puddle clay, the lintel over the western ope was replaced with timber beams and a hole in the floor over the western intramural stairs was covered with a salvaged stone slab (Plates 14-16).

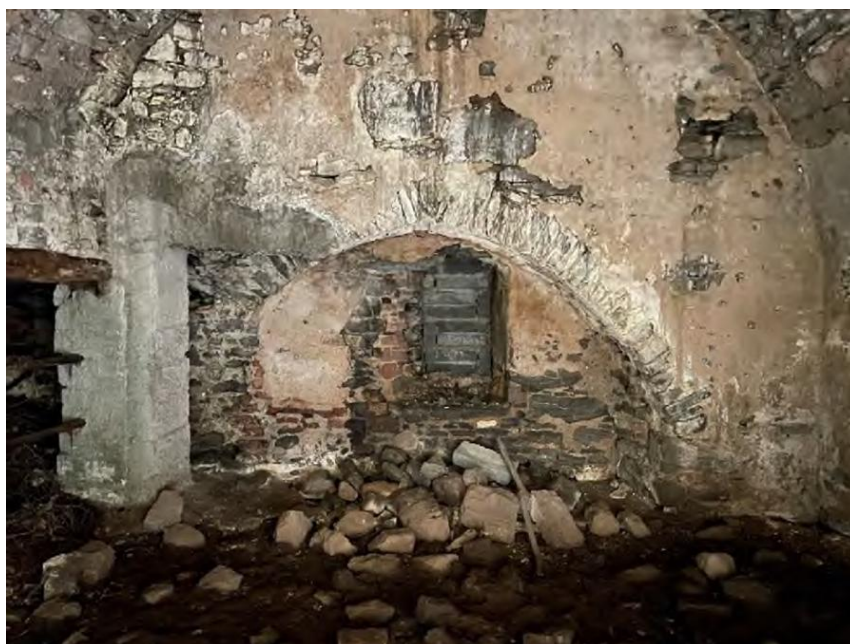
The removal of uneven hardened muck mixed with collapsed masonry stone within the vaulted ground floor space of the castle was archaeologically monitored. The hoof pocked muck was observed to be 0.15-0.2m in depth (Plate 17). The scattered, loose stone embedded in this muck was retrieved and examined and several moulded fragments were recovered. Loose stone around the western exterior wall was also examined and several further fragments were recovered (see Section 4.5 below).

**Plate 17:** Ground floor interior showing compromised arch, hoof-pocked muck and loose stone, facing north

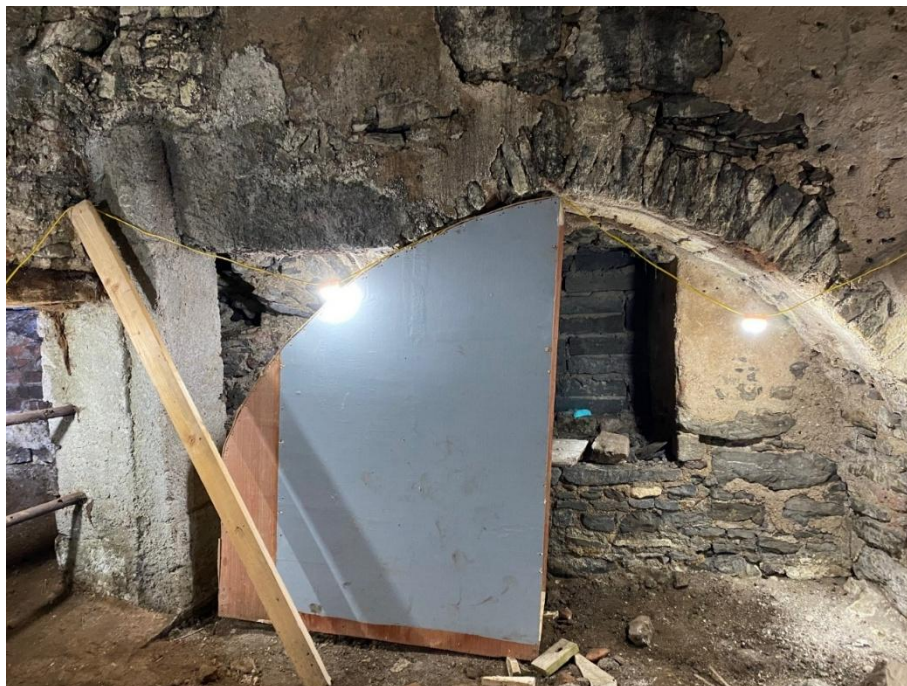
An intramural arch in the western wall at ground floor level had failed sometime in the building's past and had been partially propped with a concrete pier. The failed section of the arch was reconstructed using stone salvaged from the site and the concrete pier and associated lintel was covered in a lime-based harling to visually blend the structure into the older fabric (Plates 19 and 20).

**Plate 19:** Ground Falsework inserted during reconstruction of ground floor arch, facing west

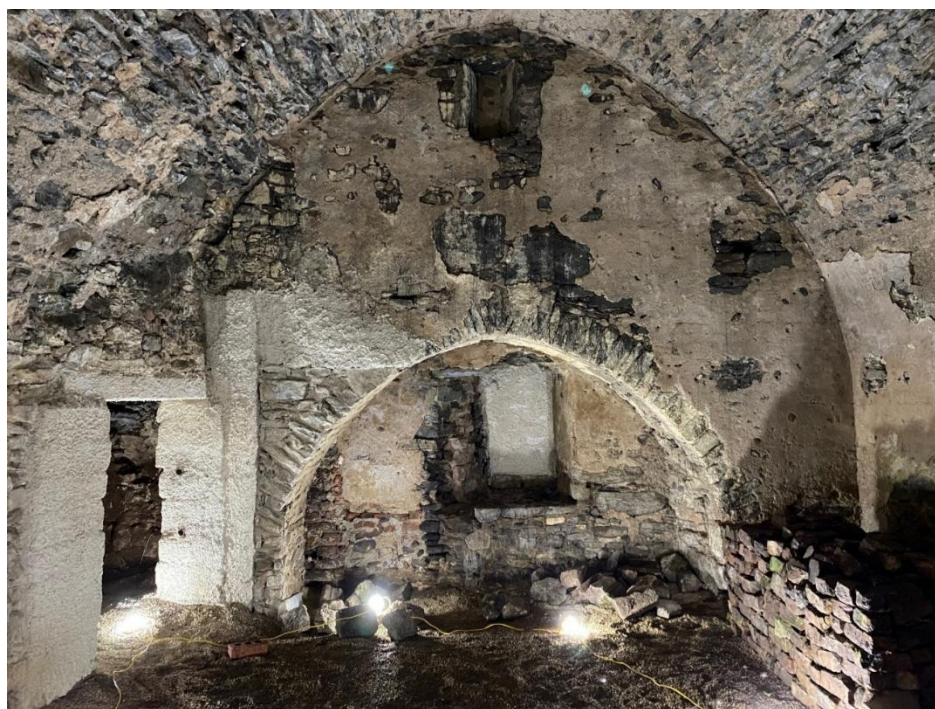
**Plate 20:** Completed ground floor arch, facing west

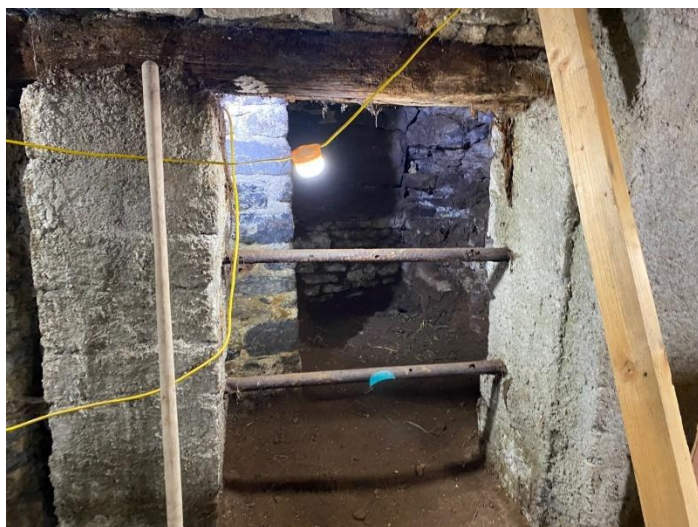
During these works, a post-medieval fireplace that had been inserted into the southwestern tower was cleaned out and degraded iron bars and a rotting timber that spanned the concrete sides of this opening, were removed (Plates 21-2). The timber was inspected following removal and was found to exhibit several dowels that may indicate it is of some antiquity. The timber was examined by Dr Ellen Ocarroll and confirmed to be oak. The sample was identified as a very fast-growing specimen with c. 30 tree rings evident. For this reason, it is not feasible for dendrochronological dating.

**Plate 21:** Timber lintel in place

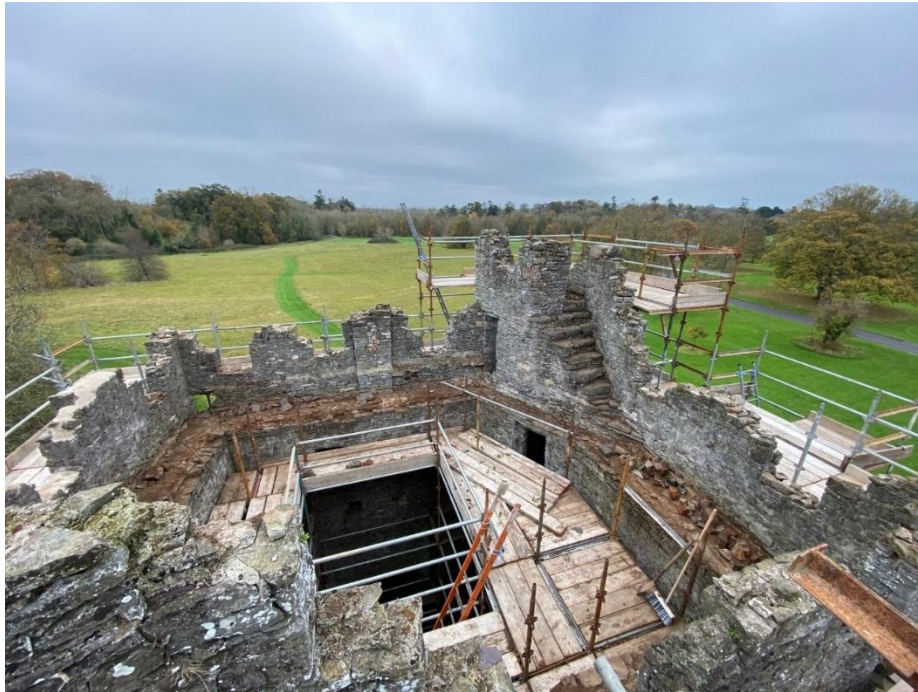
Significant water pooling, collection of hummic material and vegetation growth was evident on the wall walks at the outset of the project. The vegetation was removed and overlying hummic soil and it was found that loose redbrick dating to the 18th century phases of the site was cluttering the top of the wall walks providing pockets within which vegetation growth was encouraged. These bricks were removed under archaeological supervision, collected and stored in the ground floor room for future use.

**Plate 23:** Upper levels showing loose redbrick on wall walks

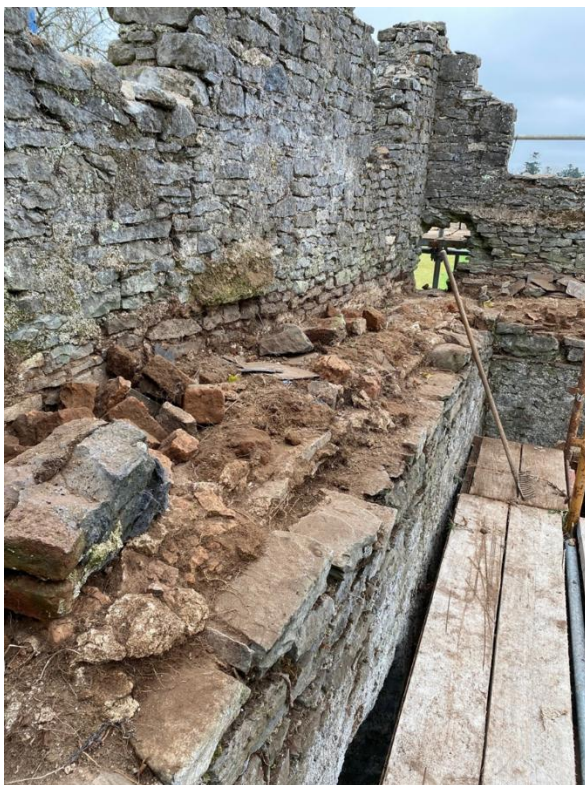
**Plate 24:** Loose brick on western wall walk

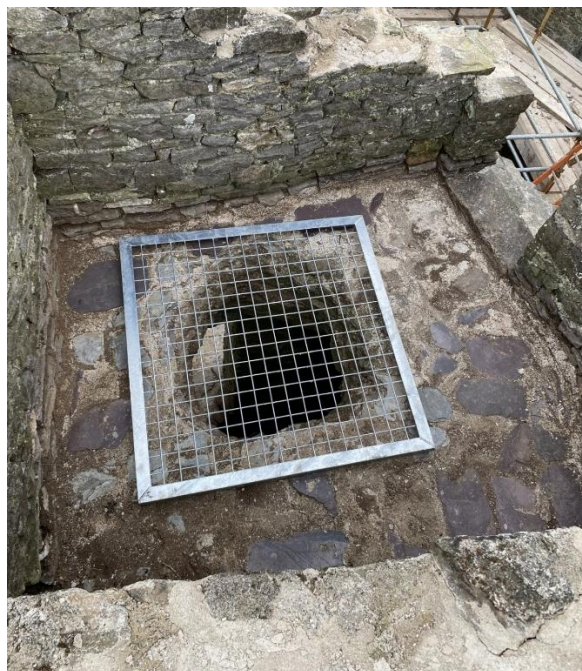
**Plate 28:** Metal grille over improvised 18th century chimney. Facing north

The first-floor wall walks were also stripped of vegetation and rough racked. In addition, the improvised chimney hole relating to the 18th century fireplace in the southwestern tower, was made safe by the installation of a metal grille over its top (Plate 28).

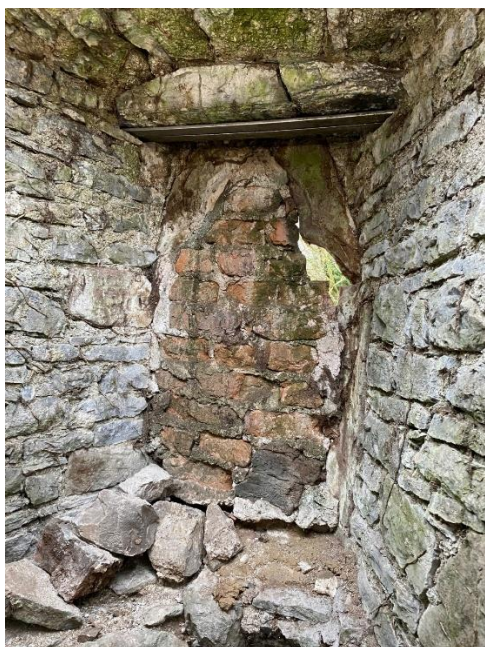
Areas of failing mortar or missing masonry were repointed and repaired throughout the castle's fabric. A red sandstone ogee headed window at first floor level had been infilled with redbrick at sometime in the past (Plate 29). The lime mortar of this infill was failing and was raked out and repointed.

**Plate 29:** Ogee headed window (interior) prior to repointing

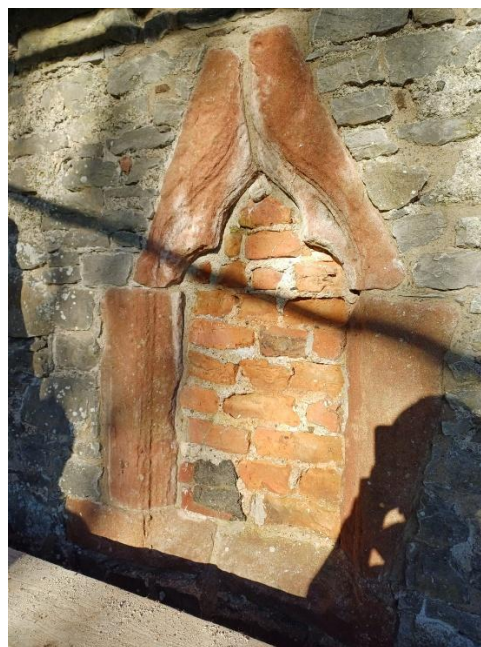
**Plate 30:** Ogee headed window (exterior) after repointing

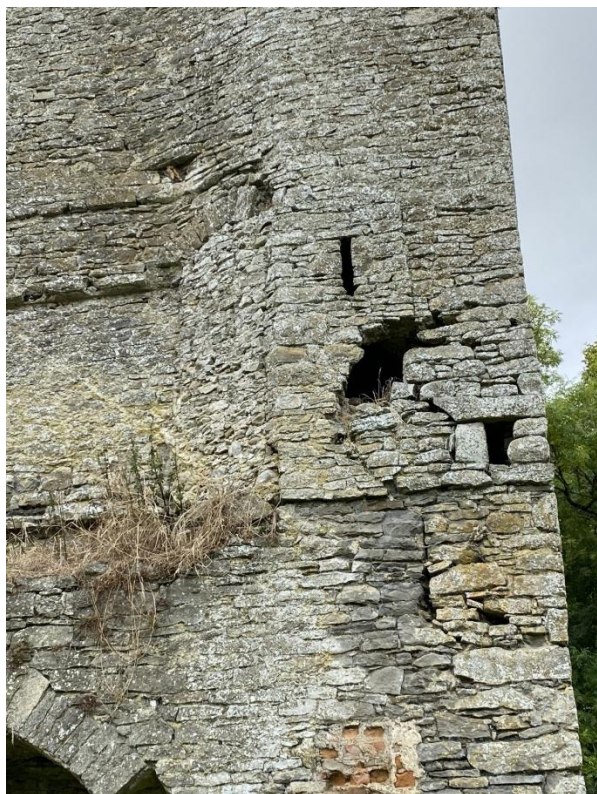
**Plate 31:** Gap in the masonry at the northeast stairwell, facing west

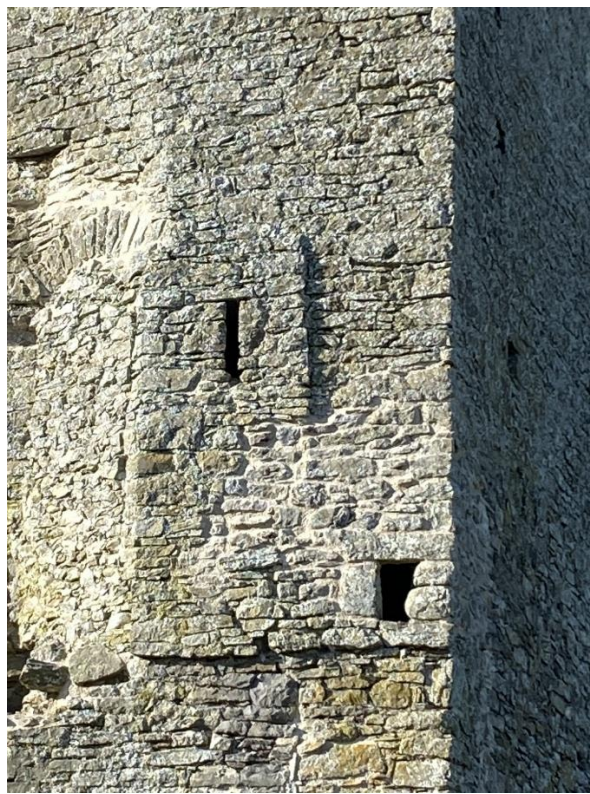
**Plate 32:** Repaired masonry at the northeast stairwell, facing west

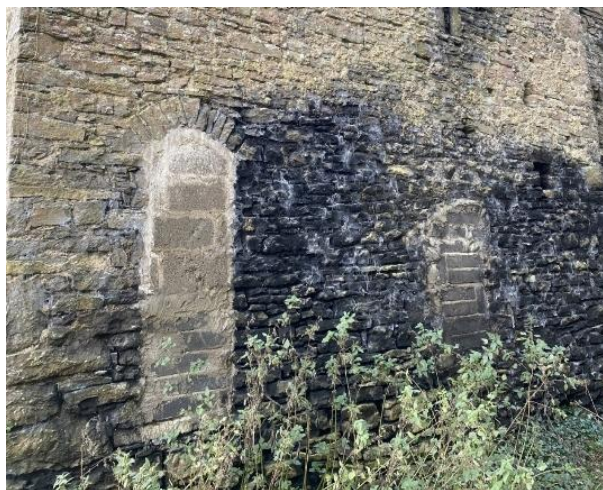
**Plate 33:** Blockwork infill of opes in western gable

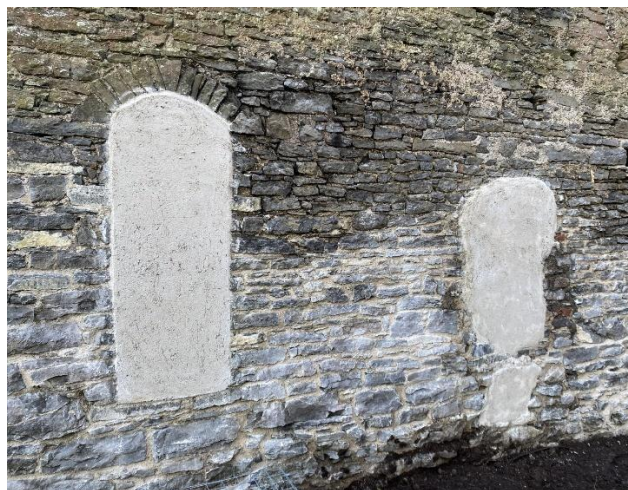
**Plate 34:** Lime render over blockwork infill of opes in western gable
