**Tower House  
at  
Glebe South  
Balrothery, Co. Dublin  
Archaeological Oversight Report**

**CMF24-1-DF002**  
**RMP No. DU005-057006-**  
**License No. 23E0833ext**  
**Finola O'Carroll**

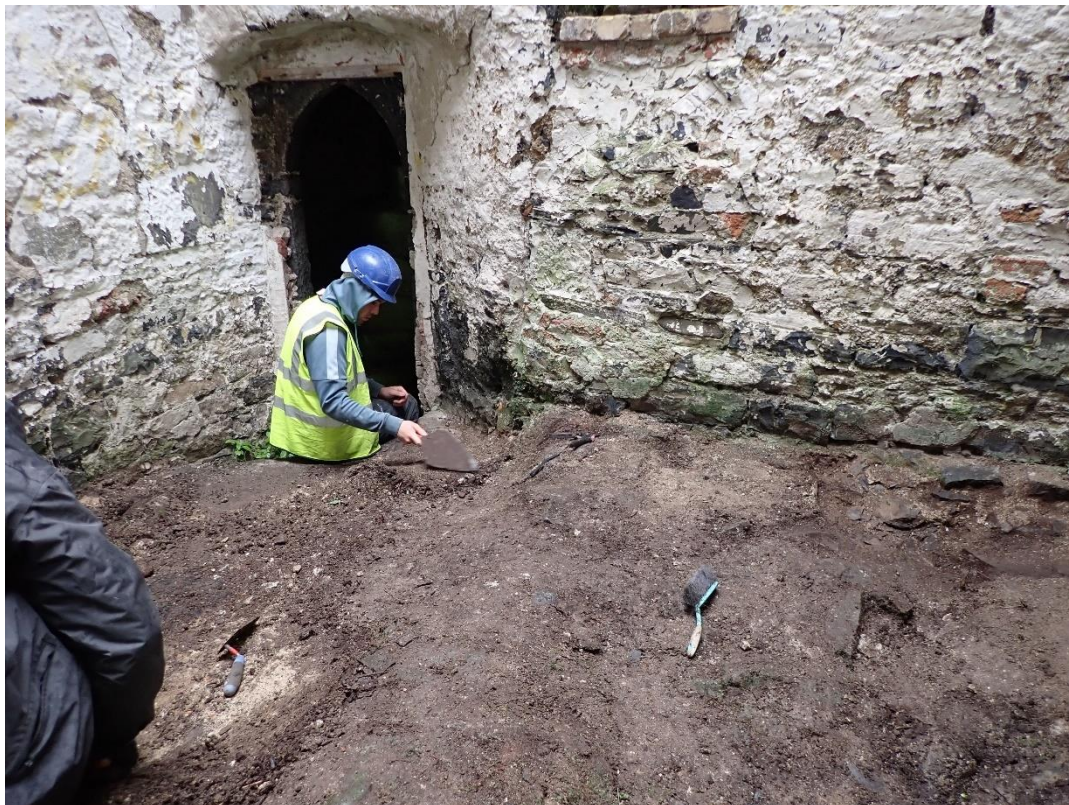
The first floor above the vault was covered in weeds, soil and other detritus. In order to ensure that water seepage through the vault to the room below was excluded, or at least minimised, the material was removed down to the surviving mortar and exposed stones by trowelling back the accumulated humus and other material. Loose stone, Styrofoam, loose mortar and various modern finds (an early electric iron, part of a piston, shotgun cartridges, and old batteries) were noted.

Plate 1: Removing the humus from above the vault

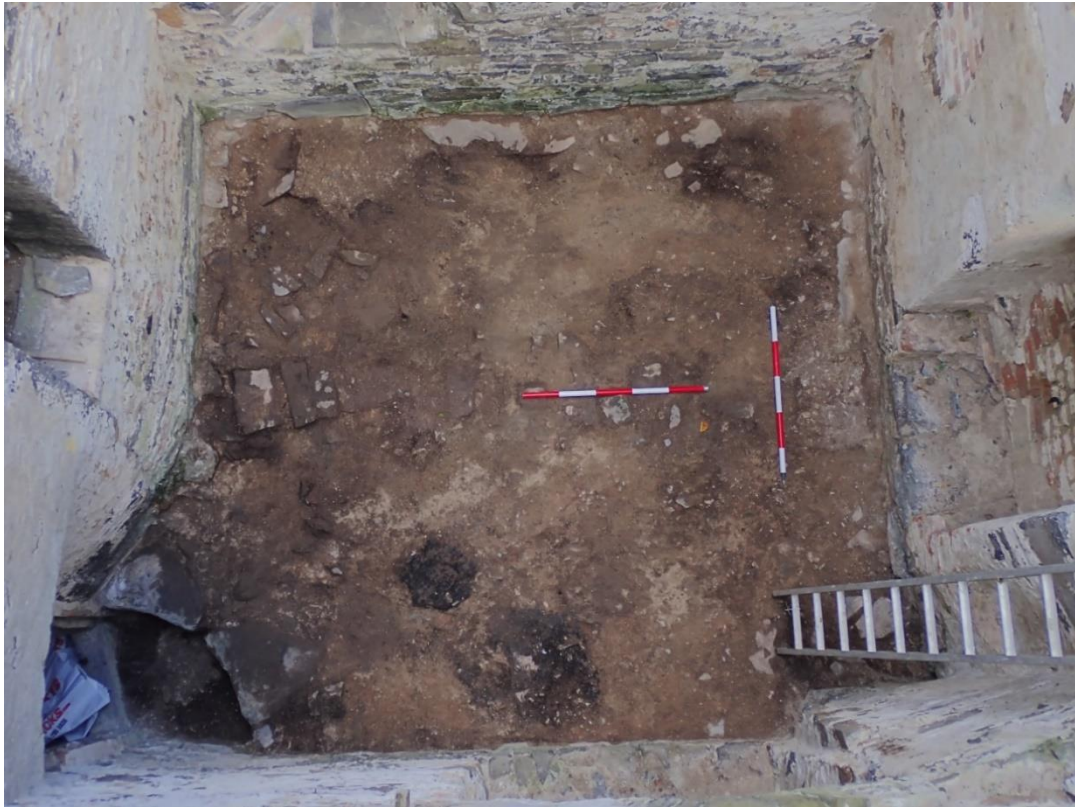
The mortar exposed was quite friable in places, more solid in others (Plate 2). There appeared to be a number of layers to the mortar, in one instance, in the northwest corner, there appeared to be some of the humic material sandwiched between mortar layers (Plate 3). This may have been a result of wash from the walls, or there may have been episodes of re-mortaring the floor surface with inadequate cleaning of the deposits on it. The stones along the crown of the vault were exposed, running east to west (Plates 2, 3, and 5). The floor sloped from the crown to the south but was more level to the north.

Along the west, north, and east walls long narrow flagstones had been placed edging the floor against the wall (Plates 2-5). At the east end there was a patch of small stones, like metalling, in the centre running up to the wall and covering the flagstones at that point.

The opening from the stair into that first floor chamber was marked by a curving step up running from the left hand door jamb to the right (south) wall about 75cms from the right hand door jamb. This step was composed of two large stones shaped to fit (Plates 2 and 6) with one smaller one completing the arc on the south side.

Plate 2: View down to exposed mortar and stone over vault. North is to the top and the curved step from the doorway into that level is at the SW corner (bottom left)

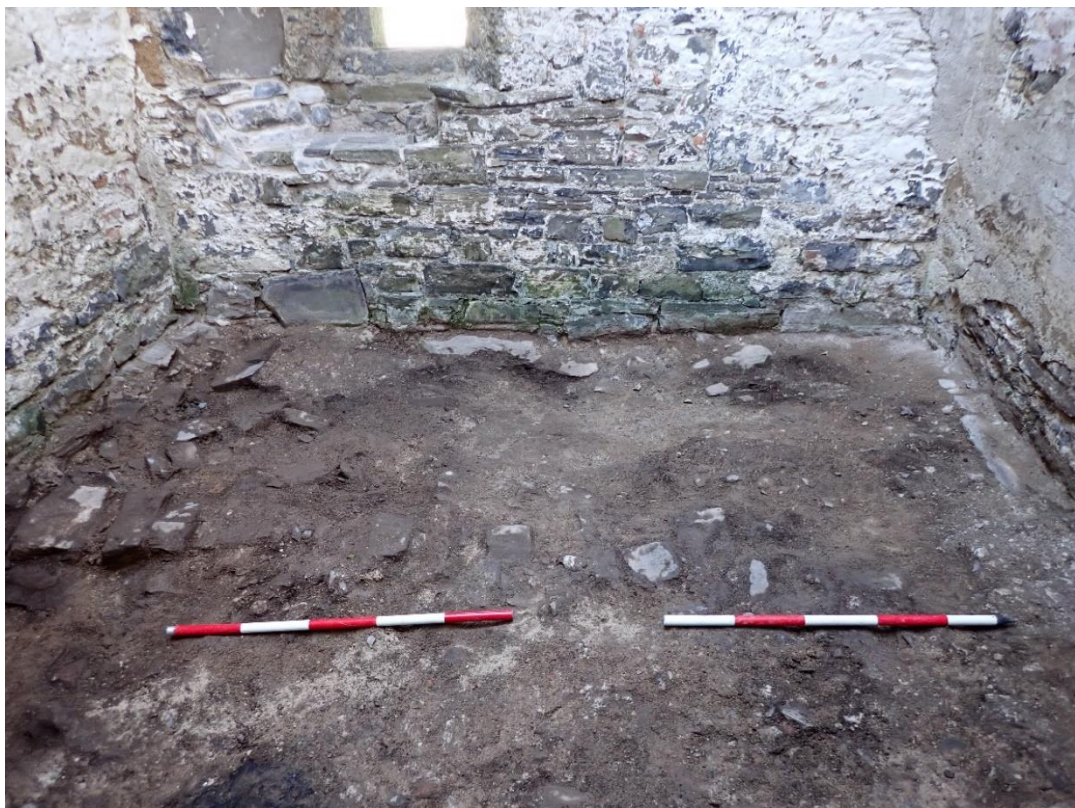
Plate 3: View looking north. Large, narrow flagstones can be seen laid along the west and north walls and the stones along the crown of the vault have been exposed

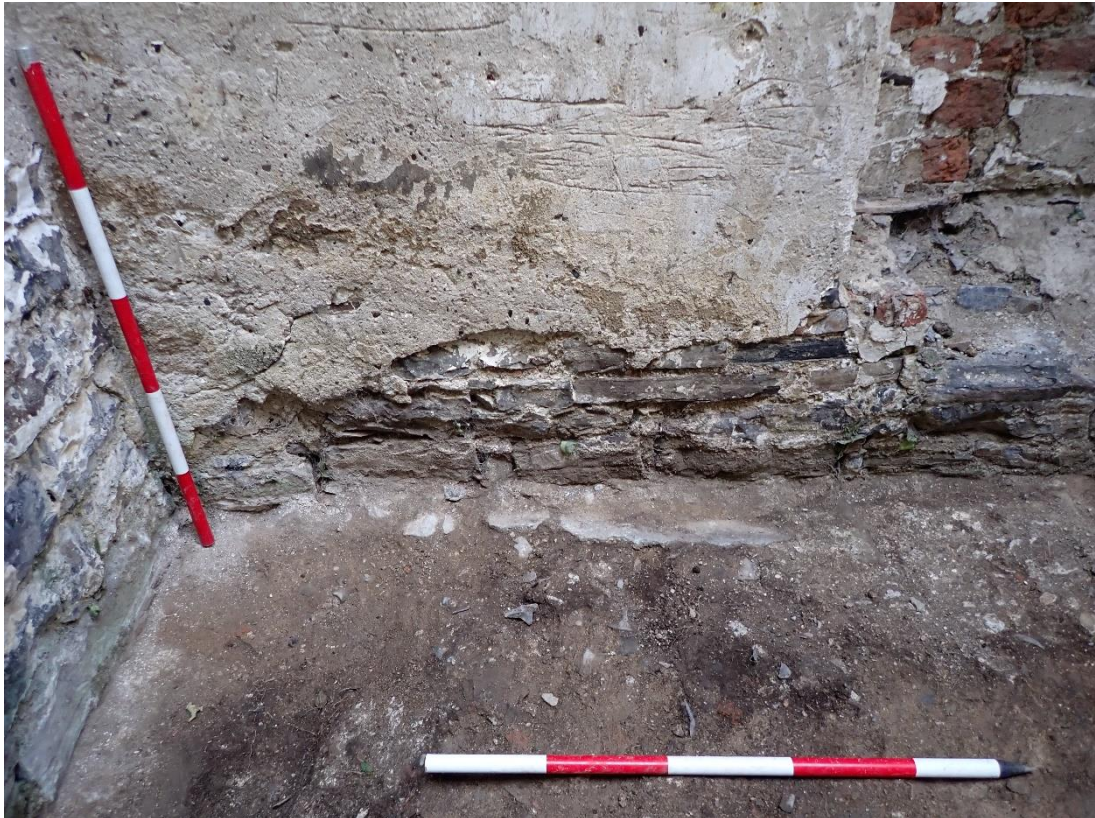
Plate 4: The NE corner, long narrow flagstones laid against the north wall, with some packed small stones towards the centre

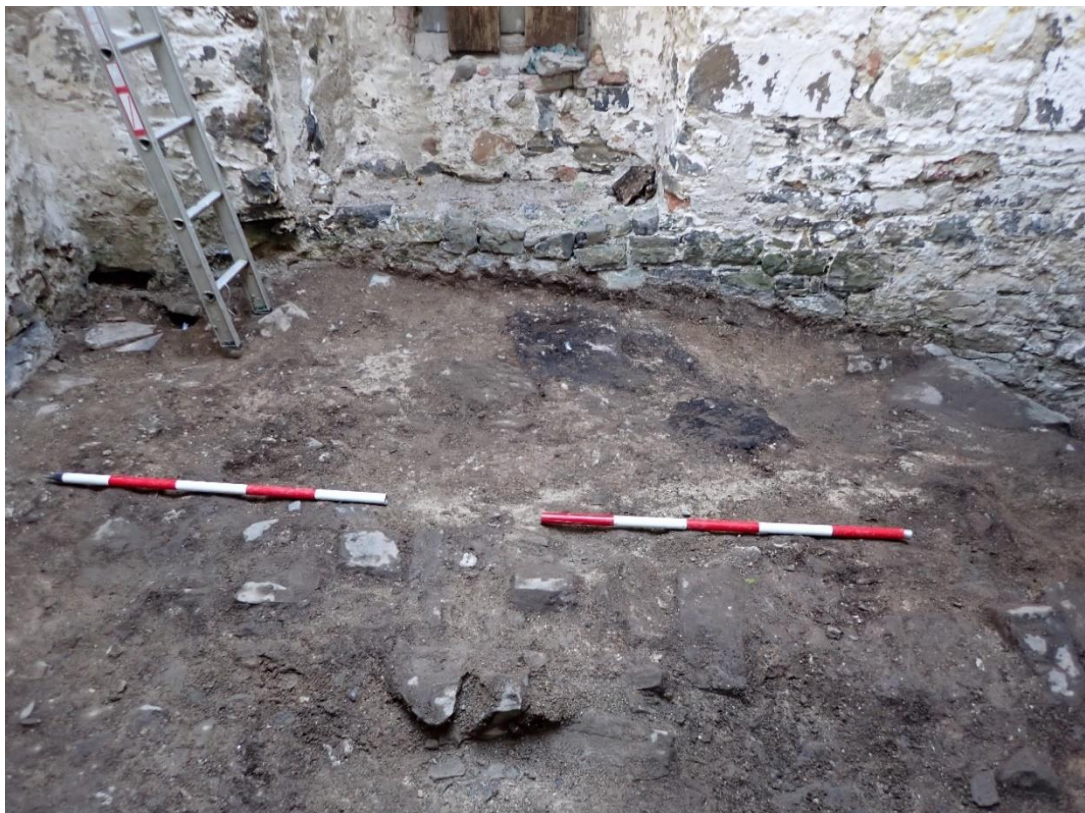
Plate 5: Looking south over the exposed stones along the crown of the vault. No flagstones are visible along the south wall, some visible along the east wall

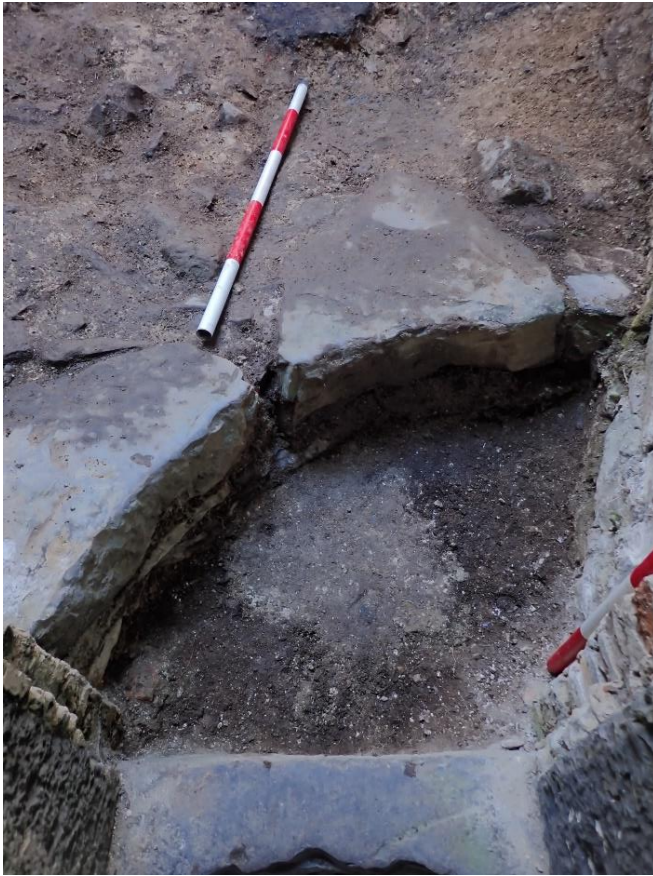
Plate 6: The curving stones making up the step into the chamber with the threshold stone in the foreground

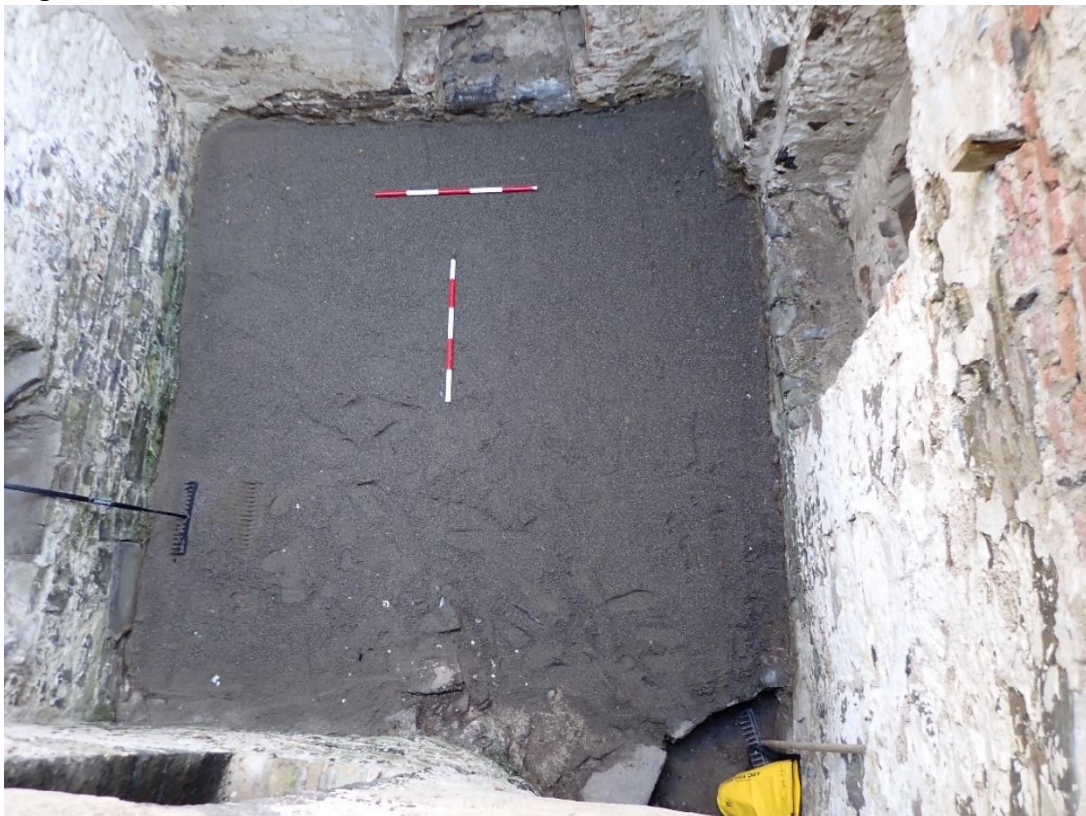
Plate 7: Sand laid on the exposed mortar to protect it

Humus and other debris were removed from the top of the vault under archaeological supervision. Sand was laid to cover the exposed mortar and stone, and a waterproof covering was fitted and then covered with gravel. A drainage system was inserted to run water off from the vault.

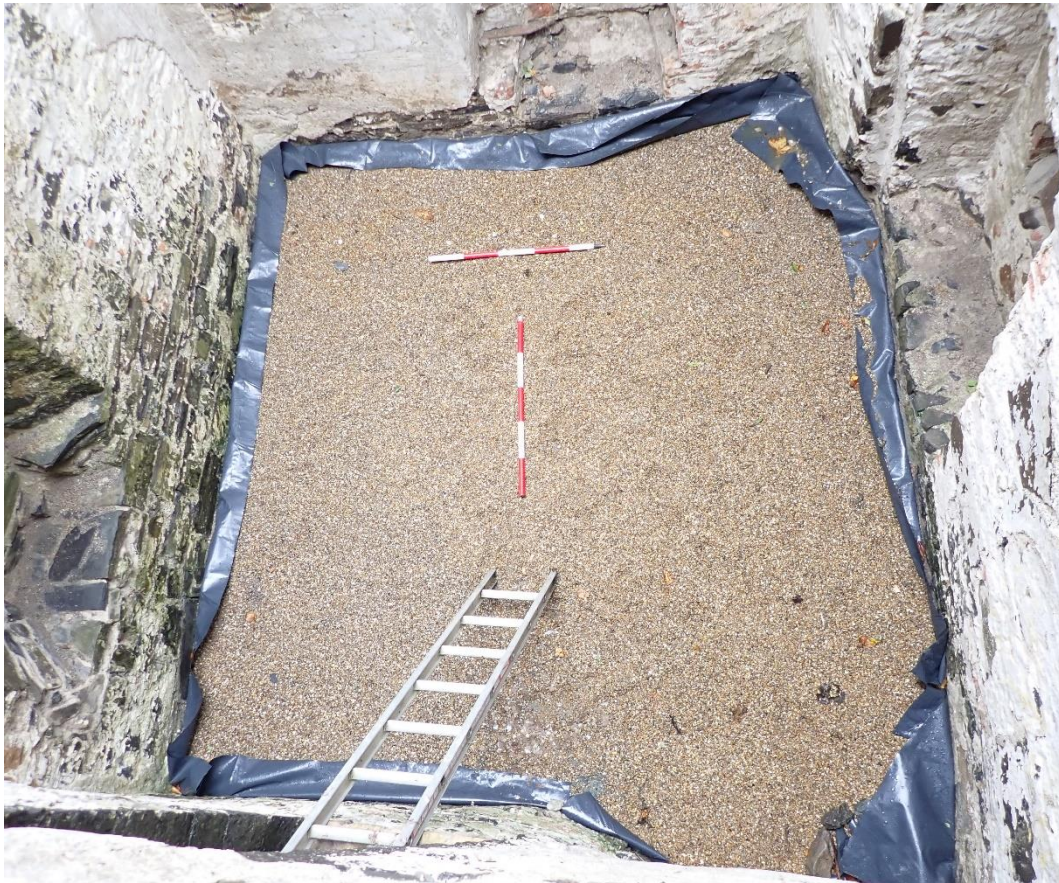
Plate 8: Impermeable membrane with gravel covering it laid over the sand, from west

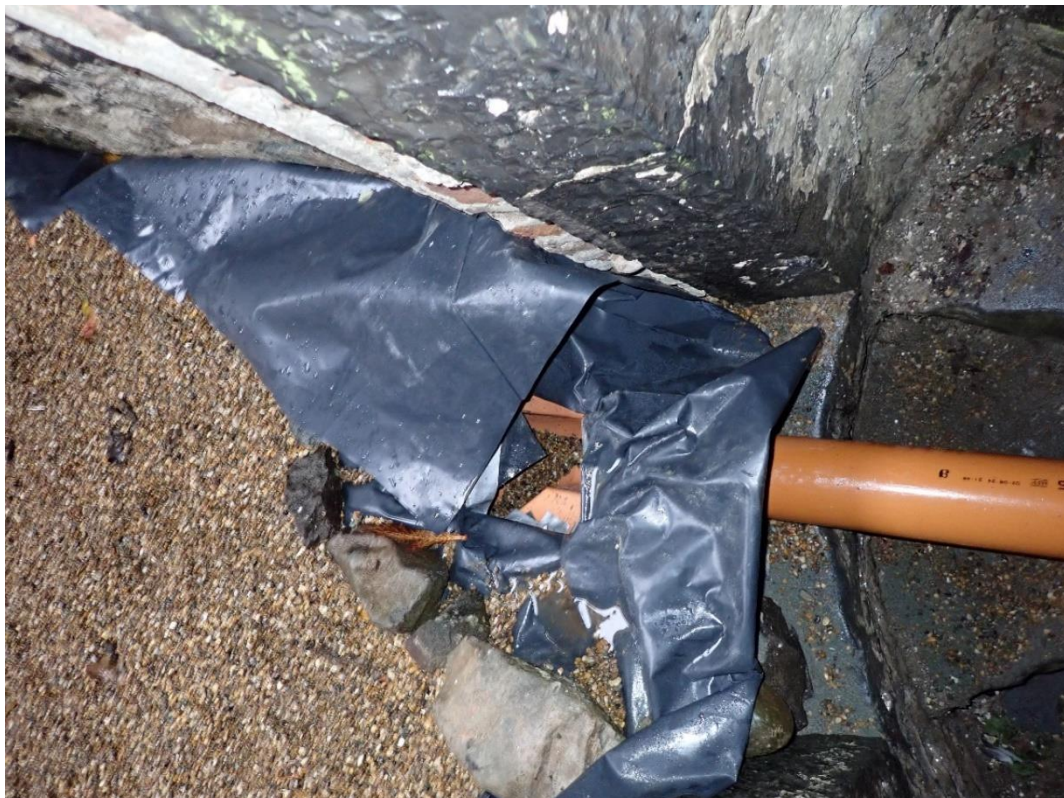
Plate 9: part of drainage system leading out over the step and ultimately draining out a window in the west wall

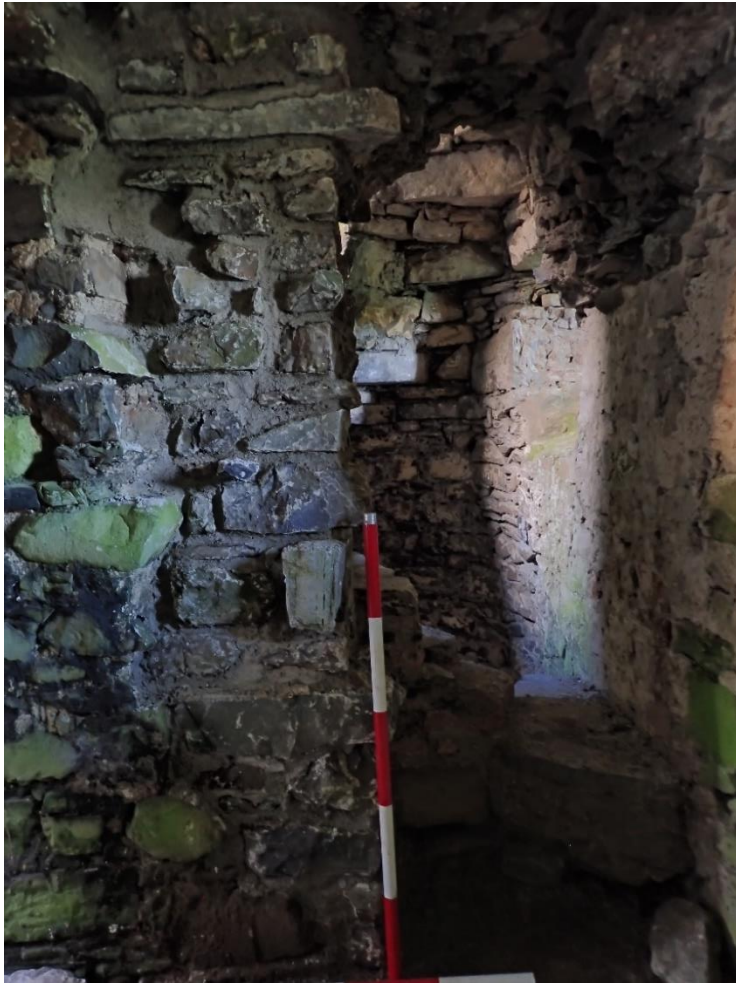
Plate 10: Re-built section of unsupported masonry where a gap was broken into the second floor room, west side, from the stairs

Second floor chamber: unsupported masonry over the opening broken through into stair was supported by reinstating some missing core masonry; exposed core masonry at sides and soffit of opening into stair was consolidated; and a cracked lintel at north wall window was stitched.

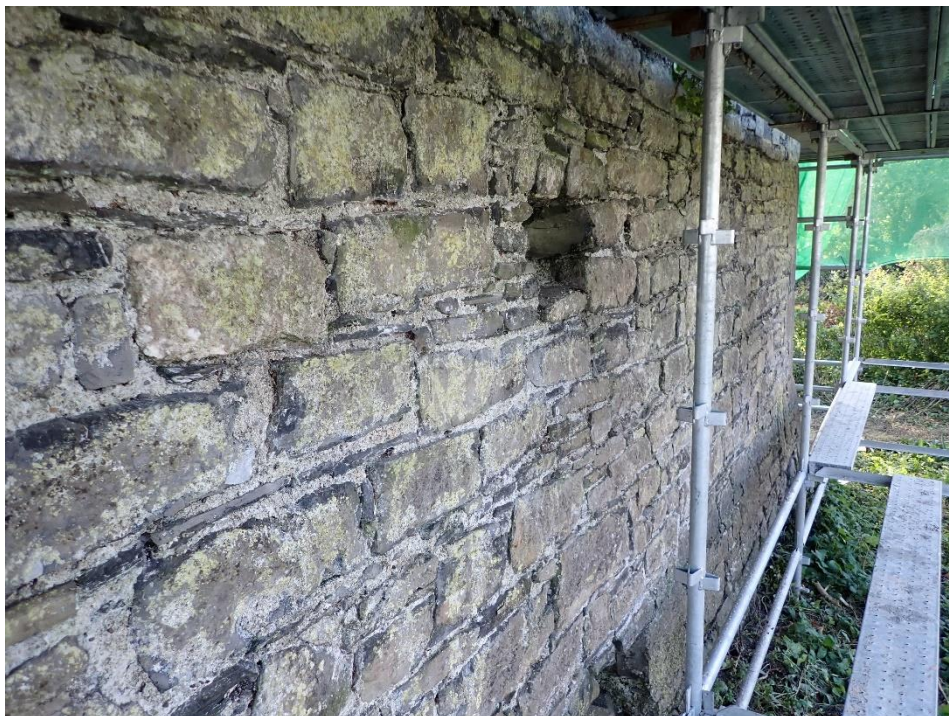
Plate 11: View looking west of the exterior of the north wall, ground floor, after cleaning

Ivy and vegetation were removed; local repointing was undertaken where joints were eroded; the loose masonry in the opening at the base of the wall was secured; and a new rainwater spout was provided where one of the three surviving spouts was broken off. The trefoil headed window was re-pointed.

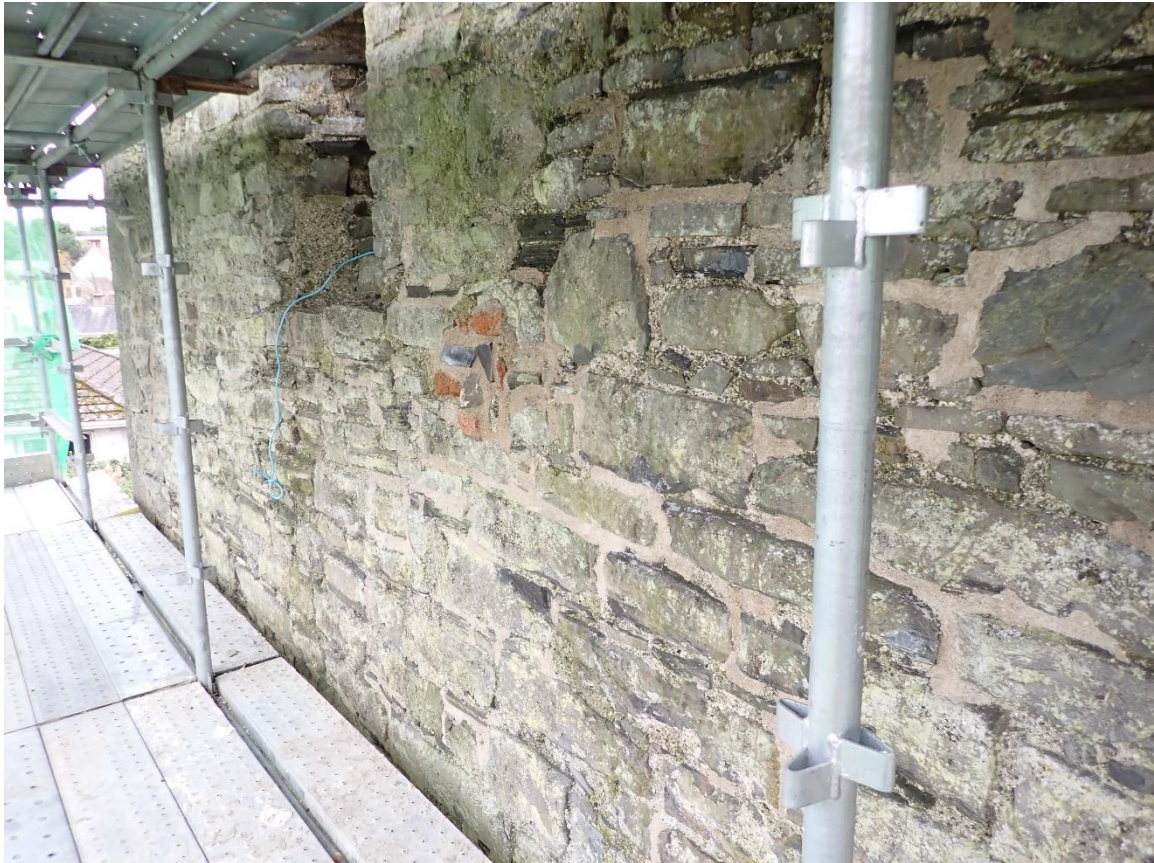
Plate 12: North wall, first floor above vault after re-pointing

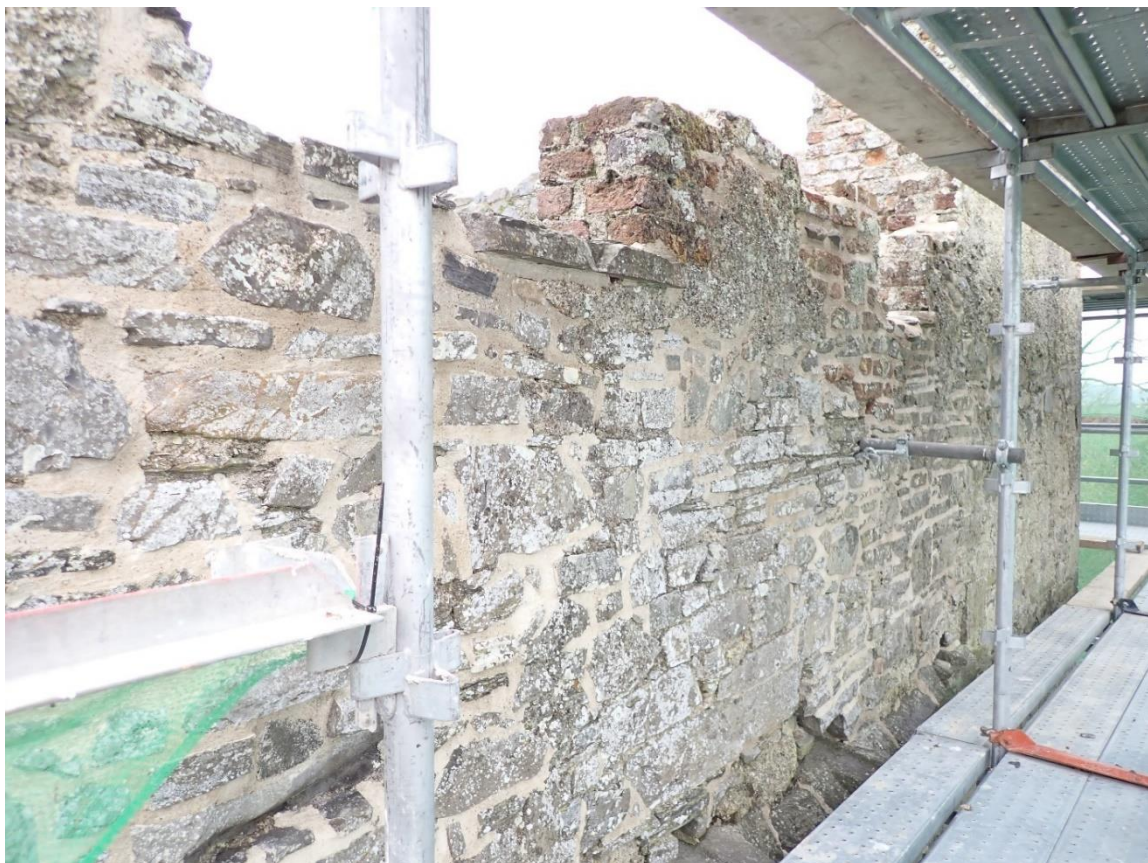
Plate 13: North wall, top floor, showing re-pointing of exterior wall and battlements

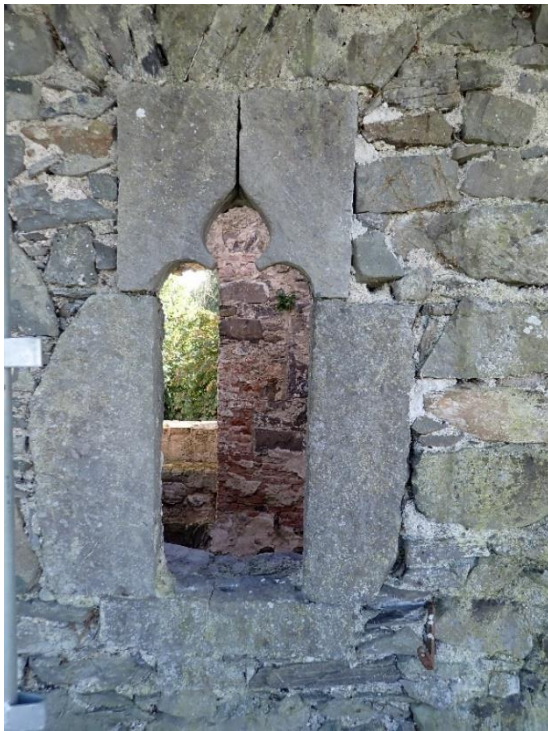
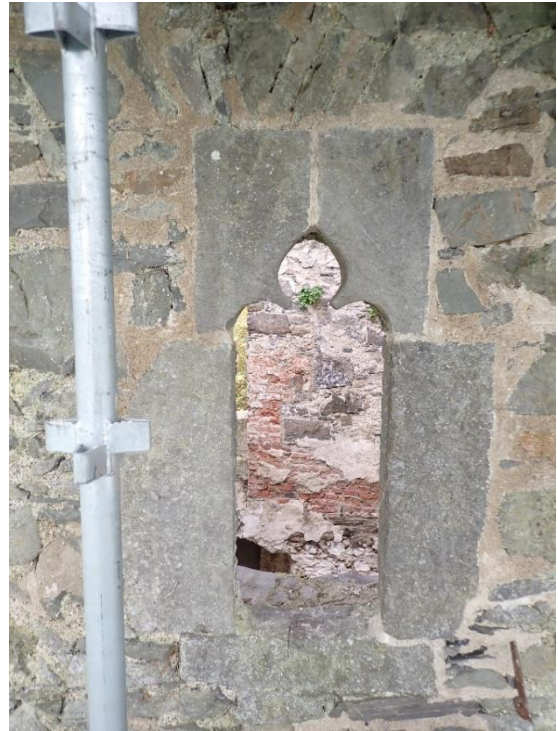
Plate 14: Trefoil headed window, north wall, before and after re-pointing. Note the off-centre keystone in the arch above

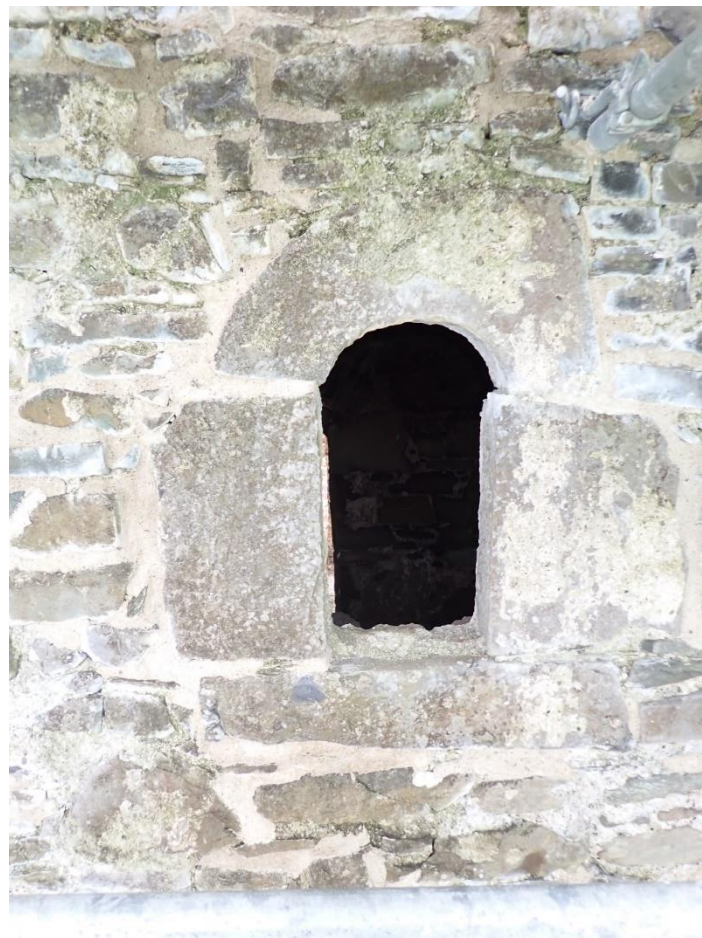
Plate 15: Round headed window to the third floor room, west wall after re-pointing

Ivy and vegetation were removed; local repointing was undertaken where joints were eroded; a vertical crack through the centre of the elevation was filled and repointed; stainless-steel helical bars were fitted over the full height of the crack; and a new rainwater spout was provided at the northwest where rainwater from the flagged roof at the west end exited via a now partly broken chute. There is a second, higher, rainwater chute at the south end of the west wall, but this was blocked by stone and mortar in the past and water does not exit through to any noticeable degree now. The chute is reasonably complete, unlike the lower, northern one which has been damaged and cut short.

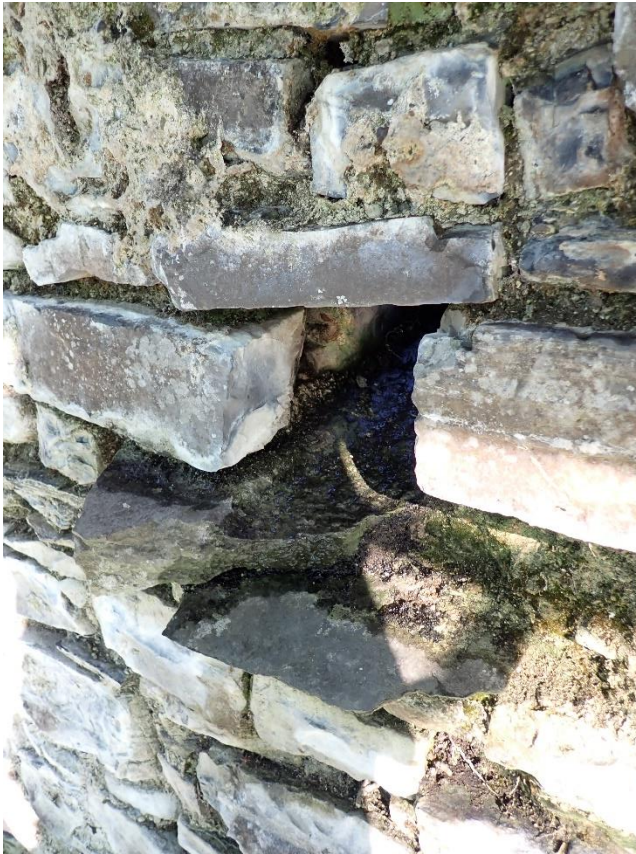
Plate 16: Damaged waterspout at north side of west wall which drains water from the north side of the flagstone roof.

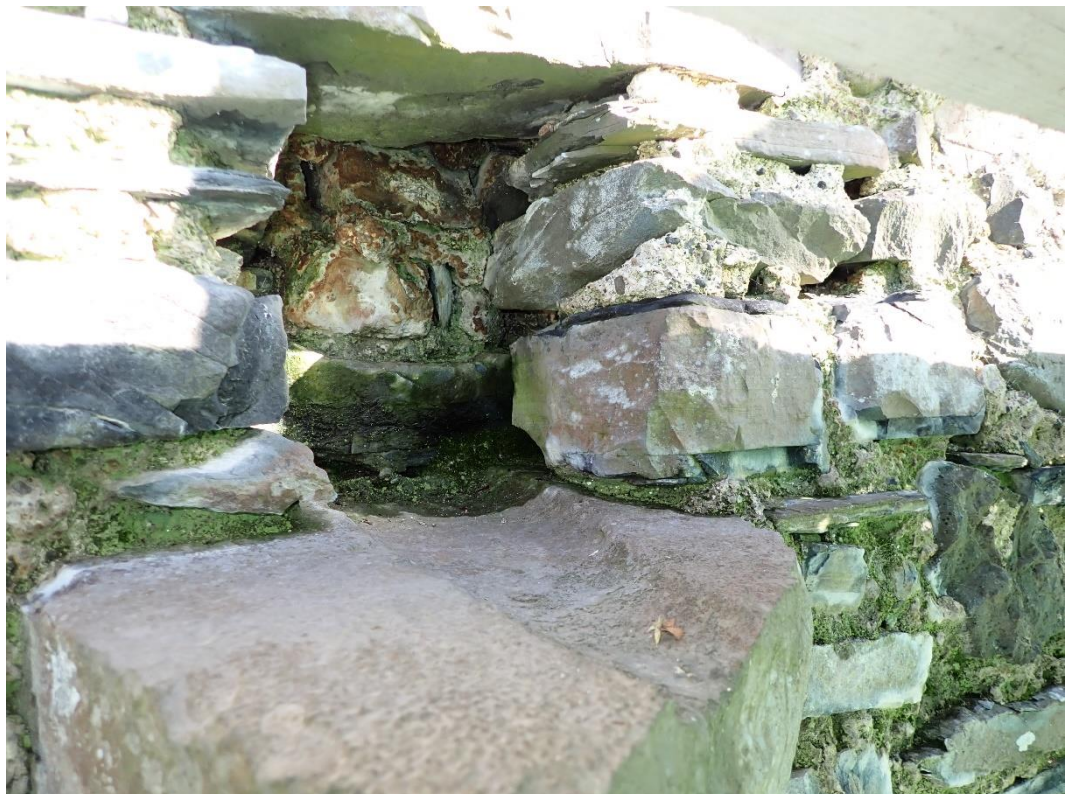
Plate 17: Blocked spout on south side, west wall

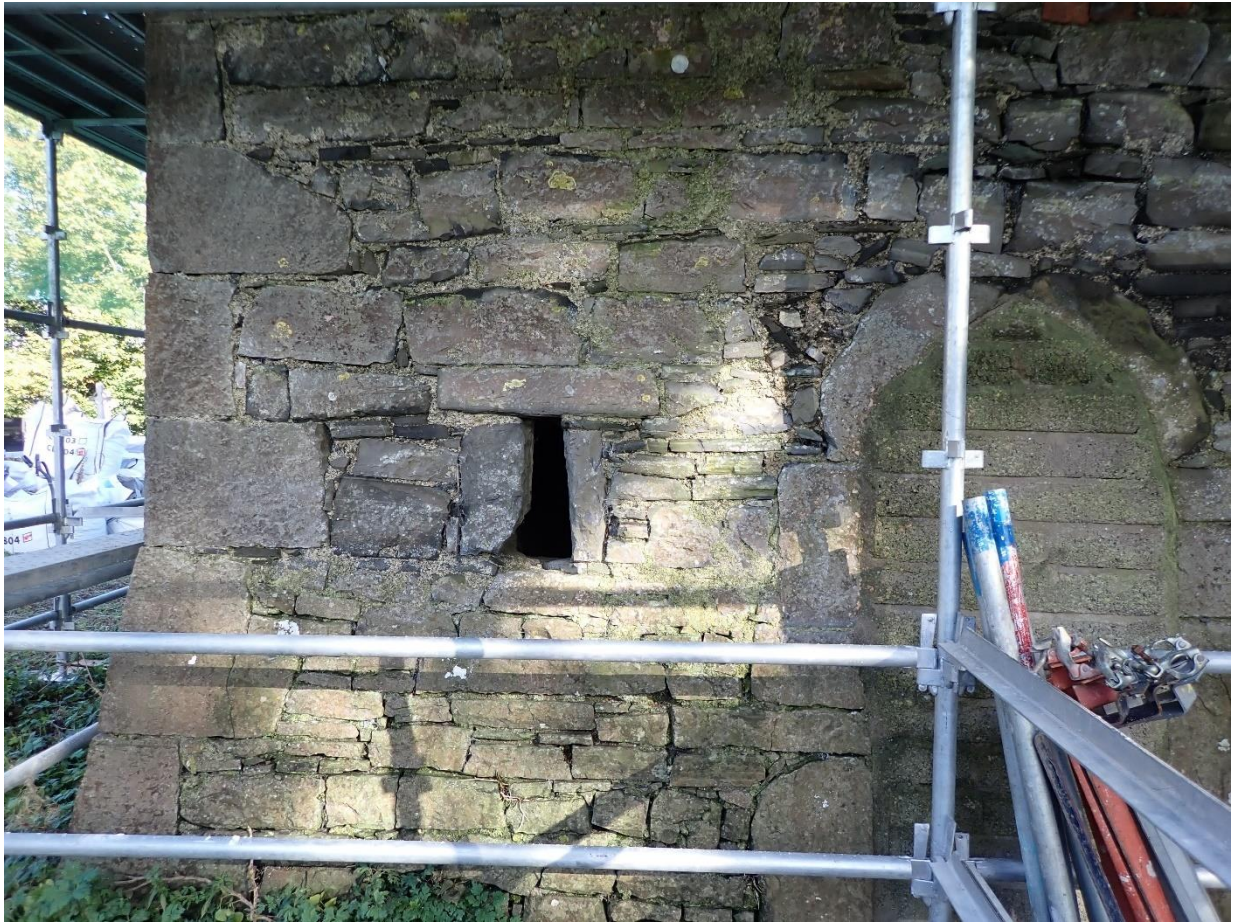
Plate 18: Lower northwest section of the west wall before conservation. Note area above door.

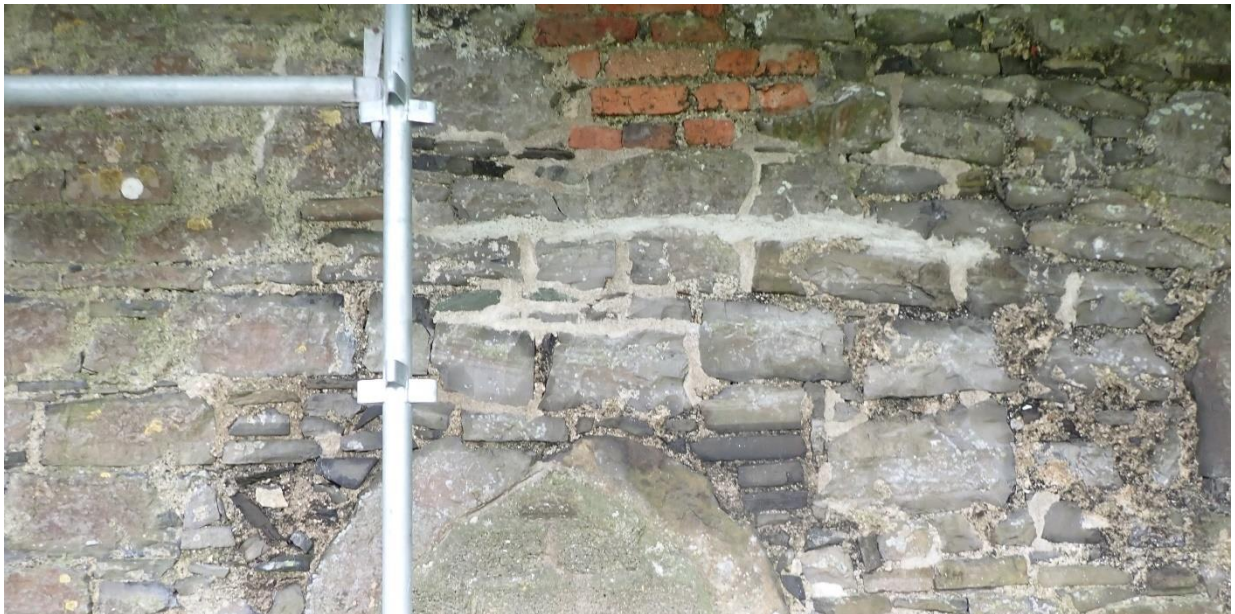
Plate 19: West wall, area above door has been stitched and re-pointed

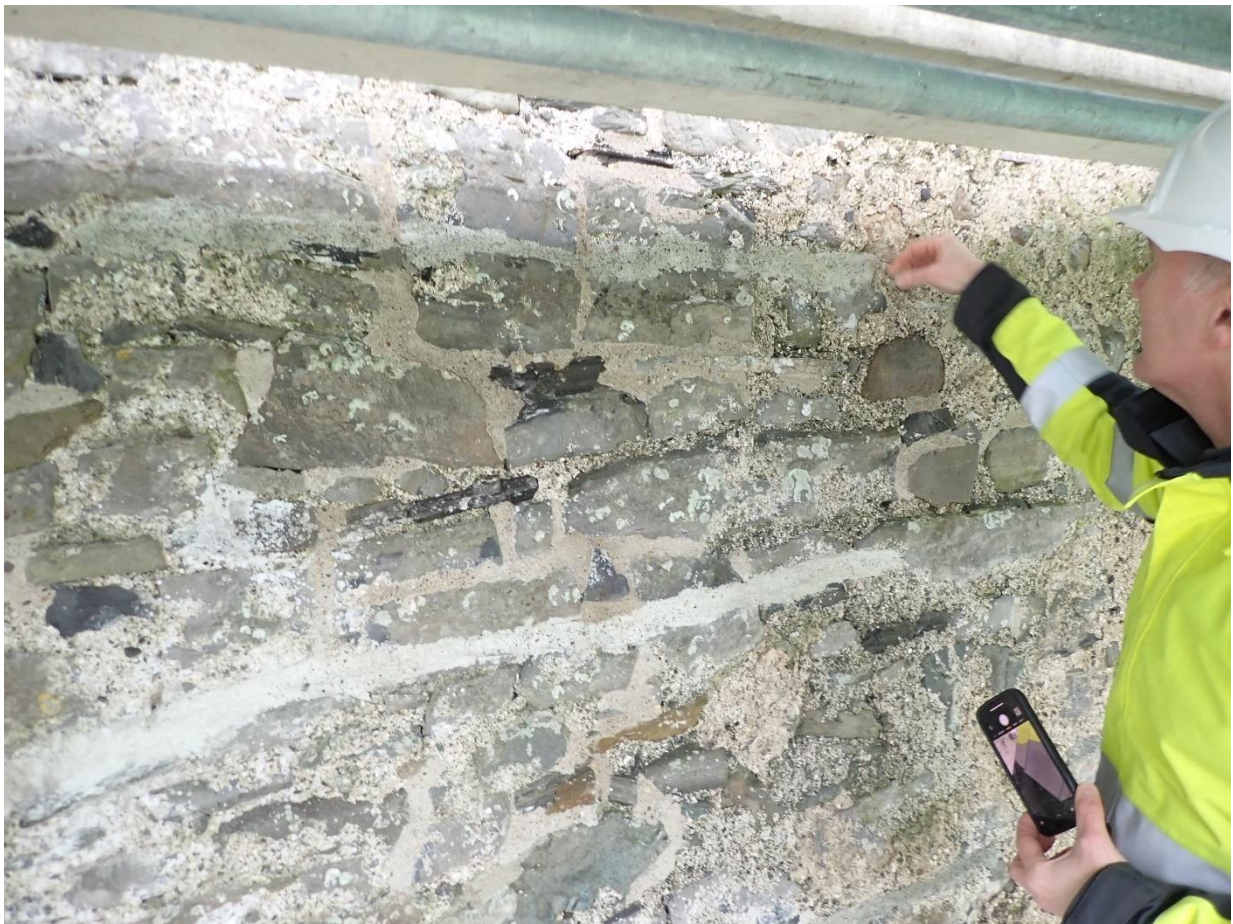
Plate 20: JK inspecting the north wall where the vertical crack was stitched and re-pointed

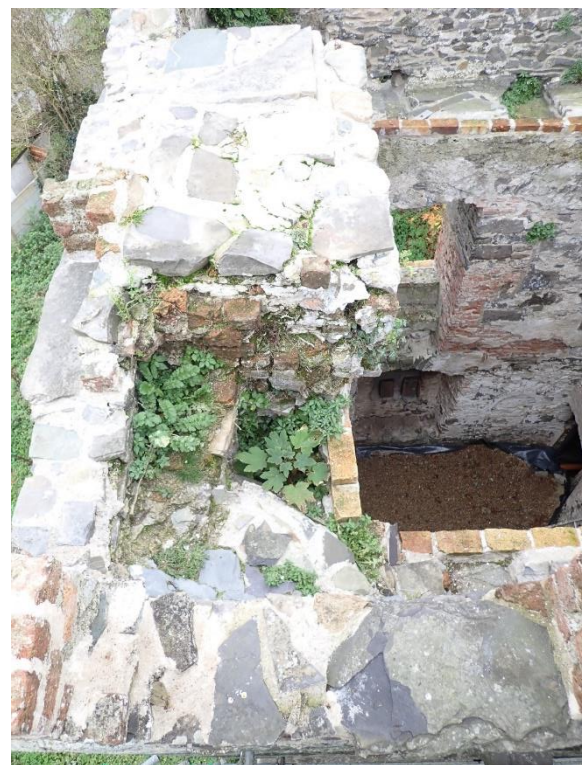
It was noted that areas of the parapet and roof which had been cleaned and conserved last year were suffering from noticeable re-growth of plants in places. As access to these areas is difficult without scaffolding it is recommended that they be covered with some form of geotextile and gravel to suppress weed growth.

Plate 21: Re-growth at the northeast corner.
