Historic Road Bridges

Fingal County Council

Volume 1
Main Document

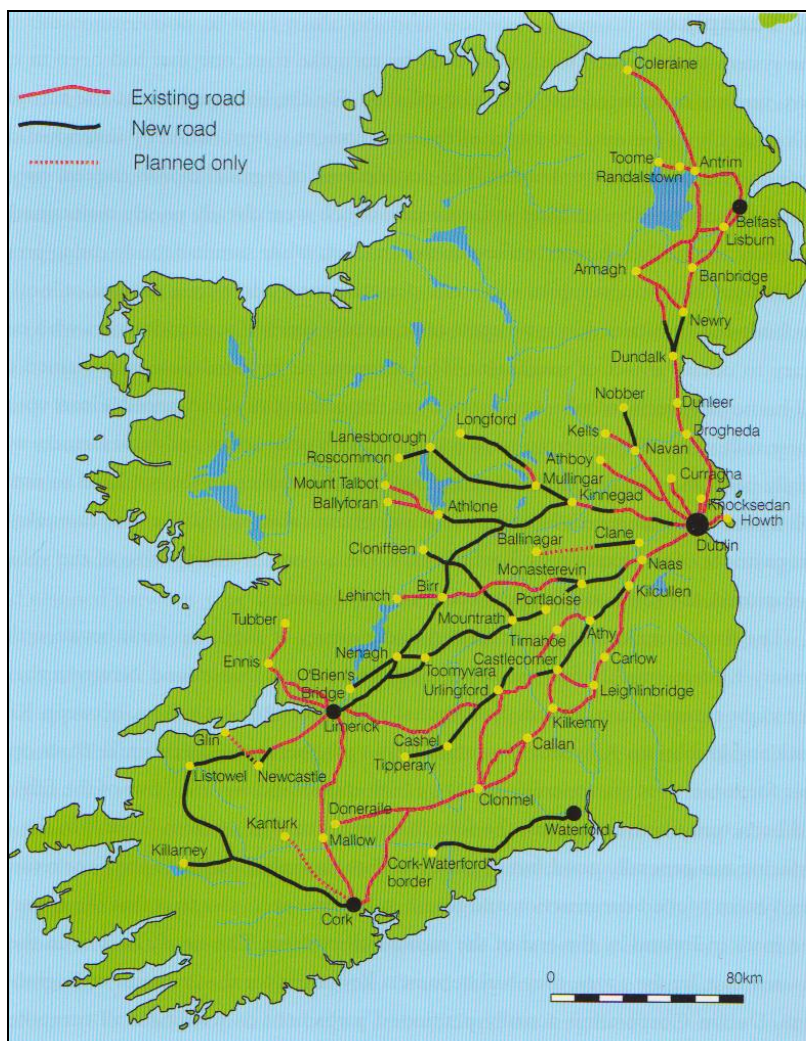
Figure 1: Irish Turnpike acts passed before 1805 (after Andrews 1964) (taken from Rynne 2006)

Turnpikes, in operation in Ireland from the early eighteenth century (and in the form of a tolled road north from Dublin from 1663 (Broderick 1996 p.15)) levied charges on the users of routes for the upkeep of the road surface and structures. *Figure 1* above outlines the extent of turnpike roads in the study area and although their exact routes varied over time, becoming more direct and capable of carrying greater traffic capacity, several routes within the Fingal area clearly owe a great deal of their development to this period of the toll-roads. The Dublin-Dunleer Turnpike originally passing over Gormanstown Bridge is the principal example in the study area but a turnpike also extended as far north as Knocksedan Bridge where tolls were used to fund developments on the road and bridges leading to this. Turnpikes in this part of Dublin were initially well serviced through the necessity to carry commercial traffic to and from the city but the economic depression following the Napoleonic Wars in the early nineteenth century, the subsequent deterioration public finances leading up to the disastrous Great Famine and competition from the opening of the Dublin to Drogheda rail line in 1844 as well as from the heavy concentration of turnpikes north and west of Dublin (Andrews 1964) all contributed to the massive debt of the trusts in charge of toll roads in Fingal and the dissolution of these in the mid nineteenth century with management of the roadways reverting to the county grand juries. Following the advances of the early period of tolling on these routes, reduction through competition and economic problems in the toll receipts lead consequently to deterioration in condition of the road and bridges until their management was reorganised. Broderick (ibid. p.26) remarks on the willingness of the central government of the nineteenth century to invest huge sums in development of canal networks instead of and at the expense of maintaining the road systems and compares this with the approach of the French government who recognised the importance of arterial road networks and funded their upkeep accordingly from the eighteenth century.

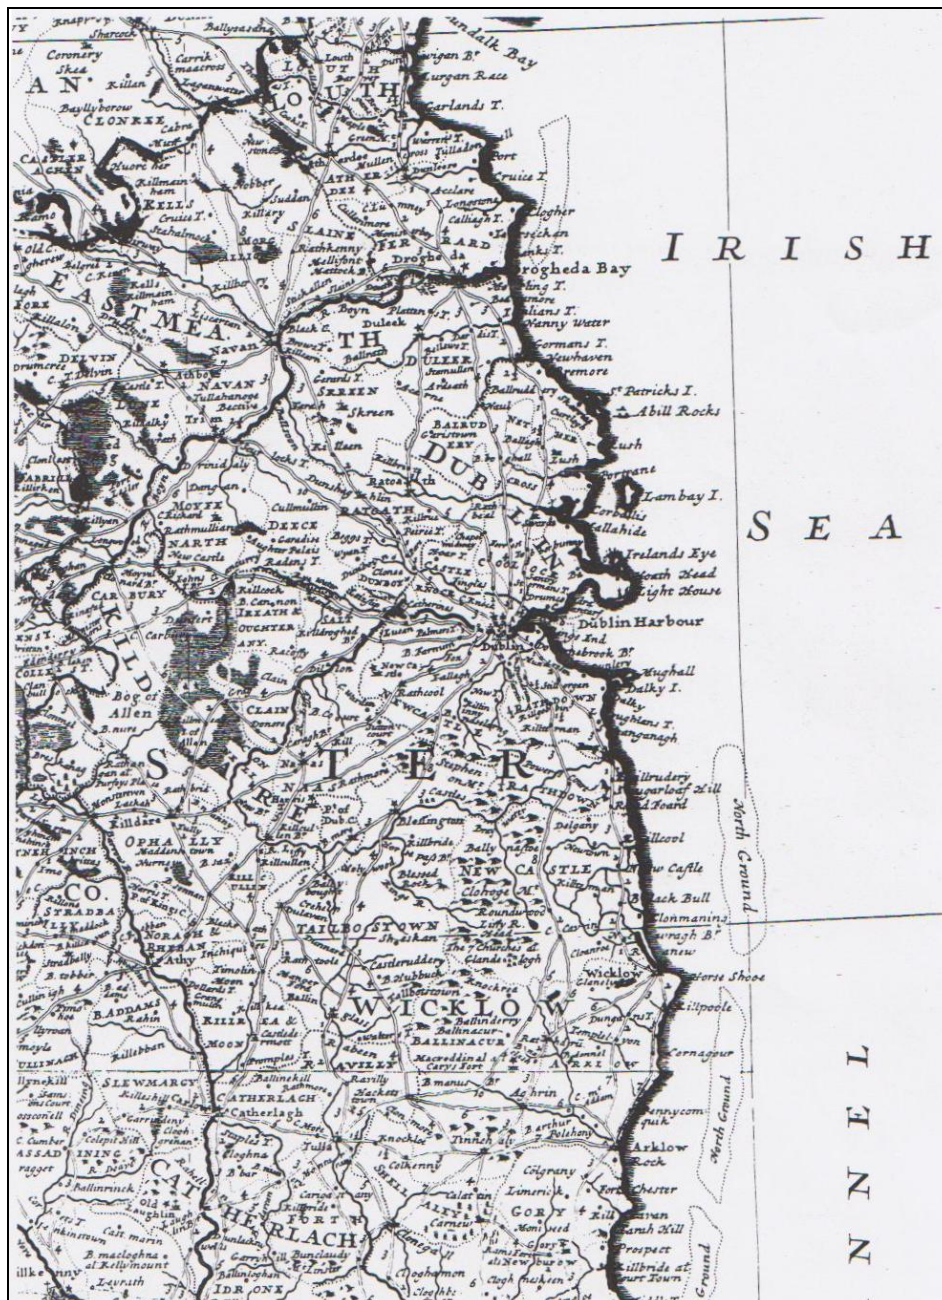
Figure 4: Extract from Moll's map of the area around Dublin (taken from O'Keeffe and Simmington 1991)

Henry Pratt's "Map of the Kingdom of Ireland" in 1702 and the subsequent map by Herman Moll in 1714 (see figure 4 below) are the most detailed early maps of the roadways of Ireland. Again, Moll's map has only a small number of bridges specifically named but the crossing of roads over rivers is identifiable and this can be cross-referenced with later surveys.

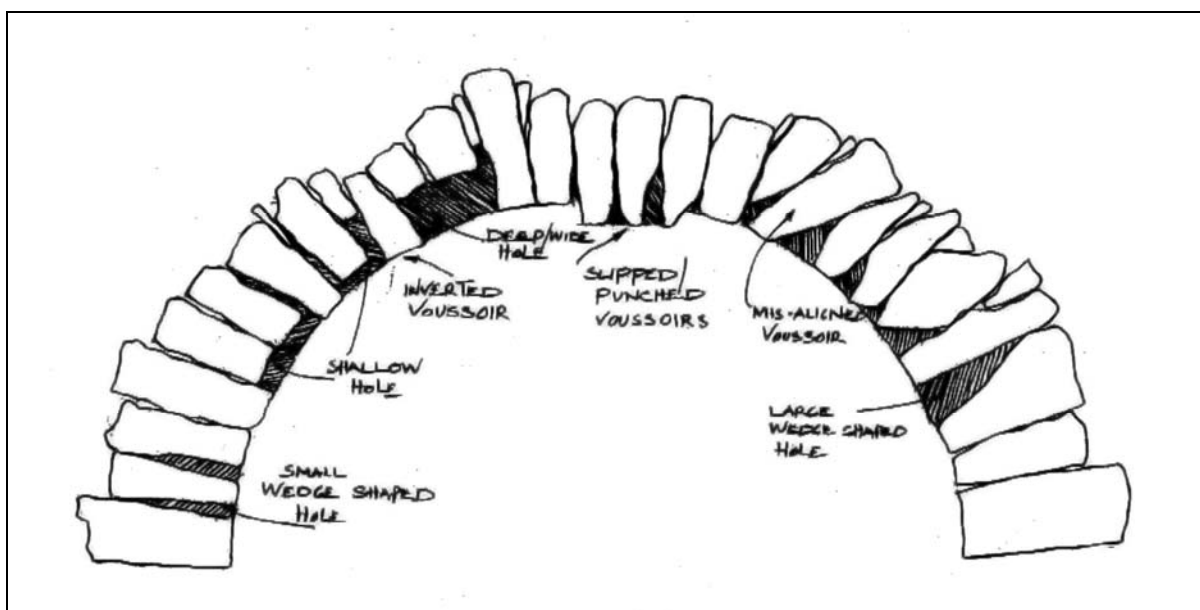
Figure 8: Intrados defects. (Illustration: Patrick McAfee).

Missing voussoirs from the underside of arch barrels can be attributable to a loss of mortar but also to the consequence of the way some of these stones were laid in the original construction.

Some faults are not accountable to the mortars that were used but are more basic masonry construction defects. Insufficiently bonded arch rings can often be observed in older bridges where the voussoirs did not extend far enough or were not tied correctly into the structure and a running crack developed as the entire arch collar detached from the rest of the barrel. Cutwaters were also often added after original construction of a bridge and were not tied adequately into the piers they abutted, with the result that they later became detached from the main structure. Other examples exist of cutwaters tied into the original constructed piers, but as a result of settlement from overloading of the bridge or insufficient foundations, the ties have become cracked or broken separating the unloaded cutwater. Cracks in wing walls may have occurred from settlement due to building on unconsolidated fill or overly shallow foundations.

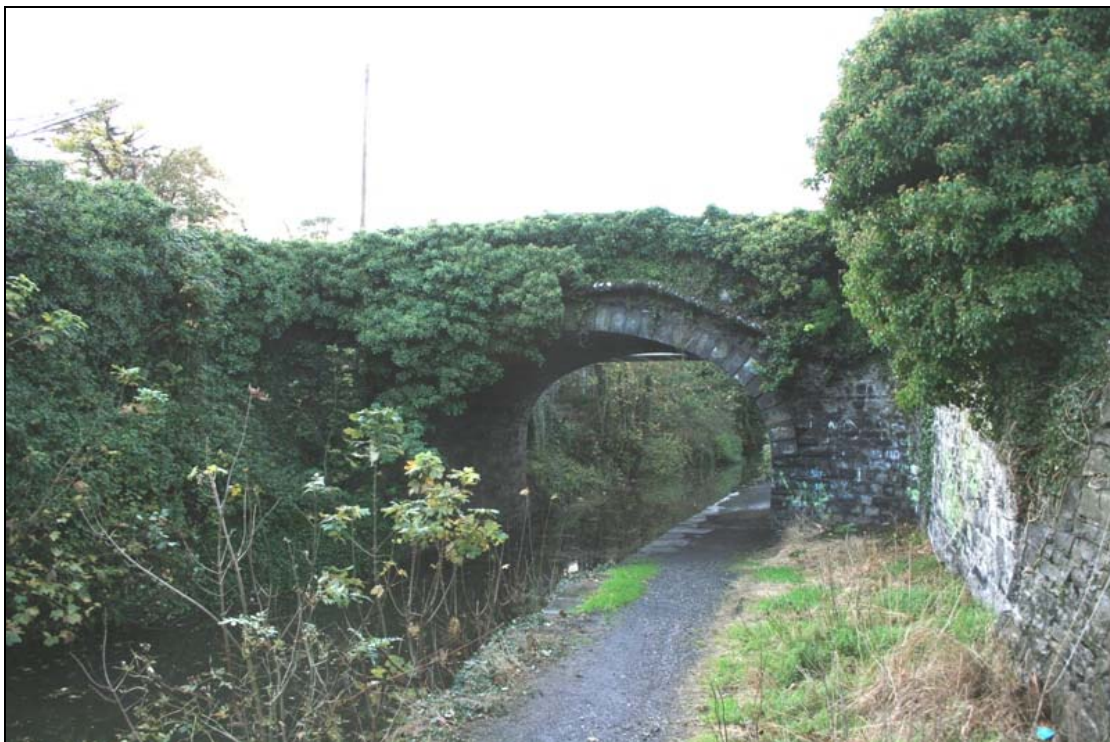
Plate 2: East elevation of Callaghan Bridge (Photo Reference: FHBS-14-BH-02)

Callaghan Bridge is an elliptical profiled stone arch bridge, carrying the R121 road over the Royal Canal. The bridge is situated on a tight bend and is severely hump-backed. The span is 7.1m and there is a large clearance under the bridge to facilitate navigation of the canal beneath.

The bridge is in good condition although there is mortar loss from the intrados in some areas. The substandard parapets have received collision damage in the past and have been repaired on more than one occasion with concrete blocks, which are not considered in keeping with the heritage of the bridge. As with Chapelmidway Bridge, the parapets do not conform with current standards (BD 52/07).

Callaghan Bridge is in good condition, but due to its shape and size it has a low capacity to take heavy vehicles (16.5t). It has mortar loss in areas of the intrados and the parapets have been damaged

by vehicular collision in the past. The mortar should be replaced where it has been lost with lime mortar.

The main problem with Callaghan Bridge is its proximity to the railway, its narrowness and the horizontal and vertical geometry of the road above it. It is highly constrained and was not designed for Heavy Goods Vehicles. There are three possible solutions to ensuring the bridge structure integrity is maintained/strengthened. The first option is the placement of a weight restriction on the bridge, which would deter large HGV's from using the bridge. This might also alleviate the possibility for collision damage. The second option is to widen the bridge (subject to topography and other constraints), which would alleviate future collision damage. The third option would be the implementation of single way traffic, limiting the traffic to the centre of the bridge only. Safety barriers could be installed inside the parapets to prevent collision damage. This option would have significant impacts on the traffic in the area. The preferred option would depend on the policy and budget of Fingal County Council and could be arrived at following a full feasibility study.

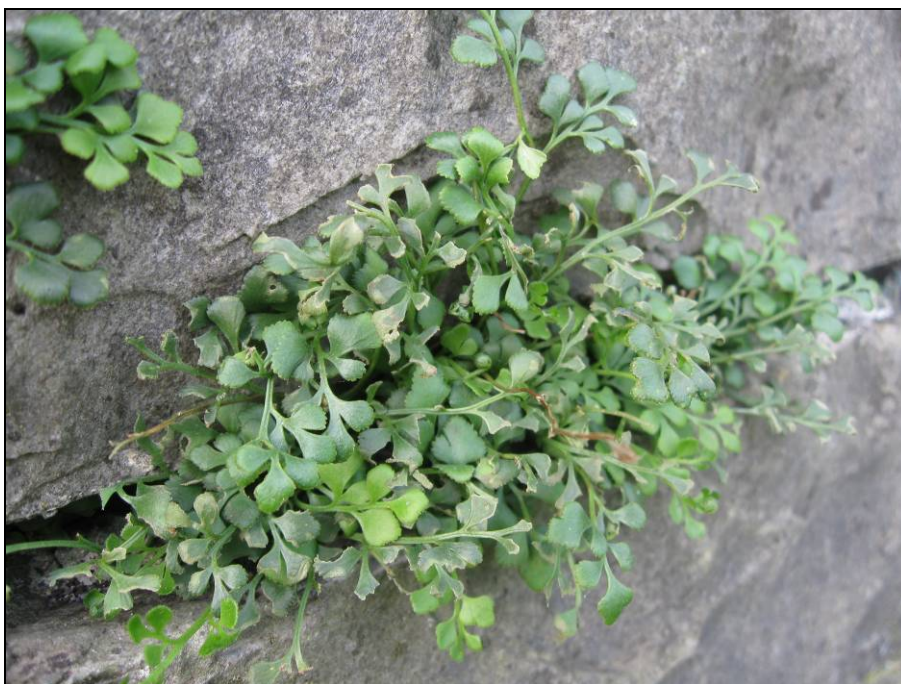
Plate 3: Wall-rue, a characteristic fern of stone bridges that is not damaging to the bridge structure.

Characteristic plant species of bridges in Ireland and in Fingal include the ferns Maidenhair spleenwort, Wall-rue (plate 3), Polypody species and Rusty-back. Hart's tongue and Male fern grow on bridges where the stone is damper, either due to localised seepage from the bridge structure or proximity to the watercourse. Frequently occurring flowering plant species include Hair-grasses, Stonecrops, Herb Robert, Navelwort, Pellitory-of-the-wall and Ivy-leaved toadflax.

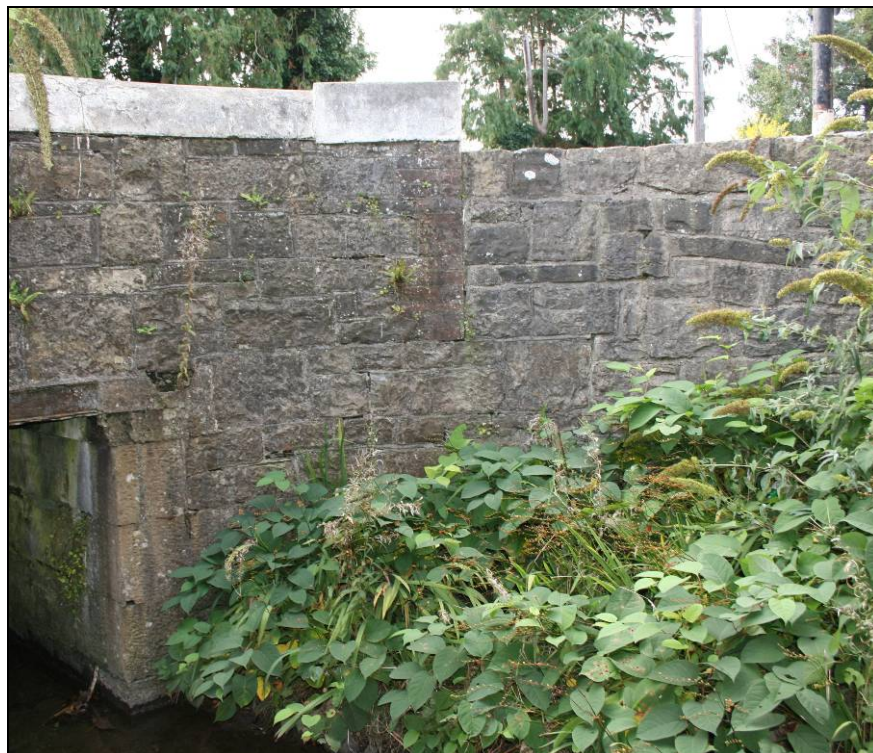
Plate 6: Japanese Knotweed and Montbretia at Oldtown Bridge (FHBS-05)

Plants growing along rivers in Fingal can also include invasive, non-native species, including Japanese Knotweed (*Plate 4*) and Giant Hogweed (*Plate 5*). The latter has toxic sap that can cause serious health problems to people that come into contact with it. This is a significant health and safety issue that requires appropriate safeguards to address the risk associated with working in the vicinity of Giant Hogweed. Giant Hogweed was not found near any of the bridges in this survey, but Japanese Knotweed and Montbretia occur downstream of Oldtown Bridge (FHBS-05) (*Plate 6*).
