Conservation Study & Management Plan 2018 -2023

Drumanagh Promontory
Fort, Co. Dublin

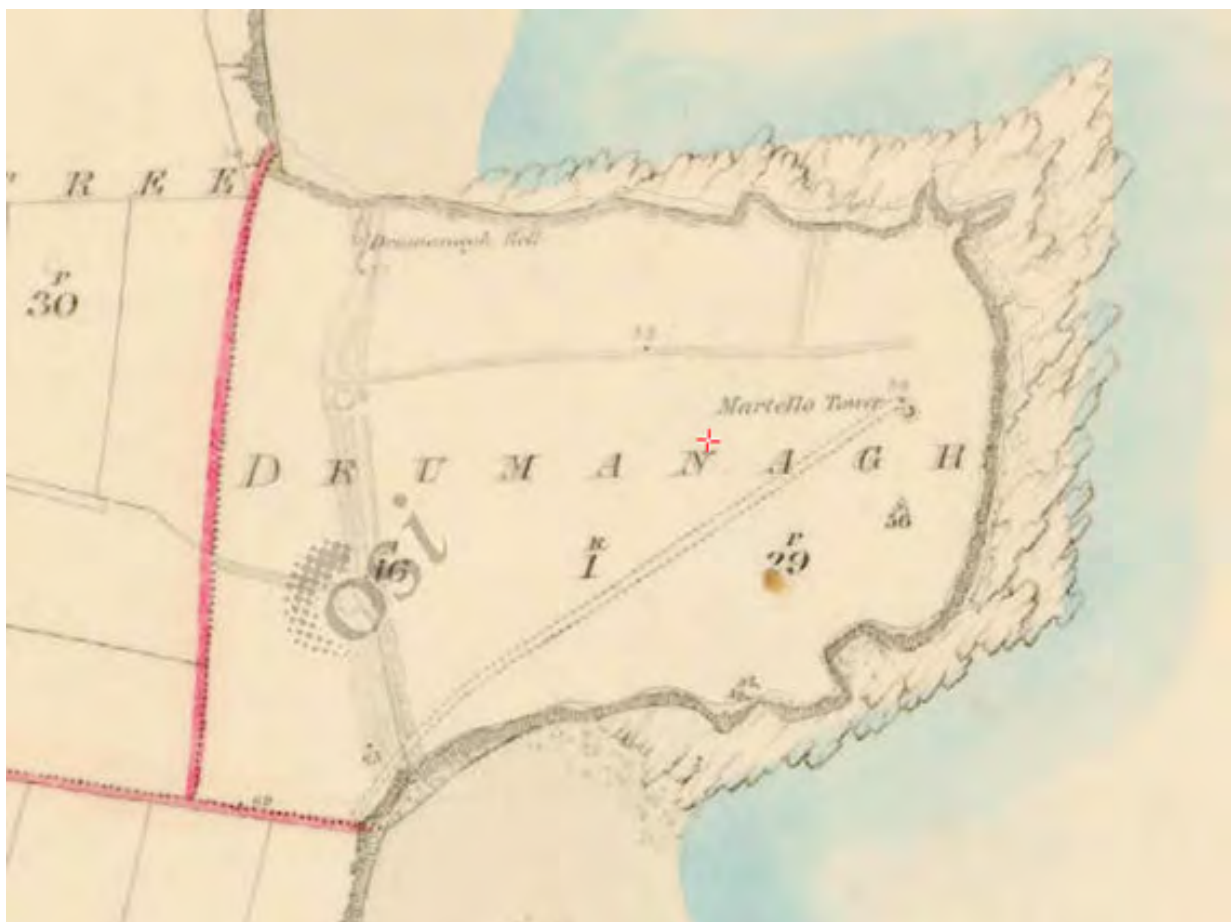
Fig. 9: First Edition Ordnance Survey Map.. Surveyed 1838, Published 1843

The First Edition six-inch Ordnance Survey (OS) map provides a particularly detailed picture of the ramparts. The northern trivallate banks appear integrated with the east-west field boundary, which in turn intersects with a north-south field boundary, indicating the land division of the time. South of the intersection of ramparts and field boundary are two distinct circular features which may represent the truncation of the ramparts at this point. As the four banks head southwards they become less well defined and more compressed.

The road to the Martello tower extends from the lane-which forms the townland boundary between Drumanagh and Rush- and traverses the ramparts to the south. A stream flows from the western field boundary, that forms the townland boundary between Drumanagh and Ballustree, into the southern ditch and Drumanagh well is depicted to the north. The rocks around the headland are distinctive and extensive.

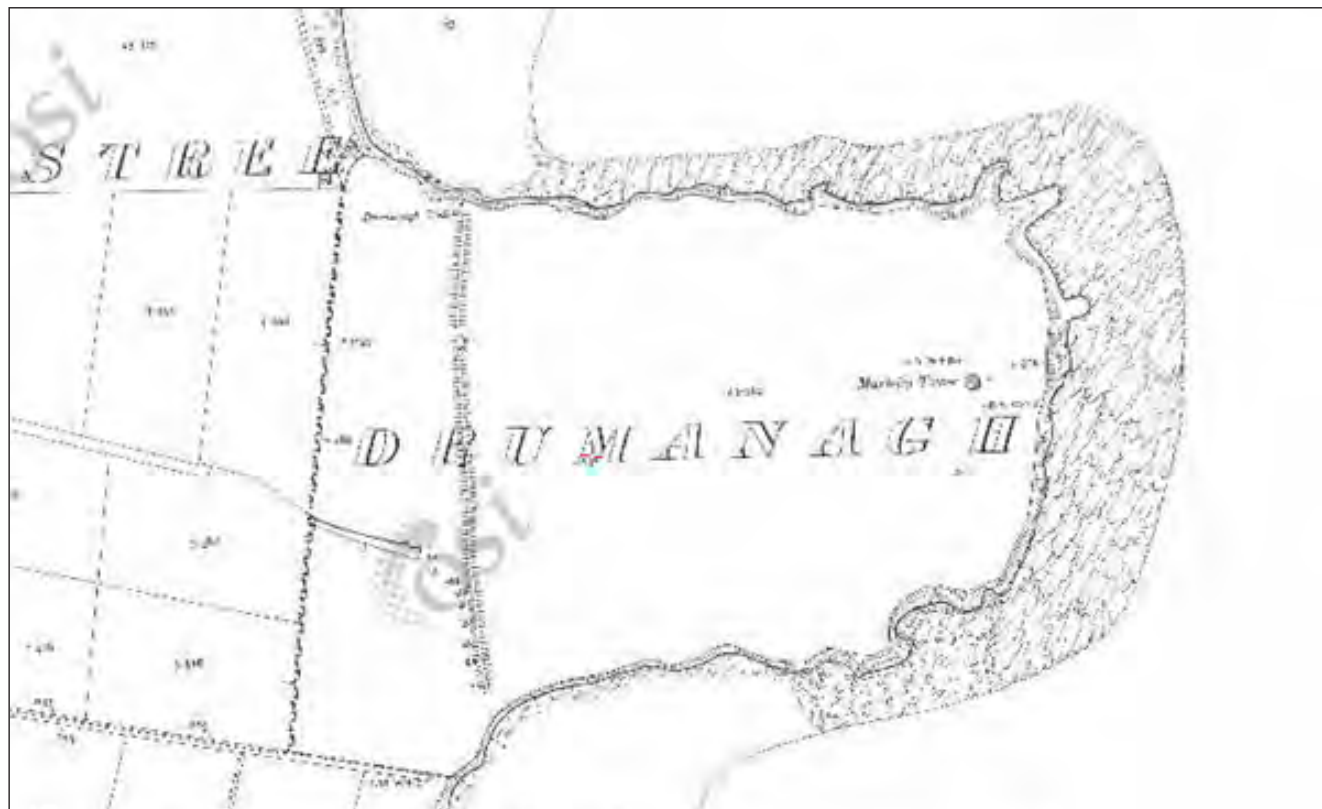
Fig. 11: 25 inch Ordnance Survey Map. Surveyed 1906; Published 1908

The 25 inch map no longer depicts the road to the Martello tower or the field boundaries to the north of the promontory. The stream no longer pools at the ramparts which are depicted as a single line.

A previously unillustrated feature is a well, located east of the western townland boundary. The structure at the cliff edge appears to have been modified and perhaps divided into two structures east of the footpath. A structure has been constructed at the field boundary perhaps on the footprint of the building previously shown on Rocque's 1760 map.

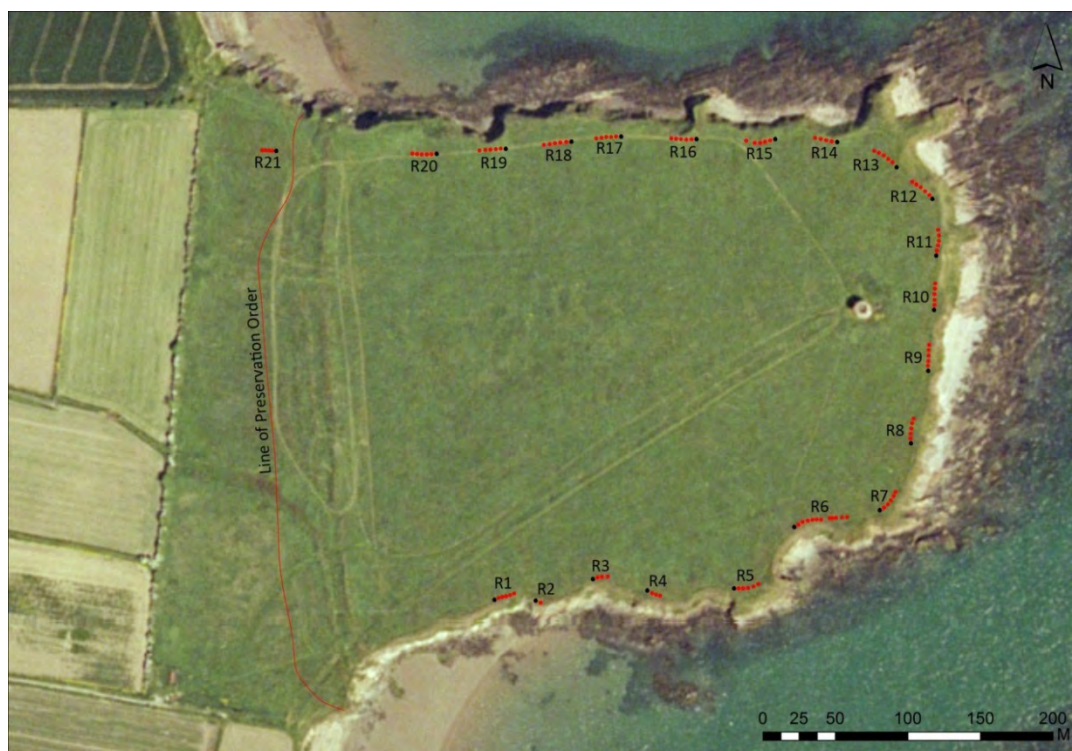
In advance of proposed fencing of the headland by the previous owners, a programme of auguring was undertaken by Mr Tom Condit, of the National Monument Service in conjunction with members of the Discovery Programme. A total of 122 test pits, arranged in a series of 'runs' comprising six or less bore holes, were excavated as close to the cliff-edge defining the promontory as feasible using an 'auto auger mechanical post hole borer' with a 20cm diameter auger over two days in June 2014. Although no artefacts or, indeed, soil horizons of clear archaeological significance were encountered during the course of auguring, this work has yielded valuable information on the depth and character of the soils along the cliff-edge and raises interesting questions concerning the nature of soils elsewhere on the promontory (Dowling 2014).

Plate 28: Aerial image of Drumanagh promontory fort showing the location of 2014 auger test pits. The western extent of the Preservation Order is marked by a red line.

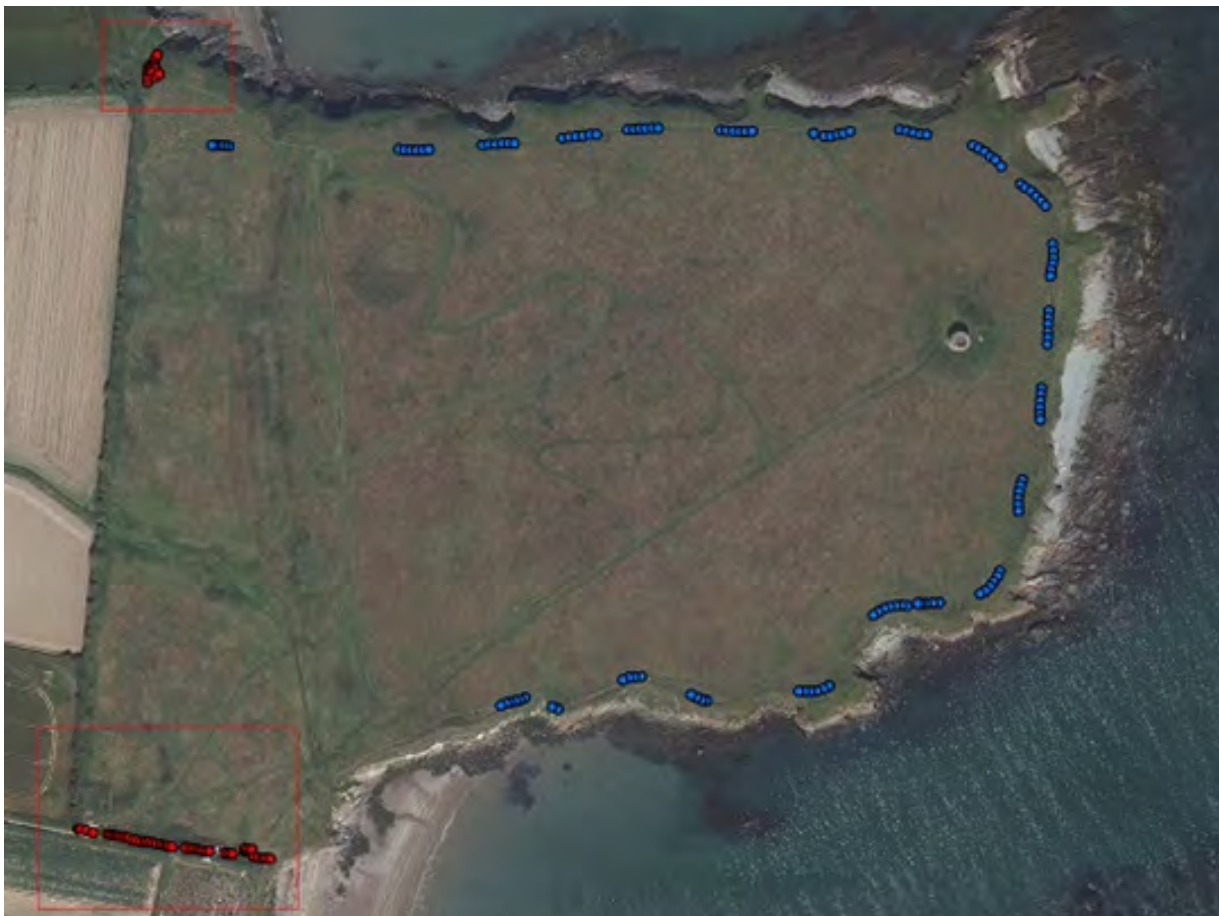
The auger survey was undertaken by Christine Baker, Fingal County Council and members of the Discovery Programme to inform the fencing of the site along the southern boundary (c.140m), along a short section of the north-west boundary (c.22m) and the installation of two kissing gates. A total of 56 auger holes were excavated using an 'auto auger mechanical post-hole borer' with a 20cm diameter auger over two days in January 2017. A high level of modern disturbance was evident, particularly along the north-western and southern boundaries with the recovery of plastic and twine. No artefacts or soil horizons of archaeological significance were encountered and unlike the previous 2014 auger survey, bedrock was not identified.

Plate 30: Auger holes locations 2014 survey (blue) and 2017 survey (red), courtesy of The Discovery Programme

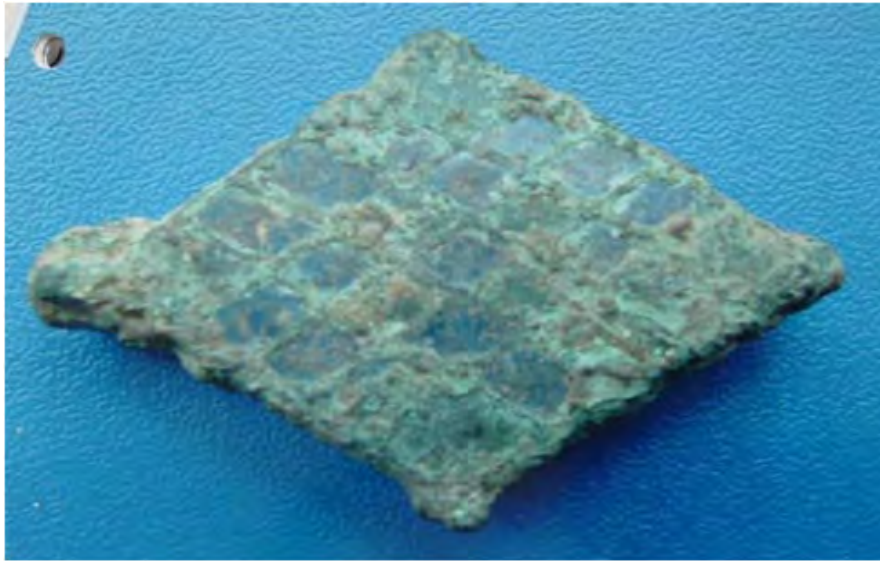
The only metal artefact discovered as a stray find (as opposed to metal-detected) is that of a seal box (2004:174) recovered from the eastern side of the ramparts in the upcast of motorbike scrambling in 2004 by local historian Cmdt. Paddy Boyle. The seal box is lozenge-shaped and made of enamelled copper alloy is of 1st-3rd century AD date. Seal boxes were interpreted as devices for securing personal communications and private letters (Bateson 1981) and therefore associated with the spread of Latin literacy across the Empire. However recent research has found the design features of seal boxes are unsuitable for attaching to documents and it is much more likely that they were used for sealing bags of coinage (Daffy 2013, 99)

Plate 32: Seal box lid from Drumanagh. Photo by Sean Daffy

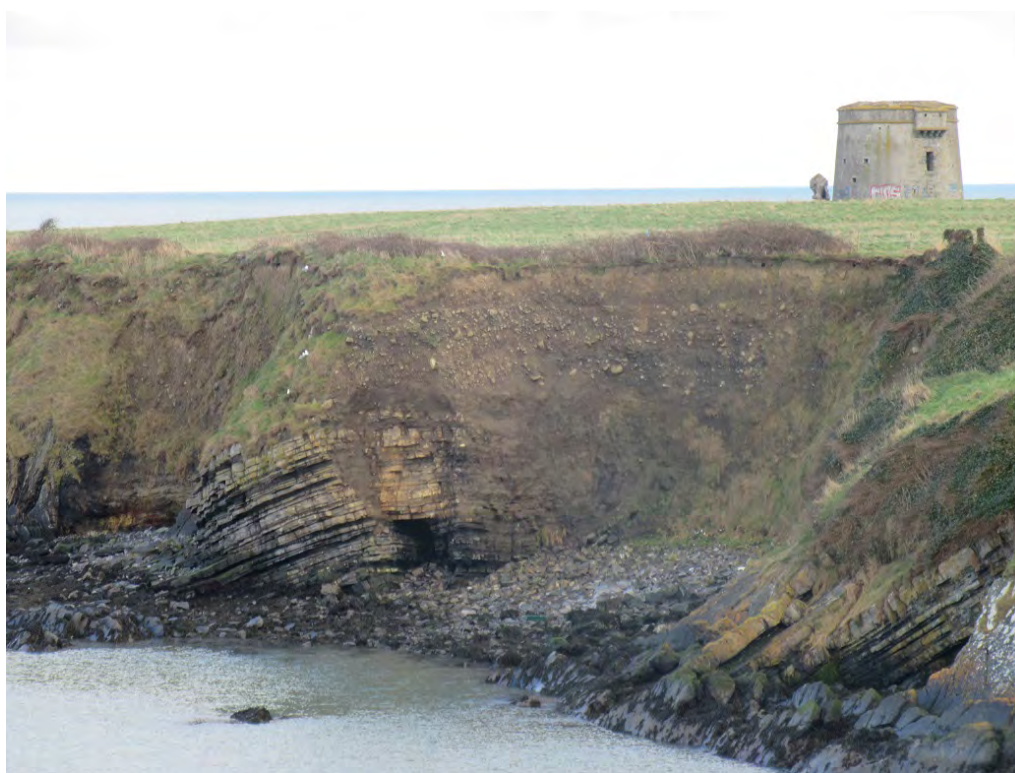
The perimeter of the site is defined by the townland boundary between Drumanagh and Ballustree to the west. This boundary consists of a well-established hedgeline and a wall externally faced by a ditch. It runs mainly north-south curving gently at the north-western corner of the site before creating a sharp corner at the cliff face. The wall is rubble built and stands between 0.6m and 1.2m in height with at least six courses of roughly shaped stone (0.25m-0.45m diam.) visible. The wall averages 0.5m in width and is loosely mortared with a whitish mortar with large pebble aggregate. The wall is mostly overgrown with brambles. A wall in this position appears on the 1760 map. The remnant of the wall visible at the cliff-face appears to be that marked on the 1830s Name Book map as 'Wall, apparently ancient'.

Plate 35: View of erosion along the northern perimeter of Drumanagh

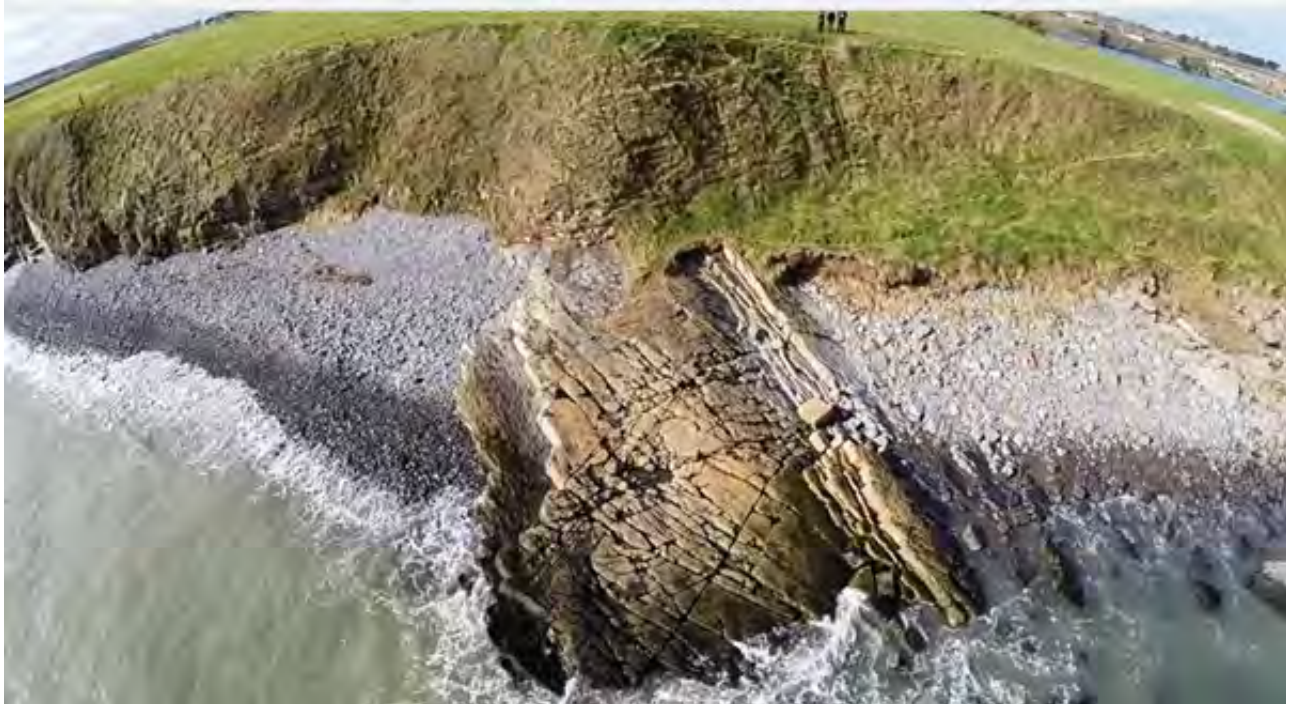
Plate 36: Views of the eastern cliff face of Drumanagh headland. Courtesy of Nua Photography

The north-eastern corner of the promontory is characterised by a distinctive bay defined by grass-covered slopes forming a lunular-shaped inlet with a sandy beach. Although surrounded by rock there is a passage-like element at low-tide that suggests low-hulled boats could land here. The slopes along the entire eastern perimeter are relatively gentle and provide access to the shoreline below. This is at odds with the supposedly defensive nature of the site.

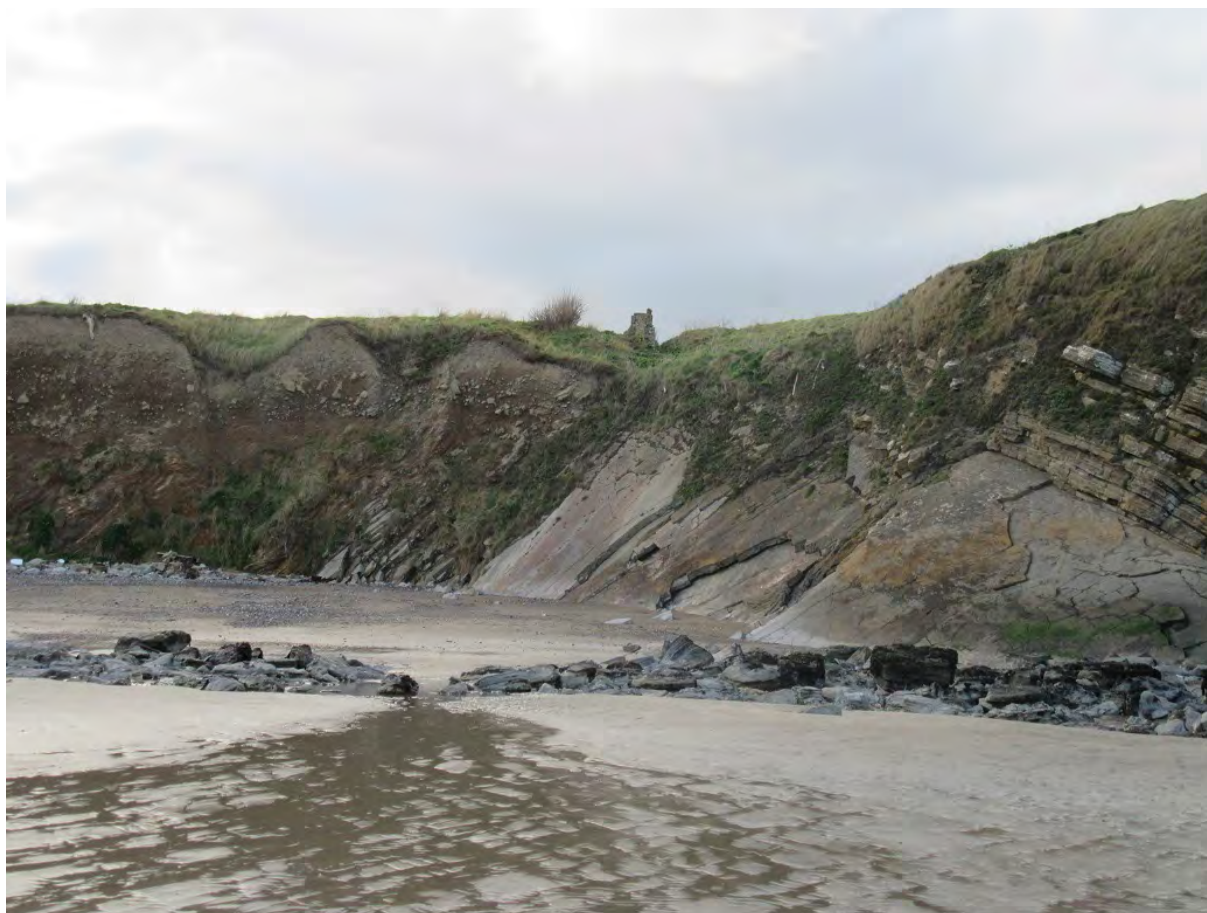
Plate 37: View of Drumanagh southern perimeter wall from Roaring Water Bay

The southern perimeter of the promontory consists of grassy relatively steep slopes over the characteristic rock of the area above Roaring Water Bay, although there is a distinct change as the promontory meets the land. Here the cliff face consists of soil and the drop is sheer. The southern perimeter of the site is defined by the laneway and is the townland boundary between Drumanagh and Rush. It consists of a wall-faced earthen bank that extends from c.2m west of the wall associated with the southern gate. This boundary averages 0.9m in height and the wall is rubble built and unmortared with stones 0.2m-0.3m in diameter. A wall in this position appears on the 1760 map.

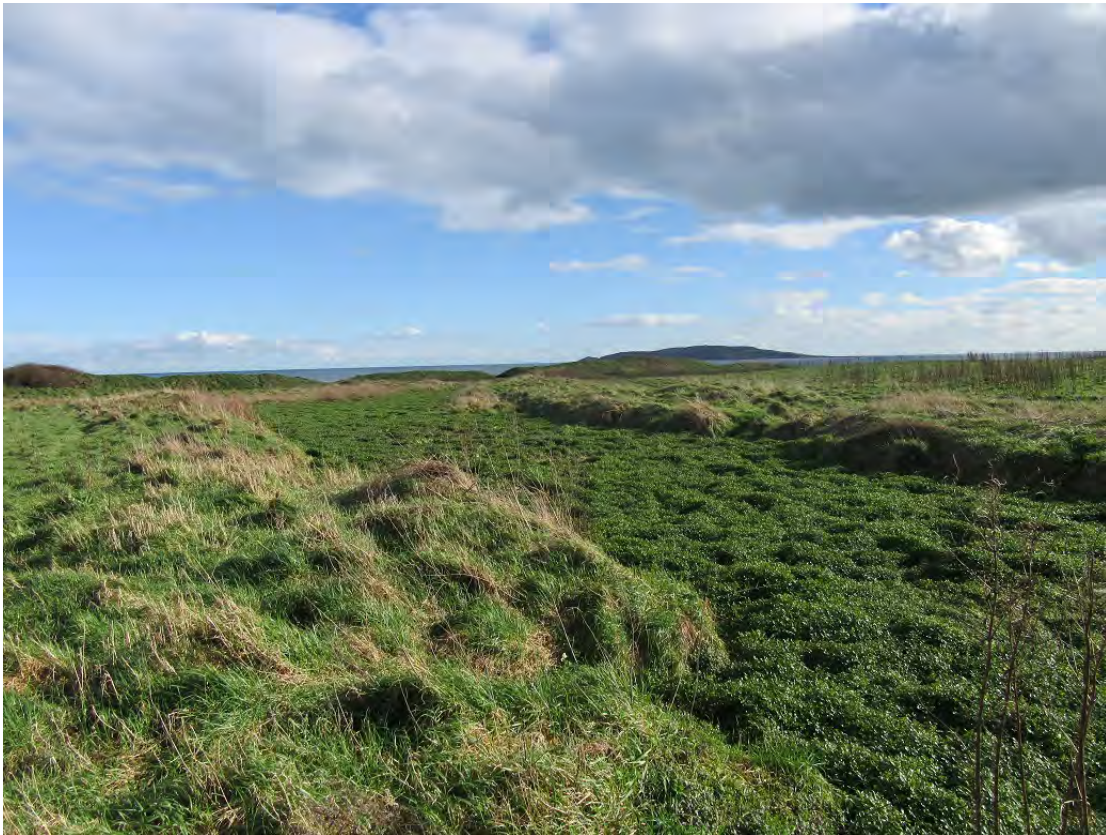
Plate 38: The pond, facing east-south-east

There are two water features in this area. The pond and stream, known locally as Roaring Water stream (Seamus McGuinness pers. comm.) is characterised as a wide expanse of shallow water overgrown with vegetation which narrows towards the ramparts where it flows through the outer ditch and over the cliff face. Approximately 130m north of this is a well. The circular well measures approximately 0.9m in diameter and is truncated to the south where large concrete blocks have been dumped. The well is lined with large (0.2m x 0.4m diam.) roughly shaped stones. At least two courses of stone are visible before the water which is 0.45m below edge. The well site is overgrown with brambles and long grass.

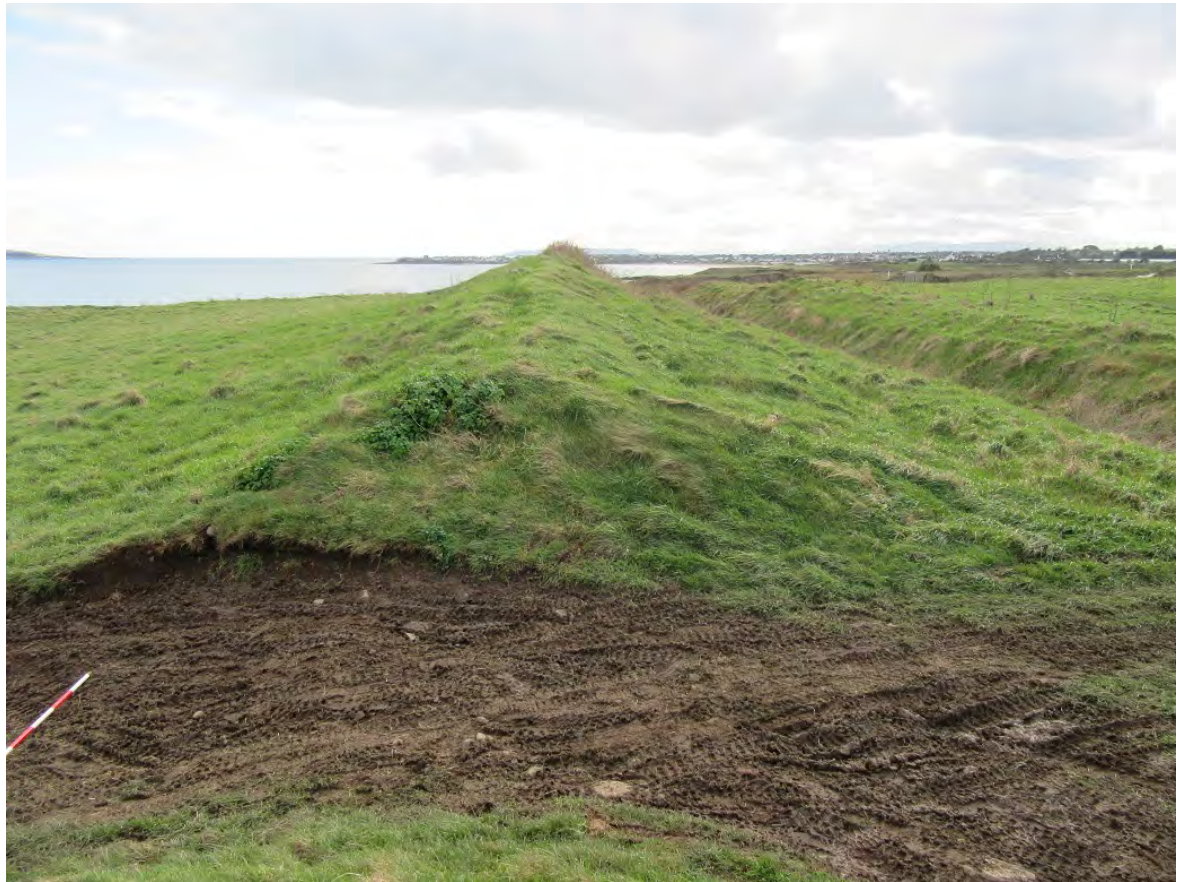
Plate 40: The main entrance to the site through the inner rampart, facing south, March 2017

The inner rampart is the most substantially surviving to a height of c.2m above the interior of the site. The ditch external to it is most pronounced towards the southern end of the site where the stream runs through it. The ramparts are traversed towards the south where the road to the Martello tower was inserted. This is now a low point with flowing water. Large timber and concrete blocks have been laid to facilitate crossing.

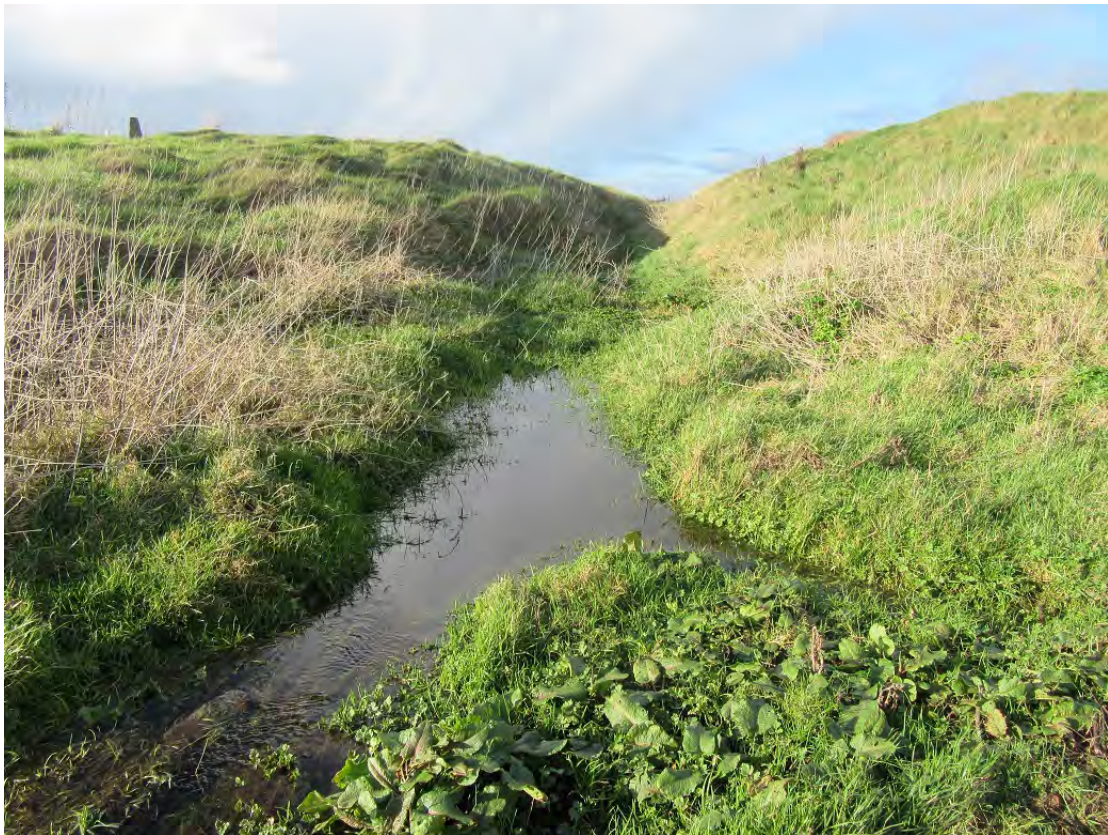
Plate 41: Southern crossing point of the stream and ramparts

The stream is also crossed by a stone bridge where it narrows towards the ramparts. It is grassed over and c. 2.5m-3m in width. This crossing is contiguous with a break in the ramparts and constitutes the main entrance to the interior of the site. Aerial photography of the 1960s-1980s shows activity at this point which may indicate the construction or modification of this entrance way. Approximately 25m north is another break in the inner rampart, c.4m in width. Towards the north of the site the ramparts have been modified (pre. 1810) to incorporate interior field boundaries which form a high bank at the junction with the inner rampart. Modification has also resulted in a distinctive circular mound visible on the First Edition Ordnance Survey map and subsequent maps. There is another gap in the ramparts towards the northern limit where the defences narrow and the inner bank and ditch and the counterscarp bank converge close to the overgrown well.

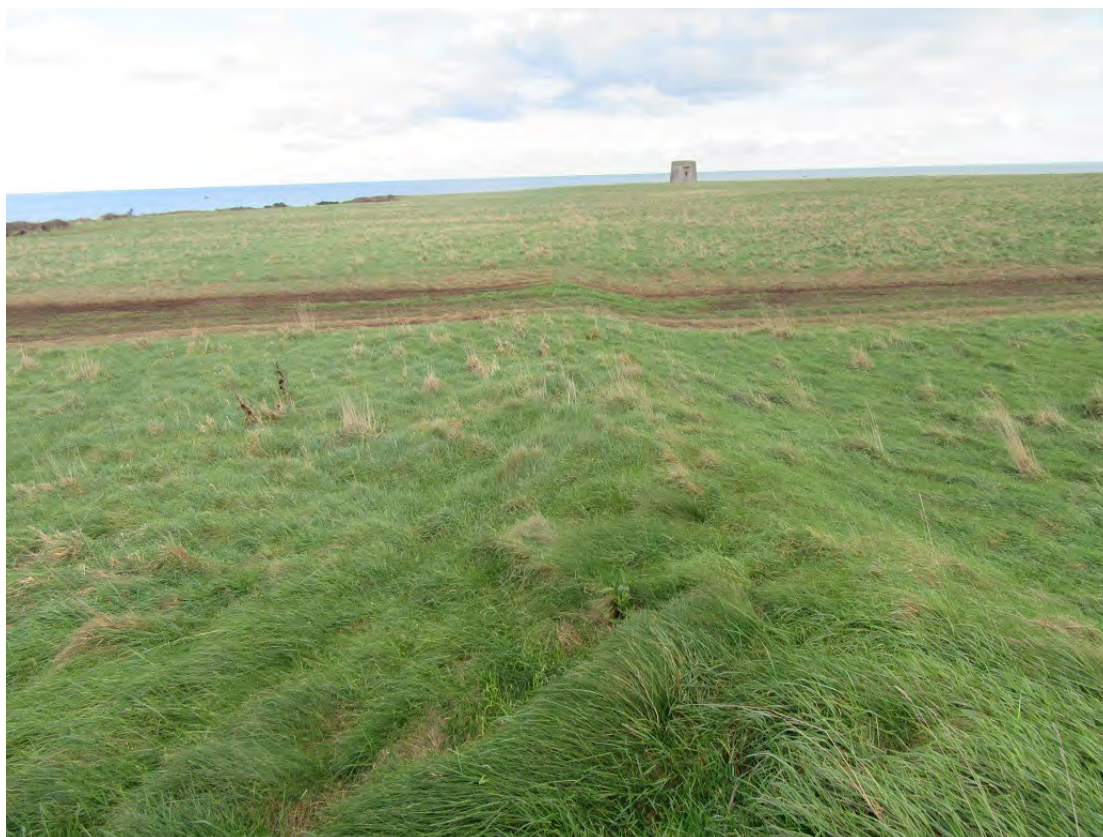
Plate 42: Relict field boundaries, facing east

The area of the ramparts and the entranceways have been used as a circuit for motorbike scrambling. An older circuit active in the mid-2000s formed a distinct ribbon shape concentrated along the interior of the ramparts and the field interior field boundaries. The current active circuit is more comprehensive circling the length of the ramparts and entranceways along its north-south axis, as well as traversing the ramparts east-west in several places. This has proved highly detrimental to the ramparts stripping them of their grass covering, exposing stone and creating rutting.

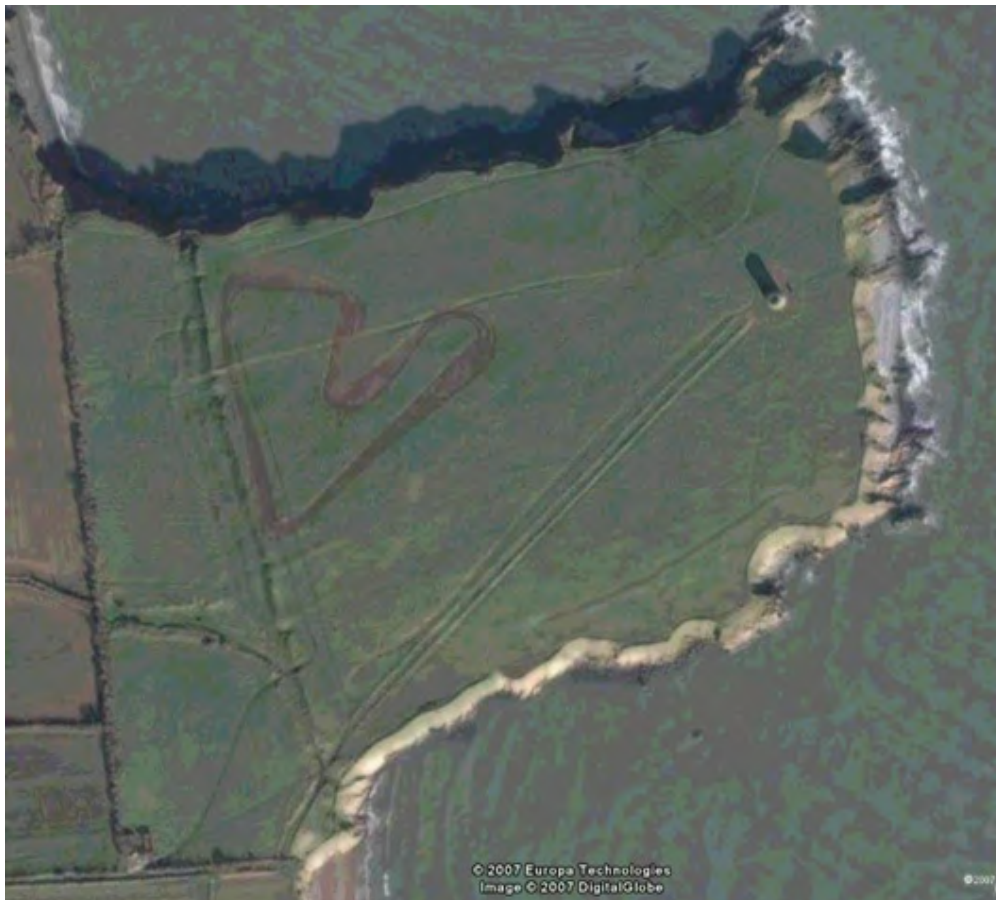
Plate 43: 2007 motor and quad biking circuit damage

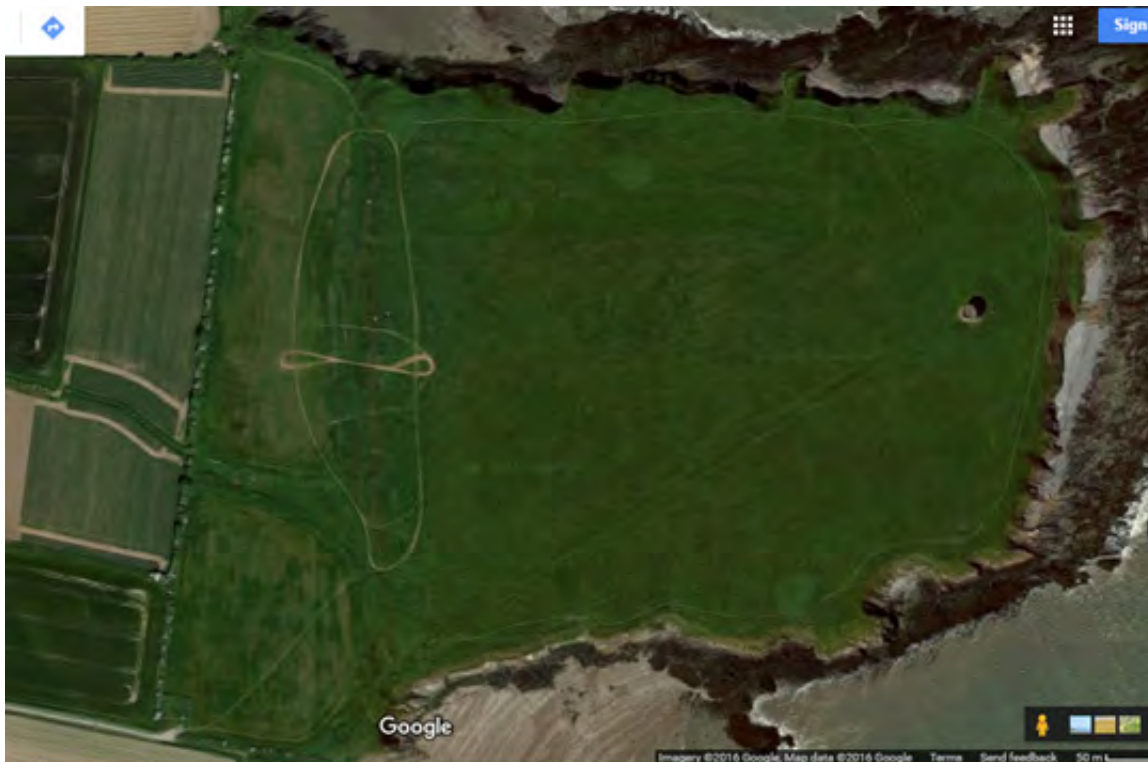
Plate 44: Current motorbike scrambling circuit, 2017

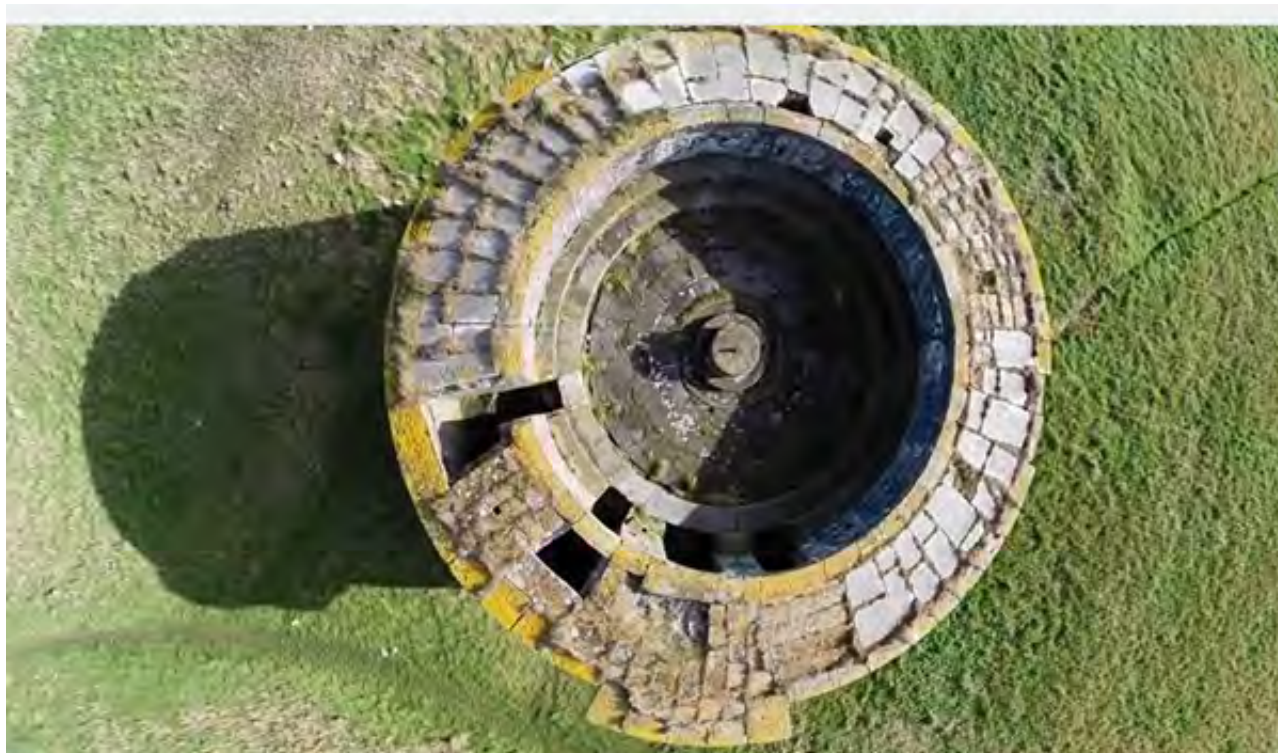
Plate 45: Drone view of the Martello Tower 2014. Image Nua Photography

Located at the east end of the promontory, there is a squat cylindrical tower built of masonry, which has been rendered. The entrance is on the west side and is positioned above ground level and it is defended by a machicolation carried on corbels. A rope has been attached to allow access by climbing in and toe-holds have been worn in the masonry below the entrance. Stones from the collapse of the nearby privy have been piled at the base to aid entry. The exterior has long been subject to graffiti –at person height around its circumference. In recent times the bars and grates blocking the opes have been removed. A limited number of coping stones on the parapet are missing.

The full extent of the threat to the fabric of the Martello tower is unknown as it has not been subject to a structural survey. It is currently evident that some of the stone coping to the parapet of the Martello is damaged or missing and requires repair. The external render around the base of the tower and around the door opening has come away and the joints of the roof of the tower are grass-filled and may require remortaring.

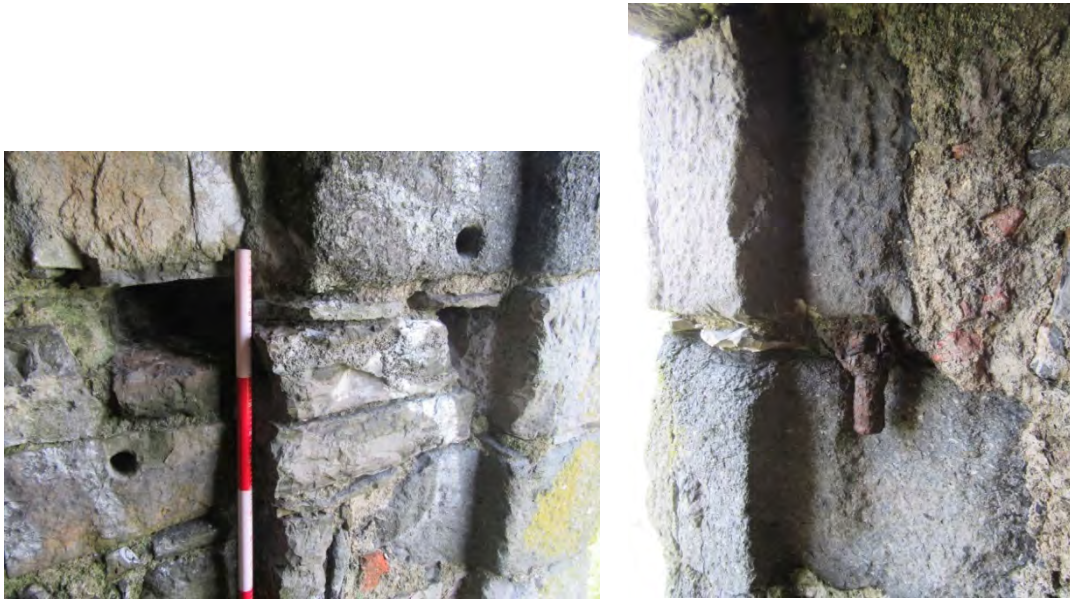
Plate 46: Interior of the Martello tower entranceway

The interior is not easily accessed but it is in relatively good condition. The entrance is square-headed with limestone rubble reveals and soffit. The remnants of the door are visible as rusted iron works and holes in the opposing stones. The entrance opens onto the first floor. The wooden floor was previously burnt and removed with the beam sockets evident at first-floor entrance level. The interior of the tower had been lime-washed but is now dotted with graffiti. The basement is divided east-west by the remains of red-brick walls and lit by opes to the east and west. There is some modern detritus, concentrated mounds of guano and scatters of brick and stone across the floor. Towards the south-west at basement level is a small fireplace and another inserted into the wall at first-floor level to the south. The entrances to the stairway are one above the other facing west immediately inside the main entrance. There is some stone collapse at the basal entrance but generally the stairway is in good condition.

Vandalism and graffiti of the Martello tower and extant remains of ancillary elements are a concern. The iron bars of the gates have been removed. A rope is continually replaced to provide unauthorised access to the interior. Fires have been lit against the remains of the privy and the number of cans indicate the immediate vicinity of the tower is being used for anti-social activities.

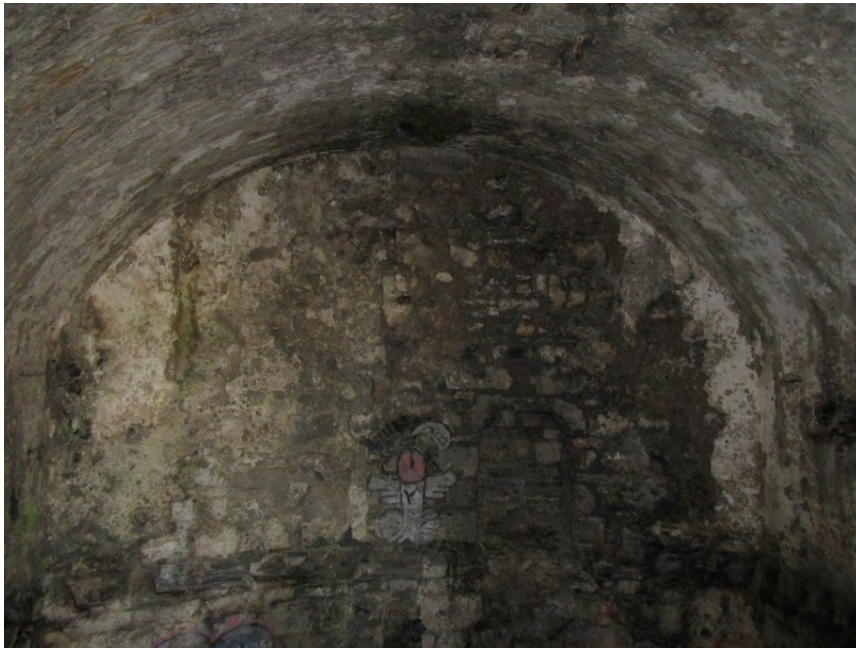
Plate 47: Interior of the Martello tower, first floor

The stone surrounding the opening to the roof and parapet is detailed both internally and externally indicating a covering, gate or door. Central to the roof is the mount for the canon with iron detailing. The internal wall of the parapet has been covered in graffiti but is in good condition. The interior of the machicolation has also been subject to graffiti but likewise is in good condition. The iron fittings of the oven have rusted and partially been removed. As is visible from the exterior there are some coping stones missing from the parapet and the joints have become grass filled but the general condition is very good with exceptional views over the coastline and the promontory itself.

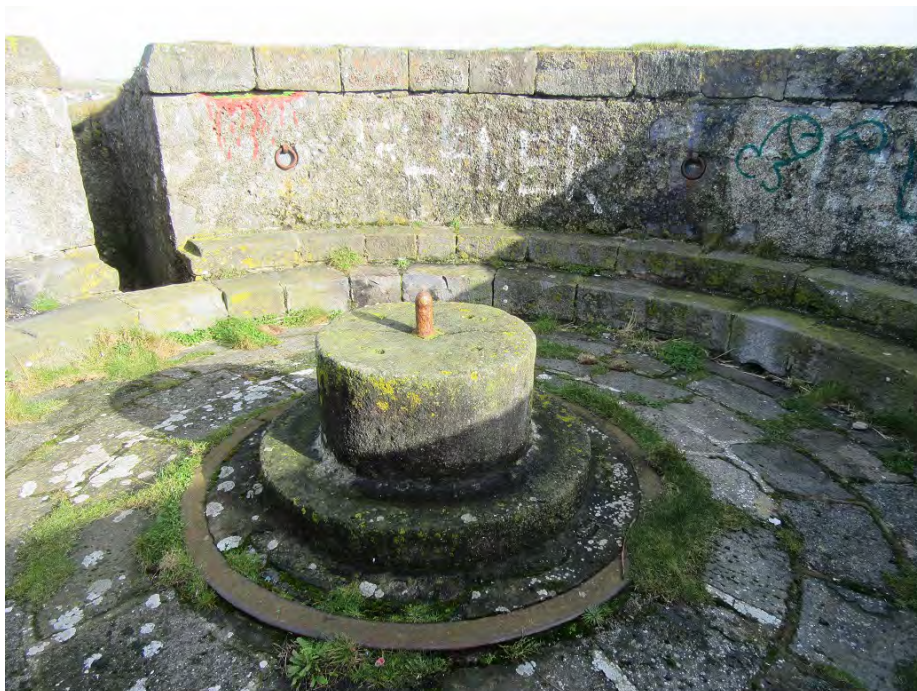
Plate 48: Roof of Martello Tower

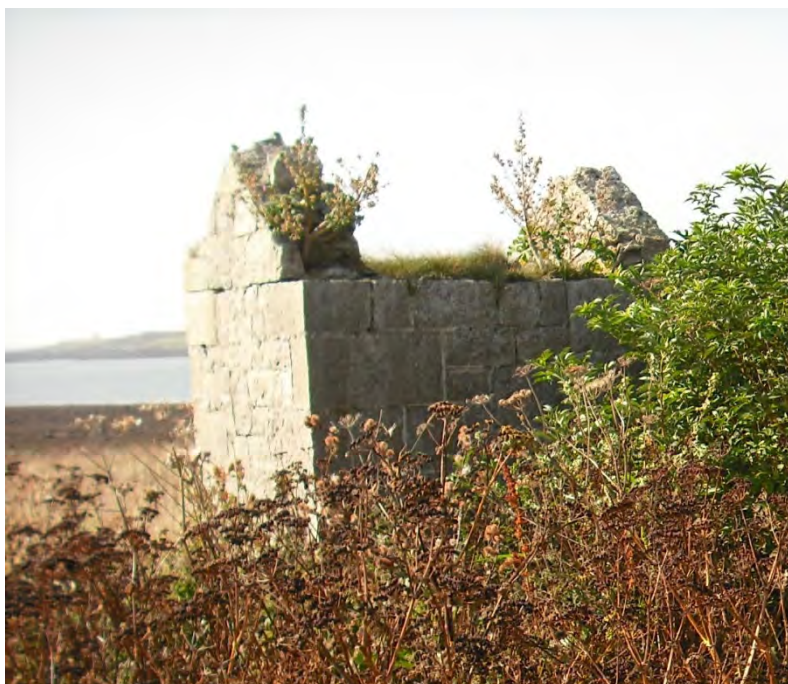
The best surviving remains of a privy are on Shenick Island, due to its relative inaccessibility. The privies have been removed from the other Martello towers in Fingal, excepting the remaining fragment at Drumanagh.

Plate 49: Privy, Shenick Island

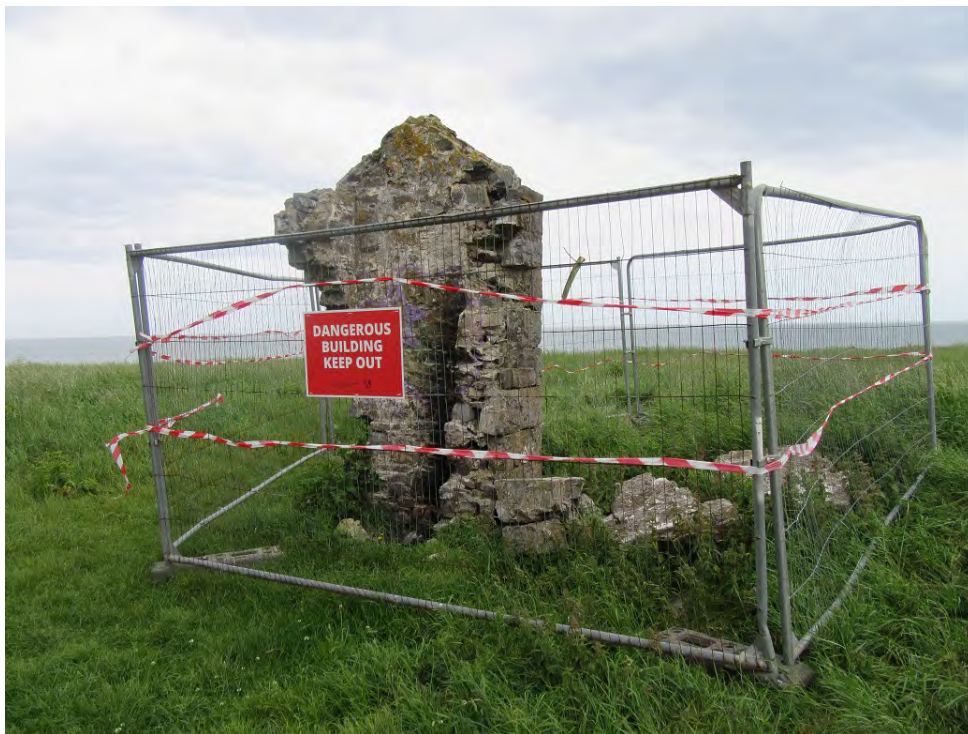
The surviving privy fragment at Drumanagh measures 2.75m in maximum height and 1.5m in width north-south. The southern wall measures 0.72m east-west at the base. The width of both wall fragments is a consistent 0.42m and the two course rubble foundation visible to the west is 0.3m in height. The remains of the privy have been subject to graffiti, fires and vandalism, resulting in cracking and significant collapse.

Plate 50: Drumanagh privy, facing east-north-east, December 2017

The privy to the east of the Martello tower has been in a ruinous condition for a number of years with no roof and only one partial wall of the structure is now still standing, the east gable wall. It is in a precarious condition. There is a stepped diagonal crack clearly visible on the inner face running from the top corner on the southern side to halfway down the wall on the northern side. The lower half of the wall is missing stones from the northern corner leaving the upper section top heavy. This combined with the diagonal crack and the fact that the mortar around some stones at the base and top has eroded raises serious concerns about the structural stability of the surviving

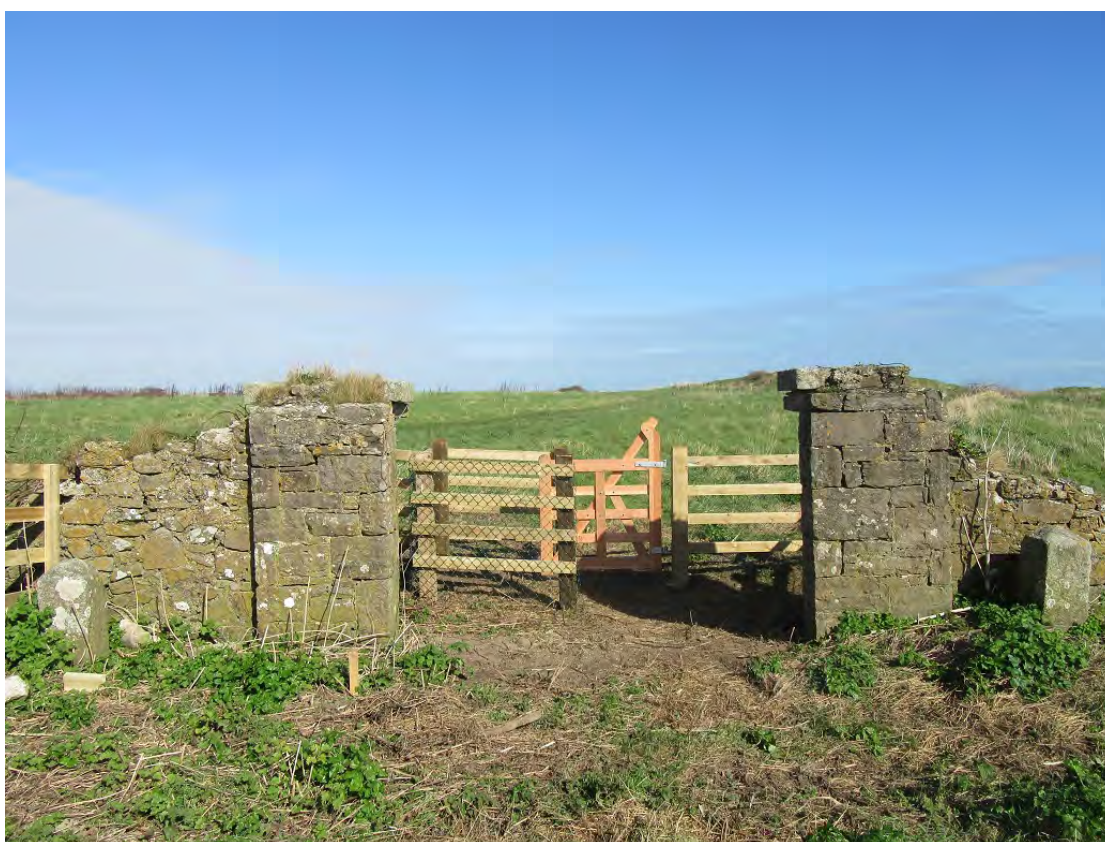
Plate 52: The exterior of the southern gate flanked by boundary stones

The south and west gate piers and immediately adjacent walls are contemporary fabric that requires attention including vegetation removal, cleaning and mortaring of joints, and stone replacement in order to arrest further deterioration.
