Conservation Study & Management Plan 2018 -2023

Drumanagh Promontory
Fort, Co. Dublin

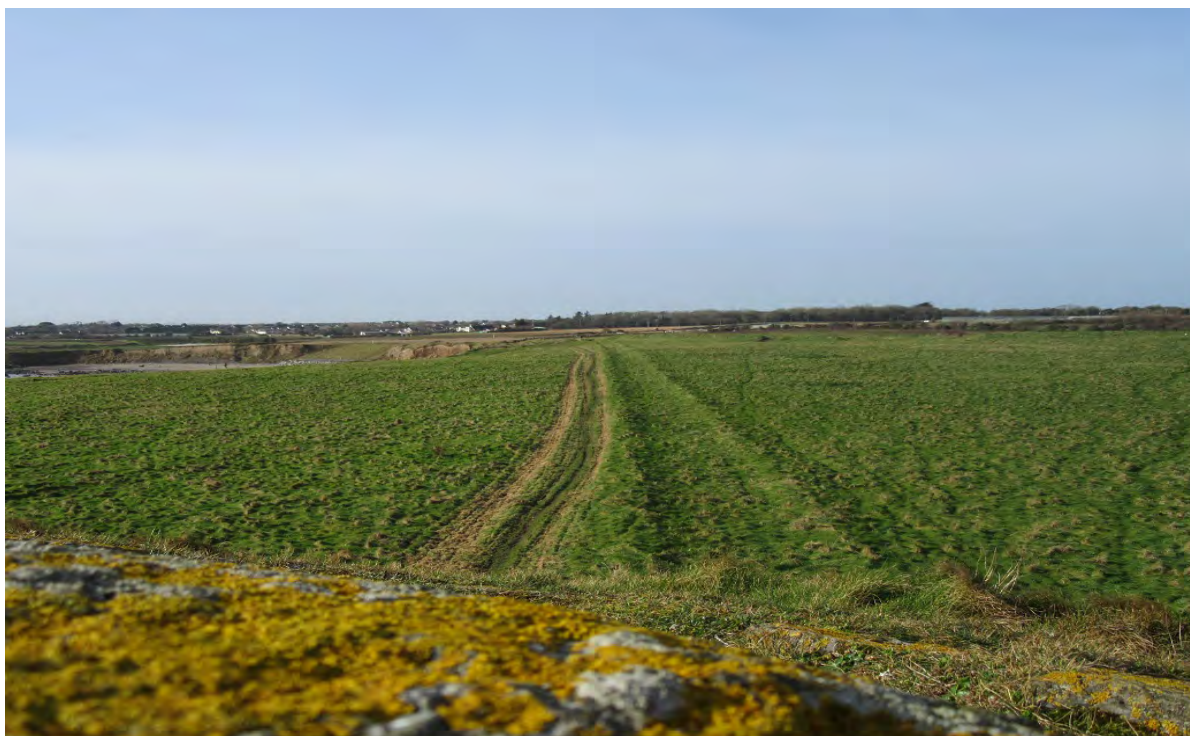
Plate 53: Original approach to the Martello tower (right) and modern trackway

The original approach to the Martello tower survives as a sunken trackway extending from the south-east corner of the fort approximately 6m in width. It is defined by low banks and ditches but overgrown and obscured along its southern limit by a pathway made by walkers and motorcycle scramblers.

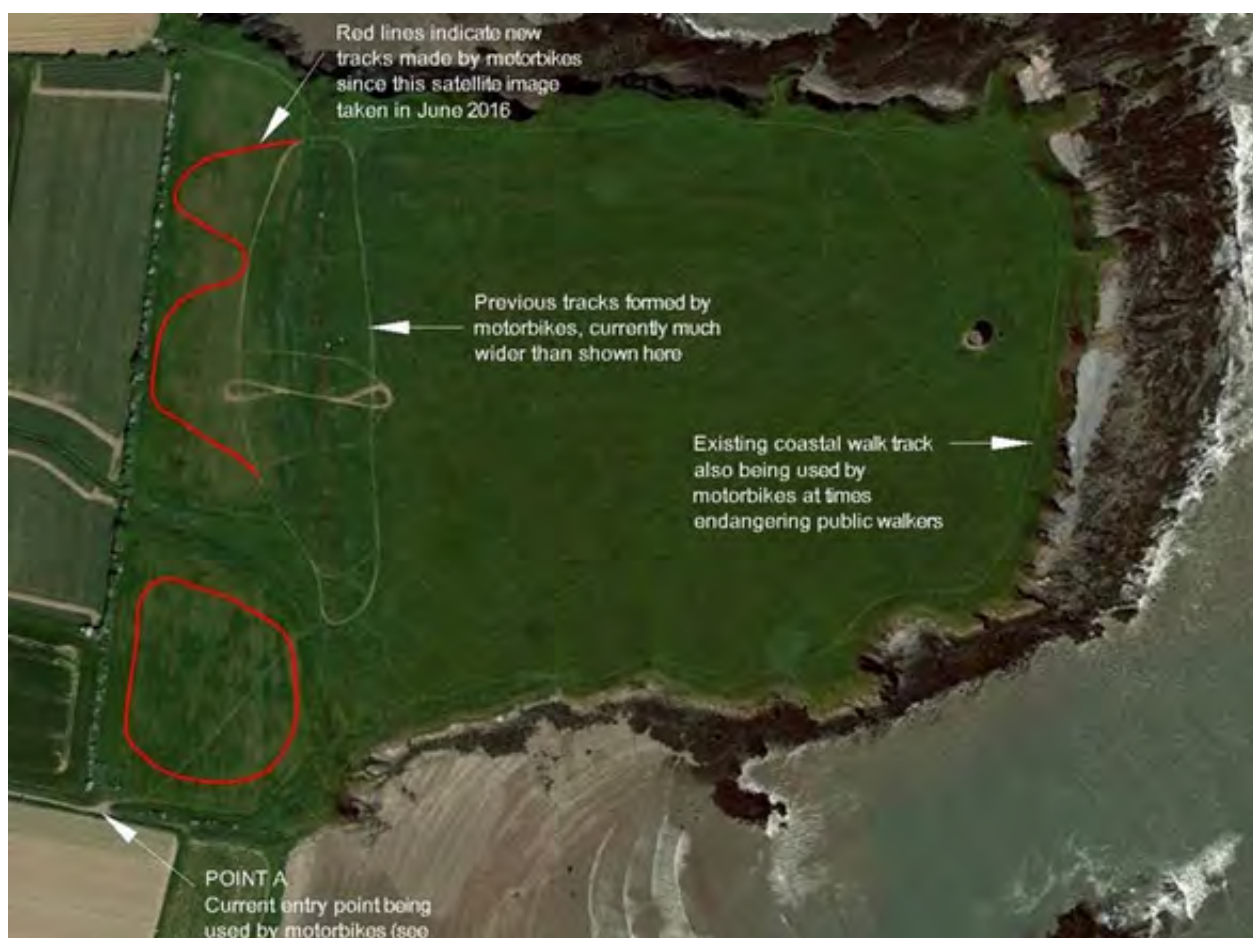
In order to develop recommendations for the management of Drumanagh it is necessary to identify the current and potential threats that could adversely affect the significance of the site. The greatest threat to the integrity of the promontory fort is the existing unauthorised use of the site for motorbike scrambling. The rutting and scarping of the banks and ditches and consequent upcast of material is having a cumulative detrimental effect on the monument itself and possibly disturbing artefactual material. It is hoped the recent delineation of the site with protective fencing and signage will obviate this threat.

Plate 54: Assessment of motorbike damage courtesy of local resident, Derek Redmond

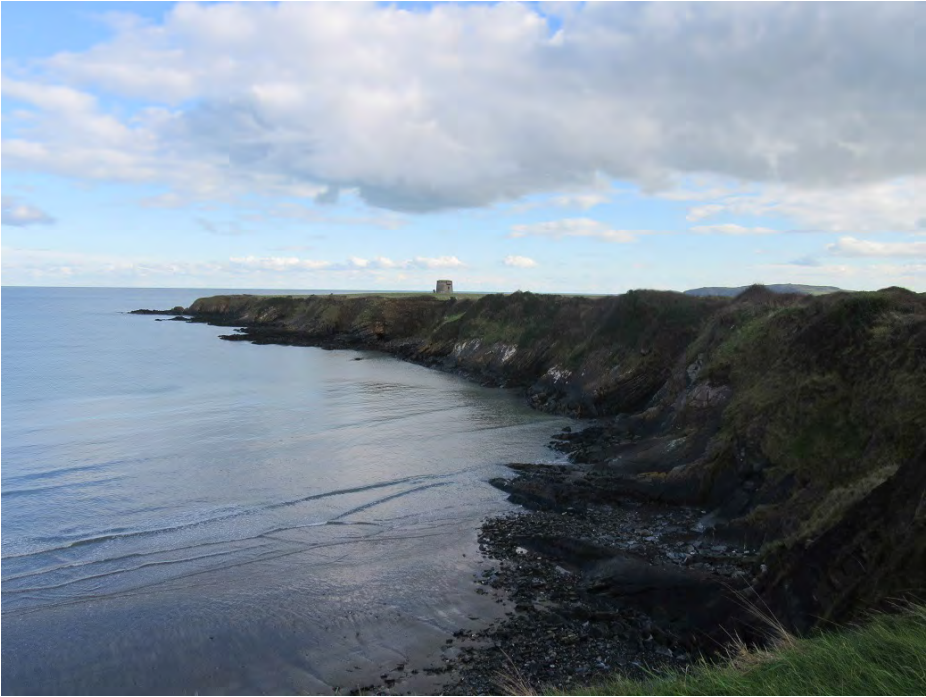
Cultural Heritage Feature	Promontory fort-coastal
Statutory Protection	RMP DU008-006001-/ RPS No.252/ Preservation order No.13/1977
Location	Extensive coastal promontory, north of Rush and south of Loughshinny:727236/756210
Description	<p>The neck of the headland c.46 acres is defended by a straight series of earthworks L.350m except where they curve inwards near the S cliff. The elevated, relatively flat promontory at Drumanagh is delimited on its landward (western) side by three closely-spaced earthen banks, each fronted by a ditch, with traces of a fourth, counterscarp, bank beyond the outer ditch. The inner bank is the best preserved rampart (w30m, h2m) The remaining banks have been greatly denuded (w17m, h.5m). Fosses are silted up. (W.4-6m, D.1m). A small stream emanates from a pond outside the ramparts to flow along the inner ditch and over the cliff edge at the south-west corner of the promontory. A number of gaps occur along the length of the ramparts, one or more of which may represent an original entrance. A system of 18th/19th century relict field boundaries defined by low earthen banks and ditches, extend across the northern and southern sides of the promontory. The LIARI project has examined the available LiDAR data in conjunction with previous geophysical survey, carried out on behalf of the NMI, and undertaken geophysical survey (Cahill Wilson et al 2014). Within the promontory a D-shaped enclosure and several structures suggestive of buildings and/or small enclosures, the presence of burnt material and pits (Dowling 2014, 13). The results reflect ploughing on the fort in the 1970s that revealed hut sites suggesting extensive settlement. Gallo-Roman pottery, second century AD Roman coins, Romano-British fibulae (brooches), copper ingots and an iron horsebit have been found at the site. Ploughing took place external to the outer rampart in the summer of 2014 impinging on the counterscarp fourth bank in the northern half of the site and the newly discovered oval enclosure (DU008-094----). Pathways carved by walkers, horse-riding and scrambler bikes have impacted on the entire site.</p>

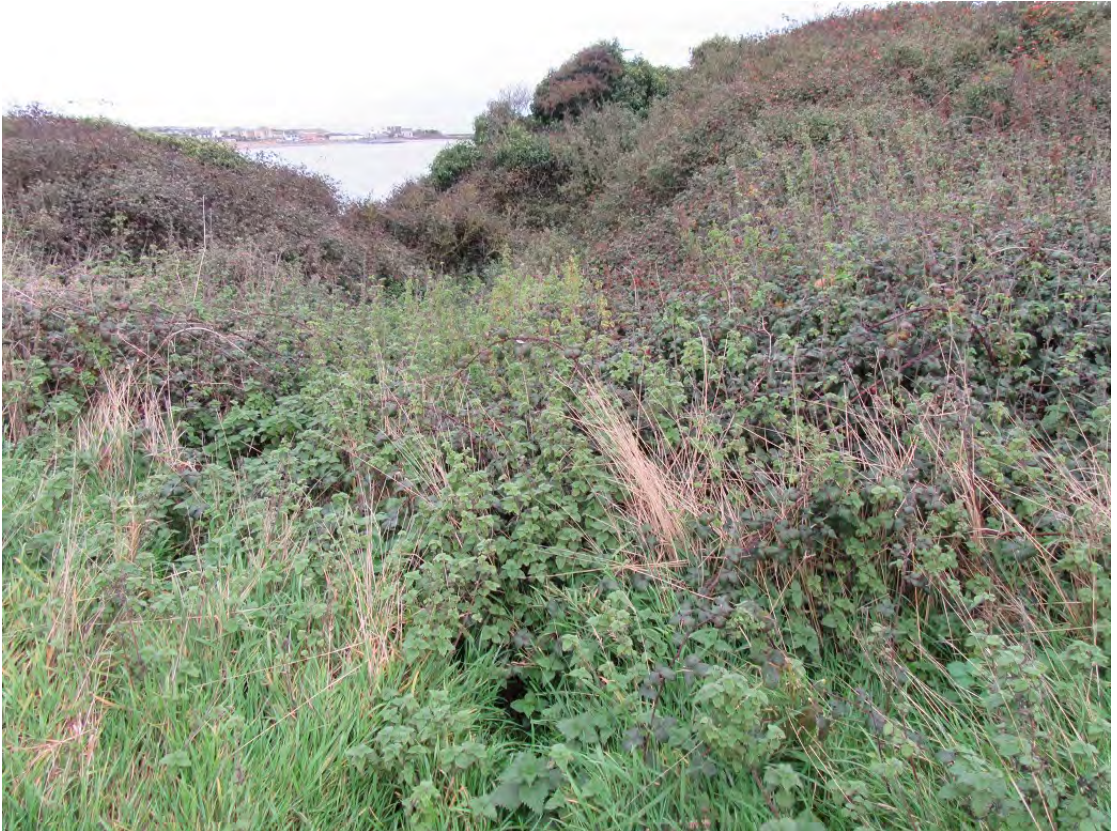
Cultural Heritage Feature	Well
Statutory Protection	RMP DU008-006002-
Location	In an overgrown crevasse immediately west of the ramparts along the north of the promontory 727001/756361
Description	This is a natural spring which lies within the defences of the promontory fort at Drumanagh. Marked on the 1837 OS map its site is completely overgrown.
Image

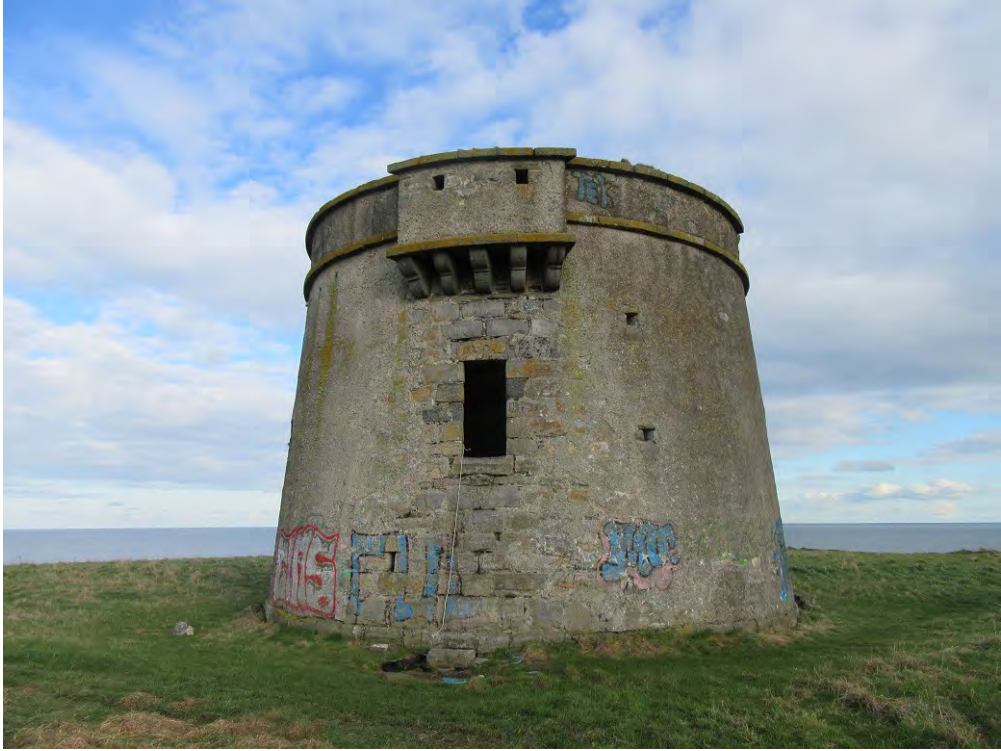
Cultural Heritage Feature	Martello Tower
Statutory Protection	RMP DU008-006003-/ RPS No.253
Location	Located to the east of the promontory: 727379/756242
Description	<p>Located in a field of pasture at the E end of a promontory fort (DU008-006001-). This is a squat cylindrical tower built of masonry, which has been rendered. Traces of a sunken roadway lead from the S end of the defences of the promontory fort to the entrance of the Martello tower. The entrance is on the west side and is positioned above ground level. It is defended by machicolation carried on corbels. The interior is lit by small square opes. A latrine stands east of the tower (Kerrigan 1996, 175). In 1821 Drumanagh tower was in use by the Preventive Water Guard to combat smuggling. It was transferred to the War Department in 1855 when it had 12 rank and file troops occupying the tower in 1857. It was disarmed by 1874. In 1908, the War Department sold the tower to General Palmer of Kenure Park, Rush for £50 (Bolton et al. 2012, 152). Very ugly graffiti at person height on circumference of the exterior with occasional example at parapet height. NIAH (Regional rating) 11318004 Martello tower, c.1805, on a circular plan with tapered profile, having machicolation supported by brackets over former entrance door. Roof: Corbelled stone with stone coping to parapet. Walls: Lime render over limestone rubble. Openings: Square headed former entrance door opening with limestone rubble reveals and soffit; door no longer remains.</p>

The full extent of the threat to the fabric of the Martello tower is unknown as it has not been subject to a structural survey. It is currently evident that some of the stone coping to the parapet of the Martello is damaged or missing and requires repair. The external render around the base of the tower and around the door opening has come away and the joints of the roof of the tower are grass-filled and may require remortaring.

- 13.5 Undertake a structural survey of the Martello tower and associated elements such as the gate piers which will produce appropriate recommendations.

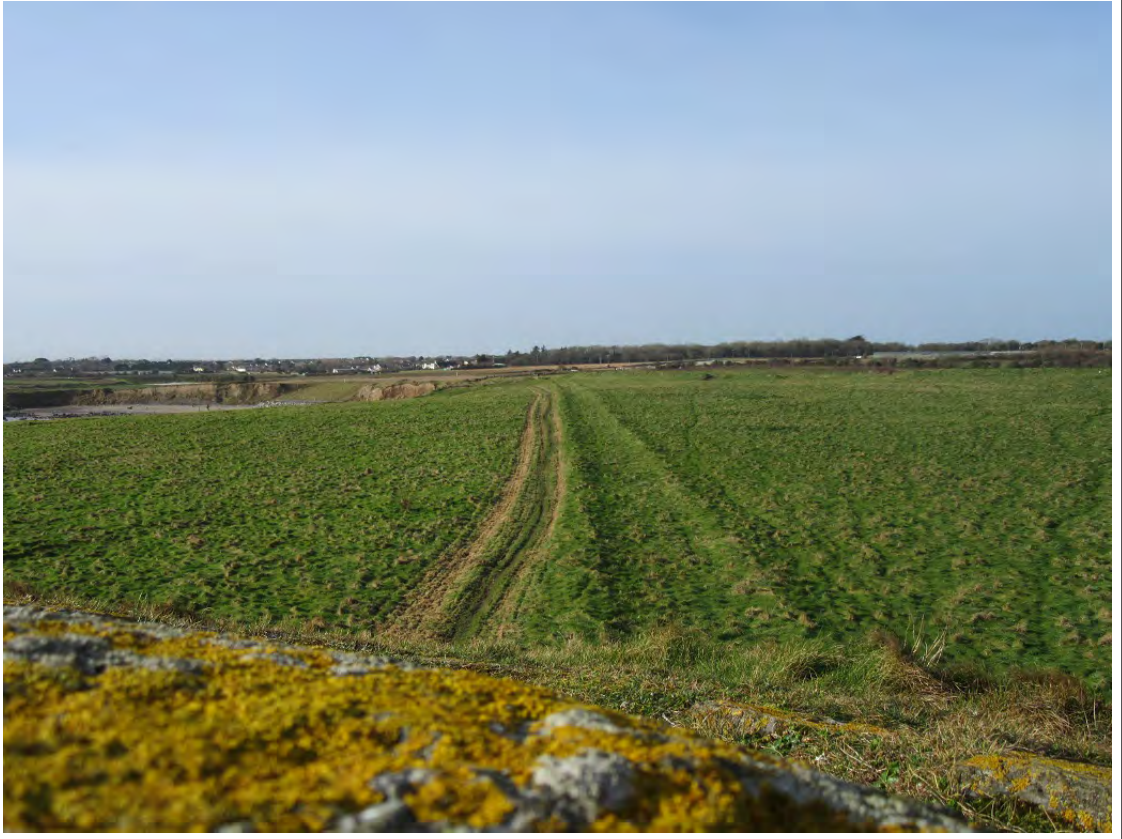
Cultural Heritage Feature	Road to Martello Tower
Statutory Protection	Within the promontory under Preservation Order No.13/1977
Location	Extends from southern boundary to Martello Tower
Description	The original approach to the tower survives as a sunken trackway extending from the south-east corner of the fort. approximately 6m in width, it is defined by low banks and ditches but overgrown and obscured along its southern limit by pathway made by walkers and scramblers
Image

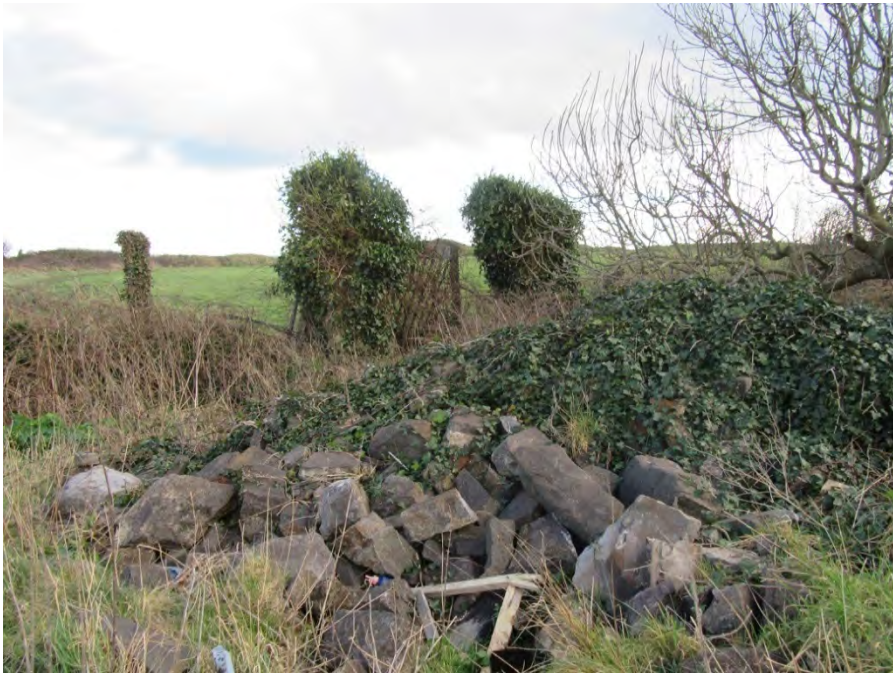
Cultural Heritage Feature	Western Boundary Wall
Statutory Protection	None
Location	Western townland boundary between Drumanagh and Ballustree
Description	This wall faced by a ditch externally forms the western boundary of Drumanagh. It runs mainly north-south curving gently at the north-western corner of the site before creating a sharp corner at the cliff face. The wall is rubble built and stands between 0.6m and 1.2m in height with at least six courses of roughly shaped stone (0.25m-0.45m diam.) visible. The wall averages 0.5m in width and is loosely mortared with a whitish mortar with large pebble aggregate. The wall is mostly overgrown with brambles. A wall in this position appears on the 1760 map.
Image

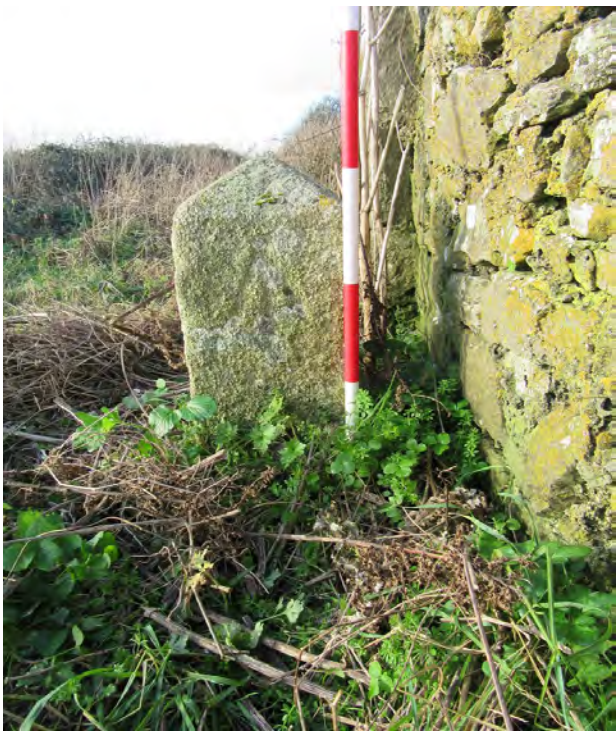
Cultural Heritage Feature	Boundary Stone 1
Statutory Protection	None
Location	South of eastern gate pier, South gate
Description	Cut granite with a pyramidal top. Located 0.4m east of the eastern gate pier and 0.2m south of adjacent wall. Visible height is 0.75m with each face measuring 0.3m in width. Arrows visible on all faces. One of a pair of stones c.5m apart marking entrance way to Martello Tower illustrated on the 1862 War Office map. Boundary stones also depicted on the OS 25 inch map (1906-09).
Image

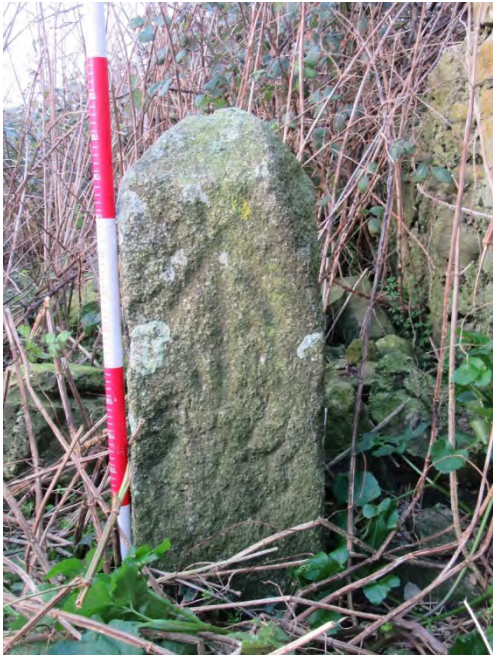
Cultural Heritage Feature	Boundary Stone 2
Statutory Protection	None
Location	South of western gate pier, South gate
Description	Cut granite with a pyramidal top. Located 0.9m west of the western gate pier and 0.38m south of adjacent wall. Visible height is 0.75m with each face measuring 0.3m in width. Arrows visible on all faces. One of a pair of stones c.5m apart marking entrance way to Martello Tower illustrated on the 1862 War Office map. Boundary stones also depicted on the OS 25 inch map (1906-09).
Image

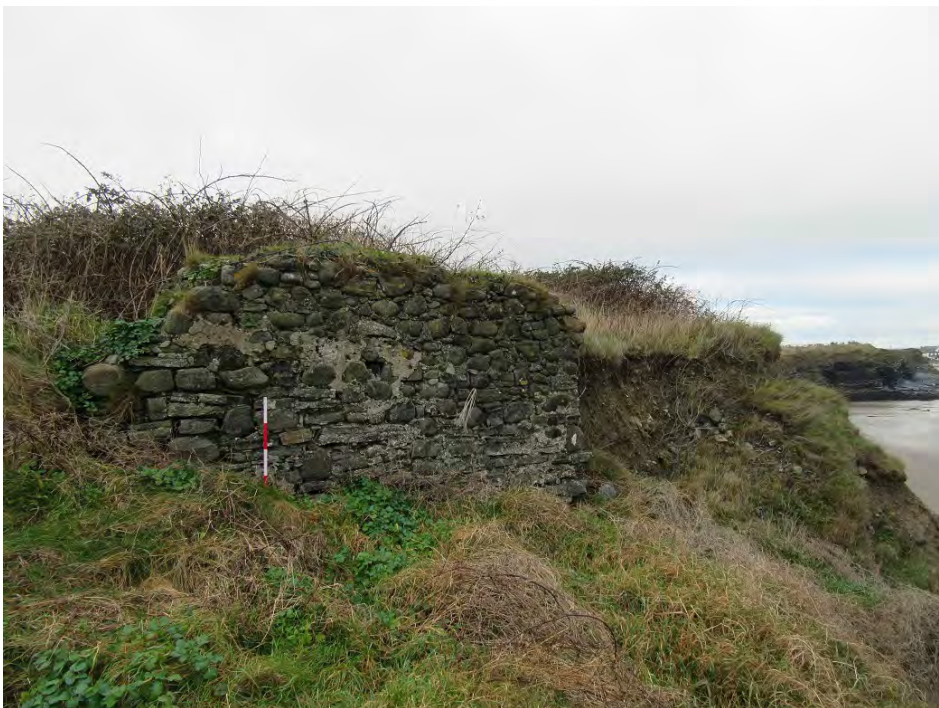
Cultural Heritage Feature	Structure 1
Statutory Protection	None
Location	External to the site along cliff face
Description	Approximately 4.6m of the northern wall of this structure remains standing to a height of 2.2m. There are visible areas of collapse down the cliff face and top the south of the upstanding wall which is partially overgrown. It is 0.7m in width and consists of rubble stones (0.2-0.4m diam.) roughly mortared with a whitish mortar with large pebble aggregate. This structure appears first on the 1760 map.
Image

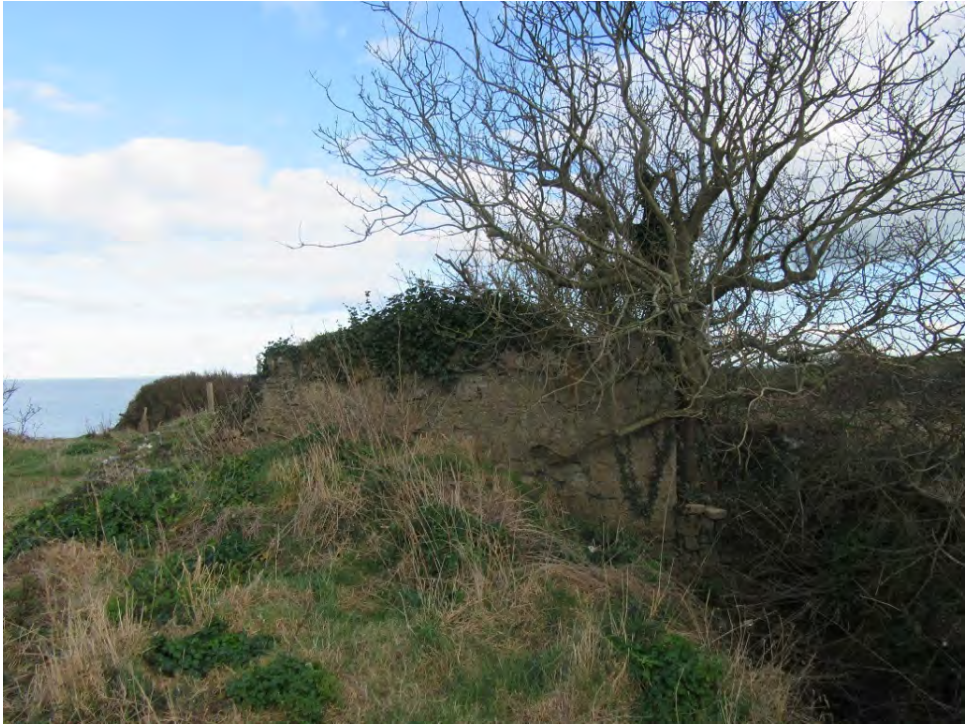
Cultural Heritage Feature	Structure 2
Statutory Protection	None
Location	External to the site along field boundary
Description	A single wall aligned north-south adjacent to the east-west field boundary west of the western gate and a mound of rough cut limestone is all that remains of this structure. There is a concrete slab and red brick in the vicinity indicating several periods of use. A structure first appears here on the 1760 map.
Image

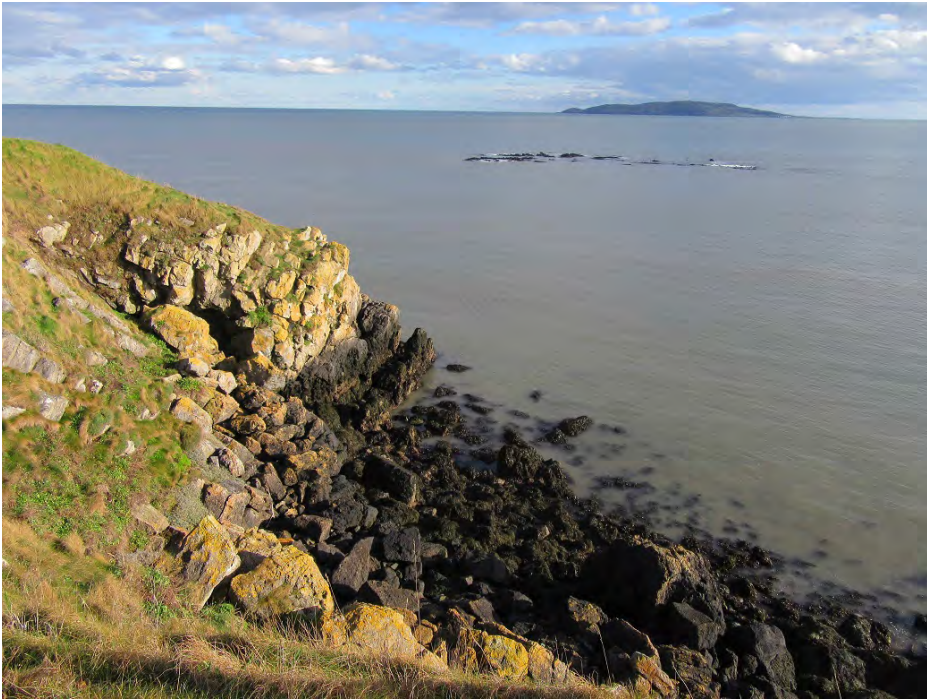
Cultural Heritage Feature	The Dane's Cave
Statutory Protection	None
Location	Southern cliff face towards eastern end of the promontory
Description	Sea cave that sits above the low tide mark of Roaring Water Bay. It is apparently entered by climbing down the cliffs. Local memories of it being red inside and containing a rock with a hole, known as the Cradle Rock (Paddy Boyle, pers. comm.).
Image
