SWORDS CASTLE **CONSERVATION PLAN**

Edited by Roberta Reeners

**Comhairle Contae
Fhine Gall**
Fingal County
Council

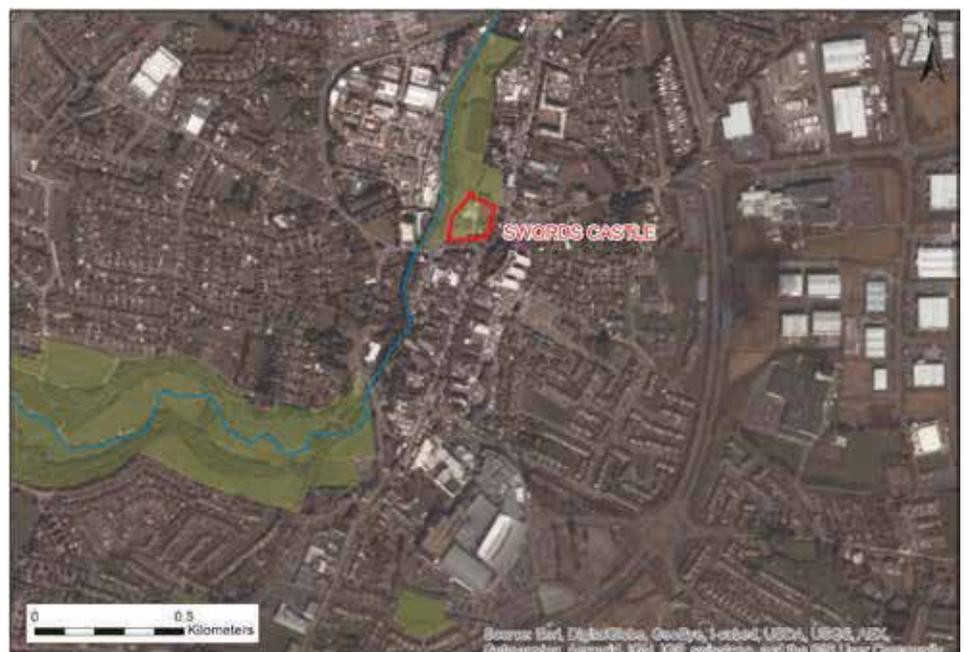
PLATE 2: Aerial View — Location of Swords Castle

The castle comprises a polygonal walled ward containing a large open space and number of buildings both ruinous and recently restored. The identification and former use of the enclosed buildings have been examined by previous studies, and the established nomenclature — the Gatehouse, Knights and Squires Chamber, Chapel, the Archbishop's Apartments and Constable's (North) Tower — has been retained in this report for convenience.

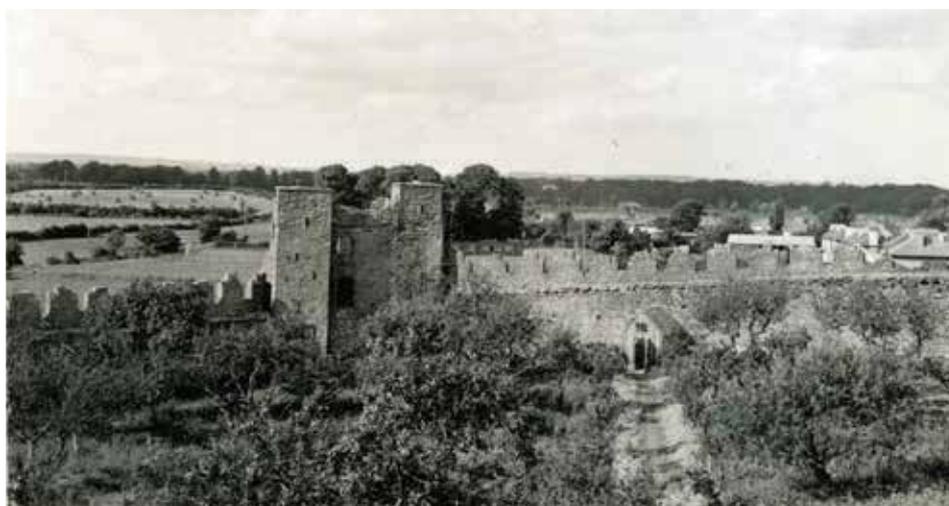
PLATE 11: Castle orchard c. 1930-1970

In this photograph, the trees are growing in the unkempt manner of an old orchard, so their productive life and management had diminished by this time. The path leading northwards to the small structure at the north wall is wide and being regularly used. The trees seem to be planted along it, so while this photograph resembles the layout depicted on the OS 25-inch 1865 map (Fig. 11), when carefully compared, there are differences in layout. However, neither the 1906 edition nor its 1937 revision accurately depict the positions of the trees in relation to the path and building. The loss of trees apparently continues, because the 1906 edition (Fig. 13) records 12 trees, and its 1937 revision records only 10 trees — the large lettering 'Castle (in Ruins)' and 'Chapel (in Ruins)' may have prevented the inclusion of the two trees that are depicted on the 1906 edition. The small roofed porch-like building in the photograph is the same one depicted on the OS 25-inch 1906 revision (Fig. 13).

The lands were eventually bought, between 1830 and 1870, by the Cobbe family of Newbridge House, Donabate. They used the lands for farming and fruit growing and planted an orchard within the grounds of the castle. A photograph from the Edwin Rae Collection shows how extensive the orchard was in the mid 20th century.

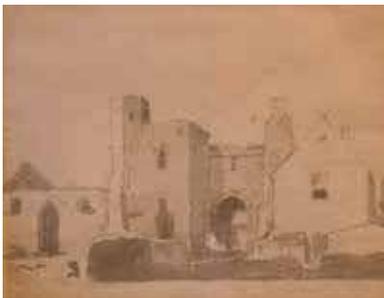
PLATE 14: View of the Gatehouse and adjoining buildings from the north-west

A second view attributed to Daniel Grose (Plate 14) has recently been published in the *Irish Arts Review*, Spring 2011, showing a view of the Gatehouse and the north façades of the chamber block and the Knights and Squires Chamber. Interestingly, it shows the Knights and Squires Chamber as inhabited or recently inhabited, as a sash window of 18th-century type is located on the north façade.

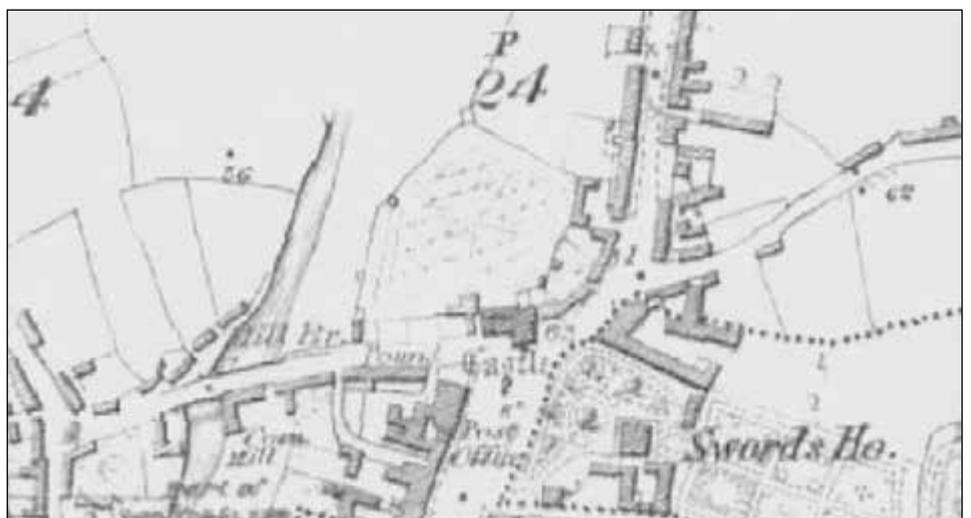
FIGURE 4: OS 1st-edition 6-inch 1836

In 1904, Adams describes the grounds within the castle walls being laid out as an orchard and garden, as does Lewis (1837). Stokes states that the castle 'enclosed a large extent of ground now turned into an orchard' (1891, 510). This is confirmed by the layout of the interior as shown on the first (1836) edition 6-inch O.S. map (Fig. 4).

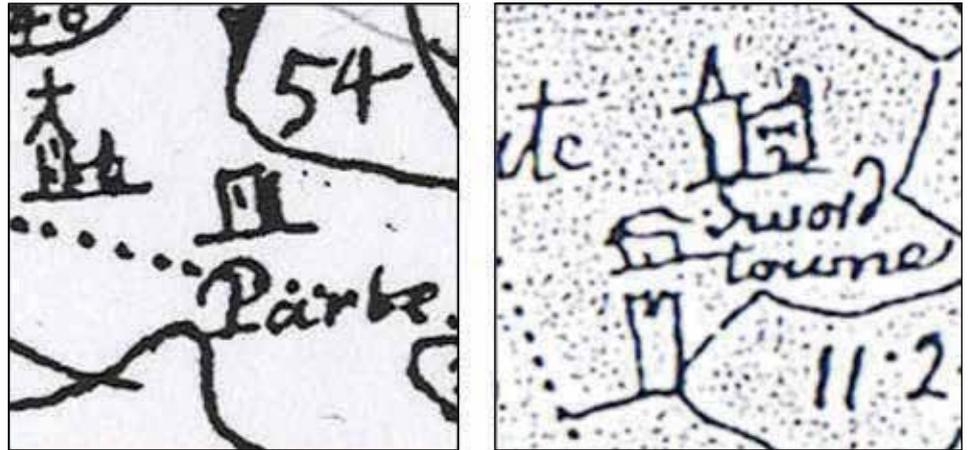
FIGURES 5 AND 6: Down Survey 1656; and corresponding Parish map

The earliest consulted historical map of Swords town is William Petty's Down Survey map of the Barony of Nethercross, which dates from c. 1656 (Figs 5 & 6). This map indicates that the medieval parish church and the castle at Swords lie on forfeited lands that formed 'Parte of Blackhall'. The castle is indicated as a simple tower. The written accompaniment to the map, the Civil Survey, records that, of 15 'lots' or landholdings ranging in size from one to 80 acres, many appear to be on the periphery of the town, while five are specifically described as being bounded by the town and lands of Swords. In the Parish map of the same year (drawn by Wilson & Weft), the manor is similarly indicated but with the notable addition of battlements.

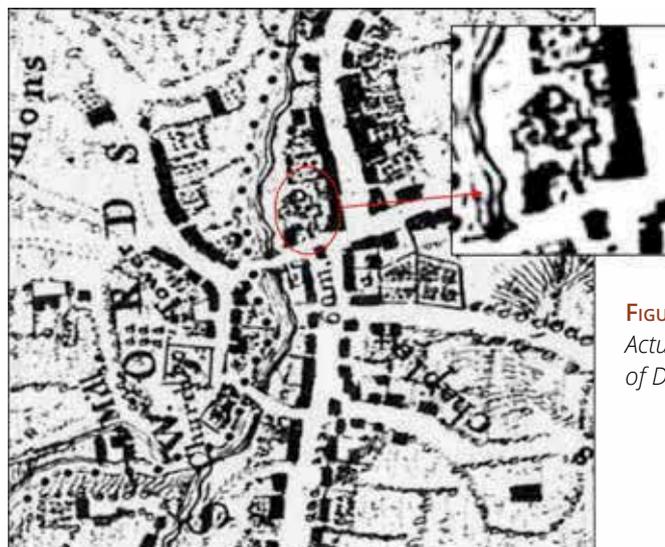
FIGURE 7: Rocque, 1760: 'An Actual Survey of the County of Dublin'

John Rocque, in *An Actual Survey of the County of Dublin*, 1760 (Fig. 7), indicates the pattern of street development in Swords in the post-medieval period. The town is shown primarily laid out along a single main street, with what is now known as the Ward River flowing approximately parallel to the west. It is focused and aligned on the castle rather than on the earlier ecclesiastical centre to the west of the river. The castle is indicated; an enclosing element can just be made out and is in an almost cruciform shape. Structures appear to front onto Bridge Street and North Street. There are no structures between the western wall and the river. Several structures or subdivisions can be made out within the ward; however, no specific detail in relation to the plan form of the internal structures can be distinguished.

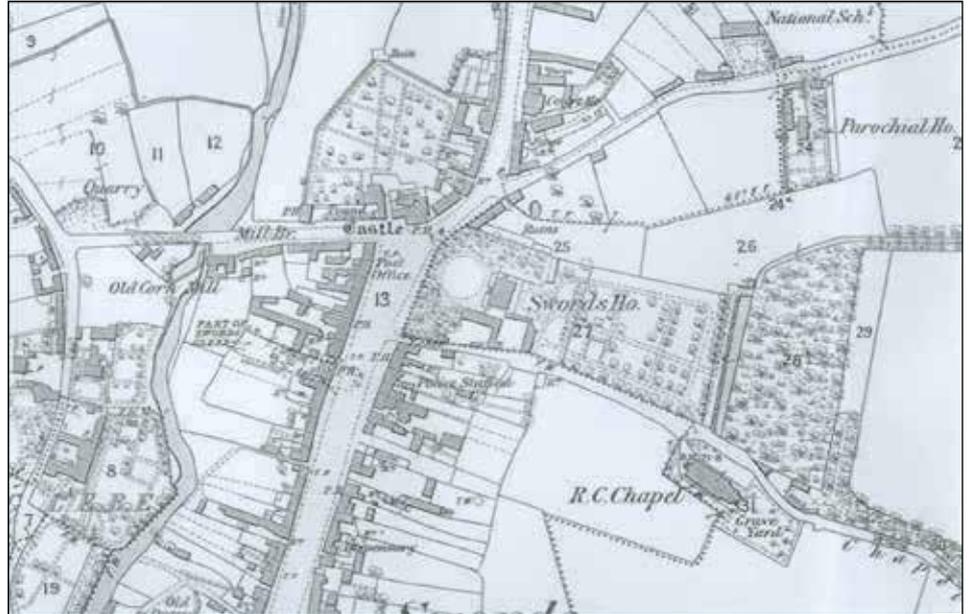
FIGURE 12: OS 25-inch 1865 revision map showing the castle and Swords Town

The OS 25-inch 1865 revision map (Fig. 12) shows many trees planted on the site but not as an obvious formally spaced orchard layout. It is probable that there were ornamental trees and shrubs as well as orchard trees by this time.

Despite its relatively well-documented history, Swords Castle has little known, discovered or published history of the enclosed garden area of ground within its walls. We are reliant on snatches of information gleaned from documents referenced elsewhere and in the Conservation Plan. The 19th and early 20th-century historical Ordnance Survey maps are the main sources for information, so we must focus on these for some understanding of the site (Part II, section 2.3 Cartographic Record, Fig. 9 [1st edition, 6-inch, 1836], Fig. 10 [1872 revision (6-inch)], Fig. 12 [1865 revision (25-inch)] and Fig. 13 [1906 revision (25-inch)].

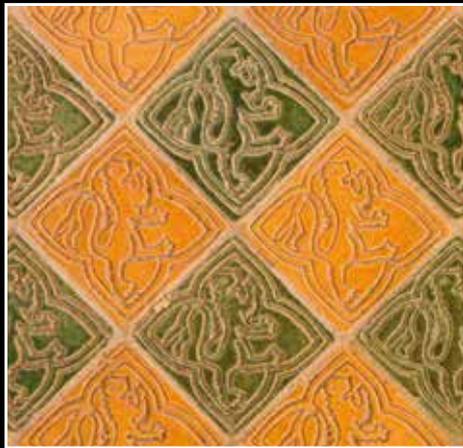
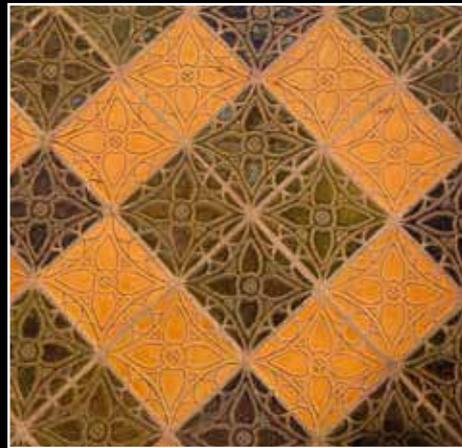
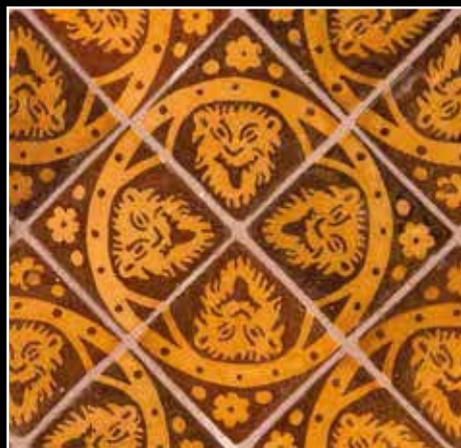
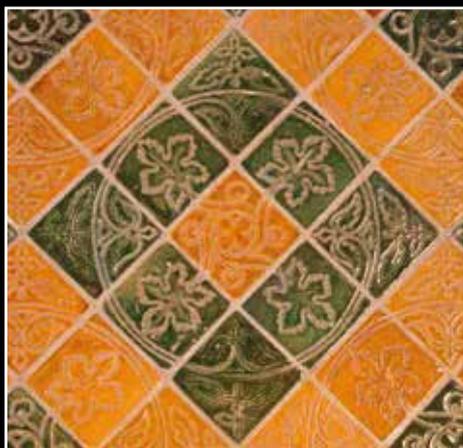
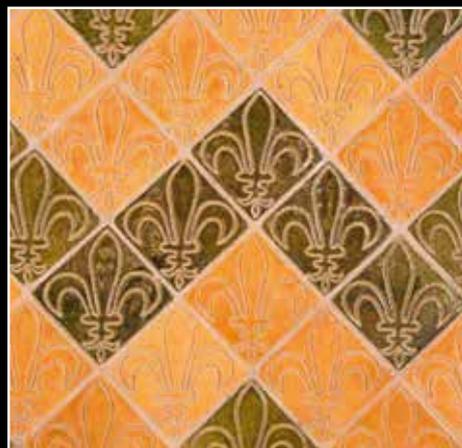
PLATE 17: Details of the reproduced tiles in the interior of the Chapel (based on excavated medieval pavement)

4. The floor of the chancel at east end of the Chapel has been tiled with new tiles designed to a form and pattern based on the old tiles found by Fanning in the adjoining angled building during the 1971 excavations. The floor is raised at the eastern end by a single step at a point roughly 4.6m from the east end. A new timber gallery has been inserted into the west end of the Chapel linked by means of a new doorway connecting through to the first floor of the adjacent Chamber Block.
5. The west wall that divides the Chapel from the Chamber to the west has been reconstructed from ground level, including all the new openings.
6. The new gallery connecting the Chapel to the Chamber block at first floor.
7. New lighting and electrical services have been inserted.

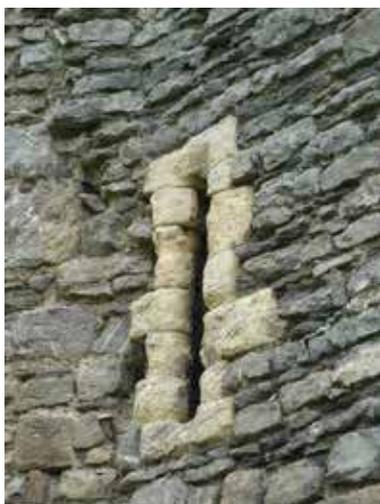
PLATE 18: Dundry stone

An analysis of three samples of carved stone from the castle has taken place (Sevastopulo, 2012) (Appendix D). The results showed that samples 1 and 2 are probably from the same or similar beds in the source quarry. Sample 3 differs in its coarser grain size, more complete cementation, and in the presence of a small amount of carbonate cement. All three samples are unlikely to be from the local Carboniferous rocks of north Co. Dublin because of their colour, the degree of sorting of the constituent sand grains and their relatively high porosity. The source is almost certainly from Mesozoic aged rocks, which have never undergone the burial of the older Palaeozoic strata. Mesozoic rocks in Ireland are confined to the north-east of the country. They are, however, relatively widespread in England. The closest comparison is with the Sherwood Sandstone Formation of Triassic age, which has been a source of building stone from Roman times onwards. The identification of cross bedding in sample 3 is consistent with a source in the Sherwood Sandstone, where this structure is ubiquitous. In England, the region with outcrops of Sherwood Sandstone closest to Dublin is the Cheshire Basin, but the formation is widespread in the Midlands, south Wales and south-west England.

'In the mid-13th-century gatehouse block, the building west of the entrance has Dundry stone dressings to two doors and to a small loop, lighting a stair, at first floor. A trefoil-pointed light above the entrance arch is also apparently dressed in Dundry stone, save for the red sandstone head; and occasional pieces of the oolite are incorporated in the rubble walling of both gatehouse building and adjacent chapel. However in the late 13th or early 14th century chapel and in the late 13th century window lighting a probable first floor hall against the east curtain, the dressings are of sandstone. The largest of the mural towers, at the north-west angle, has a few dressings of Dundry freestone, in the embrasure of one of the second floor windows and in the basement door. In addition, a Cotswold oolite, perhaps Painswick stone, occurs in the entrance block, restricted to two dressings of the second floor door from the stair.'

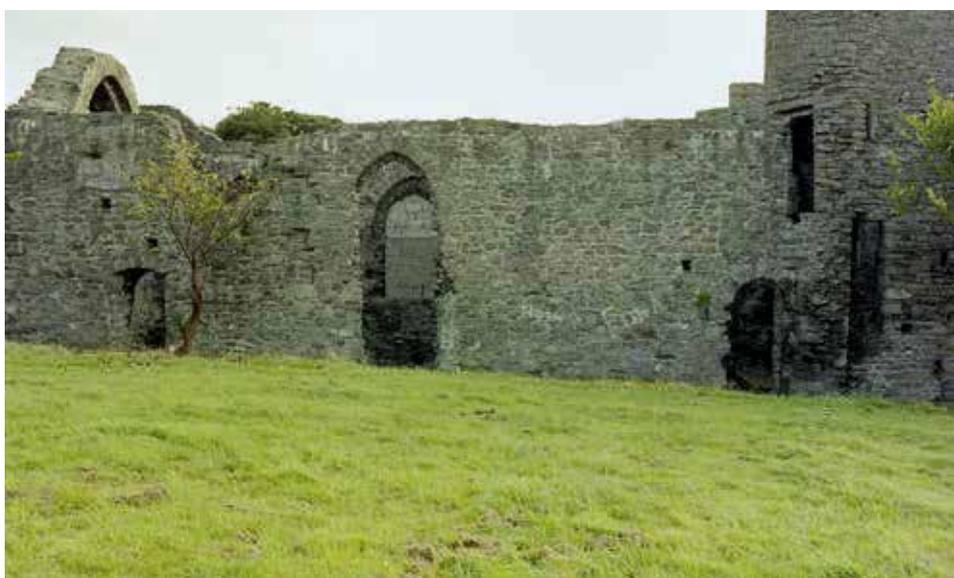
PLATE 24: *View of north façade of the Chapel, 1987*

The Chapel is a single-cell structure that has been considerably repaired and reconstructed in the last 20 years; the building as it was c. 1987/8 was recorded by Crimmins and Mandel. The space contained within the walls is 15.3m long and 5.2m wide. There are two doors in the north wall at ground-floor level, one at the east end and another at the west end; the eastern door may originally have formed part of a porch.

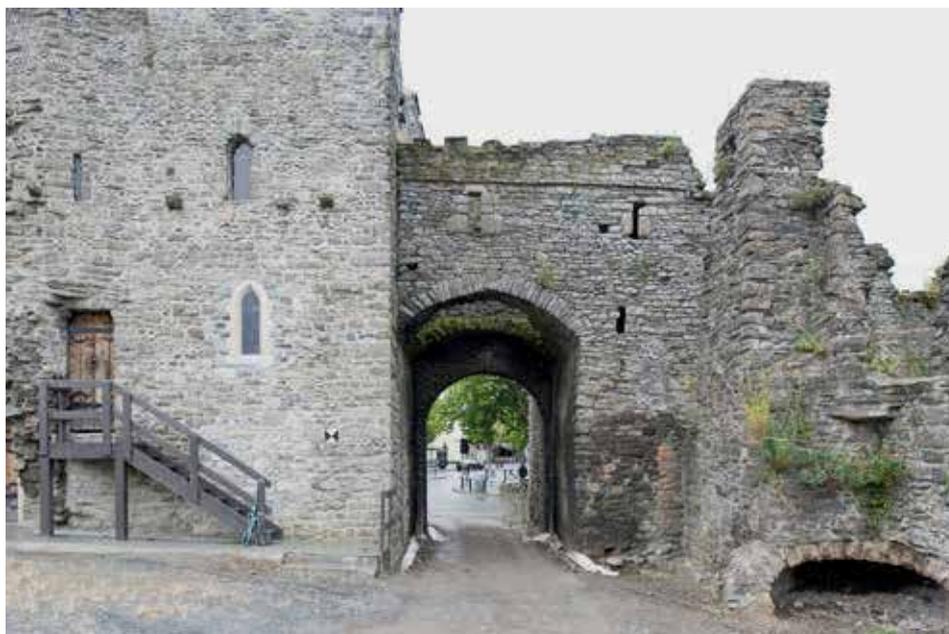
PLATE 25: Chamber Block, north façade

1. Walls extended upwards to incorporate new crenellated parapets
2. New timber trussed and slated roof
3. New intermediate timber beam and plank floors
4. The reconstructed west wall adjoining the Chapel (see above)
5. New stone surrounds to door and window openings
6. New stone stairs
7. New concrete ground floor
8. Part reconstruction of the vaults at ground floor level
9. New lighting and electrical services have been inserted

The Chamber Block contains three floors of accommodation. This plan arrangement is very typical in the 13/14th century and is found in virtually all manorial residences of the time containing a solar (a French-Norman term describing a living area above ground floor level) over vaulted undercrofts at ground level. The vaulted undercrofts at ground floor were used for the storage of precious foodstuffs and other articles that needed high security. The solar was the archbishop's private chamber where he slept and entertained guests. In this case, the solar was at second-floor level, with a room below that was probably used by the archbishop's closest attendants and as a waiting area for visitors prior to seeing the archbishop. The original stone-lined four-light rectangular window on the south wall had timber-hinged lower casements and grooves for glass in the upper sections — this arrangement of employing hinged wooden shutters as a design feature was used when an open window was required with fixed glass above. The stone window frame used Dundry stone.

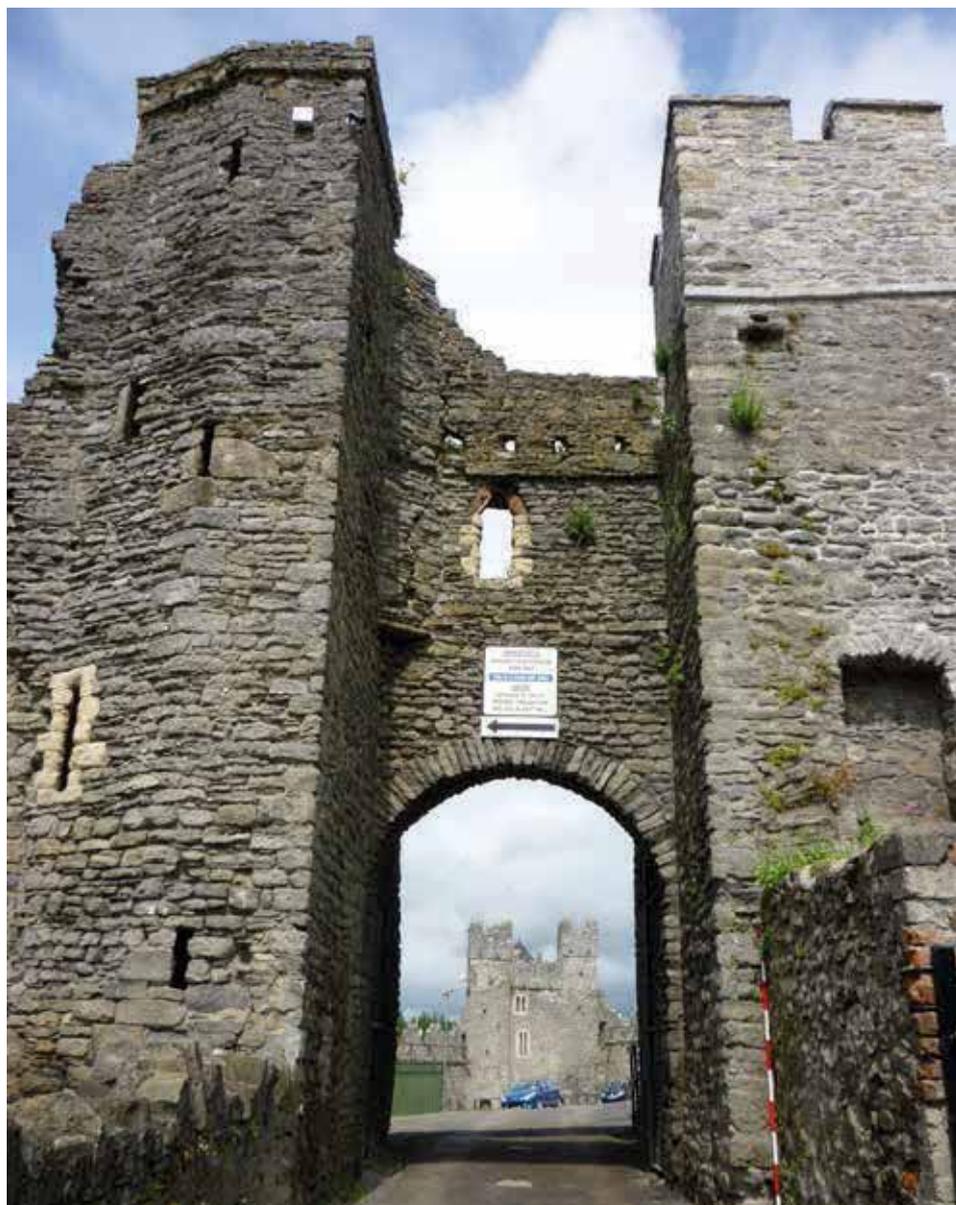
PLATE 26: Gatehouse, view from the south

The structural condition of the vault over the Gatehouse is a cause for serious concern, as detailed below.

The ruinous Gatehouse is a major concern at present. The vaulted masonry has partially collapsed directly over the main entrance (which is open to the general public). Further deterioration would appear to be inevitable unless the vault is repaired and the upper structure is reinstated in some form to provide adequate weathering. The vault was not designed to project in cantilever fashion from the edges, so the collapse of the central portion compromises the natural design. It is not clear what remedial work has been undertaken to prevent unravelling of the voussoirs around the collapse. The most effective remedy would be to reinstate the vault. If this is not permissible, then the masonry will need to be anchored back to safeguard its structural integrity. In our opinion, it would be prudent to erect a safety net (or crash deck) below the partially collapsed vault to protect the general public from falling debris and masonry that may become dislodged due to natural degradation. This is a health and safety hazard at present.

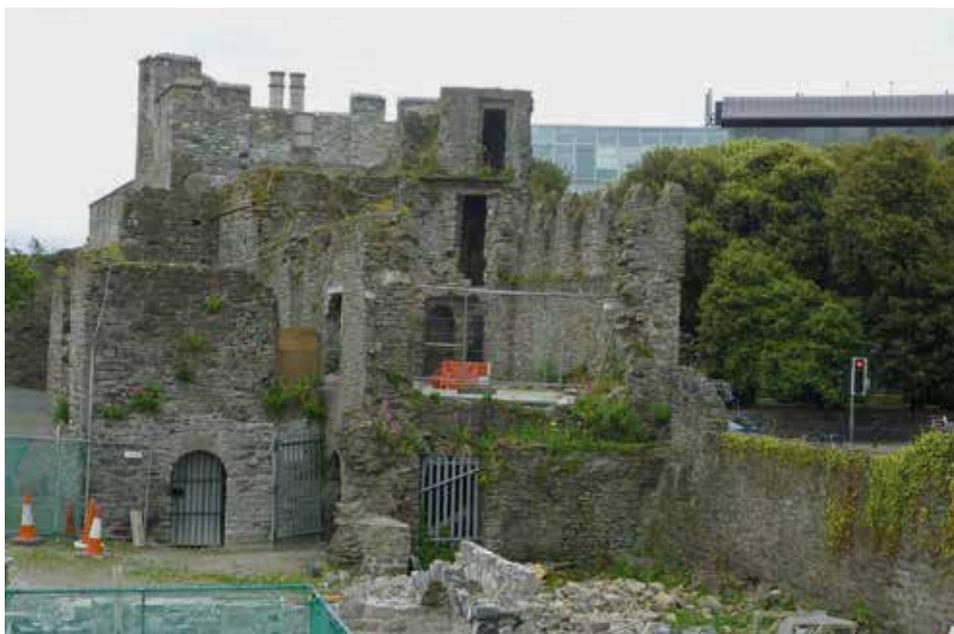
The Knights and Squires Chamber building is so called from the description of 1326 (Stalley, 2006). It is now a two-storey building but was at one point a three-storey building, as the south boundary wall has been built over and through the original structure. It also bears the imprint of several phases of building/demolition/rebuilding, making it difficult to interpret correctly.

The building is ruinous and structural stability of individual elements requires immediate attention. The buildings clearly extended west, as the scars of broken walls and the remnants of a vault at the south-west corner indicate.

PLATE 29: *Knights and Squires Chamber, view from the west*

The ruinous Knights and Squires Chamber is probably the greatest cause for concern at present. It would appear from visual inspection that the historic loss of the structure above first floor has permitted the elements to degrade the vaulted masonry over a long period of time. It is likely that the lime mortar jointing of the vault was compromised by several natural actions (such as washing out from rainfall, freeze-thaw action, root attack etc.), which effectively reduced the thickness of the vault and weakened it, causing it to drop and spread. The additional lateral thrust to the main entrance from the drop is considerable, and has been significantly increased by the well-intentioned addition of a heavy weathering screed. While remedial works (which await commencement) that have been formulated by others (Edden, 2010) may help to restore the structural stability of the supporting wall, it would have been prudent to prop the arch and reinstate the upper structure to restore weathering prior to embarking on concrete screeding and subsequent remedial work to the masonry. Permanent reconstruction of a properly weathered upper structure remains the most effective means of weathering the vault and is recommended.

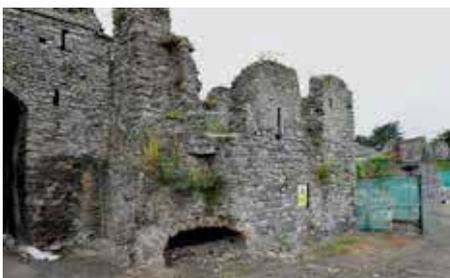
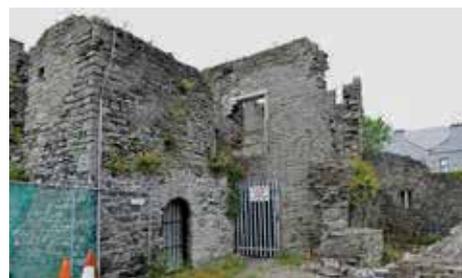
PLATES 30 AND 31: *Knights and Squires Chamber, view from north and NW corner*

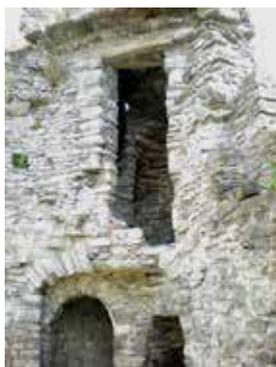
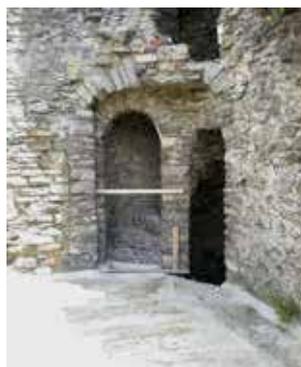
PLATES 32 AND 33: *Knights and Squires Chamber, 2nd-floor doorway to void and 1st-floor corner entry to spiral stairs*

The ground floor of this building contains vaulted apartments. At first-floor level, there is a single room with access to the two spiral stairs in the NW and NE corners. Both connect from the ground to the (now missing) second floor. The stairs to the NE corner is encased in a circular turret, while the stairs at the SE corner is enclosed within a polygonal turret that may be a later alteration/addition (Stalley has pointed out that polygonal enclosures to stair towers are not generally found before the 15th century, an opinion also given by Wood in relation to comparable buildings in England) (Wood, 1994).

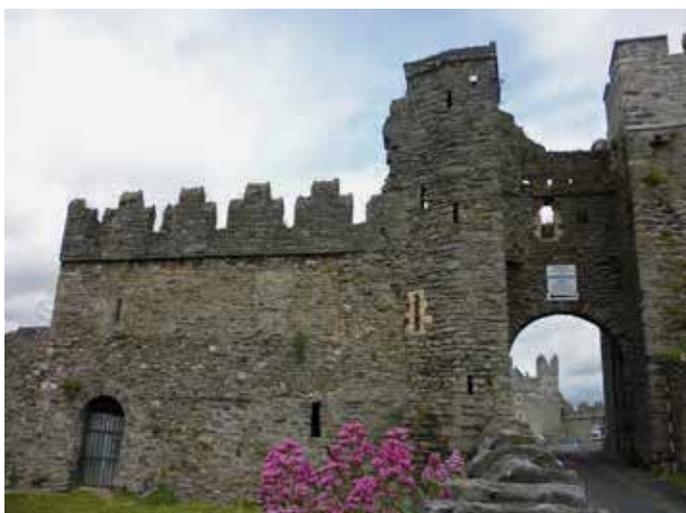
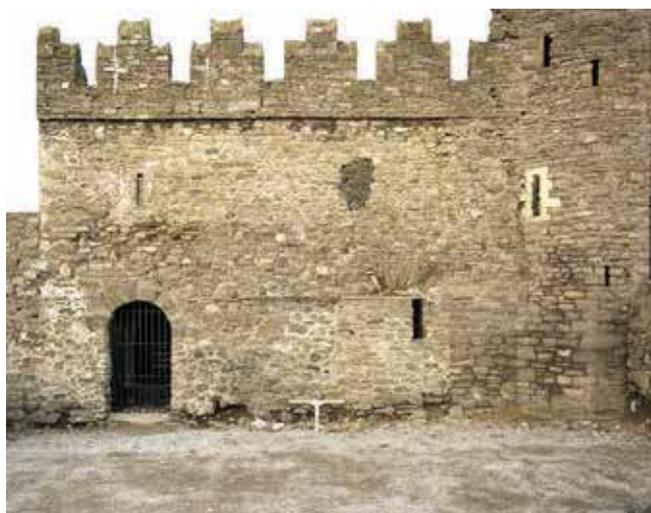
PLATES 34 AND 35: *Knights and Squires Chamber, south façade (2011 and 1987)*

The exterior of this part of the complex contains several slit windows within stone-framed openings, and stone arch-headed door openings, one on the south wall to the exterior of the site and two on the west wall.

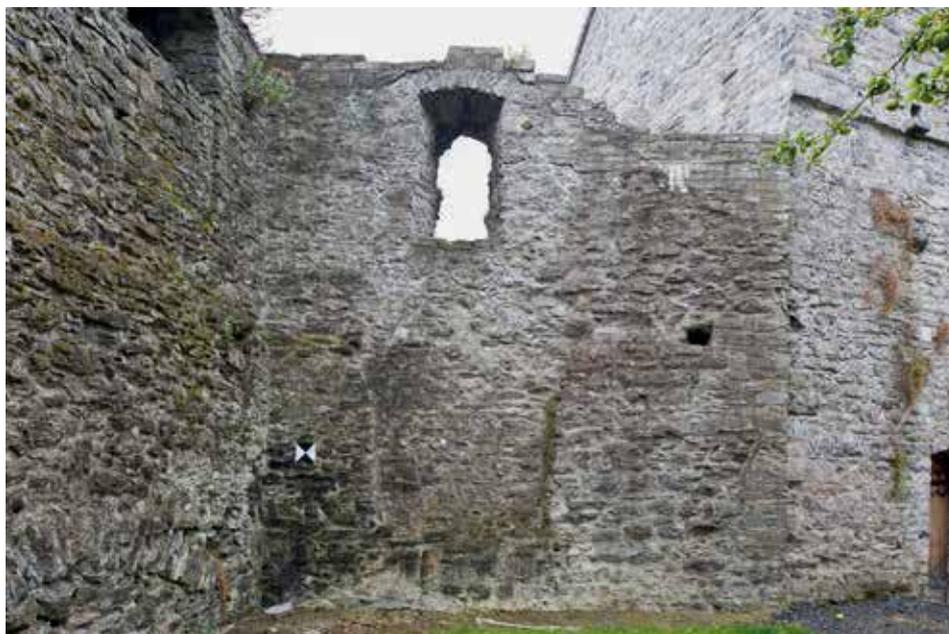
PLATE 36: *Archbishop's Apartments, view to south wall*

This two-story building is approximately 12.5m long and 6m wide, of which the east, south and part of the north walls survive. There are corbel stones evident in the east wall at first-floor level suggesting that the first floor was a timber beam and plank floor. The foundation layer of the west wall was exposed and recorded during Fanning's excavations in 1971. Fanning found medieval tiling *in situ* and burials. These are discussed in detail in the archaeological section (3.4) of this Plan.

The north and south walls appear not to be parallel, and part of the south wall has been reconstructed (again off line). The post holes and part of a partition structure at ground level found by Fanning suggest that the ground floor was sub-divided into separate spaces, but the single-space room above must have been one of considerable grandeur.

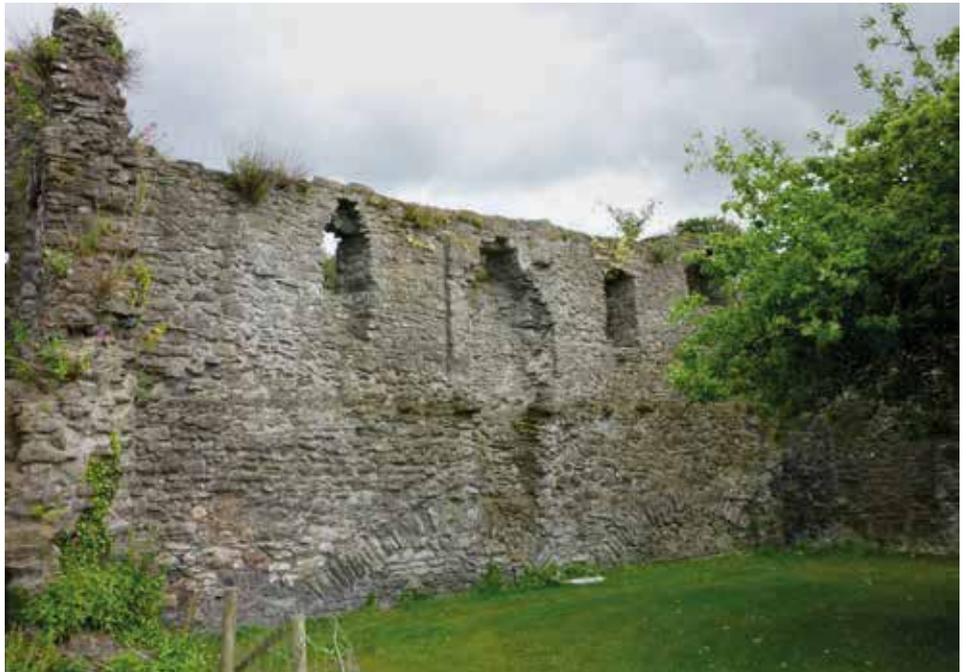
PLATE 37: *Archbishop's Apartments, view to east wall*

The east wall is c. 0.82m wide at the southern end and widens out to 1.2m at its northern end; on the outside, this wall is buttressed by a central stone pier supported on a concrete plinth.

The interior façade of the east wall shows two large relieving arches on the ground-floor wall. Above that is a row of stone corbels at first-floor level, confirming an early timber beam and plank first floor to this building.

The central fireplace opening on the east wall appears to have been altered. The flue of this chimneypiece exits through the external wall above it (as was common in early medieval buildings). There are two window openings flanking the fireplace to the right and one to the left. These openings are different in shape and form, indicating several periods of building/alterations. The fireplace is probably a 15th/16th-century construct with additions.

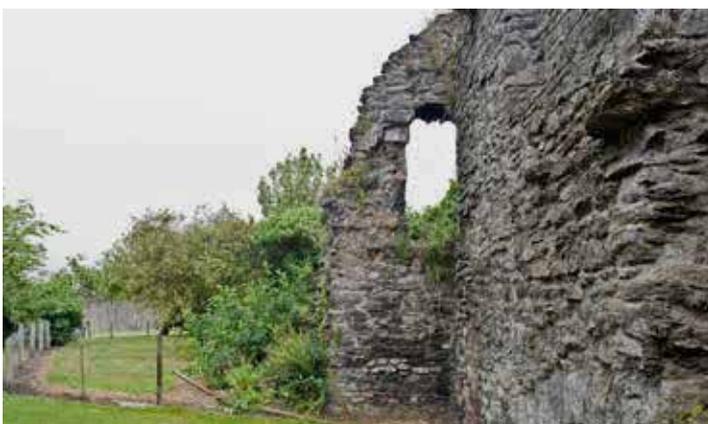
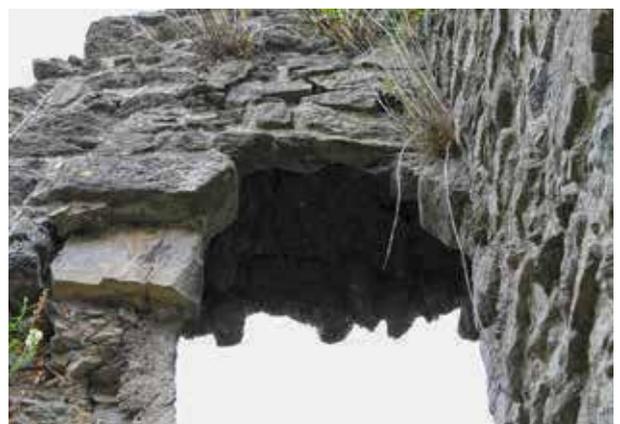
PLATES 38 AND 39: *View to doorway between the Archbishop's Apartments and the East Tower (left); Close-up of the 'Caernarfon arch' over the doorway (right)*

The stone arched doorway connecting to the east tower at first-floor level, with carved ogee spring-stone and the cut stone jambs visible on the east side of the opening, is remarkable. The form of the arch closely resembles a form described in Leask (1941) as a 'Caernarfon arch', which he observed also in castles at Ballymoon, Co. Carlow (date of construction ascribed by Leask as 1310) and Ballyloughan, Co. Carlow. The slit window adjacent in the NE corner at the nodal point where this building abuts the east tower suggests a lobby arrangement, and that the two buildings were in use together at some point.

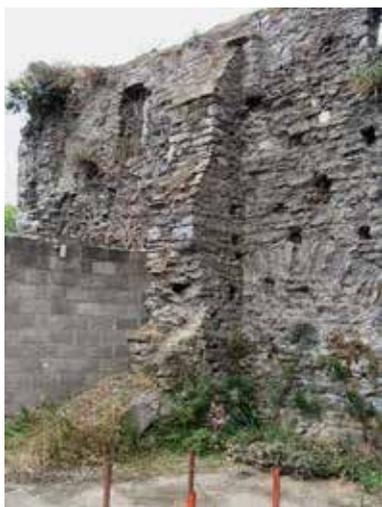
PLATE 40: *External face of east wall*

The external face of the east wall at the Archbishop's Apartments (5.4m high internally, but 7.0m high externally) presents a number of loose and damaged stones, as well as voids from missing stones. The defective masonry in the wall and buttress should be consolidated.

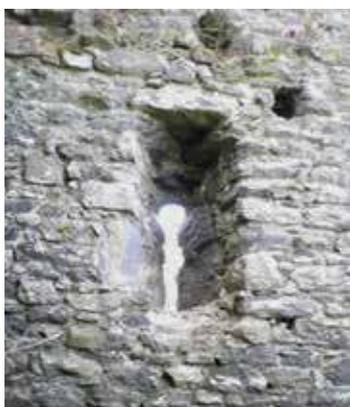
PLATE 42: *'Keyhole' ope at first-floor, south wall of East Tower*

The tower immediately north of the Archbishop's Apartments is a ruinous structure consisting of north, south and east masonry walls extending upwards to three floors above a simple barrel vault at ground level oriented east-west. Only a 2.5m long section of the barrel vault still stands; the location of the west wall is unknown. The tower walls are 1.05m thick, suggesting an early date for this structure. The eastern end vaulting appears to have been aligned transversely to the east-west axis.

Two of the window openings in the ruinous East Tower appear to have defective arches and are liable to deteriorate if they are left in their current condition. It is possible that the masonry at either side of the arch has been consolidated to the point that it corbels out safely, but this is not apparent, so it must be assumed that the arch is at risk of progressive failure and eventual collapse.

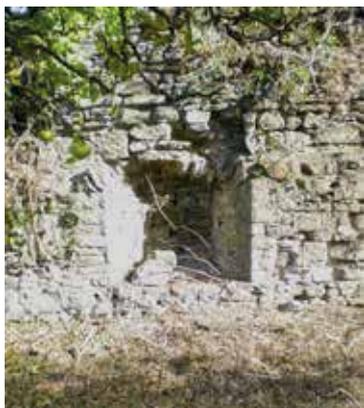
PLATE 43: Possible ope

There is a 15.2m long section of boundary wall, 1.05m thick, built with limestone rubble masonry. It is heavily overgrown with ivy immediately north of the tower.

North of this is a gable with a stone mullioned Gothic window, suggesting a building of which only the east wall remains with part of the north and south flanking walls. The window mullions are of red sandstone and show the remnants of tracery within it. Below the window are two recesses in the stone wall that may be later alterations or possible opes. Leask describes these openings as 'two small windows' (*JRSAI*, 1914, 262).

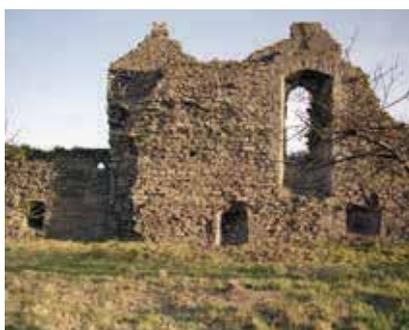
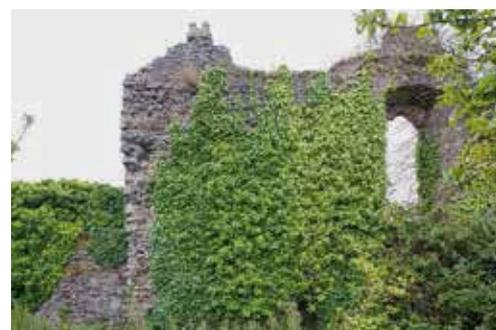
PLATES 44 AND 45: Gable Ruin, taken in 1987 and 2011

The condition of the east wall is in question because a significant portion of the wall is obscured by dense rampant vegetation, hindering both visual inspection and manual checking for loose stones etc. There are some signs that remedial work is required.

A variety of rampant shrubs is growing at the base of the east wall, both inside and outside the ward, as well as a couple of isolated young trees which, if left unchecked, may cause local damage. The young Sycamore tree, in particular, is very likely to impact adversely on the masonry in a relatively short space of time by means of wind-driven branch strike, gradual root up-thrust, and ground heave due to seasonal moisture drawdown.

Extensive areas of the east wall are covered by ivy, which will tend to weaken the lime mortar joints and inhibit drying out. There is also widespread growth of invasive *Buddleia*, which will drive its roots deep into the masonry core, loosen individual stones, and eventually burst the masonry in time.

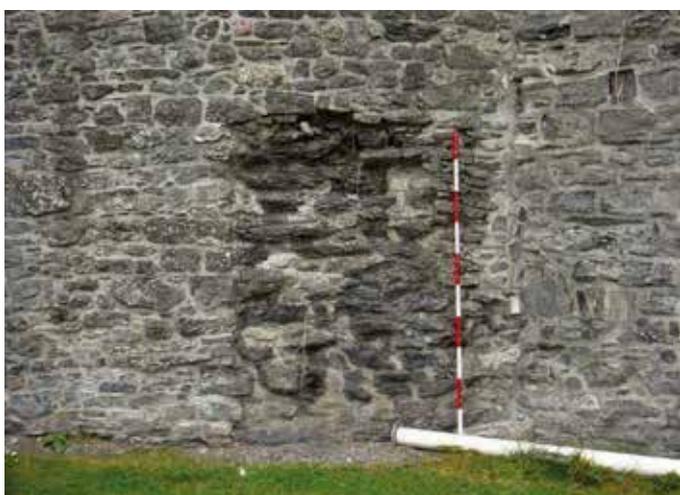
PLATE 46: Restored wall showing original fabric

The west, north-west and north walls of the 'castle' have been substantially rebuilt with the recent works; they are crenellated with stepped merlons, with a newly built wall-walk on the interior of the battlements. The wall-walk is connected by doorways to the interior of the mural towers and Constable's Tower. The walls have a predominantly flat-faced exterior, with a very minor batter at the base for structural support.

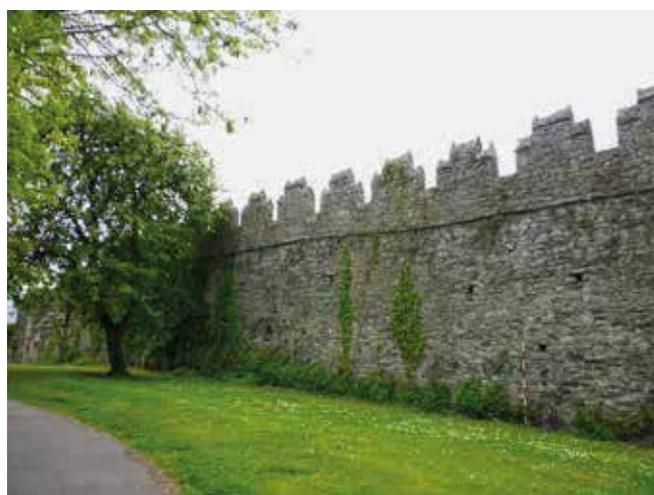
PLATE 47: North Curtain Wall

The section of North Wall at the North Tower in the north-east corner (2.3m high internally, but 4.8m high externally) also presents a significant lean outwards from the ward towards the Park, but it is likely that the returning east wall at the corner provides some restraint. This wall should be monitored for cracking and progressive movement.

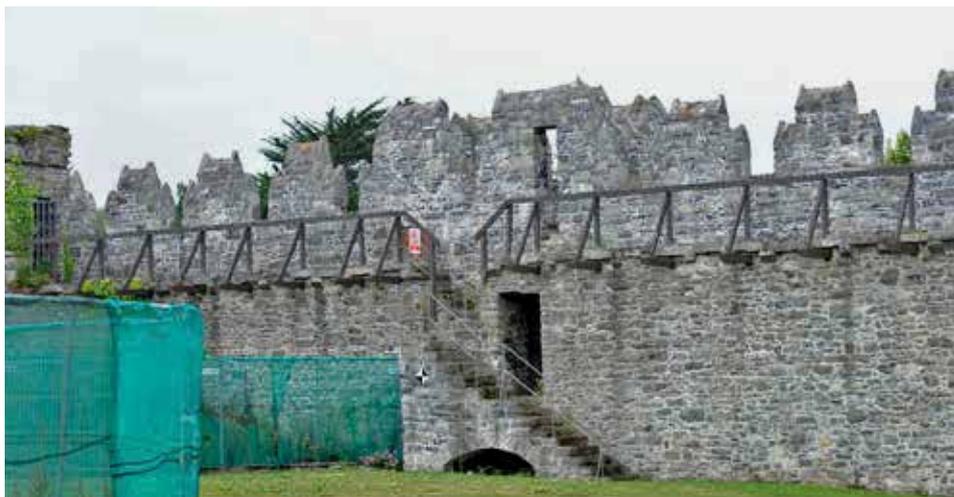
PLATE 48: *View to West Wall (interior)*

The West Wall is roughly 45m long and presents an overall height of about 6.3m externally. The main body of the wall is 3.7m high internally to the walkway and tapers slightly from 1.5m thickness at its base. The parapet is 1.1m high and 0.4m thick. This wall terminates at a small, renovated corner tower (perched on an attractive triple squinch arch) beside an adjoining public house to the south; it extends to a wall angle to the north, and includes a ruinous structure (West Tower). This section of Curtain Wall appears to have been consolidated in modern times: the jointing appears to have been re-pointed; the stepped merlons of the crenellated parapet have been made good; and the wall-walk is open to the general public.

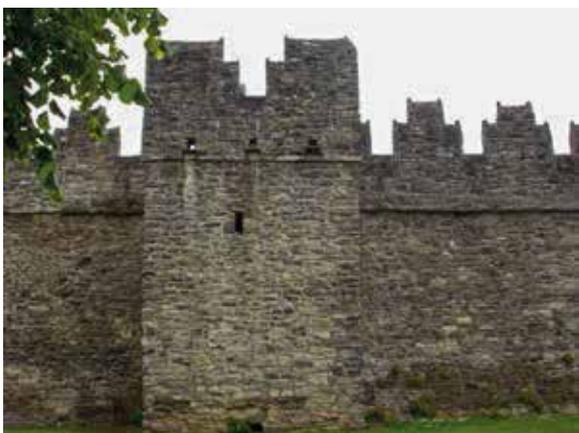
PLATE 49: *Mural Tower on West Wall*

1. A small Mural Tower approximately 10m north of the SW corner of the site, this tower is mostly exterior to the curtain wall. Access by stairs from the interior of the site is provided up to wall-walk level.

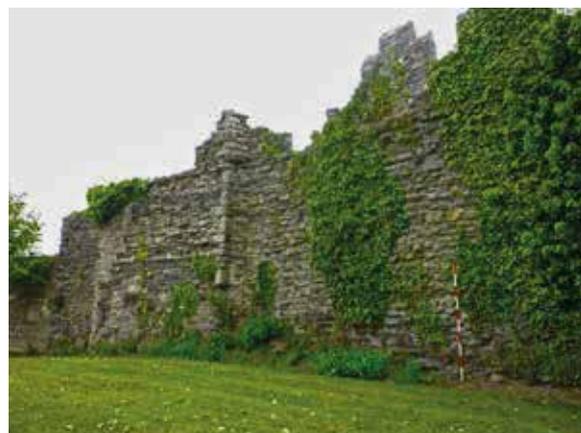
PLATE 50: *Mural Tower on North Wall*

2. The ruins of another Mural Tower are immediately adjacent to the NE corner of the site. The only remains now visible on the internal face are part of a stone vault at ground-floor level, with a curious rib at the point where it adjoins the north wall. This vault may have been the base of a building. On the exterior, there is a breakfront with cut stone quoins on the west corner and the scar of a gable, indicating a now-missing building to the north of this tower. The wall in the breakfront section is thinner than the curtain walls; the quoins suggest a date in the late 16th or 17th century for the alteration — perhaps the work of the Dutch settlers.

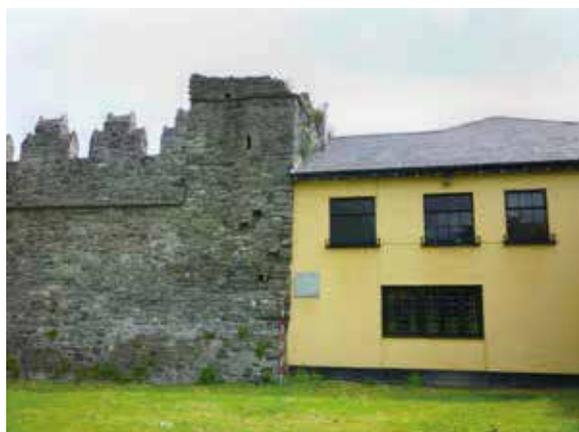
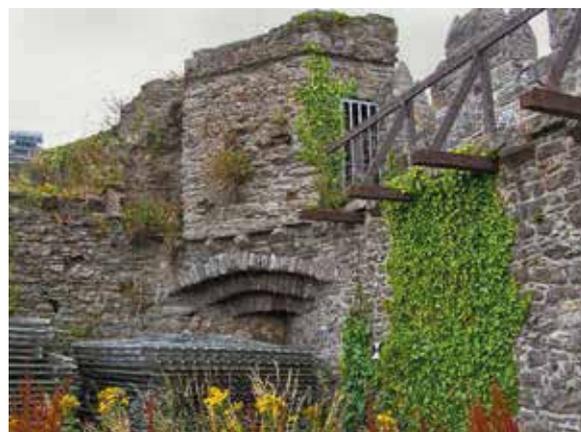
PLATES 51 AND 52: *Mural Tower at the south-west corner (external and internal view)*

3. The angle tower on the SW corner of the site is flush with the external face of the wall. It is supported on a series of three squinch arches (that span diagonally across the internal corner), while the wall-walk is carried through by two openings in the superstructure of the tower. An opening in the east face of this tower suggests the wall-walk continued on the south boundary.

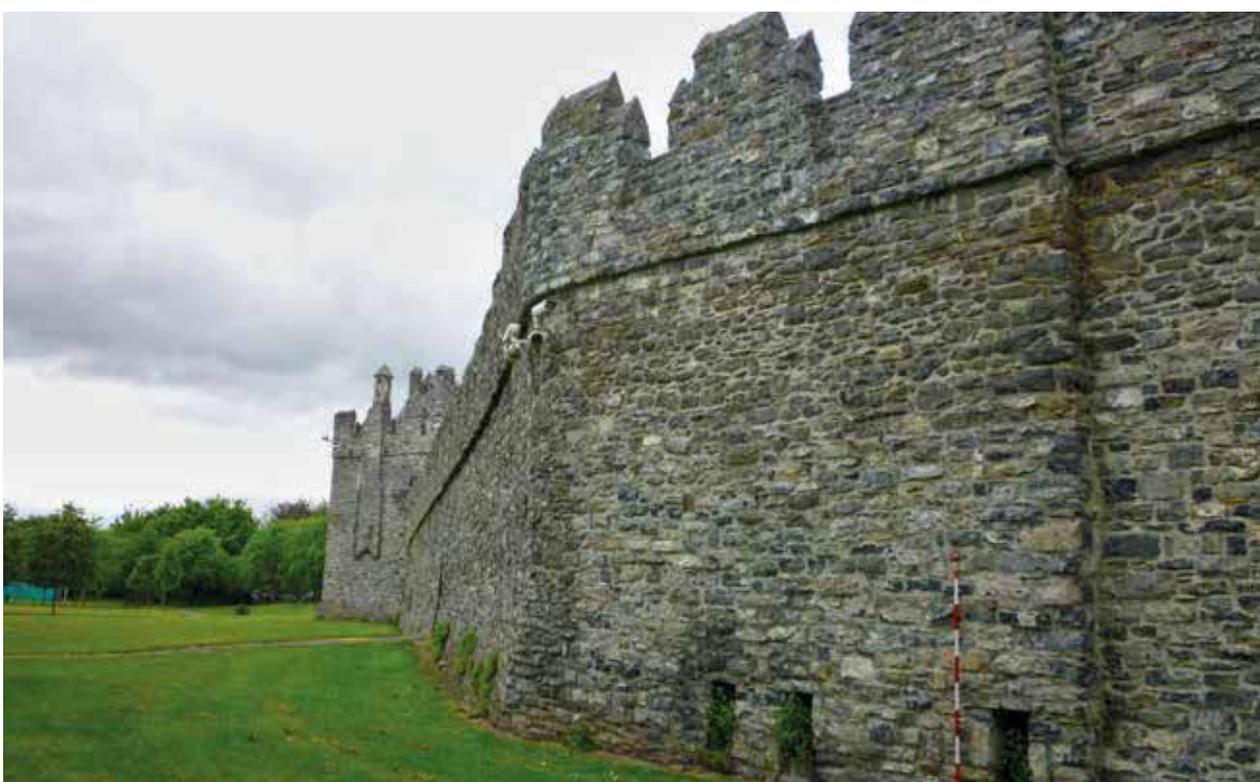
PLATE 53: *Garderobe Tower*

4. A Garderobe Tower located beside the junction of the west and north-west sections of Curtain Wall provided sanitary facilities for the castle. Its chutes exit through three points low on the exterior wall.

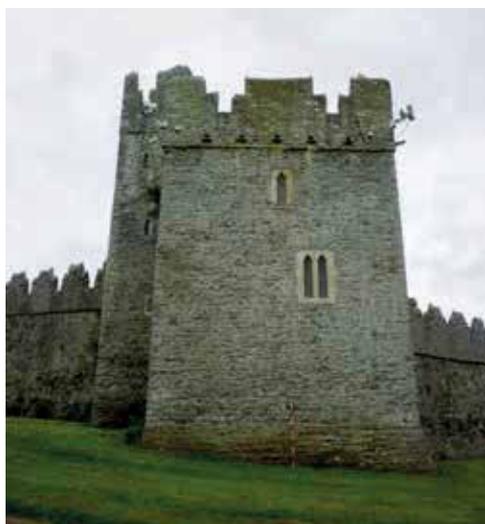
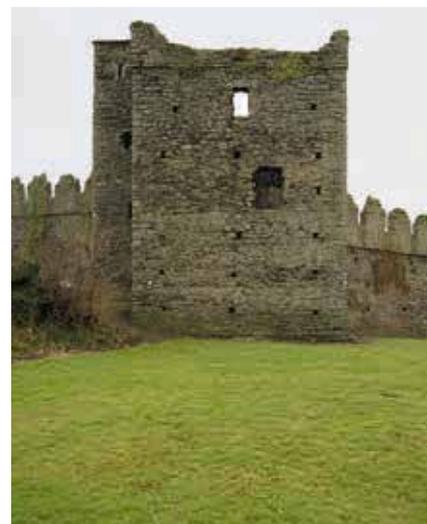
PLATES 54 AND 55: Constable's (North) Tower 2012 (L) and 1987 (R)

Constable's Tower has also been largely reconstructed during the current phase of works. There is a record of this tower as it was in 1986, recorded by Geoghegan *et al.* in a UCD study. The new work is largely as shown in proposed drawings made for Fingal County Council by Heritage International in 1996. The work includes the following:

1. Reconstructed upper parts of walls (mainly above string course) with wall-walk and crenellations
2. New timber trussed and slated roof
3. New intermediate timber beam and plank floors
4. New limestone surrounds to door and window openings in both grey Irish limestone and pale cream English limestone
5. New limestone chimneypieces
6. Repairs to stone stairs
7. New concrete ground floor
8. New lighting and electrical services
9. New cut limestone belfry atop the chimney on west façade

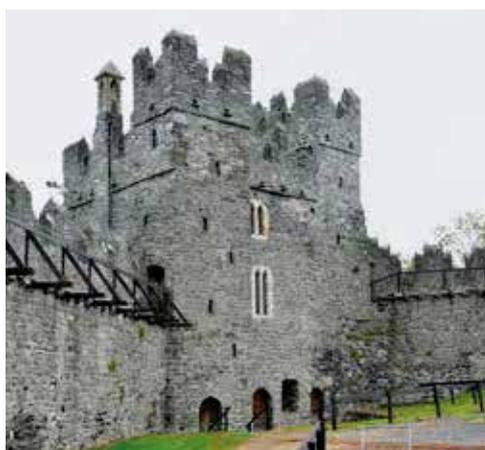
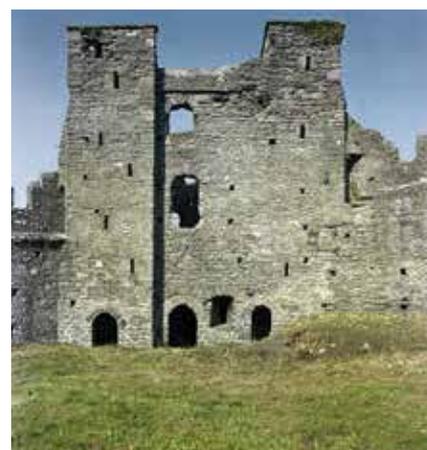
PLATES 56 AND 57: Constable's (North) Tower from south façade 2012 (L) and 1987 (R)

Constable's Tower is a three-storey structure that sits proud (projecting both internally and externally) of the wall, forming a bastion commanding the exterior space.

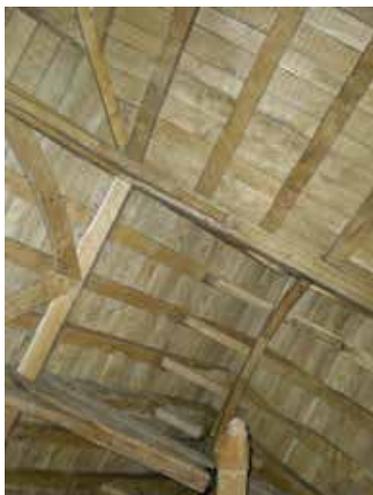
PLATE 58: *Constable's Tower interior, top floor. View of new roof trusses and boarding*

Constable's Tower is subdivided by vaulted 'cells' at ground floor and contains a large chamber with fireplace on both first and second-floor levels, with newly installed simple stone fireplaces. A subsidiary Garderobe block projects from the east façade, within which a Garderobe chute drops to discharge on the east side outside the walls. A large chimney on the west wall that is corbelled out c. 300mm from the wall is supported on a segmented arch located c. 3m over ground level. The first-floor chamber is lit by a two-light window on the north façade, while the upper chamber has two slit windows — one on the north and one on the east façade. The mural stairs and the Garderobe block are lit by several slit windows.
