SWORDS CASTLE **CONSERVATION PLAN**

Edited by Roberta Reeners

**Comhairle Contae
Fhine Gall**
Fingal County
Council

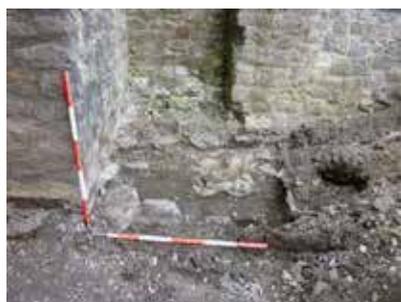
PLATE 62: 2011 investigation, west of the Knights and Squires Chamber, showing the terram layer of the 2001 investigation

The removal of overburden to the top level of the archaeology was carried out as an archaeological exercise (E. O'Sullivan, 2001) in the area in front of and to the west of the Knights and Squires Chamber. The top of the archaeological level was identified c. 0.3m-0.95m (sloping from east-to-west) below the ground level recorded at the time which comprised overburden. The excavation revealed evidence of wall footings, paths and ground surfaces. The ground surface uncovered comprised a rough, stony surface crossed with paths and drains. Finds include a fragment of medieval moulding and occasional mortar bonding and a mixture of medieval and post-medieval pottery. Fragments of decorated tiles similar to those identified in the Archbishop's Apartments were also found. It is suggested that this area may have been used as a yard. The date of this ground surface is uncertain; however, owing to the presence of the architectural fragment, it would appear that the surface post-dates the original usage of the castle building.

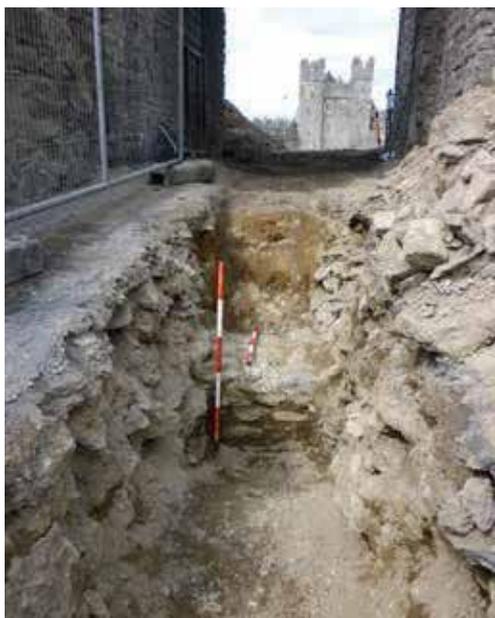
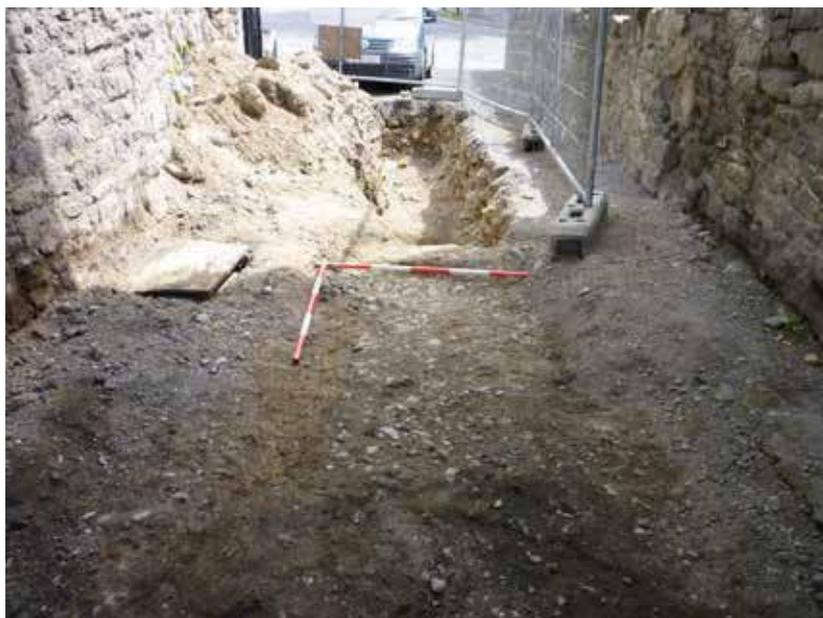
PLATES 63 AND 64: *The investigations under the Gatehouse, 2011*

In 2011, archaeological monitoring under Ministerial Consent took place of a trench excavated for the purpose of laying a cable during the course of stabilisation works. These investigations took place beneath the gateway arch and along the entrance ramp and revealed a wall c. 0.8m wide, which ran east-west across the front of the gateway entrance. The width of the wall suggests a medieval date. Parallel to this wall, a further two considerably narrower walls parallel to the larger wall were identified close to the entrance at the street. The function of these walls is unknown and should be subject to further examination.

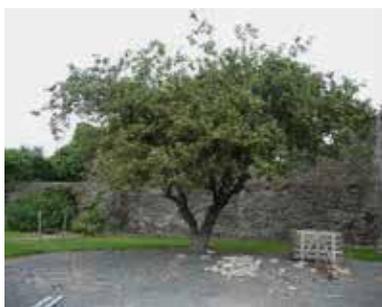
PLATE 66: *Apple tree*

The few surviving apple trees growing at present in the east side of the enclosure date from the 19th to the early 20th century and are the remnants of the orchard planted by the Cobbe family. The largest of these is an old Bramley that is probably the oldest survivor. It and several other veteran fruit trees, all on the raised ground level, are relics of the old orchard and should be preserved, if possible.

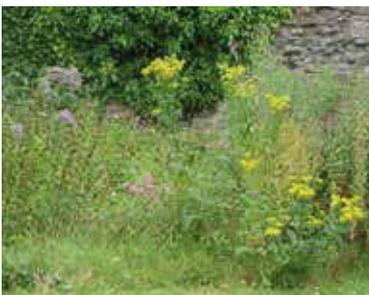
PLATE 71: *Ivy, buddleia and ragwort*

Highly undesirable woody species such as bramble, common ivy, buddleia, perennial nettle, wall valerian, ragwort and feral snapdragon were also seen in the crumbling sections and in the scrub layer at ground level. These pernicious species should be removed as wall repairs progress and the ground area of the remnant orchard is cleaned.

Action 7.3.3 Removal of rampant vegetation (ivy and buddleia) is urgently required to prevent structural damage. The removal of invasive roots needs great care and may also require localised remedial consolidation.

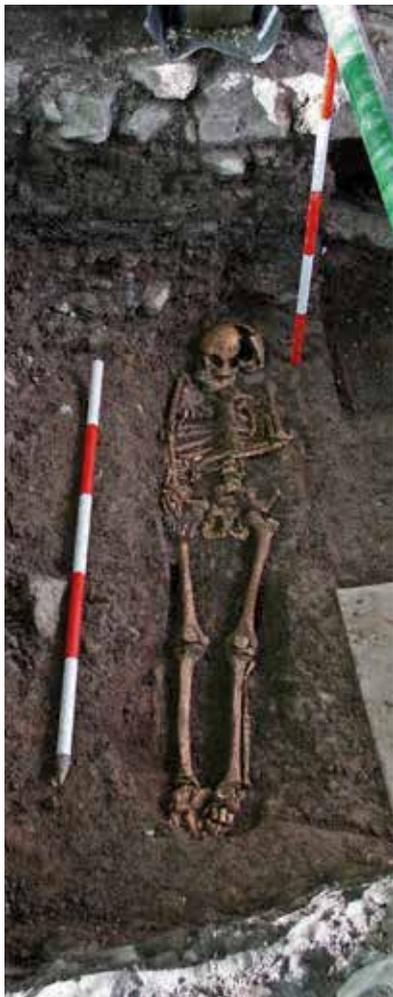
PLATE 74: One of a number of burials recently identified under the arch of the Gatehouse at Swords Castle during stabilisation works

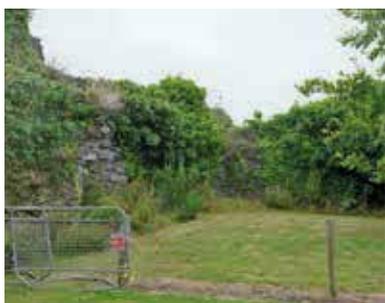
PLATE 81: View to north-east corner of the castle and possible access location

This eastern section of wall could provide evidence of these changes but it is choked in ivy and scrub. Under supervision, it would have to be cleared of the rampant vegetation in order that an assessment could be made, and to clarify the nature, extent and exact location of the breach (if there at all). If at all possible, the re-use of an existing (albeit blocked-up) breach would be preferable to creating a new opening.
