**Report on Archaeological Monitoring at the Ward River Valley,
Swords, Co. Dublin**

Fingal County Council

21E0630

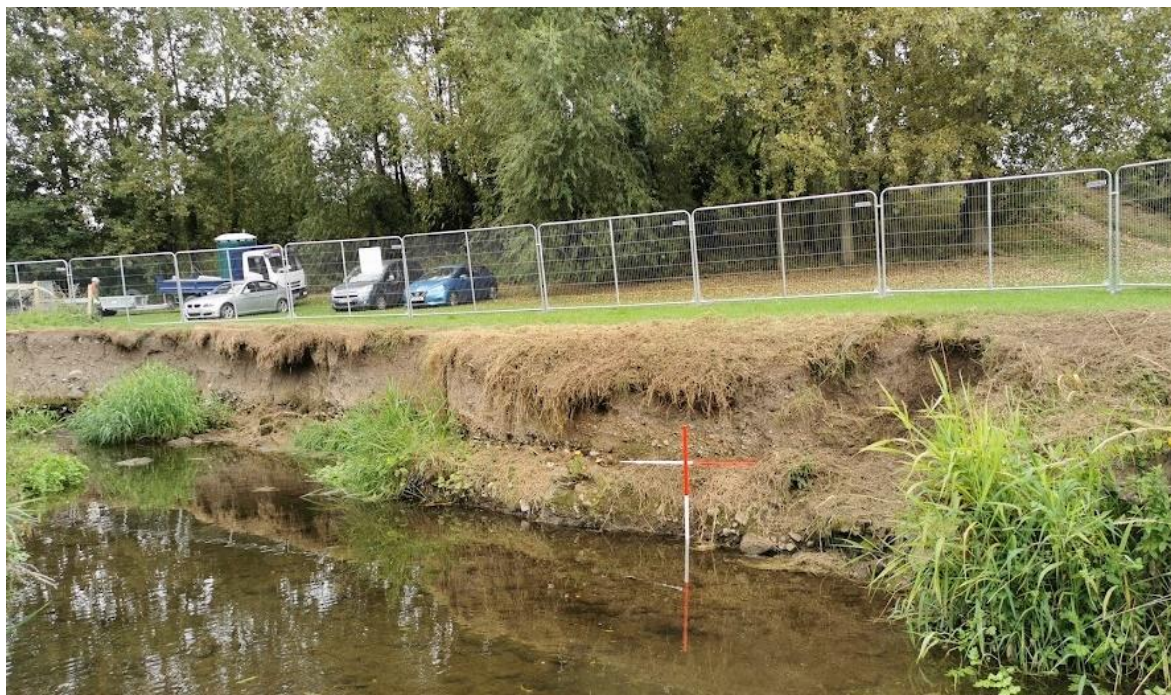
Plate 1: View looking east at the southern bank of the river; Heras fencing now positioned on the bank

Works began on the 13/09/2021. The main Contractor was Integrated Utility Services Ltd. Heras fencing was installed to create a working space separate from the general public. A wade survey and photographic record of the riverbank were carried out with the assistance of personnel from Integrated Utility Services. No material relating to the burial site was noted within the river, which was relatively shallow with approximately 30 – 40cms depth on average along its length, though it deepened at the location of the previously exposed burials. See Survey Report below for a full record.

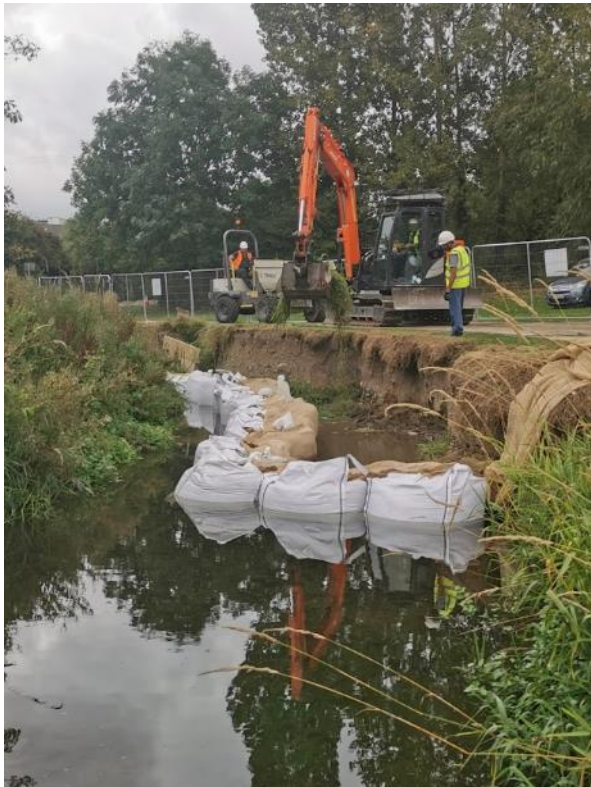
Plate 2: View looking east at sandbags and cleaning of the riverbed

The following day (14/09/2021) bog mats were laid on the surface within the fenced area in order to allow machinery to track across the grass. Then a series of one tonne sandbags were placed in the river in a line parallel to the bank but 2m out from it. This formed a bund to contain the working space and prevent undue contamination of the river.

The next stage (15/09/2021) was to clean the riverbed along the base of the bank in order to have a stable surface on which to place the boulders. A claw bucket was used to lift vegetation, but no further disturbance of stones or river silts occurred as this was deemed unnecessary.

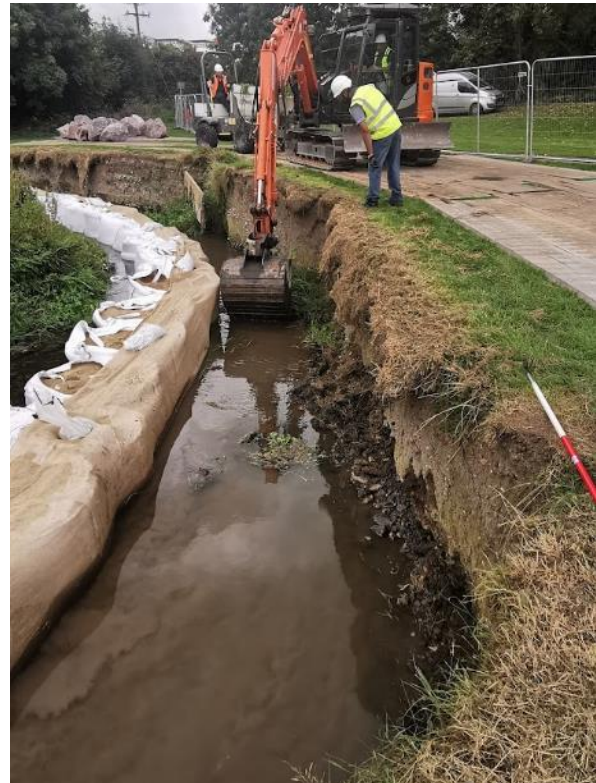
Plate 3: View looking east at cleaning operations, note bog mats on the surface.

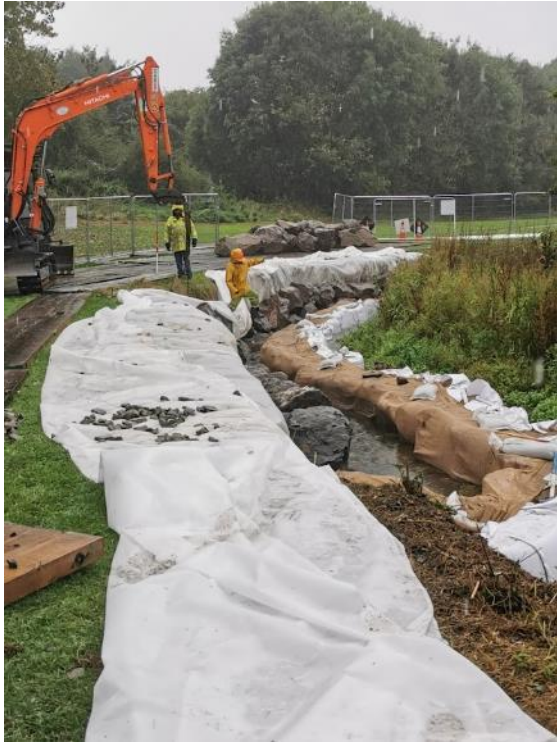
Plate 4: View looking west at the placement of boulders against the bank, protected by geotextile

On Thursday 16/09/2021 deliveries of large boulders were made to the site, and these began to be deposited in the river on Friday, 17/09/2021. The riverbank was firstly protected with geotextile and then the boulders put in position.

Depending on the depth of the bank, which varied somewhat over its length, and the size of the boulders, two to four courses of boulders were required. The spaces behind the boulders were infilled with smaller stone to minimise the effect of scour during flooding episodes.

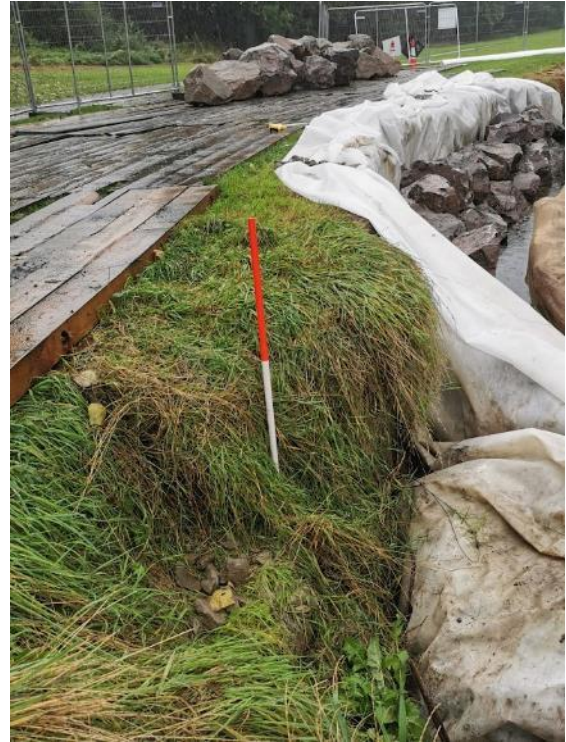
Plate 5: Looking west, general location of exposed skeletal remains marked by ranging rod

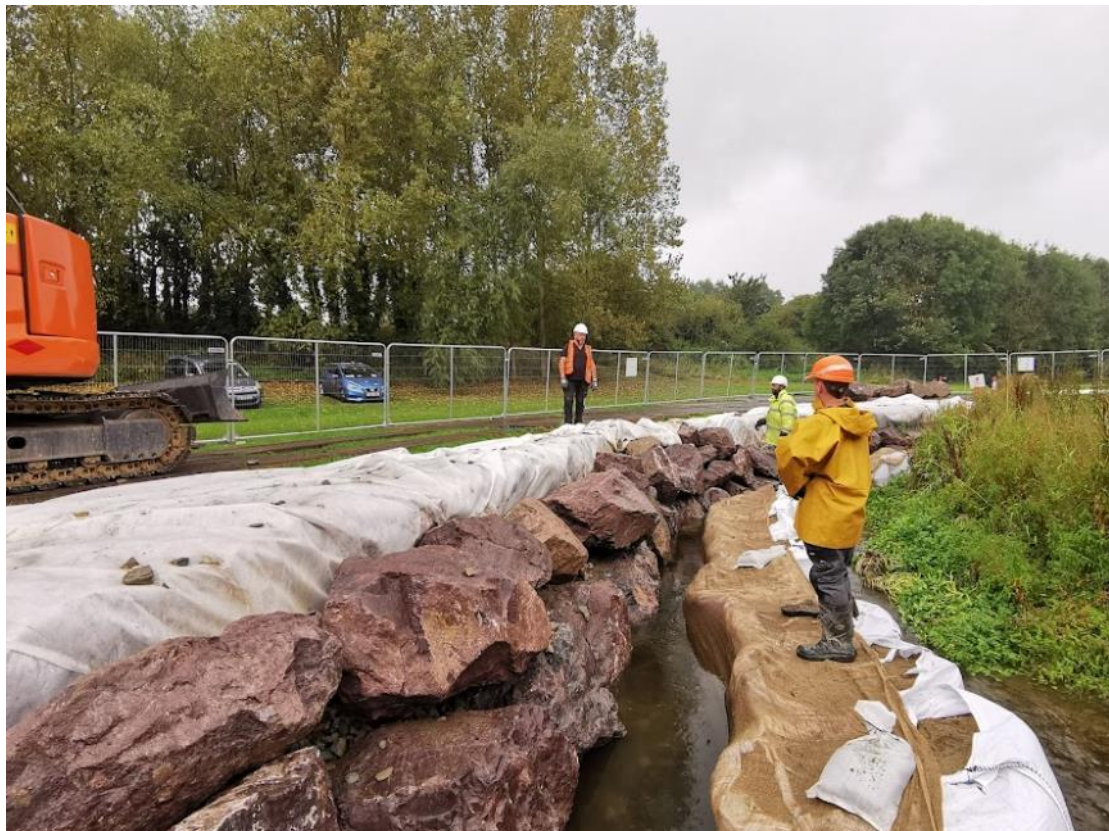
Plate 6: View looking west at the boulders in position.

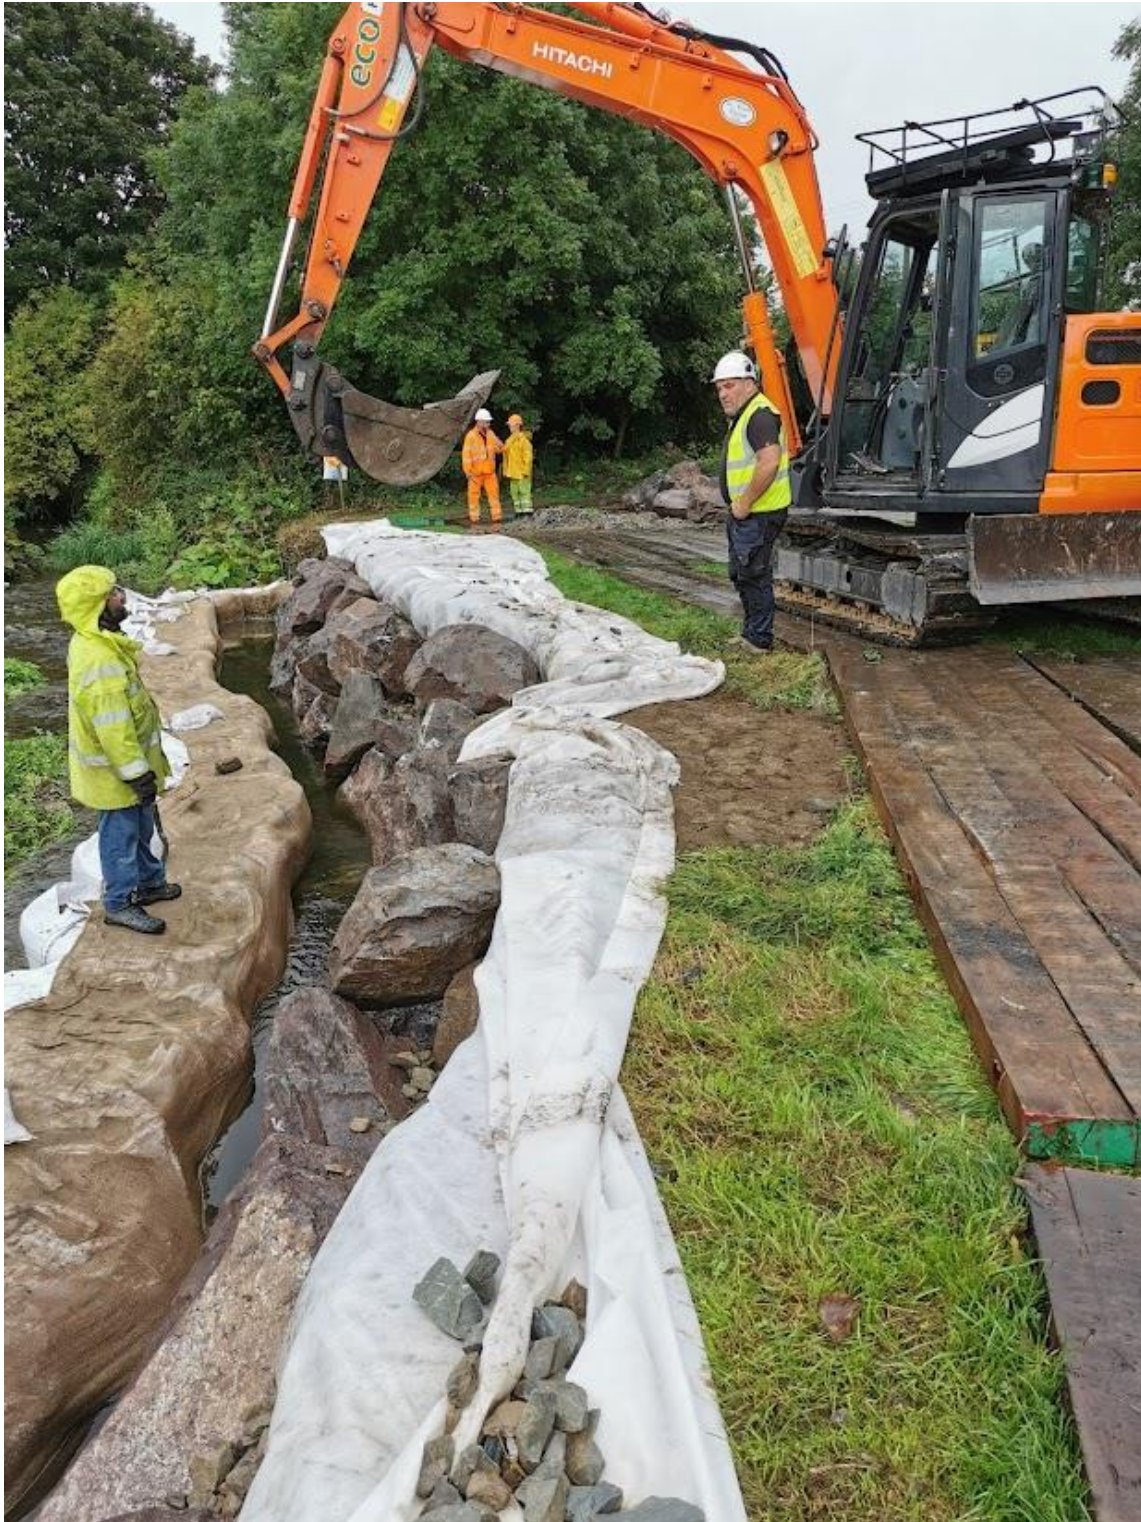
Plate 7: The area of the exposed burials has been infilled by soil and protected by rock armour

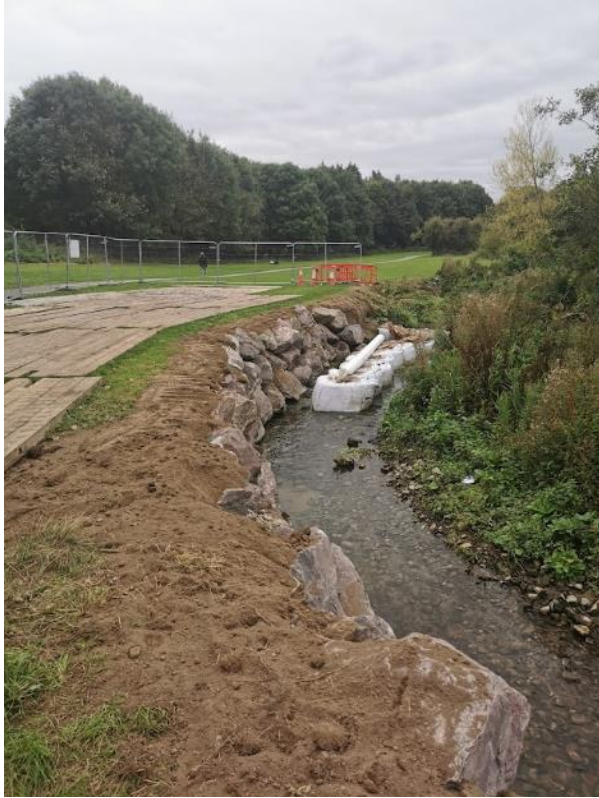
Plate 8: Looking west at soil capping of boulders, the sandbags are being removed

The following Monday, 20/09/2021, smaller stones and soil having been used to infill the boulders the geotextile was cut back, and the boulders capped by topsoil. The sandbags were lifted from the riverbed prior to the final reinstatement.

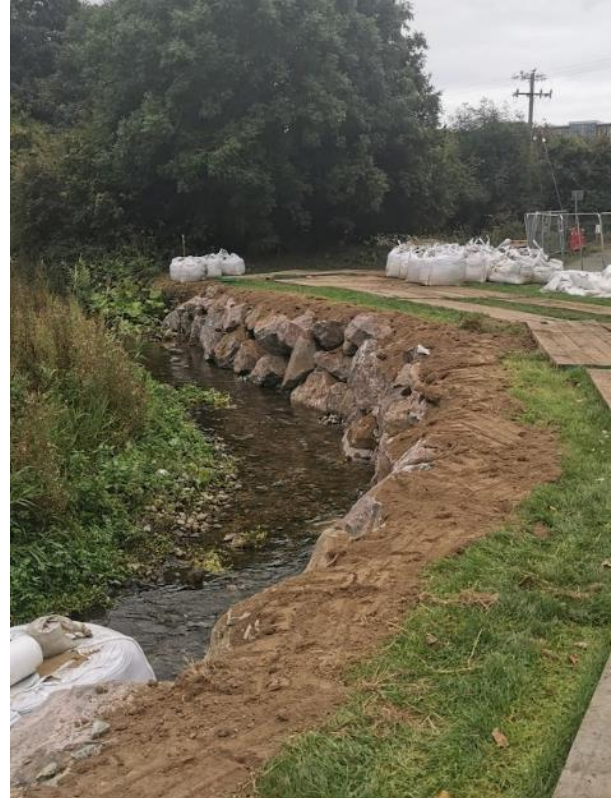
Plate 9: Looking east with the re-buried skeletal remains in the middle of the photograph

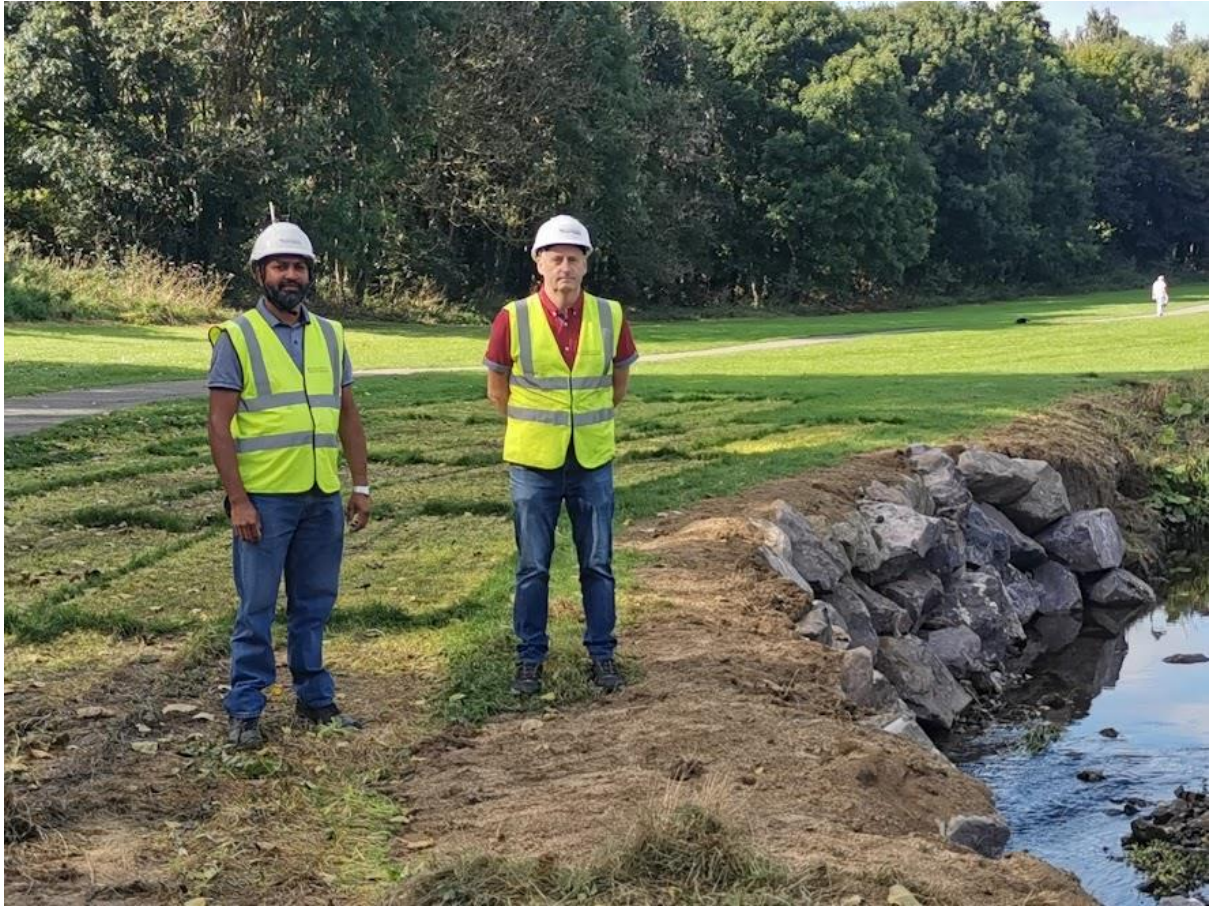
Plate 10: Removal of bog mats after completion of all the reinstatement measures

Work was fully completed on Wednesday 22/09/2021. The fencing and bog mats were removed, and the boulders fully bedded into the riverbank.

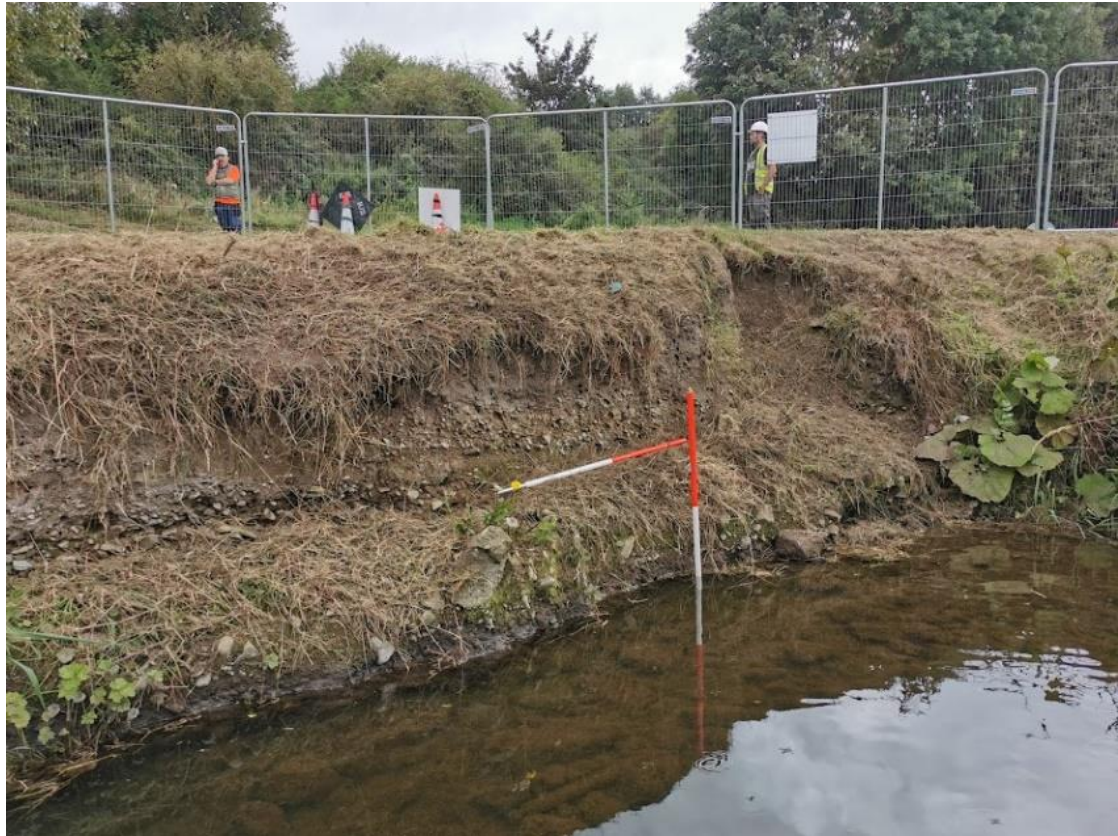
Plate 11: View looking west showing ledge formed by lower cobbles

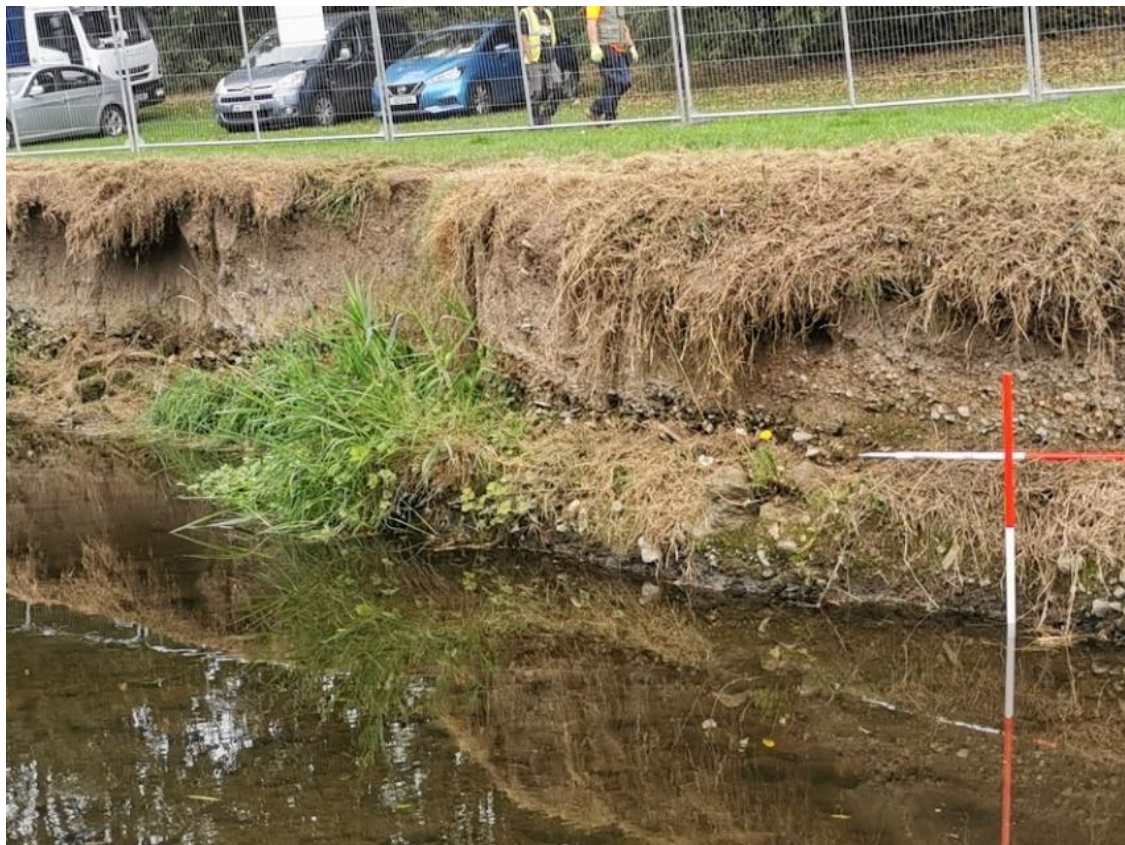
Plate 12: Continuation of bank running to east showing decrease in upper stony fill

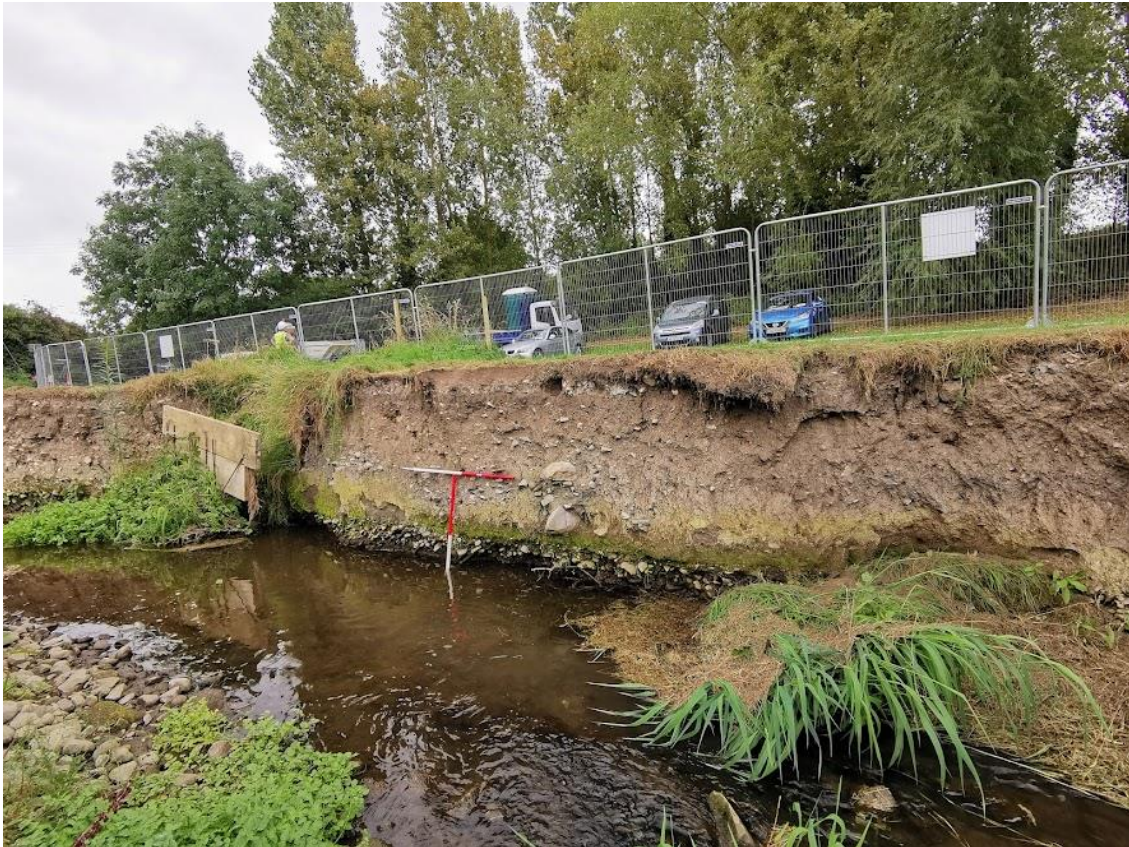
Overlying this is a deposit characterised by both as a midden deposit and recorded as being between 0.10 – 0.15m deep (McCormick) and 0.17 – 0.21m deep (Brady). It is described as a blackish brown or greyish brown (humic) silt with frequent stones, shell, and animal bone. This deposit is apparent along the length of the bank, though not so clearly visible at the western end. It also seems to rise and fall somewhat in level, (see Plate 13).

Plate 13: Looking west showing location of burials behind boards; grey buried sod layer is visible near top

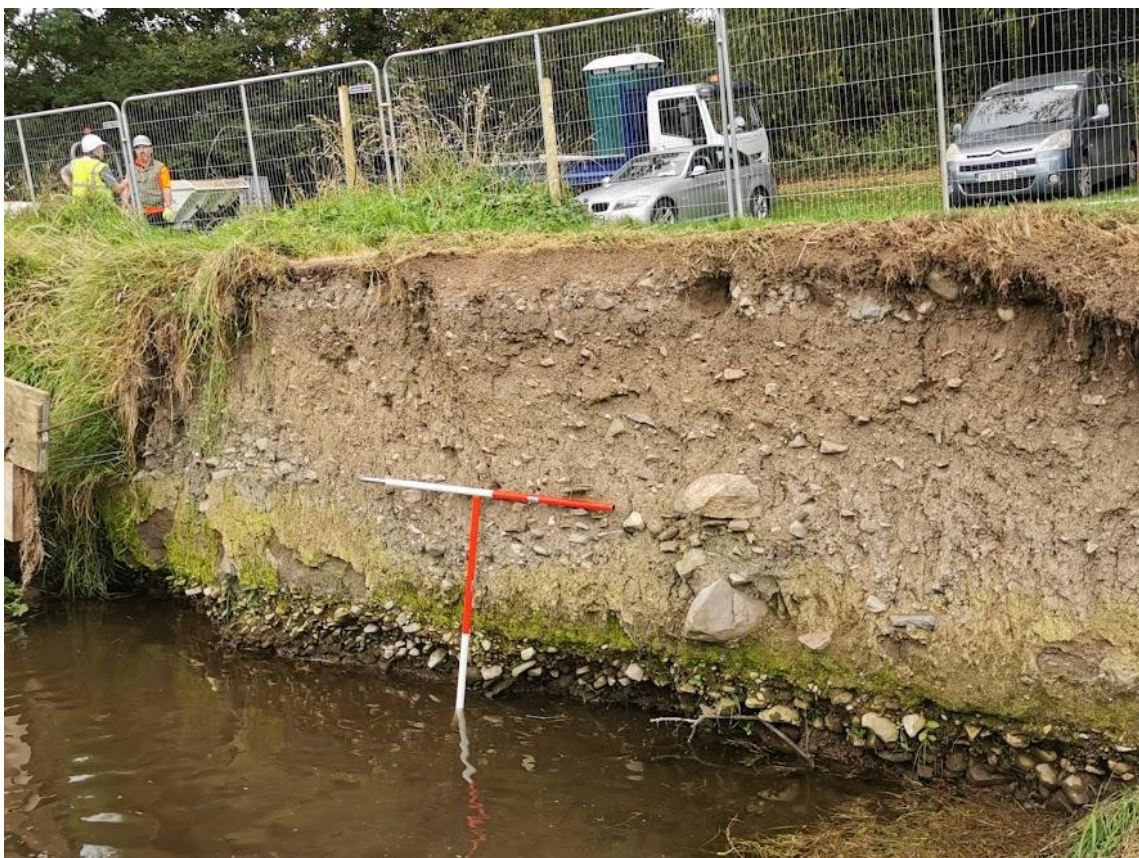
Plate 14: Note the dip in the level of the grey stony midden layer beneath the horizontal ranging rod

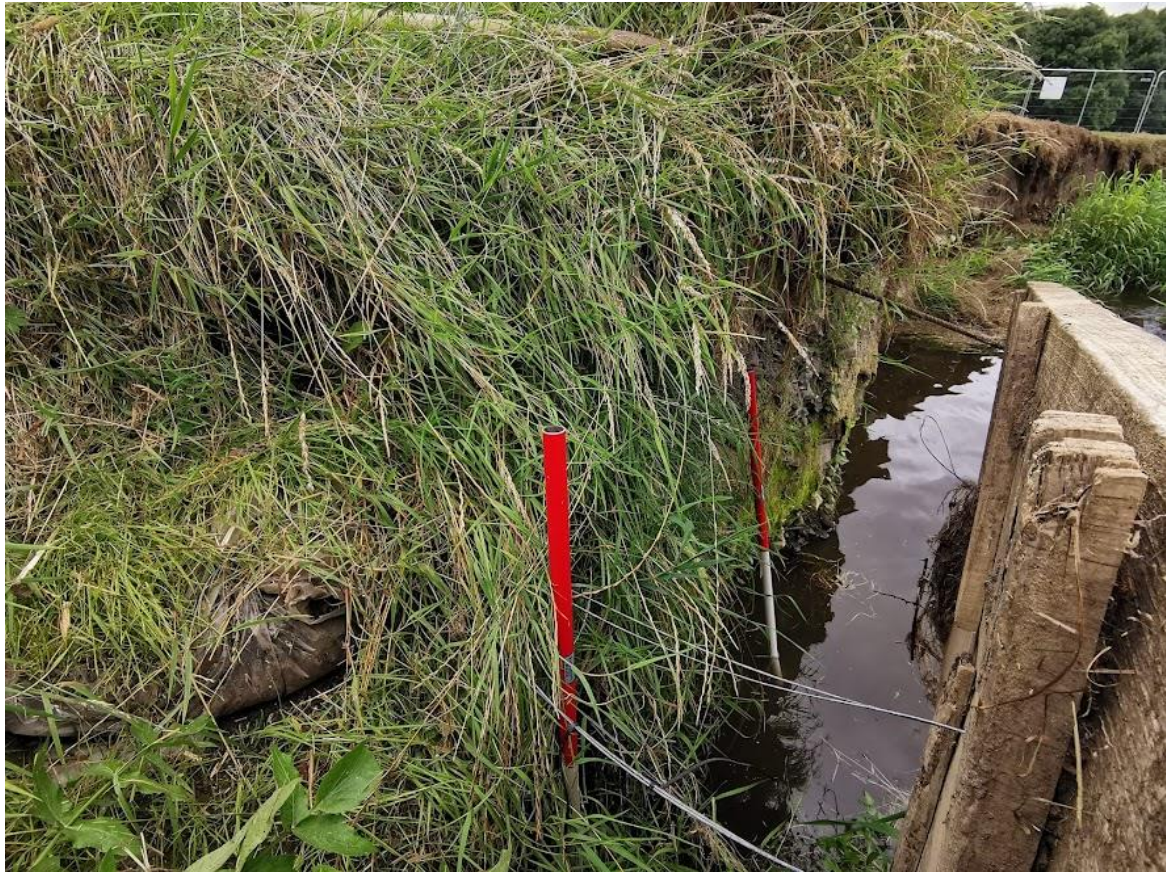
Plate 15: position of the covered up skeletal remains relative to the riverbank, looking west

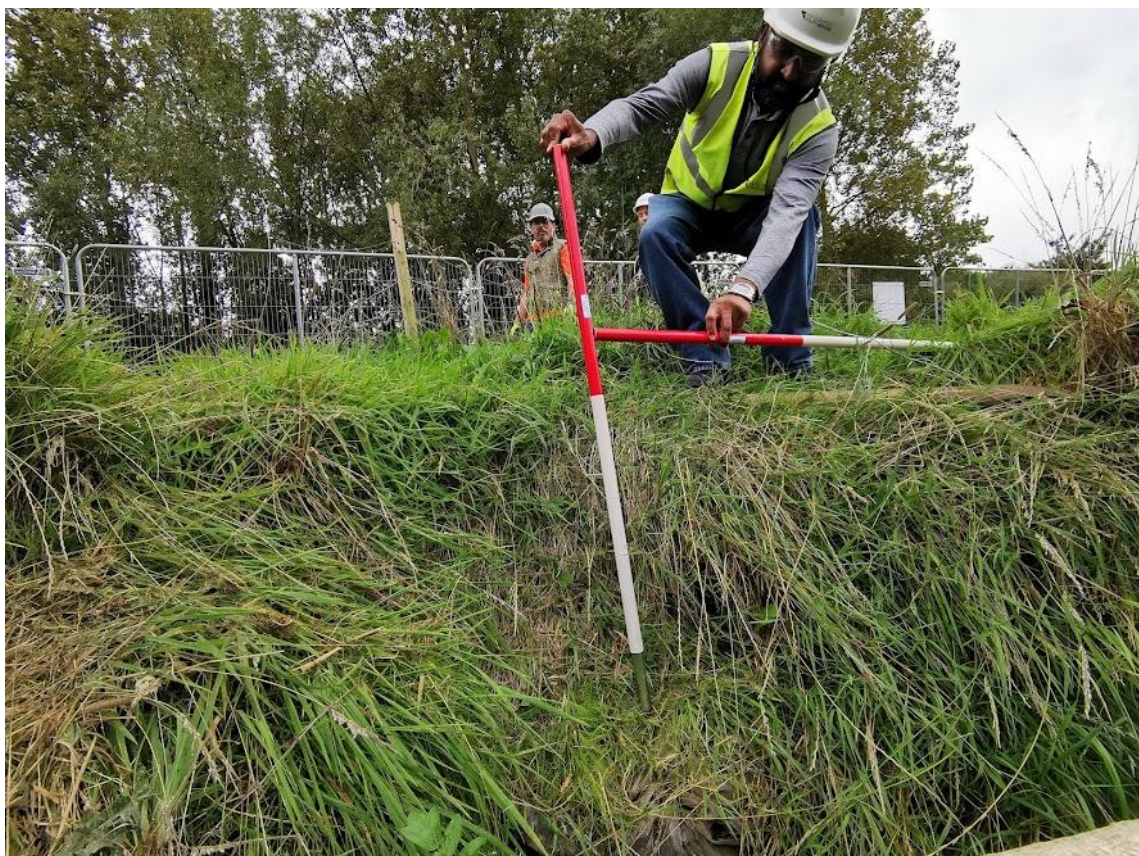
Plate 16: Indication of the depth of the skeletal remains below the modern surface

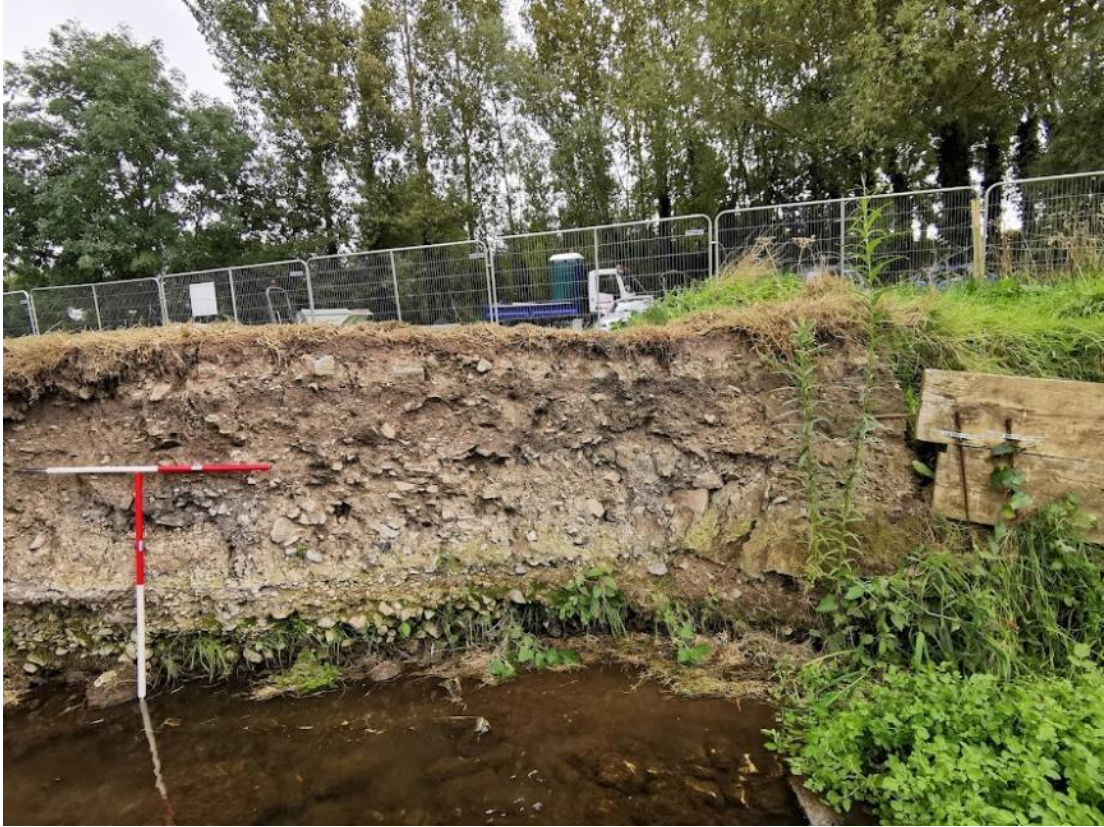
Plate 17: Riverbank between two areas of previous excavation, note the dip in the middle deposit at the ranging rod. Note grey buried sod near the top of the bank also, with modern material overlying it

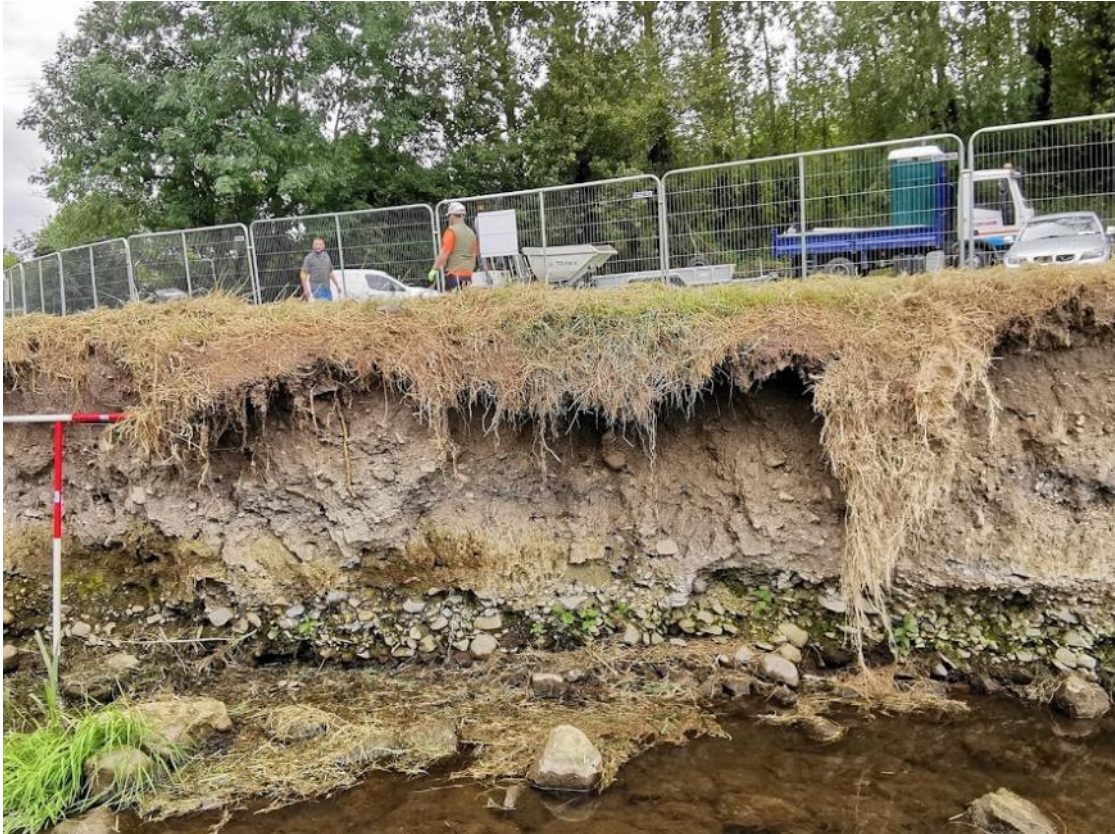
Plate 18: Note the area about 2m right of the ranging rod and the grey sloping midden deposit on the far right, this may represent the site of the 1999 excavations

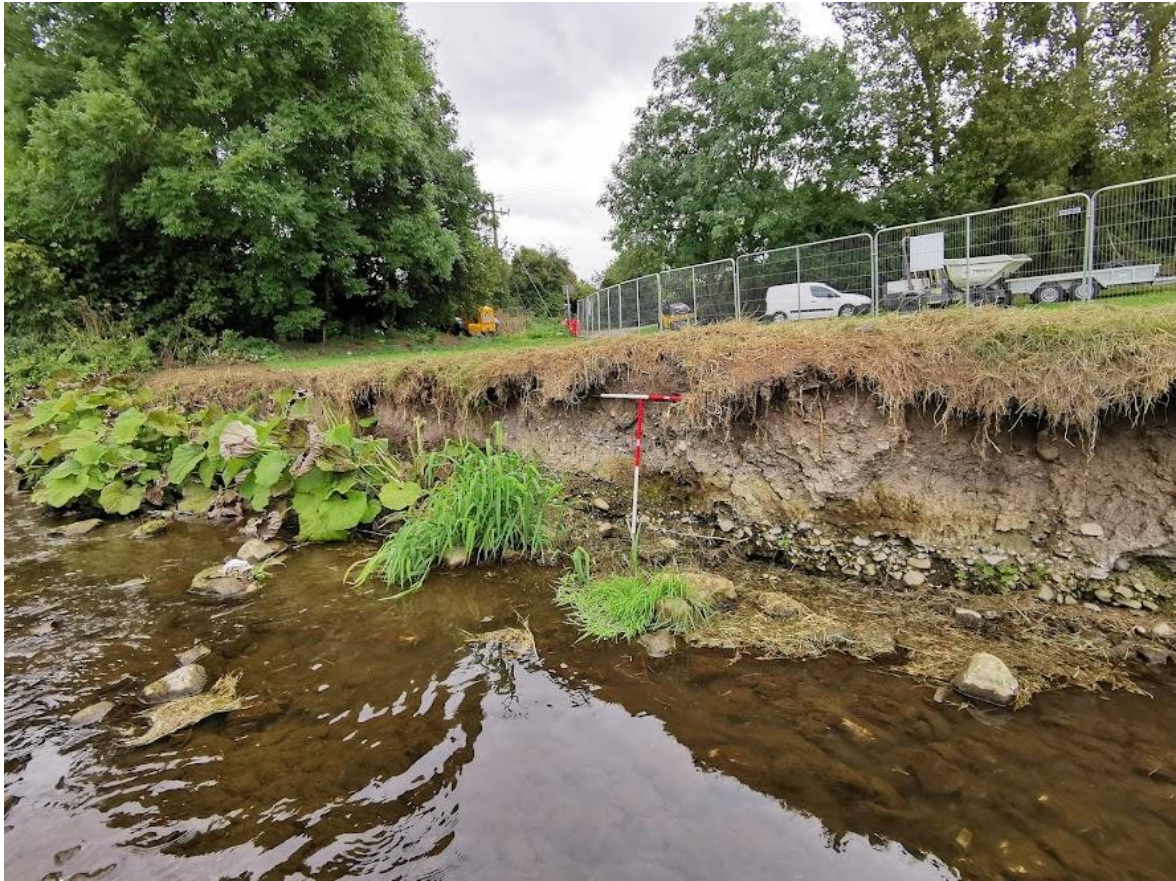
Plate 19: the east end of the section to be rock armoured, prior to the removal of vegetation. The bank appears to be decreasing marginally in height

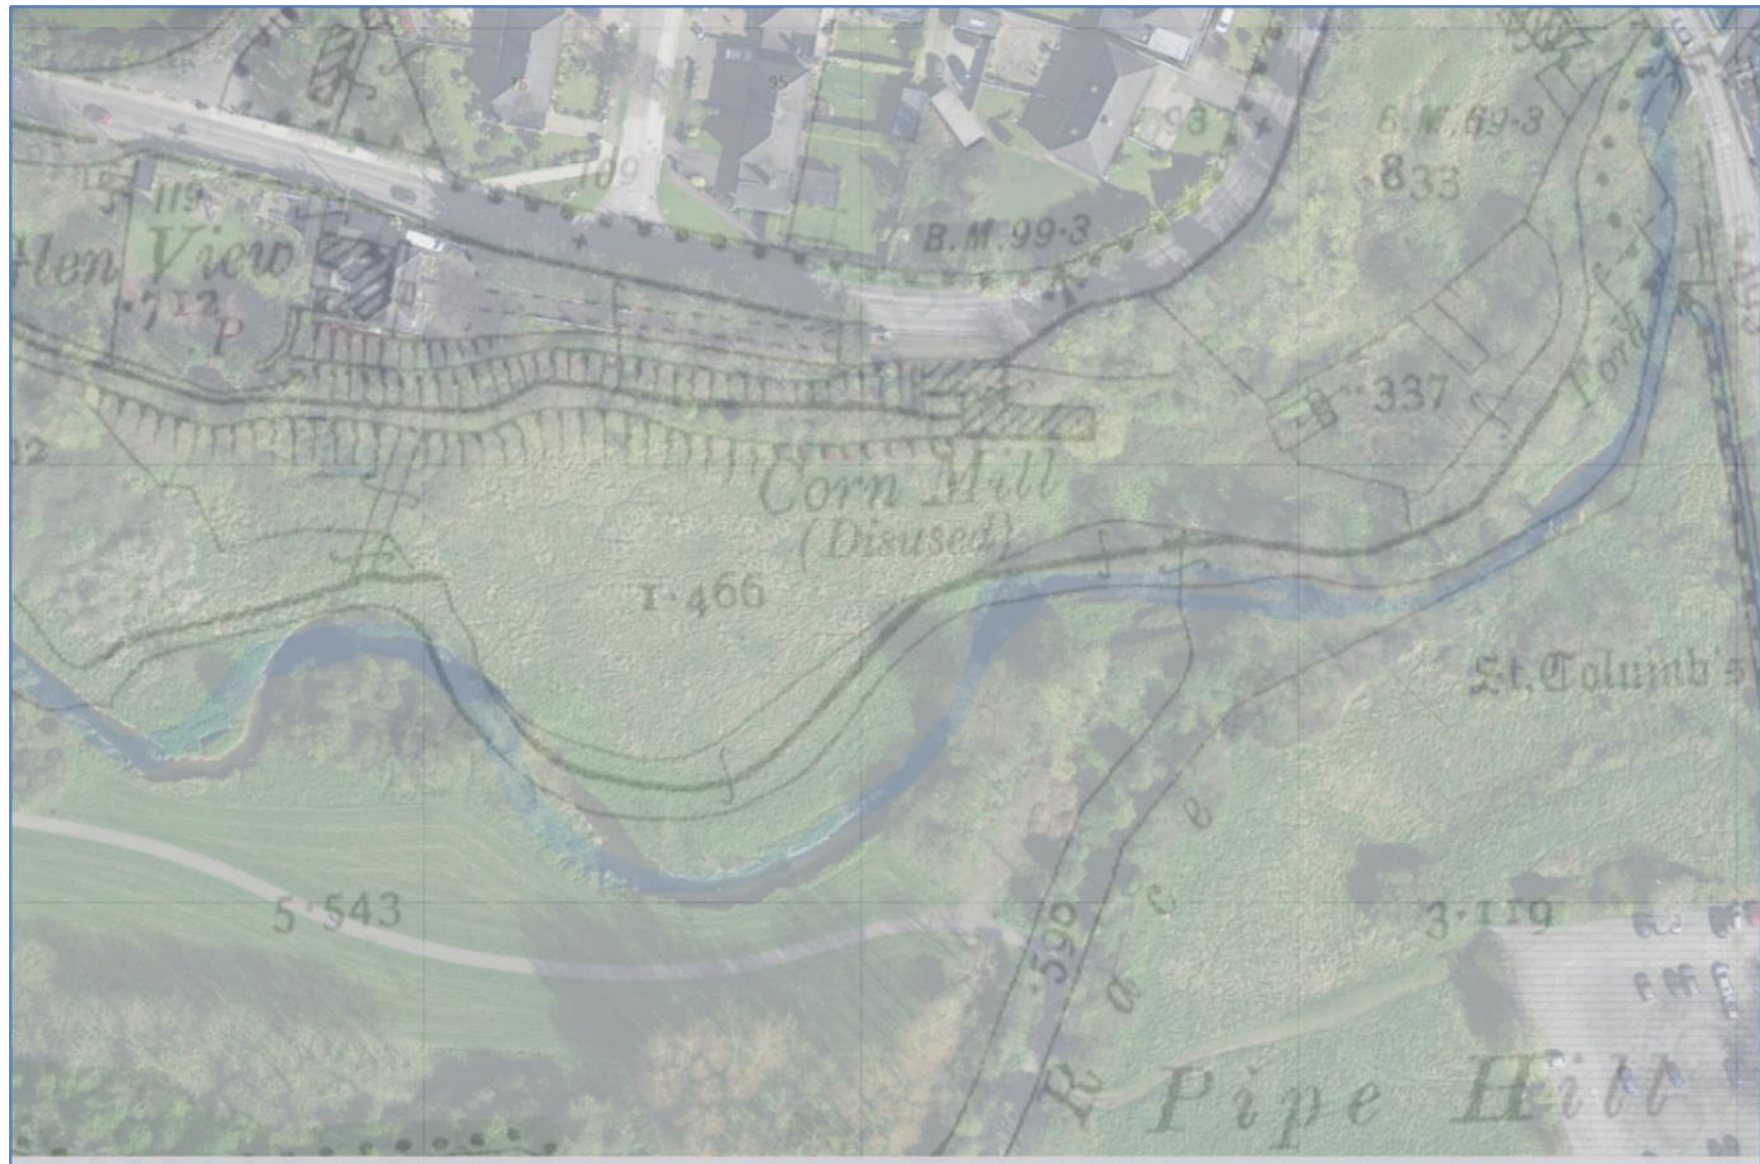
occupation debris may fit with the idea of nearby occupation but it is not necessarily the case that this area flooded regularly in the past. There has been significant alteration of the ground through the presence of mills and mill races which may have impacted the natural floodplain, most likely predominantly to the north of the river. In fact a simple exercise of overlaying the 1st Edition OS maps of the area onto the modern maps, and onto recent aerial imagery shows the southward tracking of the river in the past 180 years (Figs. 2 – 4).

Fig. 4: Overlay of the Historic 25" map and the modern Geohive map onto the aerial premium image. River mapped in blue on the modern map.
