CONSERVATION MANAGEMENT PLAN

ST FINTAN'S **CHURCH**,
CARRICKBRACK ROAD,
SUTTON, DUBLIN 13

ON BEHALF OF
FINGAL COUNTY COUNCIL

FEBRUARY 2025

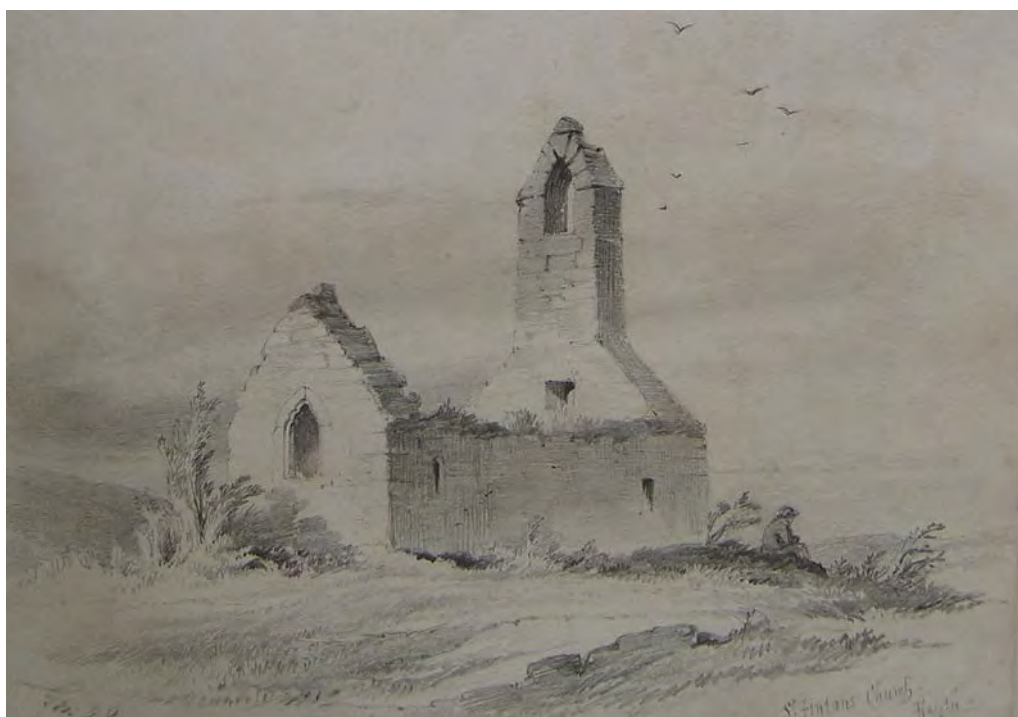
FIGURE 6: Watercolour view of St Fintan's church from the east¹⁶

Du Noyer's depictions show the church as it appears today in most particulars. The cinquefoil eastern window, the round headed and flat headed small windows in the southern wall, the bellcote with circular ope above the door and the pointed arch doorway are all depicted in detail. The northern side of the door arch is missing one or more voussoirs from the apex. The eastern window, has not yet been blocked up. The surroundings are shown as untended with low bushes or saplings growing around. The suggestion of a low bank skirting the northern side of the church may be seen in the sketch of the west gable. A clump of vegetation is depicted growing at the southeast corner of the church with a sapling emerging from the scrub. This sapling may well be the young deciduous tree depicted in this location by Edward McFarland in 1853 (Figure 8). McFarland's painting, while lacking the clarity and detail of Du Noyer's images, conveys a sense of the setting and depicts the church as a well-kept structure with a small amount of grass and weed growth on the wall tops. A large, ostentatious memorial dominates the foreground and this can be identified with the Jackson Pedestal Tomb that is still extant, though now surrounded by an iron-railed enclosure. The presence of the Jackson tomb presents a slight problem of chronology as Joseph Devonsher Jackson did not die until 1857,¹⁸ four years after the apparent date of McFarland's painting. The remainder of the graves are marked with rough stones reminiscent of the upright stones still extant to the east and south of the church.

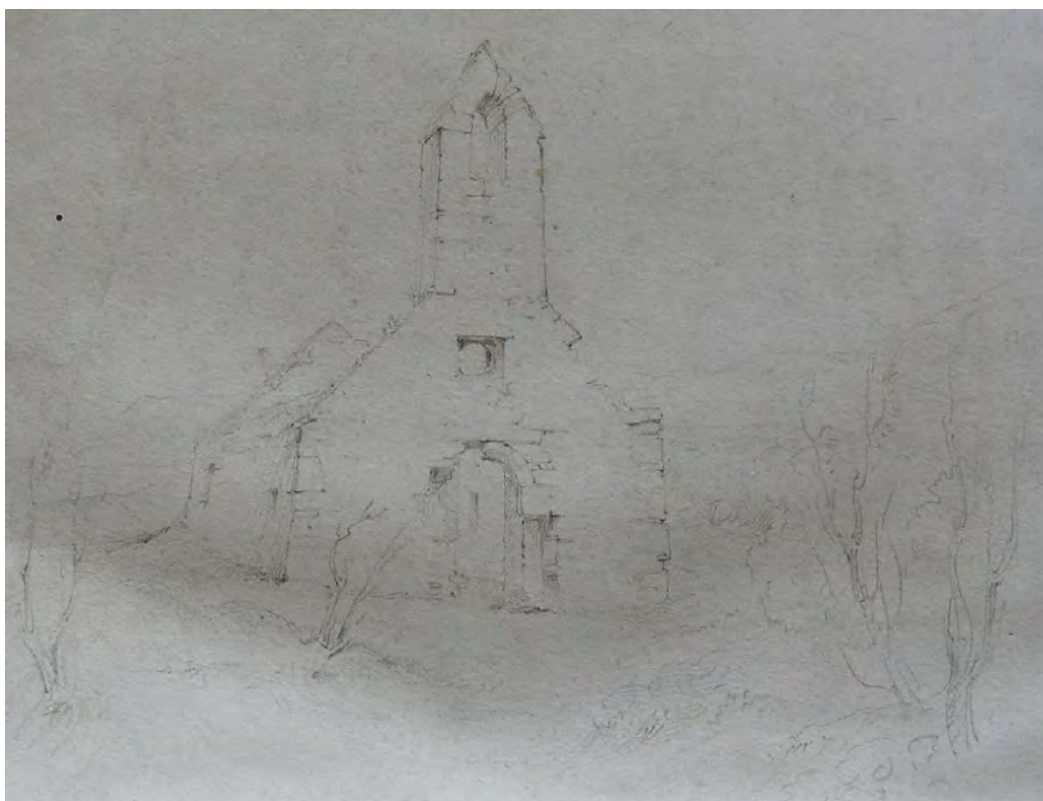
FIGURE 7: Sketch of western gable, St Fintan's church c. 1841¹⁷

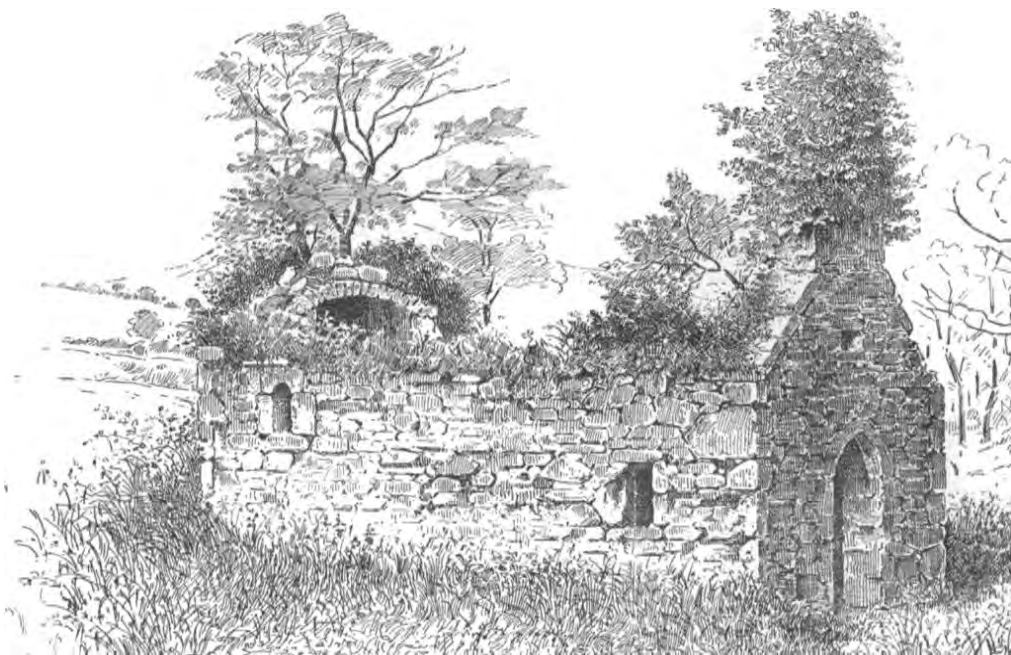
FIGURE 10: North-west view of St Fintan's Church, Howth, drawn by J. M. Kavanagh²³

That Cochrane is describing the building as it appears today is clear from his descriptions and plans and is further reinforced by the accompanying line drawing which shows the northern wall prior to the erection of the Bellingham enclosure (Figure 10). The large tree at the southwestern corner is still standing and a heavy growth of ivy covers the bellcote. A photograph of the inside of the infilled eastern window clearly shows the same stone infill that currently survives.

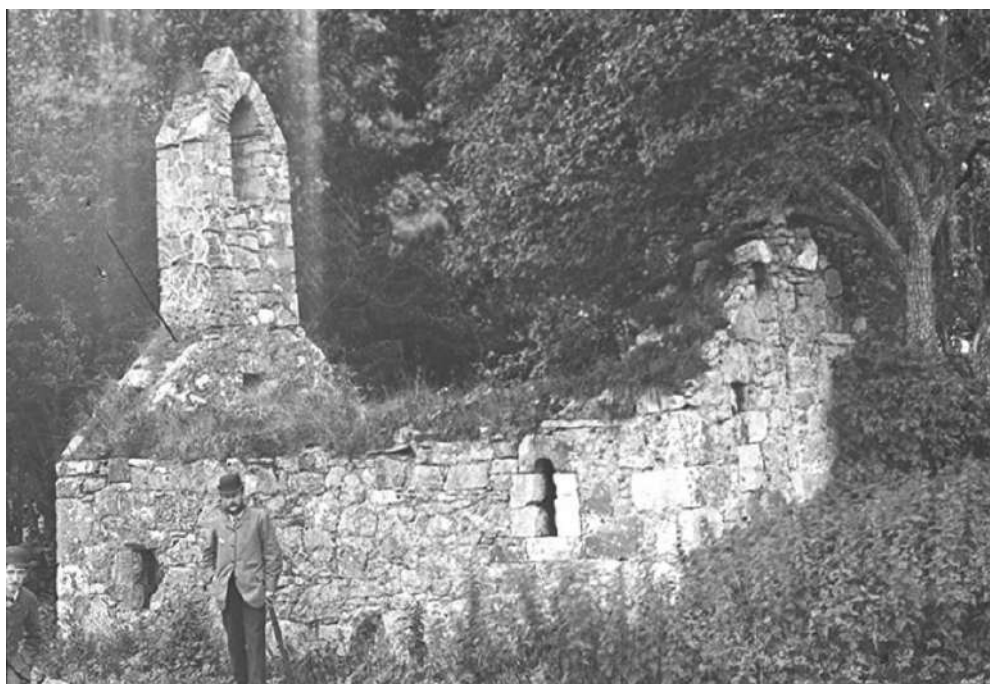
PLATE 2: Lantern slide showing the northern wall of St Fintan's Church c. 1890s²⁷.

A lantern slide from about this time survives in the collections of the Royal Society of Antiquaries of Ireland which shows the northern wall of the church (reversed; Plate 2) with grass growing from the wall tops and the large tree in leaf (this looks to be either an oak or a beech). A tall stand of nettles partially obscures the eastern gable where two putlog holes are visible, as per Westropp's sketch.

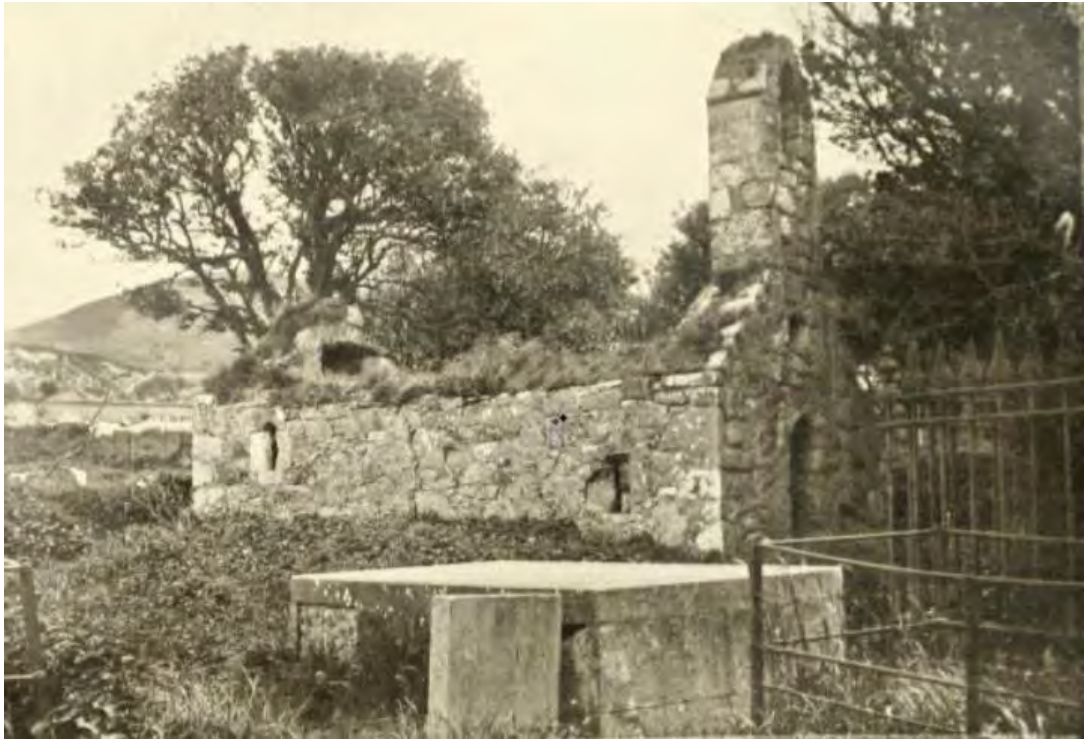
PLATE 3: St Fintan's Church, facing south by T.F. Geoghegan c. 1917 (in Ball, p. 15)

Ball's entry is accompanied by a photograph of roughly the same date showing the grass topped walls, the mature tree and the encroaching nettles and briar (Plate 3). This is the first depiction of the church within which a large crack running from the top to the base of the northern wall can be seen about halfway along its length. In the foreground, a fresh looking upright gravestone, a chest tomb and two iron railed enclosures are visible. This is the earliest photographic record of memorials on the site.

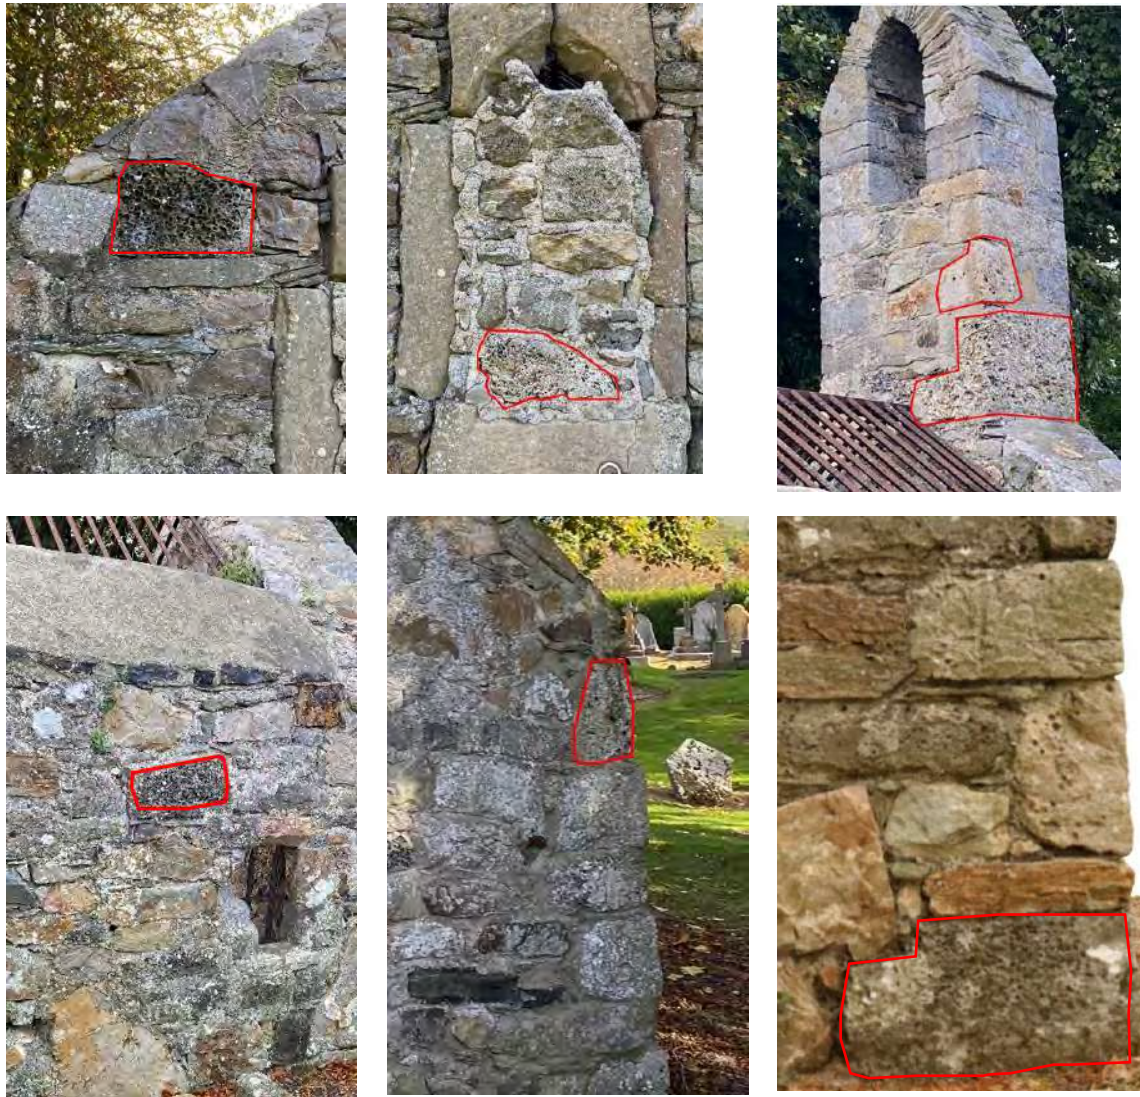
PLATES 6A-F: Clockwise from top left, wedge-shaped tufa blocks in a) eastern gable; b) eastern window infill; c) bellcote; d) northern wall; e) western gable and f) notched/rebated southeastern quoin

it and this might be an example of how the outer cladding sat into the inner tufa voussoirs (Plate 6f). While Cormac's Chapel is on an impressive scale, the majority of the other double vaulted churches are more comparable to St Fintan's in size, with St Mochta's House in Co. Louth providing the closest parallel (Figure 14). Entrance into the upper loft above the barrel vault was, at St Mochta's via an intramural stair. The width of the walls at St Fintan's would not allow for such an arrangement, however, the more common access for these lofts was via a wooden ladder as at St Kevin's Church, Glendalough or St Flannan's Oratory, Killaloe.

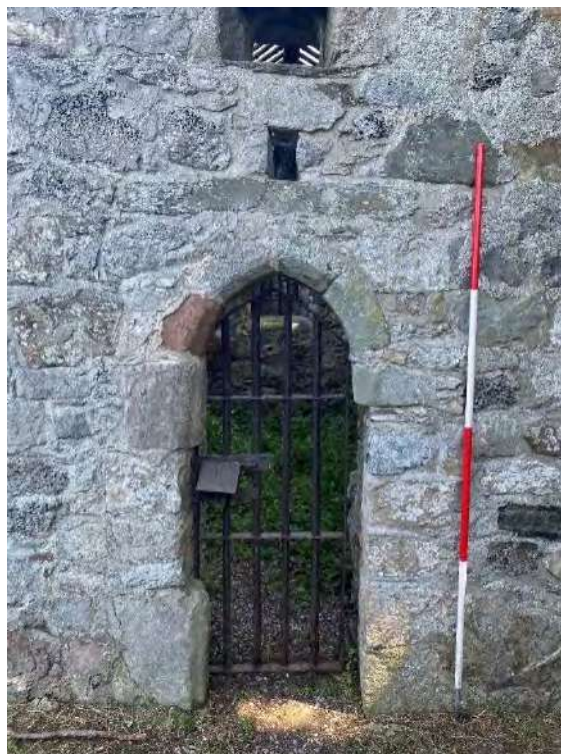
PLATE 8: Exterior of doorway, facing east

The ASI description of the doorway identifies a large flat lintel, centrally placed over the current archway, as an original flat-headed western doorway. Such flat-headed western doorways are indicative of an 11th century date and they do survive in the wider region in medieval churches where they have usually been blocked and replaced by doorways entering the nave from the side walls. However, at St Fintan's, the level of the lintel is 2m above the ground level. This is considerably higher than is usual for such portals, in addition, the interior of the portal is formed by a neat segmental arch of small, dressed limestone voussoirs which is inconsistent with a flat-headed lintel (Plates 7 and 8).

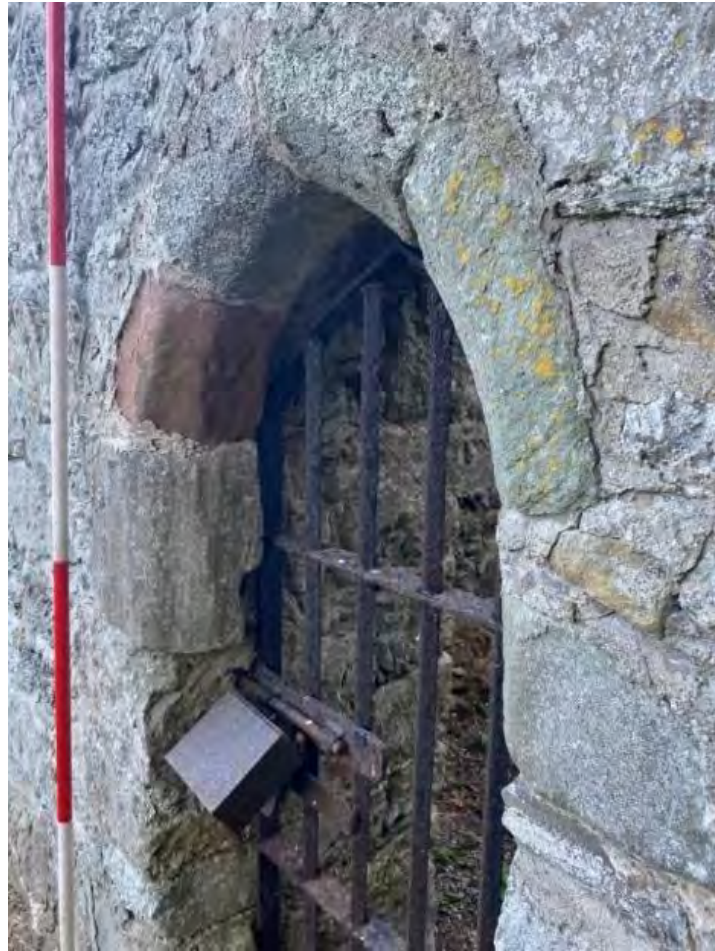
PLATE 9: Inner edge of doorway arch facing north

chamfered but the scale is different to that of the other stones. It has a hole bored into it to accept a drawbar, but this does not line up with the current iron gate, further suggesting this stone was not original to the doorway. However, the jamb bears evidence of multiple striations (Plate 9) that are often a feature of church doorways, resulting from the sharpening of blades or the grating of stone dust for the purposes of apotropaic magic.⁵⁰ Very few church portals illustrate this phenomenon as well as the sandstone arch at St Mary's on the north side of the Howth peninsula. The lower jamb on the northern side is of the same type of sandstone and is of similar scale to that with the drawbar. This sandstone is of a type not local to the area, but which can be found in the chapel beside Howth Castle whose robbed out eastern window is of this material. The scale of both jambs may indicate that they derive from the Howth Castle chapel.

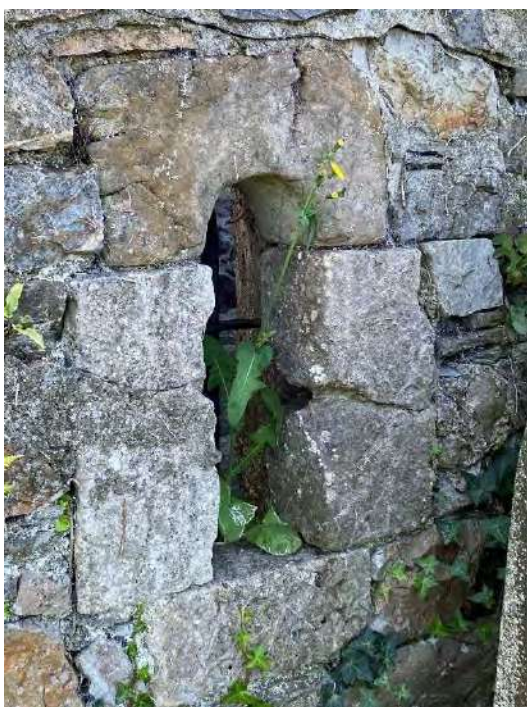
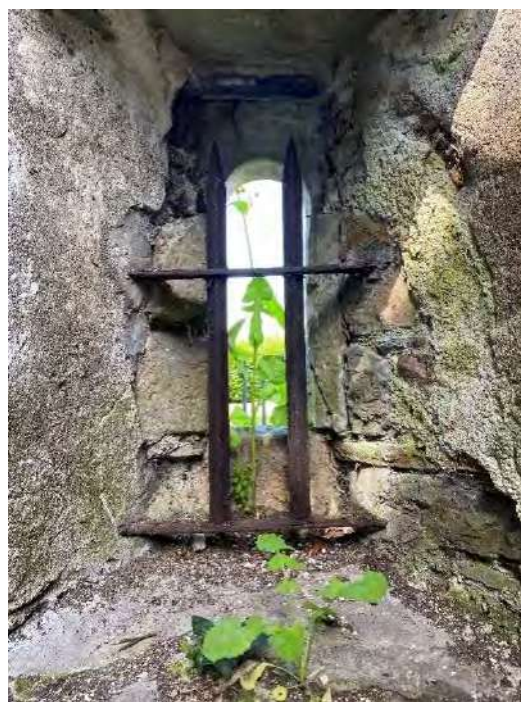
PLATE 10: Exterior of northeast window

Two rounded sandstone window heads are evident in the church. The first forms the head of the window in the eastern side of the northern wall. This window is composed of two jambs and a base of weathered, grainy, light coloured stone that might be Dundry Stone.⁵¹ All of the potential Dundry stones are chamfered on the inside to create a splayed reveal. The southern jamb, as noted by Cochrane in 1893, has been damaged by the expansion of a corroded iron bar formerly inserted into the window. While this window, on first inspection, appears to have the highest potential for being in its original position, however, the mismatch between the stone type of the head and the rest of the window is further evidenced when viewed from the interior where the head is seen to be distinct from the jambs and base (Plates 10 and 11). A second window head is placed within a niche or 'press' constructed in the interior of the northern wall. Clearly ex-situ, this fragment has been placed in an unusual and esoteric position, forming a cavity which is finished with a fragment of hemispherical stone (discussed further below; Plates 12 and 13).

The possible Dundry Stone window is likely to have originally been capped with a lancet-type head. A similar Dundry stone lancet window can be seen at nearby Kilbarrack Church in a similar position in the north of the chancel, however, in this example, the chamfer is external and glazing grooves are evident. The stones at St Fintan's may therefore have been reversed in order to present an unchamfered face to the exterior, therefore accommodating the sandstone head.

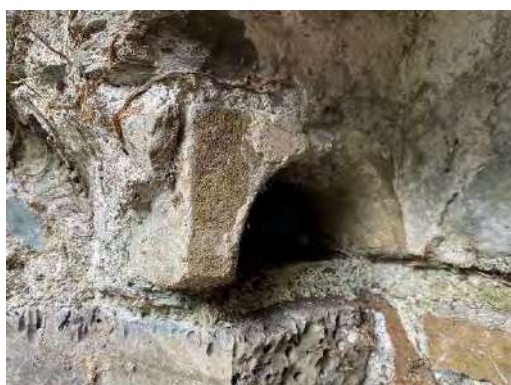
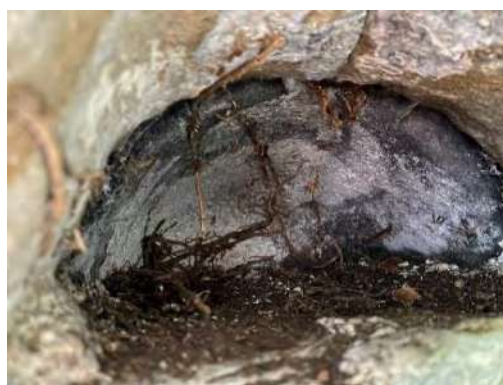
PLATE 12: Round headed window head in northern wall 'press'

The window heads of sandstone are likely to be original to the church and while this round-headed form is common to churches of the late 11th to 15th centuries, the type of sandstone they are made of appears commonly in Dublin during the 14th to 16th centuries.⁵²

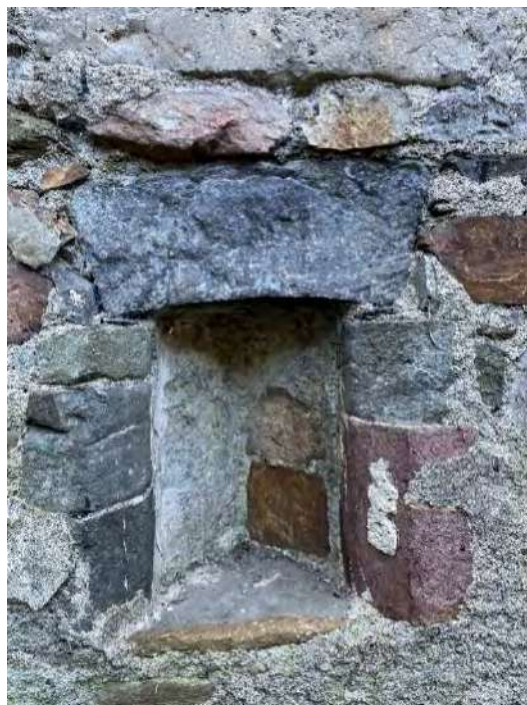
PLATE 16: Southeastern wall press

The window in the southeast of the church has little light to shed on the building. Outside, the jambs have been entirely replaced during the 20th century refurbishment of the wall tops while the interior splay and surrounds contain no cut stone. One final wall press to the west of this window is formed partially of the blue limestone seen in the doorway and some of the chamfered fragments may derive from the original doorway surround. Given its location, the press contains no sign of a piscina and this adds to the overall sense that these wall presses/niches have been constructed out of fancy with a random supply of cut stone, rather than to perform any liturgical function. The southern jambe of the press is formed by a

chamfered red sandstone fragment. This type of stone is not local to the area, though is widespread in Fingal, and is likely to derive from medieval trade with the Chester area.⁵⁴ This type of sandstone is used in a polychrome arrangement in the 15th century gatehouse at Howth Castle.

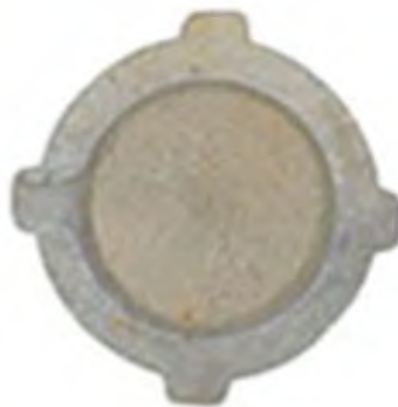
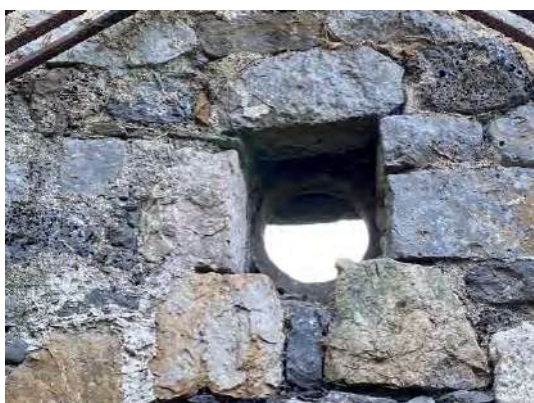
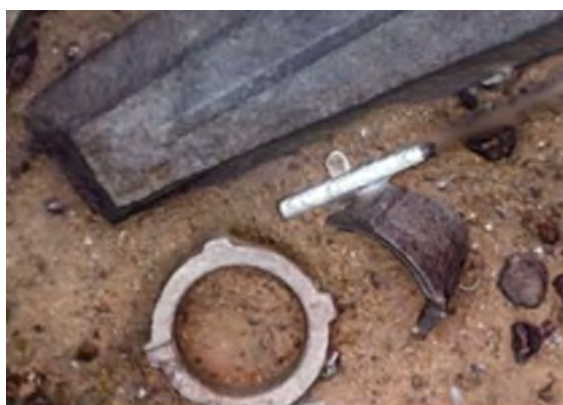
PLATE 17: 13th century purbeck marble mortar

PLATE 18: Circular stone in-situ

PLATE 19: Photogrammetry of the Dorset wreck showing Purbeck marble mortars on sea bed⁵⁵

What makes the presence of a large stone mortar on the site all the more intriguing is the identification of a smaller lugged white stone mortar of medieval or early modern date within the upper graveyard close to cross DU015-031004 (Plates 17-19). The presence of these implements onsite brings to mind the ubiquitous bullaun stones of early medieval monastic sites.

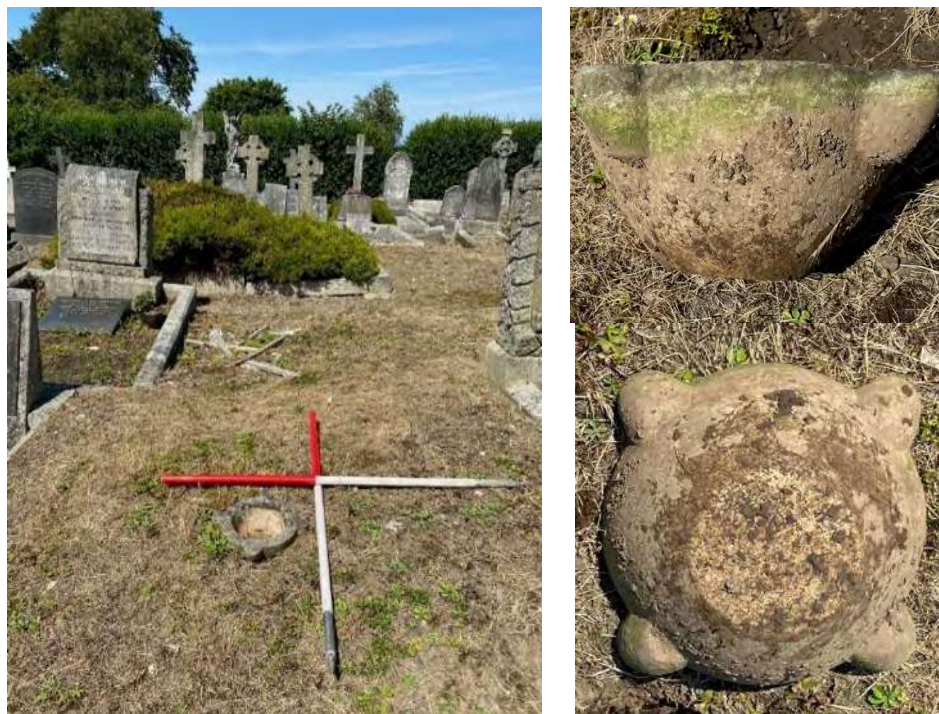
PLATE 20: Lugged mortar of white stone in upper graveyard

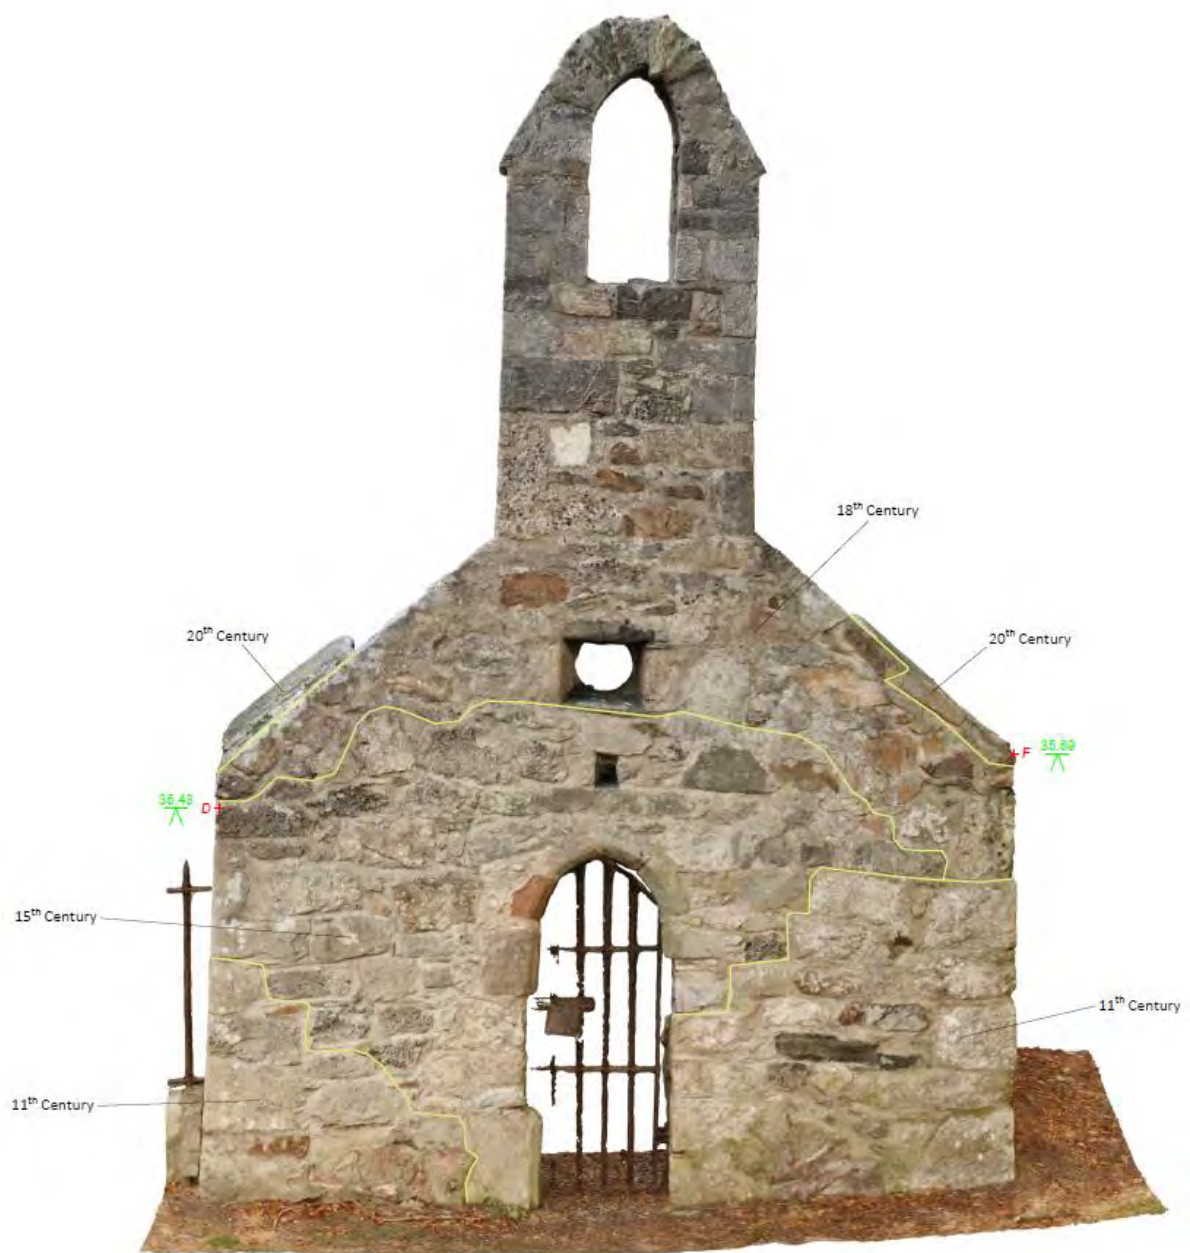
FIGURE 19: Rectified photographic model of western façade with phasing

- **Phase 4: 18th/19th century** – a remodelling of the church was undertaken in either the 18th or early 19th century. While a depiction of the church on John Taylor's 1816 map would appear to show the building in an earlier phase, the fact that the building appears in its current form with weathered and damaged elements in Du Noyer's representations in the 1840s would suggest that this remodelling was carried out a considerable time before his sketches were made. It is therefore considered likely that the church was remodelled with the reconstruction of the upper parts of the west gable, addition of bellcote, the construction of the upper half of both side walls, including the reconstruction of all side window opes and internal niches/wall presses was undertaken in the later 18th or very early 19th century. No record survives of mass being celebrated in this church and it is tempting to see this remodelling as an effort, perhaps by the owners of Sutton House, to prettify what was to be their final resting place by the creation of a picturesque ruin that was never intended for liturgical function. The absence of any evidence of roofing supports or a roof ridgeline on the internal face of the bellcote are in favour of this reading of the building. The survival of internal render however challenges this interpretation somewhat. On the balance of evidence however, it is proposed that the church was not roofed at this time.

- **Phase 5: c. 1850** – sometime between the Du Noyer sketches in the 1840s and the painting by McFarland in 1853, the damaged western doorway was partially rebuilt with salvaged jambes and voussoirs of sandstone and granite.

- **Phase 6: c. 1980** – Rebuilding in calp limestone and cement mortar of the wall tops along the north and south walls, the installation of the iron grille and the flaunching of the wall tops.

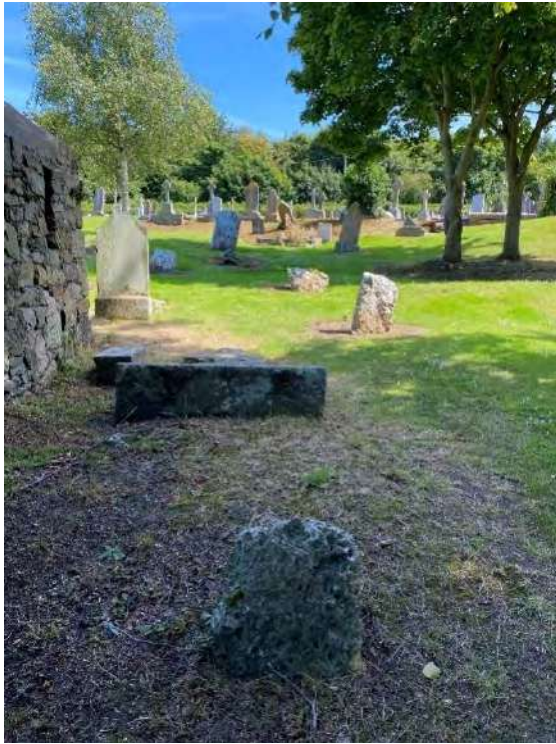
To the east and south of the church, several large slabs of undressed and unmarked stone stand as gravemarkers around the central area of the enclosure. These rough markers are very difficult to date, though several are composed of tufa (Plates 22-23). They are reminiscent of early medieval markers such as those at Reefert Church in Glendalough. Interestingly, these gravemarkers do not share the same alignment as the church. They are generally aligned northwest-southeast and, if these are early medieval gravemarkers, they may indicate the former presence of a principal church that was built on a different alignment.

PLATE 22: Tufa gravemarker in foreground, and background

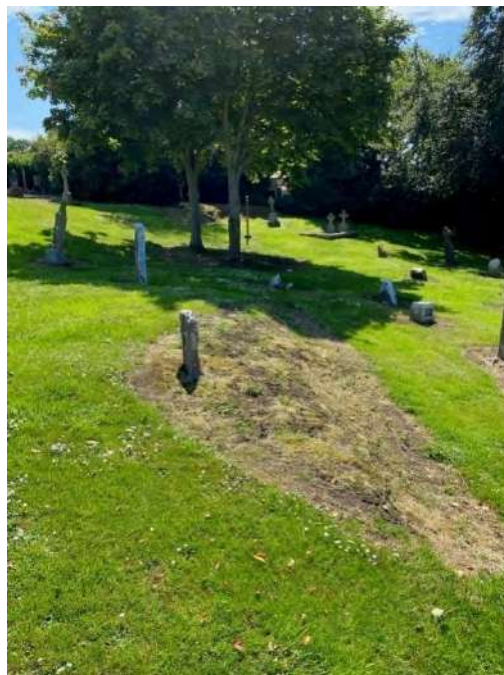
The graveyard is well maintained, however parched areas around the graveslabs within the enclosure would suggest regular use of biocide. A large semi-circular area along a break of slope to the east of the church appears to have been aggressively treated with biocide also. No modern cleaning of headstones was identified with lichen growth in place on many of the stones.

PLATE 24: View southwest along the break of slope showing biocide treatment

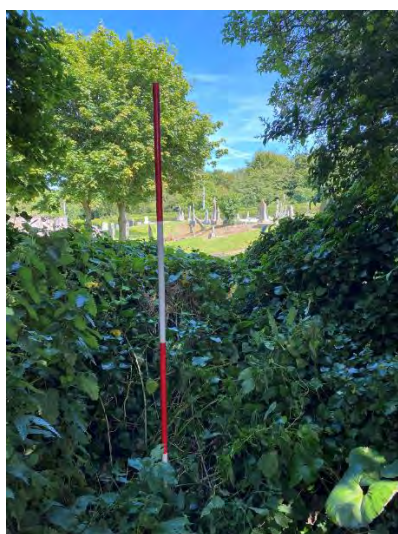
The bank surrounding the church is mentioned from the earliest references to the church. The bank curves around the western side of the graveyard and stands to a maximum height of approximately 1.4m and is 6m wide. The curve of this boundary is continued to the northwest by the line of the random rubble coursed wall. The northern boundary of the graveyard has been straightened; however, a low remnant of the northern ditch is clearly visible in the Digital Elevation Model (Figure 23) curving around the top of the graveyard. The northeast and eastern boundary of the original ecclesiastical enclosure This area of the graveyard is overgrown with trees, brambles and tall stands of nettles. The southern boundary of the enclosure has been formed by scarping the slope and digging into the hillside. This escarpment runs in a curving line from the east to southwest. The three sides of the enclosure, with various degrees of curves create a distinct ‘plectrum-shaped’ enclosure with the suggestion of an entrance on the eastern side.

PLATE 25: Outer face of bank facing east the west

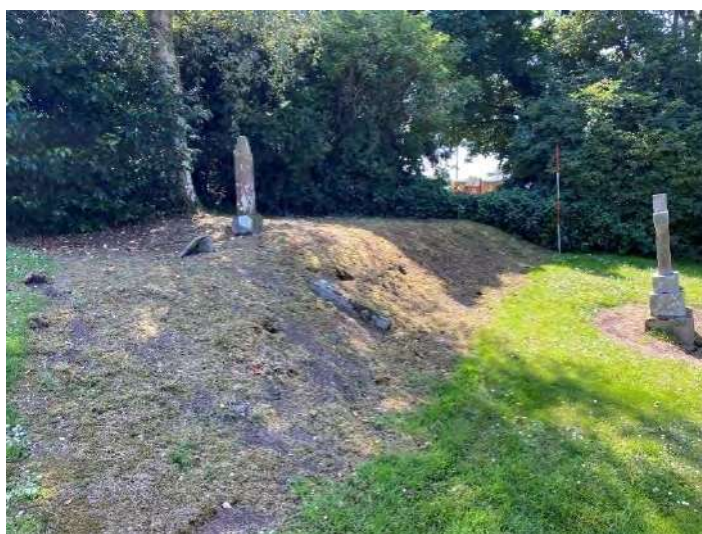
PLATE 26: View along escarpment towards inner face of bank, facing west

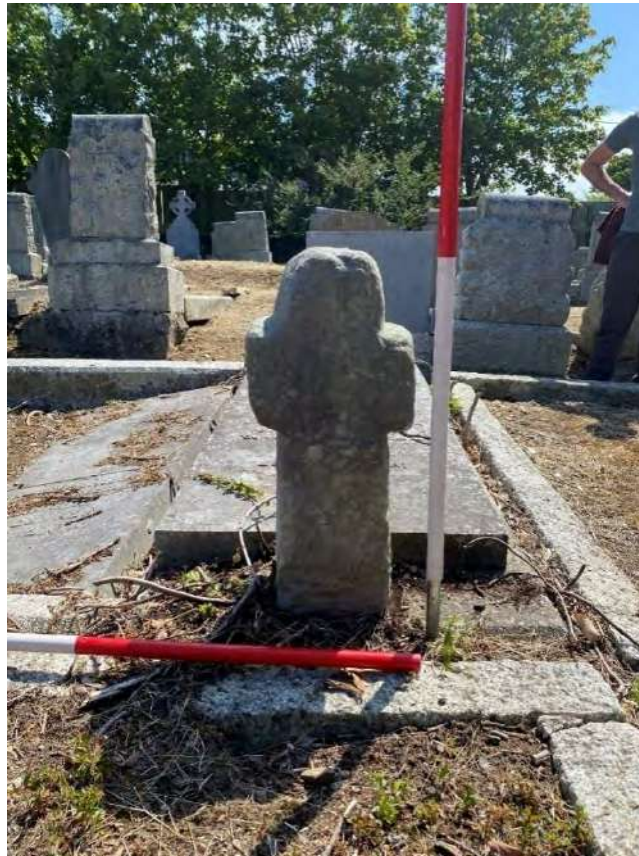
PLATE 28: Cross DU015-031004 facing north

That the cross has been moved from its original context and placed outside of the historic graveyard boundary as a memorial to a grave that it is not associated with, is clear. The cross currently stands at the head of a graveslab dating to the 1930s. It is not clear how exactly the cross has been fixed to the granite surrounds of the graveslab, but it is likely that a small amount of cement has been used. The 'danger' noted in the ASI record of vegetation encroaching appears to have been mitigated in recent years but this might have been achieved through the use of biocide.

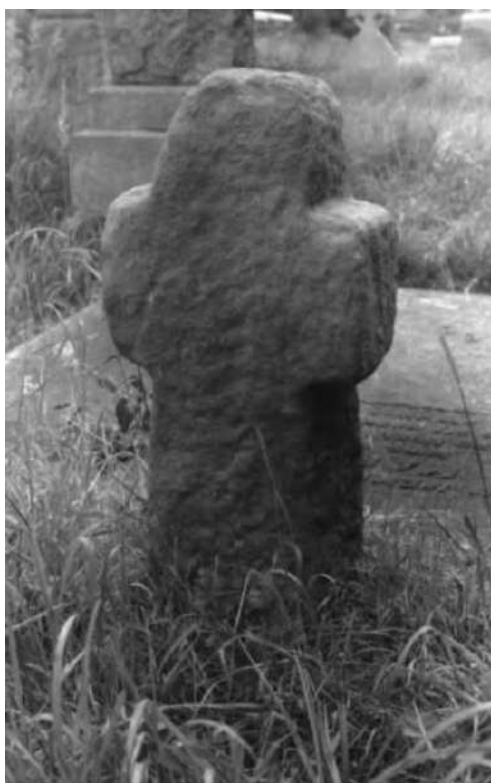
Of more concern is the possibility that the cross has been subject to aggressive cleaning. Although very difficult to tell from the black and white photographs, the 1993 images hint at a darker surface on both faces, perhaps with a line running diagonally from west to east across the face of the arms that may suggest the cross had been buried to this depth for a long period of time. It is not possible to be conclusive about this, however.

PLATE 29: North face of cross DU015-031004 in 1993, from SMR file

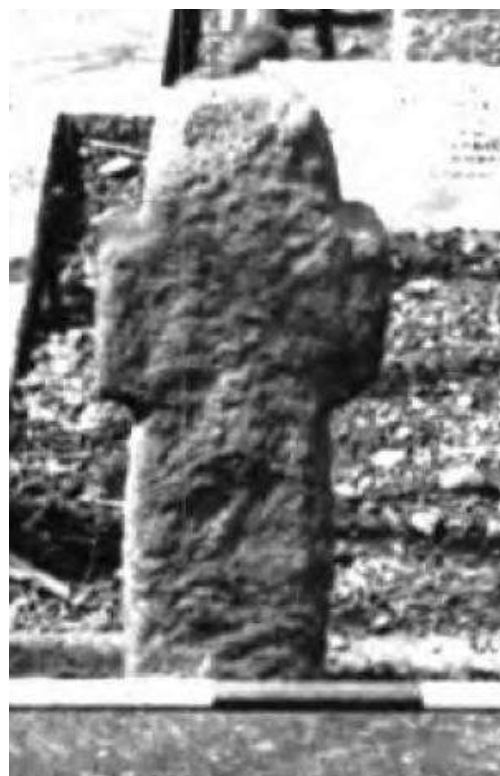
PLATE 30: South face of cross DU015-031004 in 1993, from SMR file

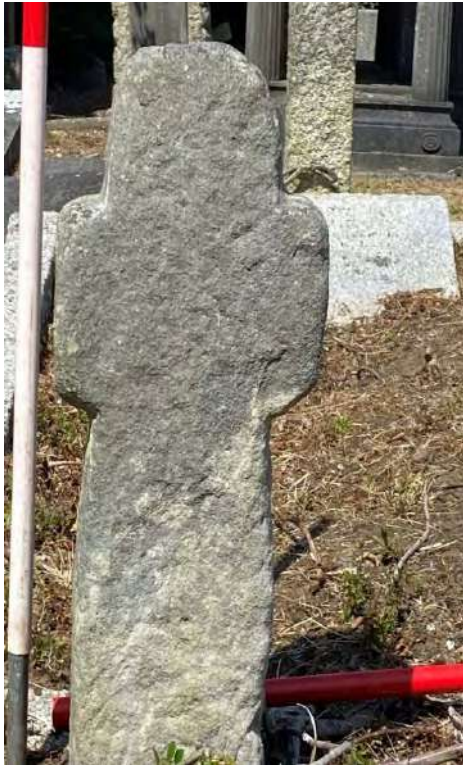
The cross is irregularly shaped and characterised by the very short arms and rough finish on both the north and south faces with gouges and grooves evident. A small remnant of pecked dressing is visible on the southern side towards the base. A notably smooth patina covers most of the terminal of the southern arm except where it has been removed by a diagonal gouge.

PLATE 31: Northern face of cross DU015-031004

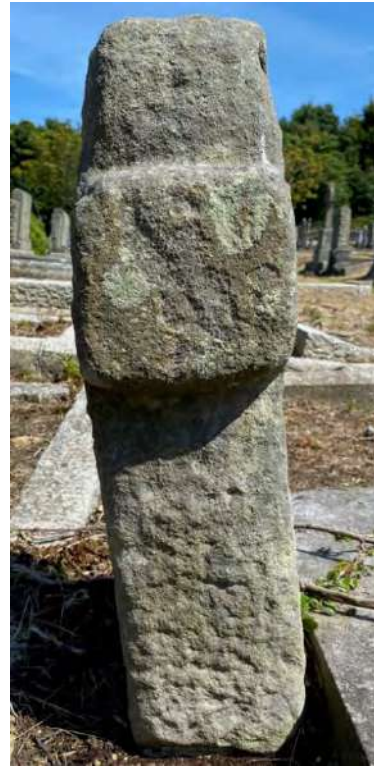
PLATE 32: western face of cross DU015-031004 with patina and pecking visible

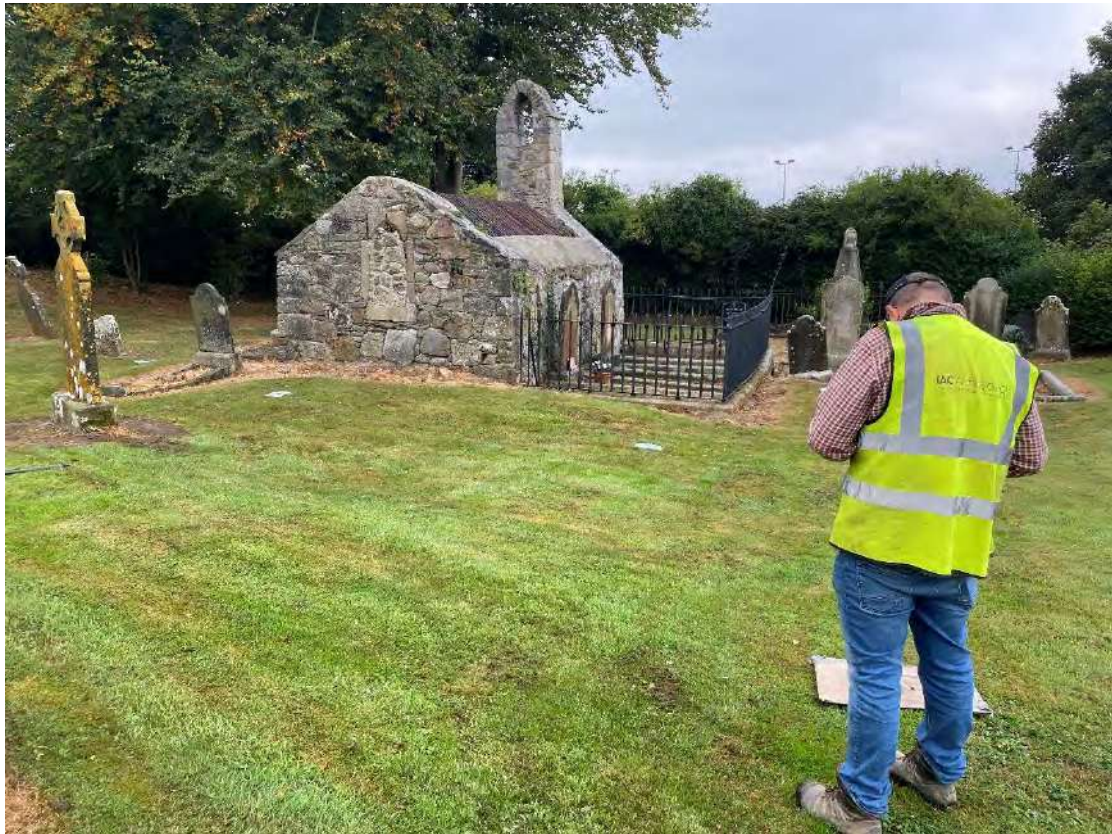
A drone survey was undertaken at the site from 7th to 9th of October 2024 in order to create Photogrammetric and Digital Elevation models (Flight number J4389.1). The survey was undertaken by Enda Lydon using a DJI Mini 4 Pro and the models were produced using Agisoft software with a 3D model generated in Sketchfab.⁶⁰

PLATE 37: Drone survey in progress

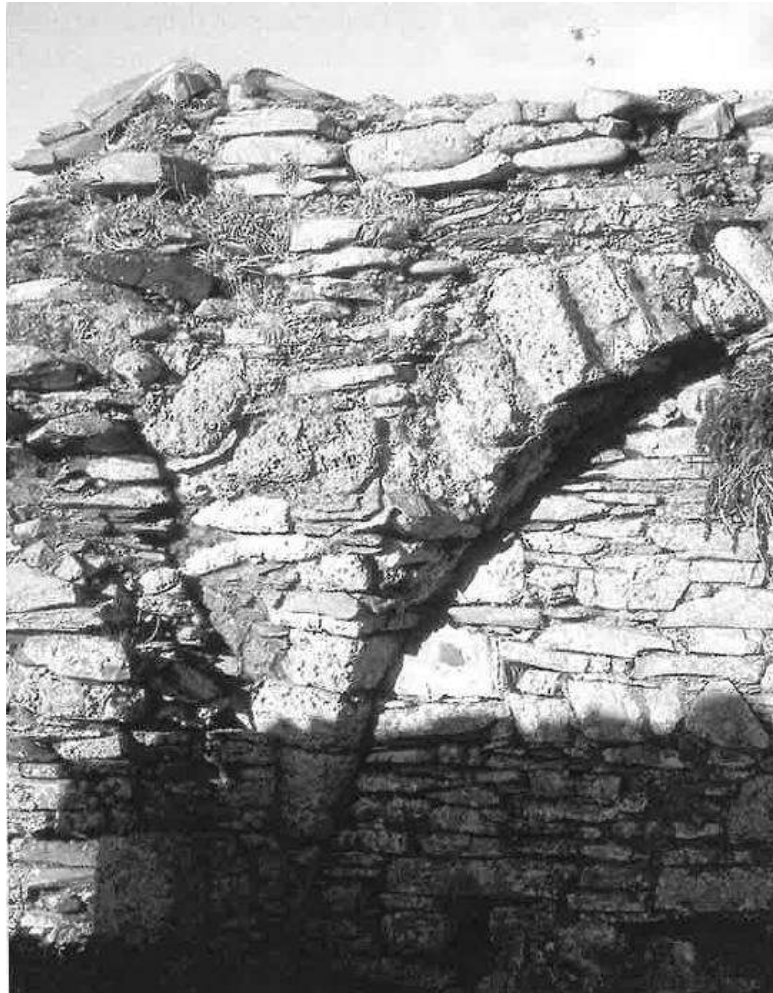
It is, perhaps, the presence of tufa stone that presents scope to propose the architectural element of most significance. The identification of a number of apparently shaped tufa voussoirs re-used within the fabric of the church suggests that this stone may have been used in an earlier phase of the church as window or door surrounds, or, more significantly, as voussoirs from a vaulted roof. Tufa appears in a number of important churches both in the locality (St Doulagh's and St Patrick's) and further afield (Cormac's Chapel). All of these churches belong to a small group of nationally important structures which represent a uniquely Irish architectural development of the later 11th and early 12th centuries, described as double-

PLATE 38: Shaped tufa voussoirs at St Patrick's Church, Skerries (Ryan et al 2004)

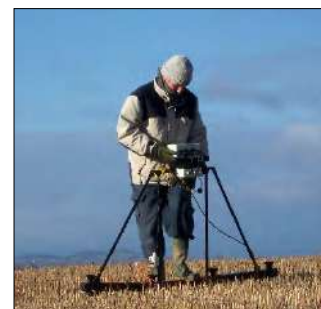
The technique is used to record variations in electrical resistance by passing an electrical current through the ground. The standard instrument for archaeological investigations is a twin-probe array of mobile and remote electrodes maintained at a distance of about 20m.

The mobile electrodes (one current and one potential, usually 1m apart) are mounted on a survey frame and connected to a Geoscan RM85 resistance meter, which records the specific resistance of the soil (measured in ohms).
