CONSERVATION MANAGEMENT PLAN

ST FINTAN'S **CHURCH**,
CARRICKBRACK ROAD,
SUTTON, DUBLIN 13

ON BEHALF OF
FINGAL COUNTY COUNCIL

FEBRUARY 2025

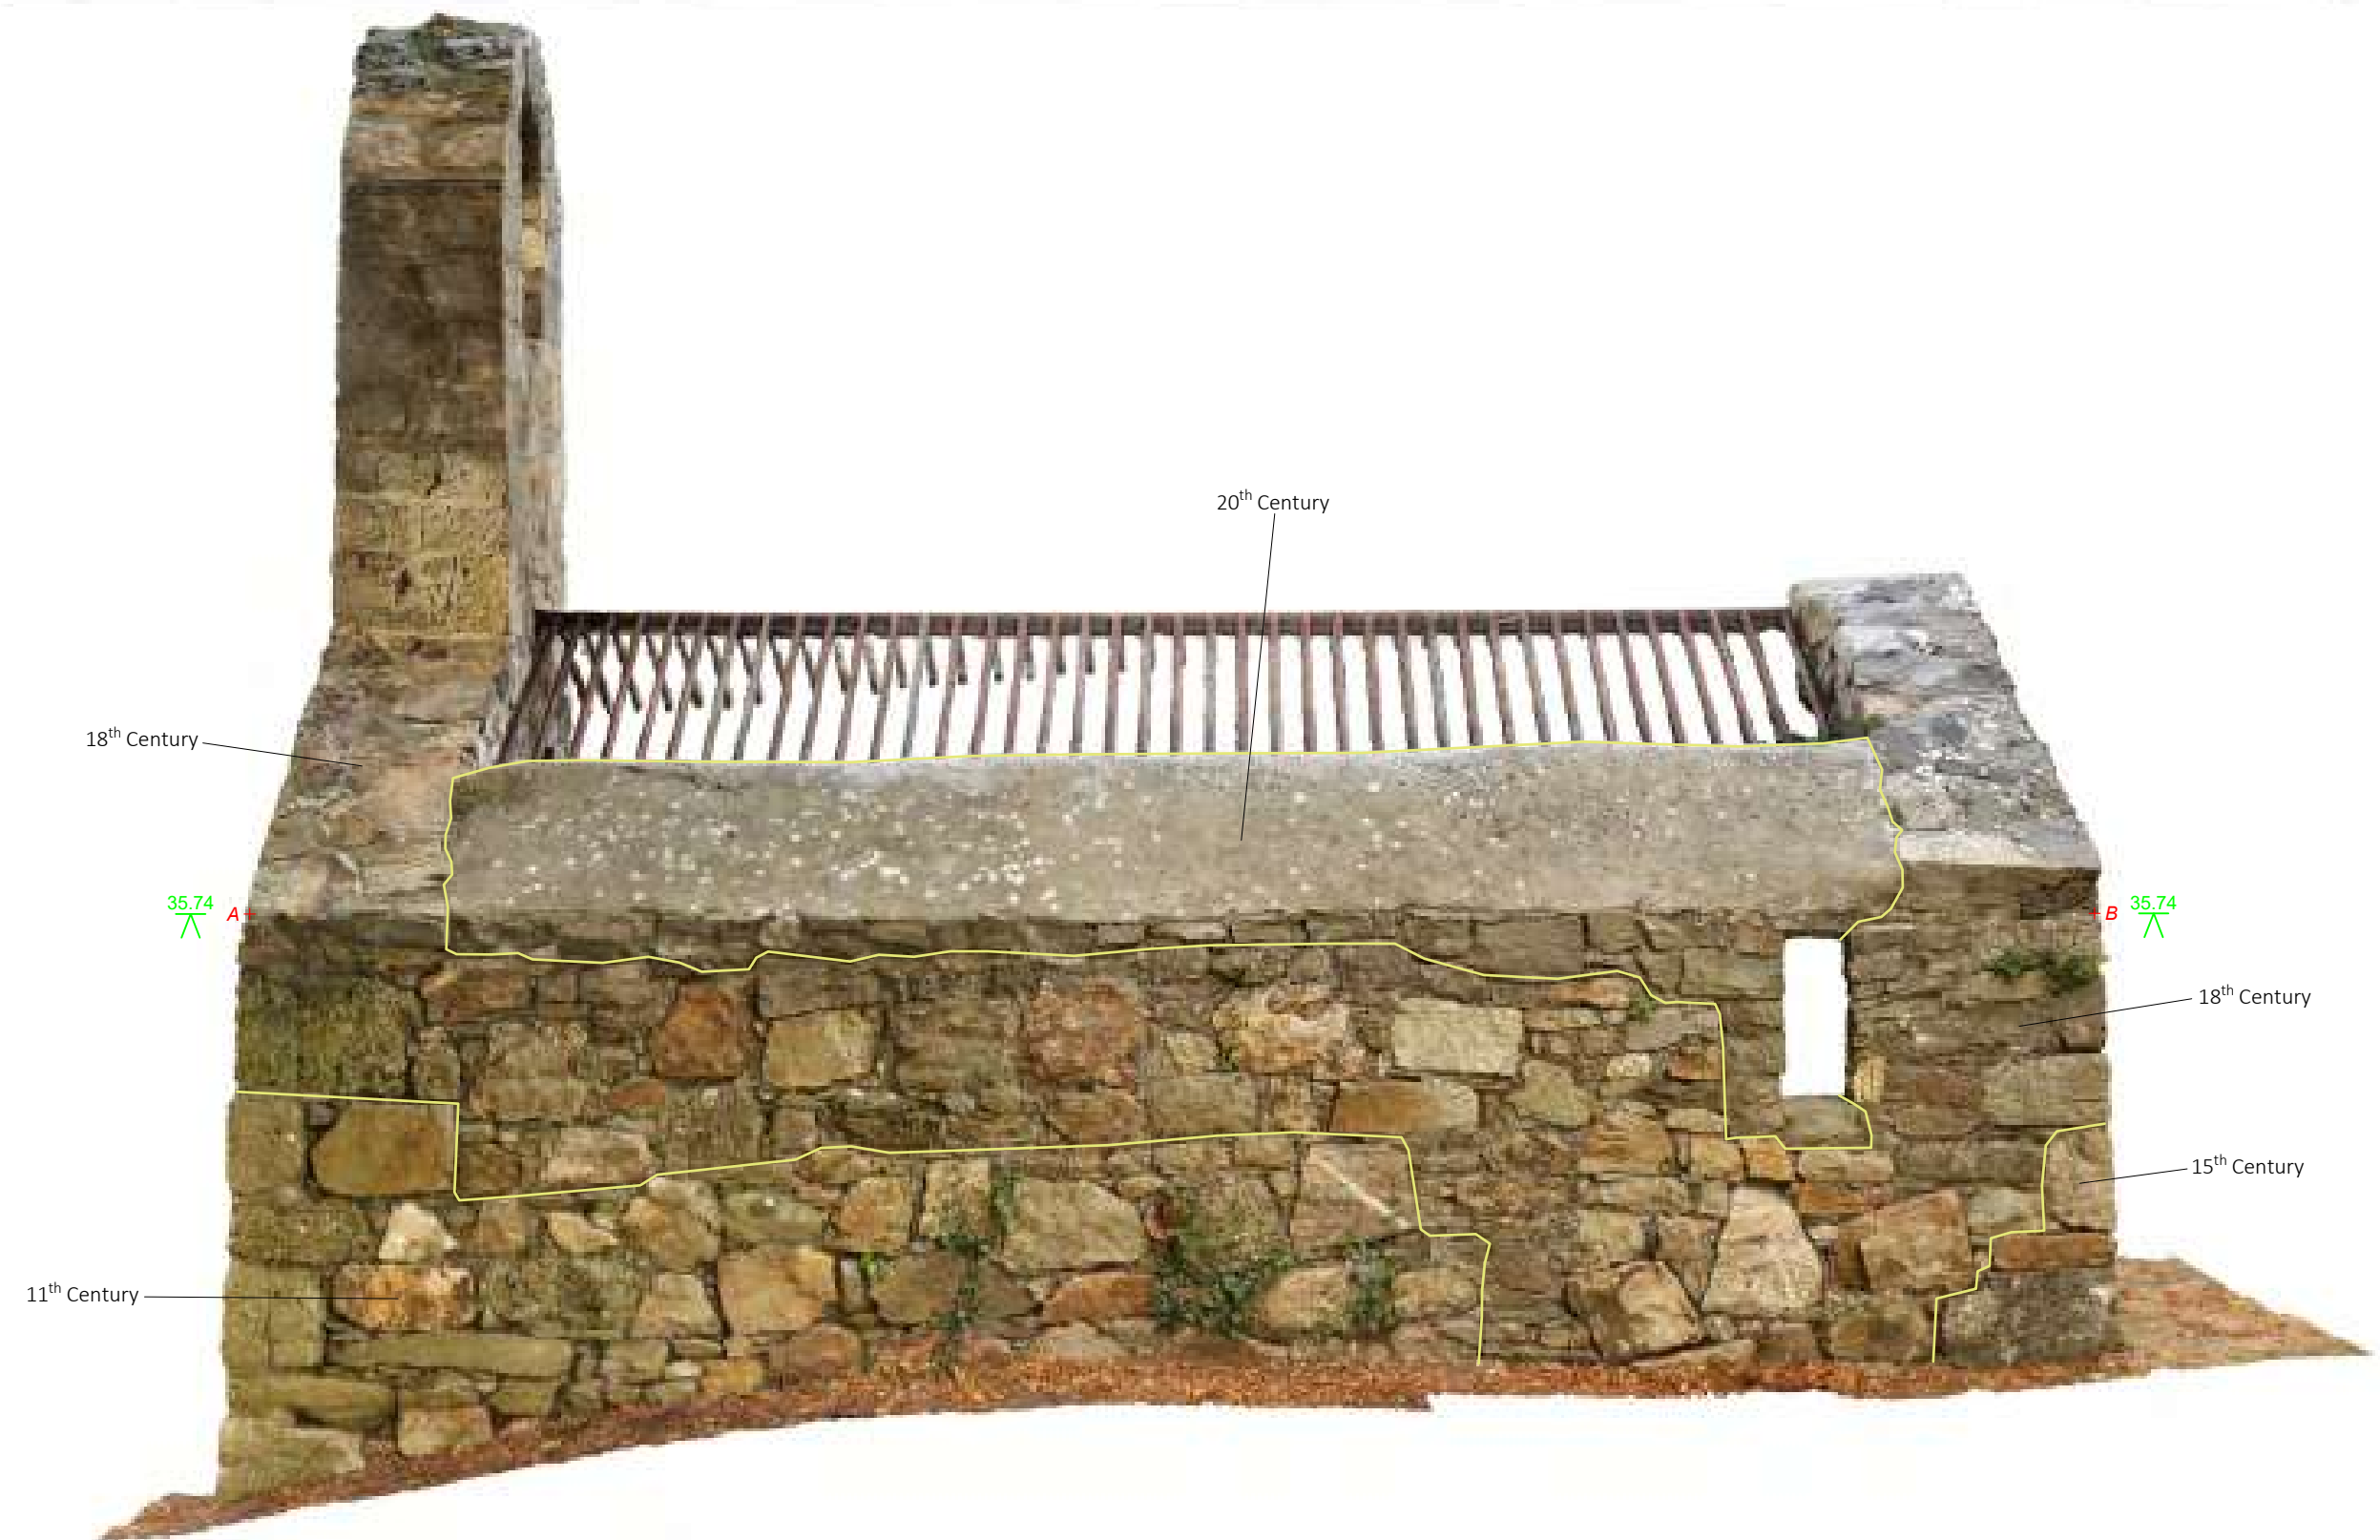
itleq	South-facing rectified image of the external south wall of St Fintan's Church	Scale	1:25@A3	Drawn by	RB
Project	St Fintan's Church, Howth, Co. Dublin	Date	14.10.24	Checked by	EL
				Approved by	PD
		Job no.	J4389	Fig.	2.6
				Rev.	-

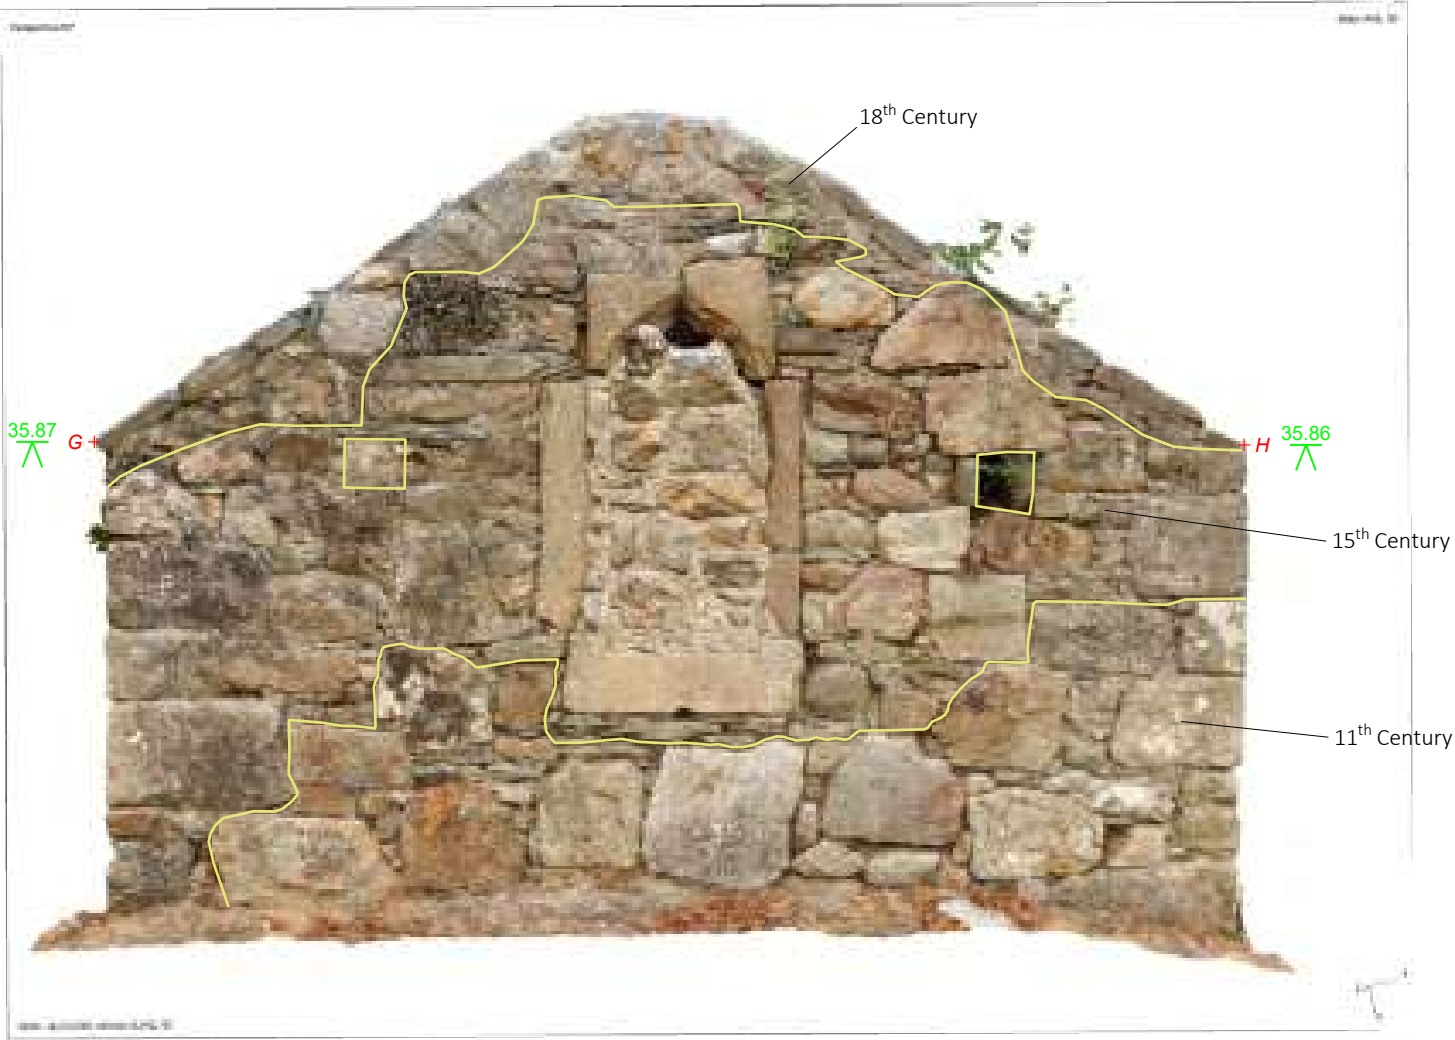
IAC Archaeology	itleq	East-facing rectified image of the external east wall of St Fintan's Church	Scale	1:25@A3	Drawn by	RB
	Project	St Fintan's Church, Howth, Co. Dublin	Date	14.10.24	Checked by	EL
					Approved by	PD
			Job no.	J4389	Fig.	2.7
					Rev.	-
