## Architectural Heritage Assessment Clonsilla Old School House Site

May 2025  
Ref Number 24014

# Architectural Heritage Assessment

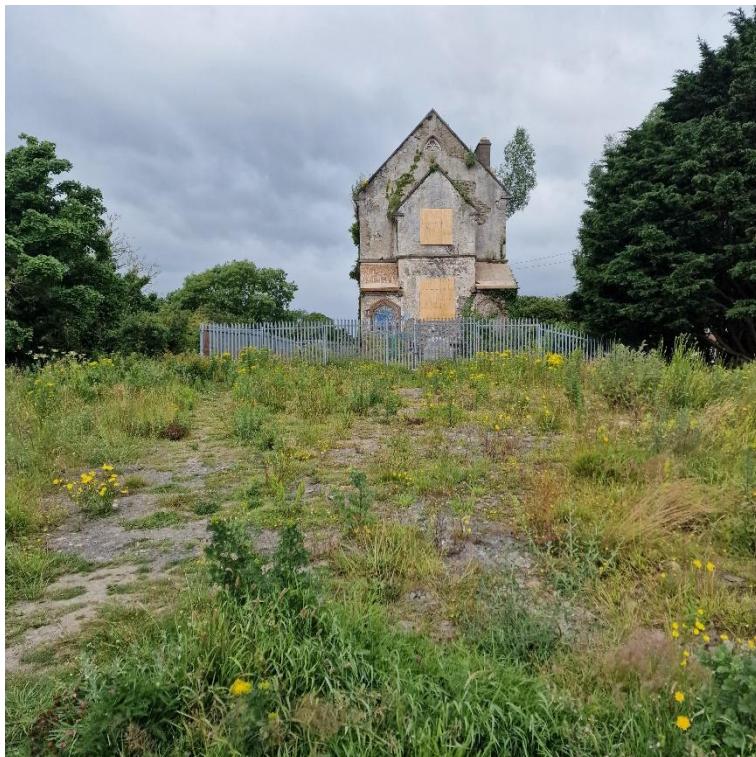
The building is a two-story over raised basement, mid- nineteenth century Victorian schoolhouse, generally retaining its original construction and features, though in a very poor state of conservation. It is detached, overall form is vertically emphasised. Pitched roof with slate finish; one brick chimney stack on the north side. Walls are brick and coursed rubble stone with decorative brick and plaster features. Primary (east) façade features a projecting, two-storey, gabled stairwell with two flanking single story entrance porches and access steps. External finishes are generally rough cast plaster with smooth plaster and brick features. Original form, construction and materials are extant though dilapidated. Interior layout is thought to be generally intact though dilapidated and vandalised.

East façade and approach. 2024

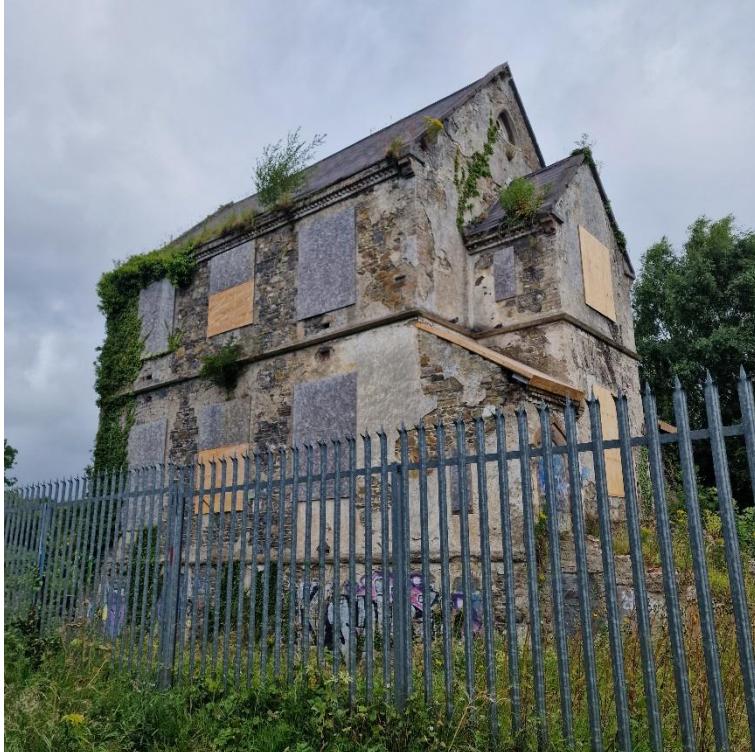
Southeast corner. 2024

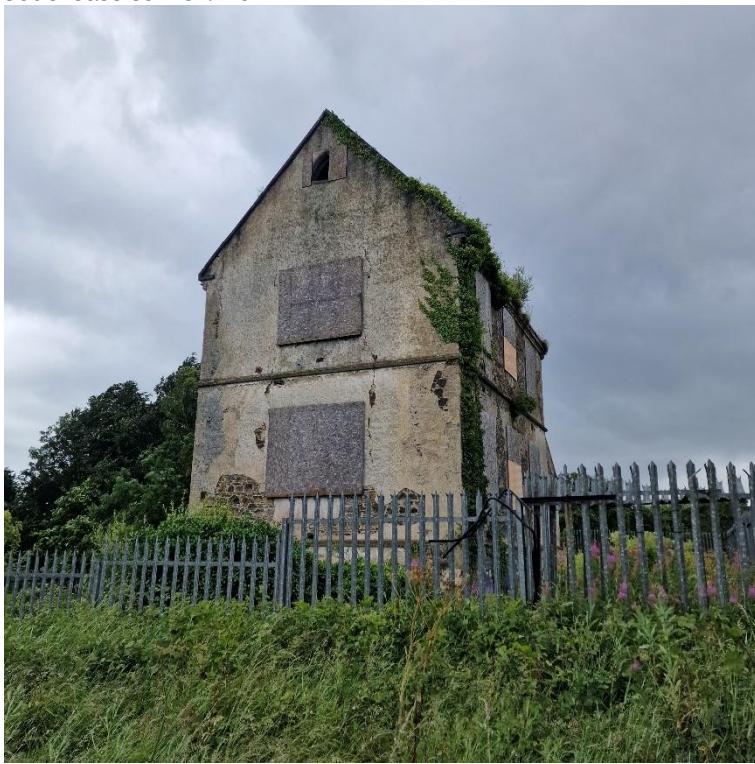
West façade. 2024

**Walls:** Generally, the coursed rubble stone walls are in a fair but deteriorating condition with structural repairs evident on the west facade, where further structural cracks require appraisal and repair. Water damage is accumulating from damage to roof and rainwater goods. Damage may be localised at present but the building needs urgent attention before the problems spread.

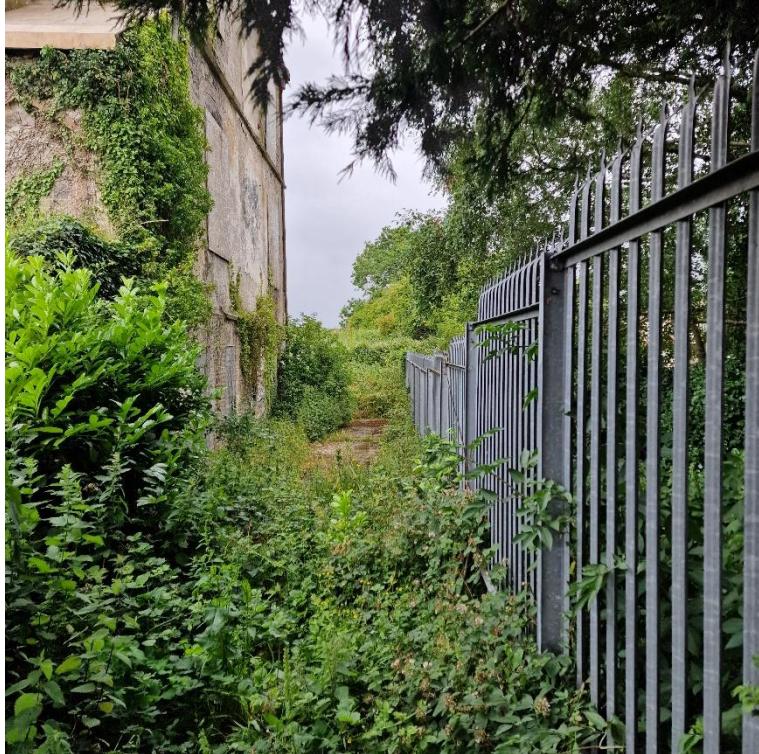
North side of the schoolhouse. 2024

**Chimney:** The brick chimney on the northern side of the building is in good condition, needing removal of vegetation and expected routine repairs likely repointing, repairs to flashing and haunching etc., which have not been carried out in recent decades.

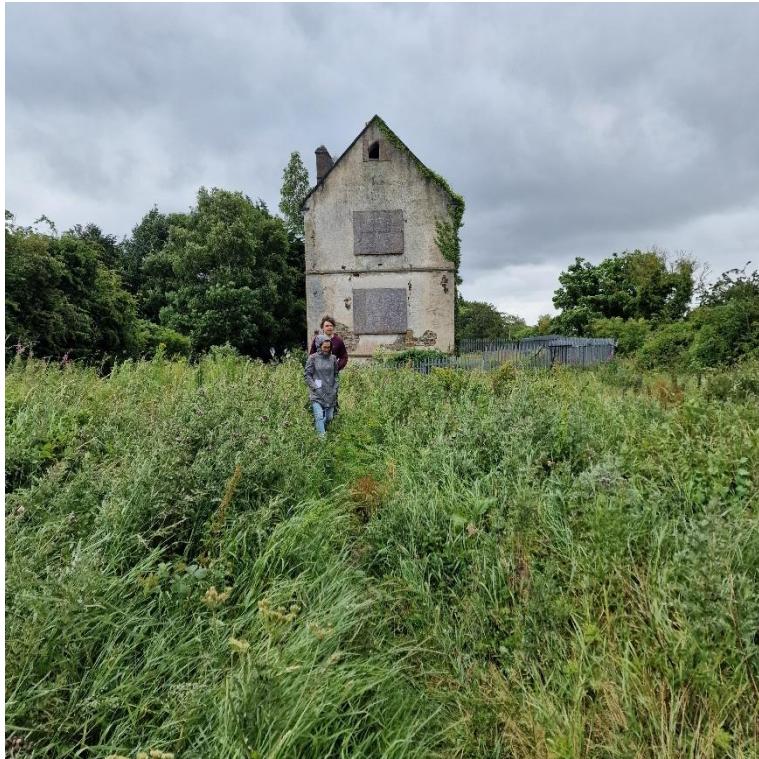
West façade and surrounding area. 2024

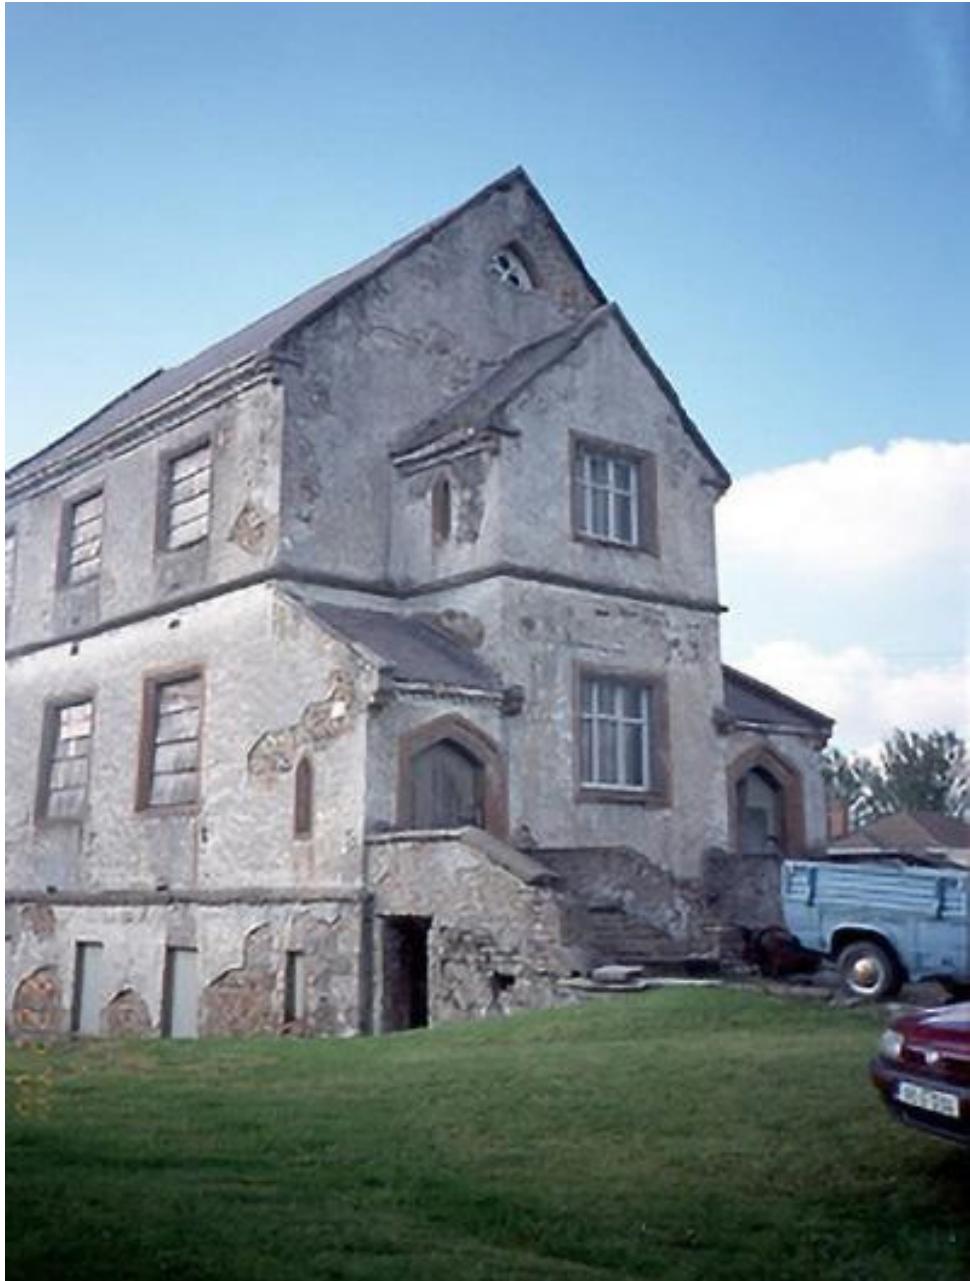
2000 Photograph courtesy of [buildingsofireland.ie](http://buildingsofireland.ie)

**Windows:** Windows were extensively present up to approx. 2000. Window opes are currently blocked or boarded up, indicating that windows are not intact. Some window frames or observable, which may form templates for replacement windows.

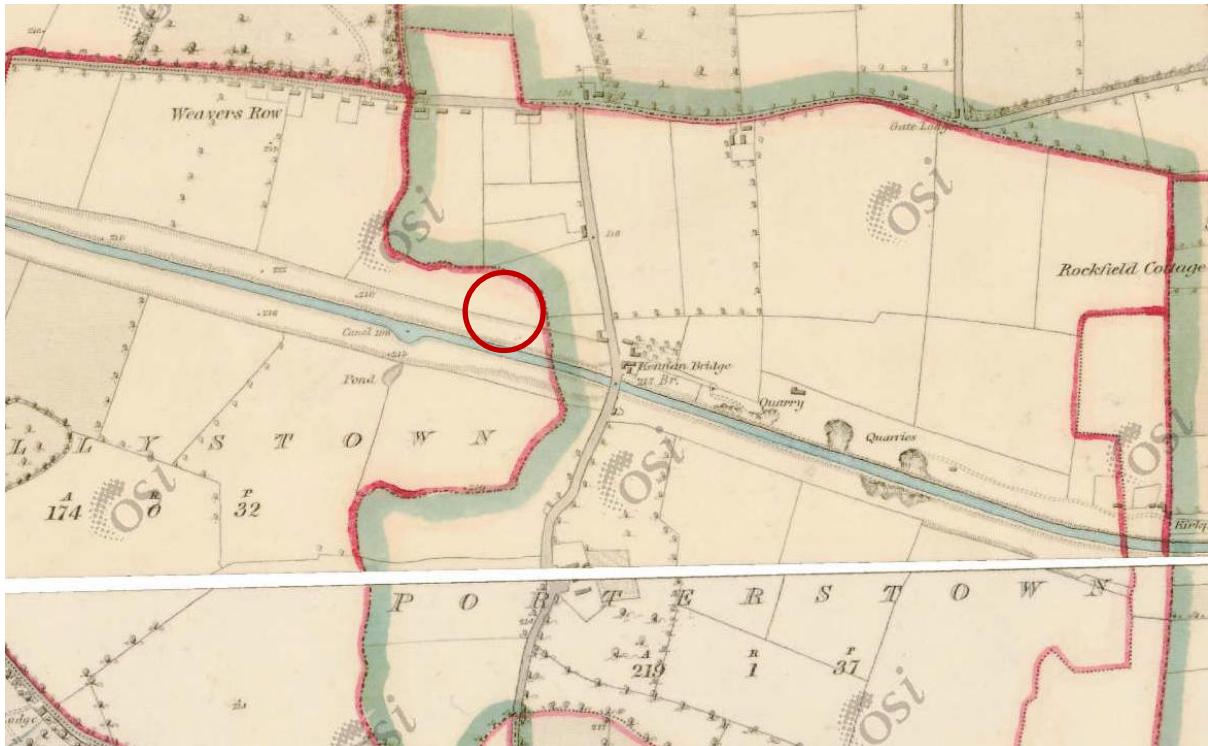
6 Inch Colour (1829-34)

The school was not yet built at the time of the first edition 6 Inch mapping, surveyed between 1829 and 1834. The canal can be seen but the railway has not yet been built.

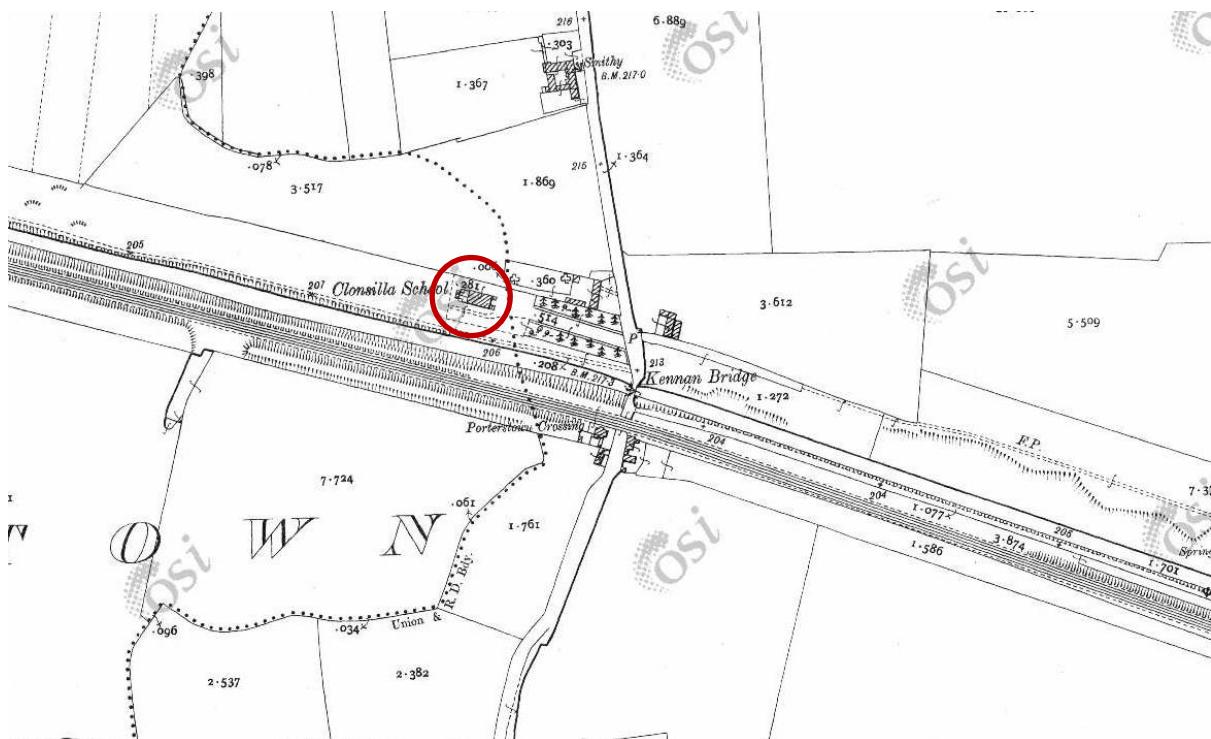
25 Inch B&W (1863-1924)  
School, railway and canal can be seen.

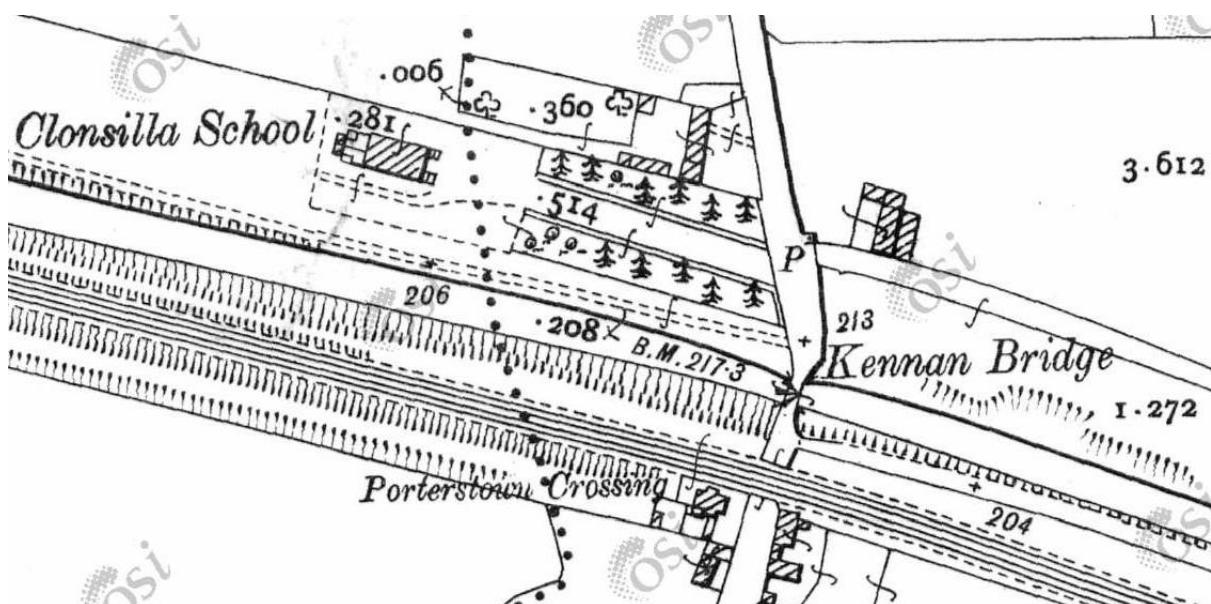
25 Inch B&W (1863-1924) Detail

The school was visible on the 25inch map, surveyed 1863-1924.  
A short, tree-lined avenue can be seen leading up to the school to the East.  
Outbuildings, a rear yard and pathway can be seen around the school.
