*Managing Fingal County Council's  
Archaeological Resource*

Christine Baker  
Field Monument Advisor

March 2012

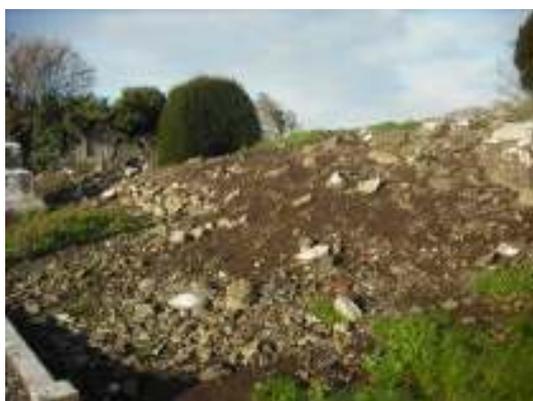
*Mounding Grallagh graveyard*

The first is the physical banks and slopes of exposed clay slipping, especially after heavy rain. This is most evident in Grallagh graveyard where there is significant

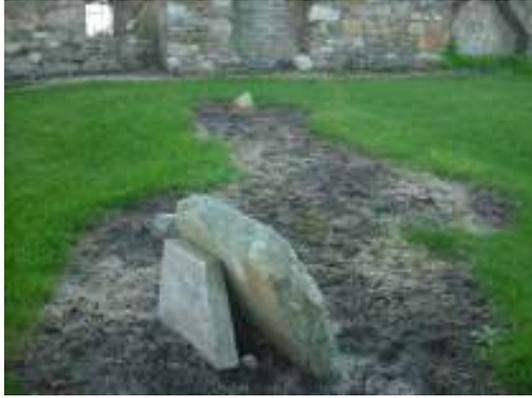
*Kilbarrack Graveyard*

It is apparent that a number of single or low standing grave markers have been sprayed in order to expose them and make them visible. This has created 'islands' of gravemarkers. Given their position, their size and that they are unassociated with plots, these grave markers are also more likely to be the older stones and as such more vulnerable to the negative effects of weedkiller.

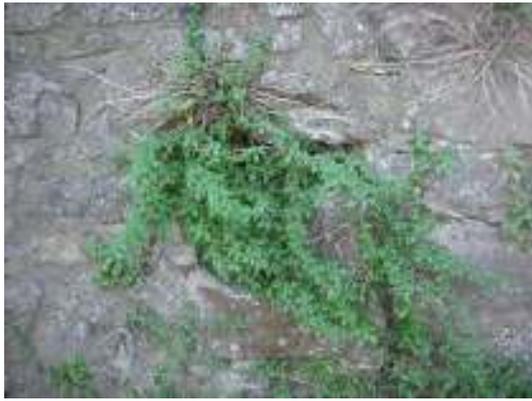
*Hollywood Stoup*

An often overlooked element is that of the stoup or holy water font. There is one each at Hollywood and Malahide churches, both located internally east of the southern doorway. Both are medieval and listed as archaeological monuments but the former has been overlooked and become overgrown.

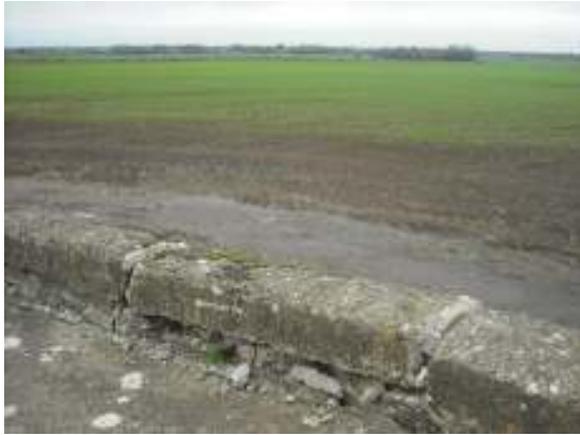
*Ward graveyard wall*

This issue was dramatically highlighted by the sudden collapse of the 18th century graveyard wall at Howth Abbey, after torrential rain, exposing the coffins of the recently deceased and the remains of older burials. Given the nature of burial there is a build up in the ground level of historic graveyards within the area bounded by the graveyards wall. Often there is a significant difference in the ground level between that immediately inside the wall and that externally. This means that there is a pressure exerted internally on graveyards walls that have so external support. This can be exacerbated by topographical features, such as the siting of the graveyard on a hillside or the presence of an underground culvert or stream. Likewise change in external landuse such as scarping and development or damage to the graveyard wall itself may increase the possibility of collapse. The graveyards of the Ward and Baldongan both have significantly different internal and external ground levels. The former has extensive areas of cracking and areas of collapse in the graveyard wall. The latter has pooling of water along its most vulnerable façade and the gapping between the internal concrete path and graveyard wall may be indicative of movement.

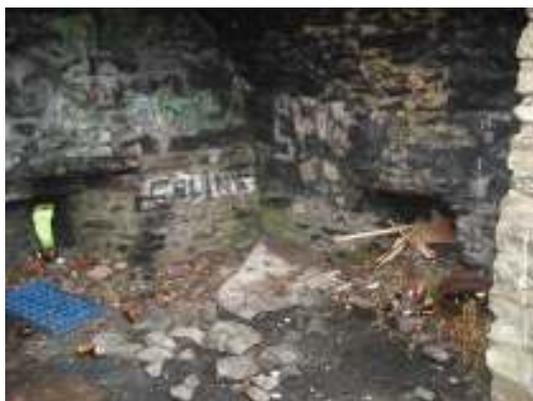
*Buzzardstown Church*

In all, 20% of the monuments defined here as structural remains, have been subject to some form of vandalism chiefly graffiti or deliberate burning. This compares with the average of 6% of all archaeological monuments defined as being at risk from vandalism in Fingal (Baker 2010). Their visibility and their ability to provide shelter make them a target for both exhibitionist statements and gathering places for anti-social activity. This is sometimes compounded by the location of the monuments-all three Martello towers at Tankardstown, Balbriggan, Skerries and Howth which are in relatively peripheral locations with in two cases adjacent to carparks-are repeatedly subject to graffiti.

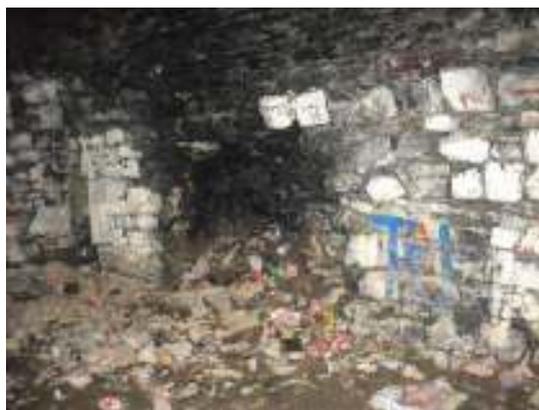
*Rush tower house*

Several of these monuments including Rush towerhouse, and Mooretown church are in the open space of large housing estates and in the case of Rush windmill, the open space of the village centre. Church ruins in historic graveyards can also become centres for drinking

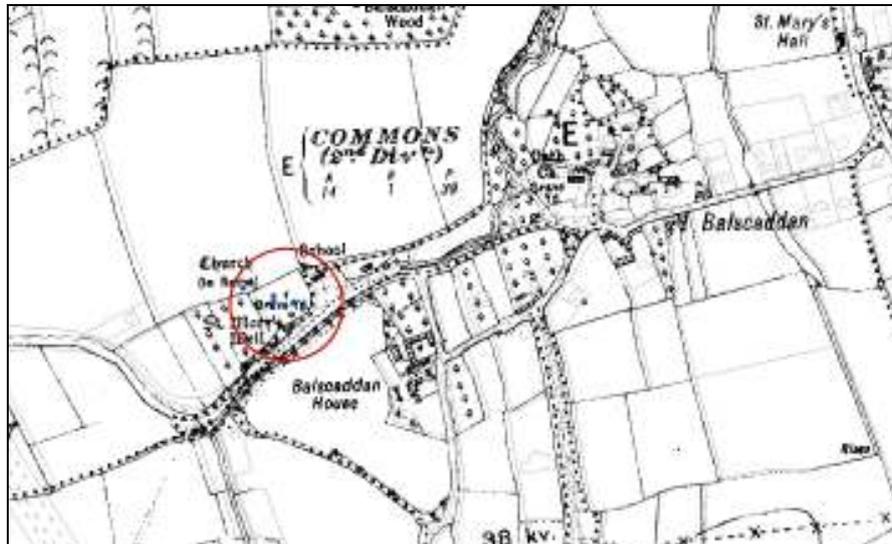
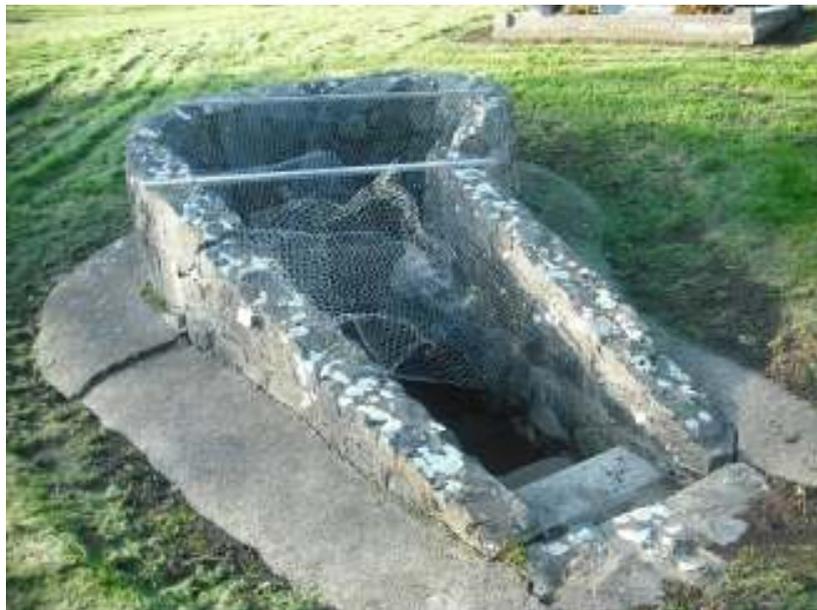
**FMA Report:** Located downslope from the church remains to the south of the graveyard. Currently the well has been 'improved' and is surrounded by a stone wall 'funnel' set in concrete with 5-6 granite steps downwards. The wall measures 2m from the top to the base and consists of <5cm water over silt. On return the well was full to the brim with water. Chicken wire and lathes had been attached directly to the top of the well.

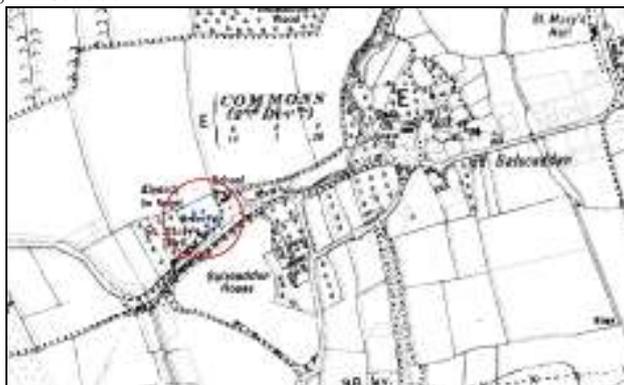
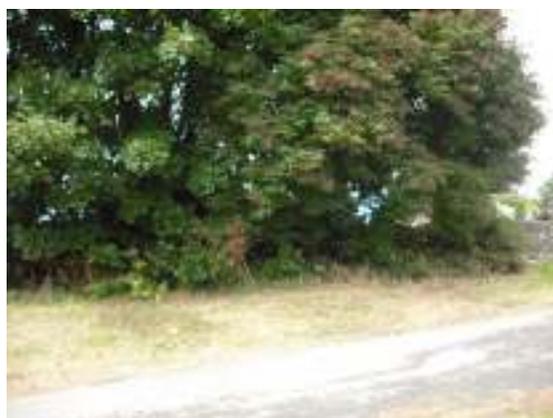
No. 5 **Balscadden Ecclesiastical enclosure** DU001-003-05

**FMA Report:** The south of the graveyard is enclosed by the bank which is particularly evident to the SE. It has however been punctuated by a house which appears recently extended and the bank has been replaced by a wooden fence. There is a significant drop to the exterior and the road. Well established tree on top.

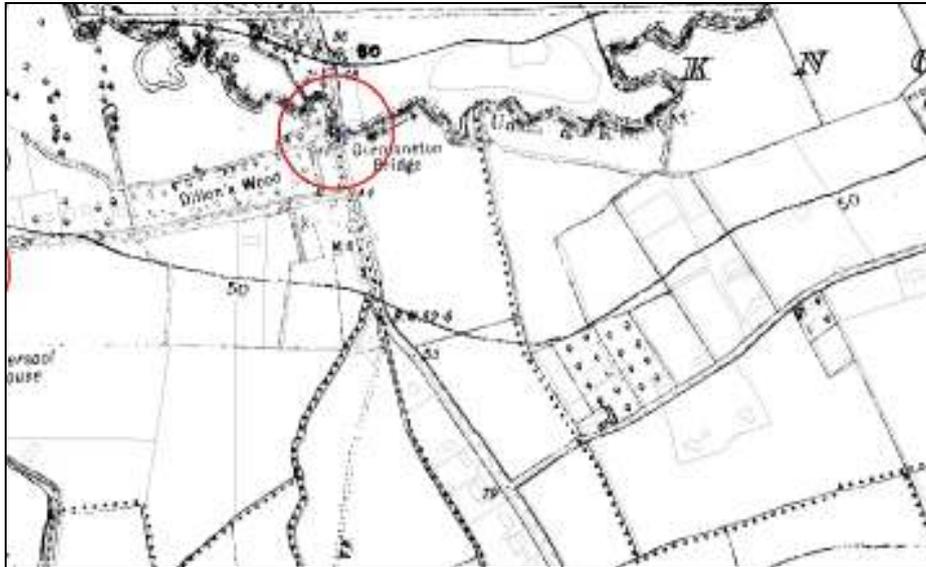
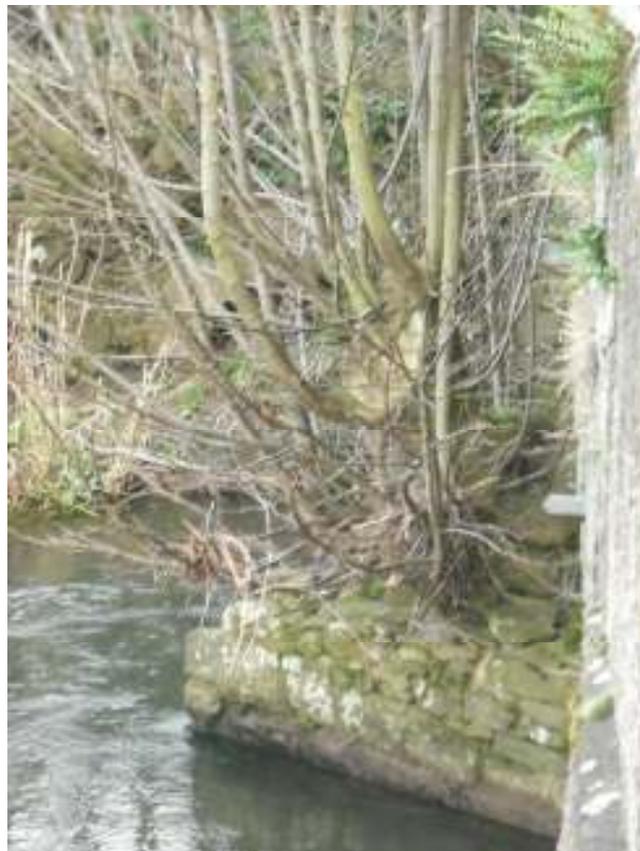
**Location:** Gormanston Bridge

**FMA Report:** Bridge over Delvin forms townland & county boundary. E. side large stone capping. W. built up. Extensive vegetation growth. Tree growing on cutwater which will destabilise masonry.

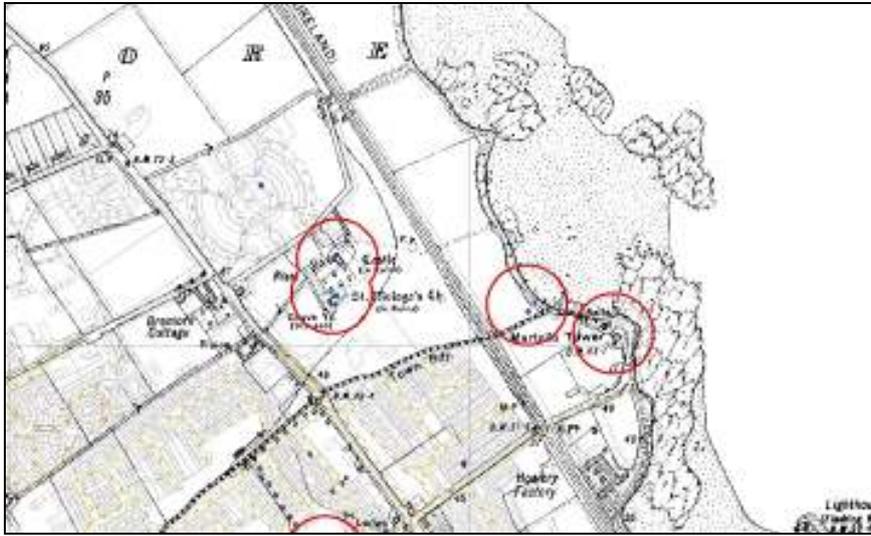
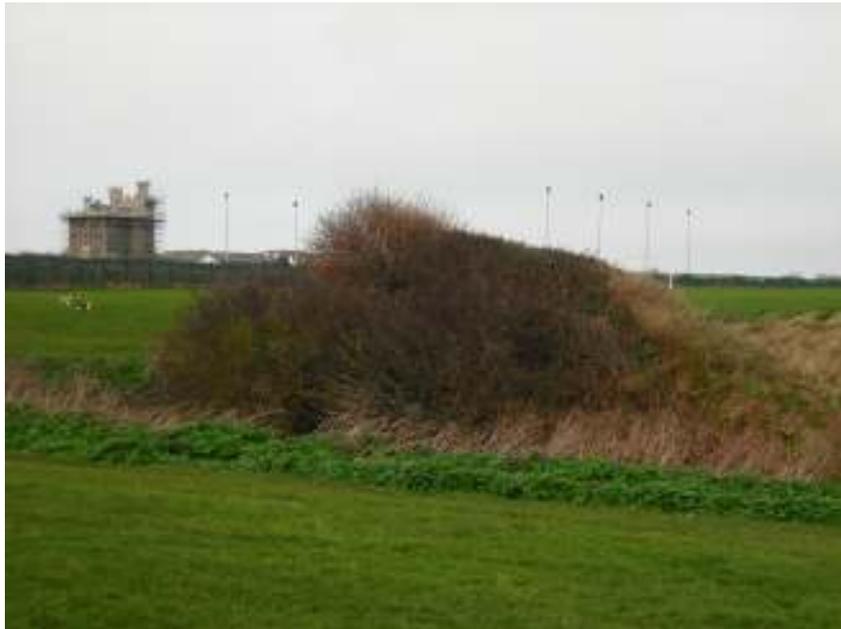
**Location:** South of playing pitches, Bremore, Balbriggan

**FMA Report:** RMP co-ordinates are incorrect. Mound almost at cliff edge to the south of FCC playing pitches. Completely covered in vegetation. Pedestrian path to beach passes it to north, drainage to south.

**Future Objectives:** Establish the extent of the archaeological remains through geophysical survey.

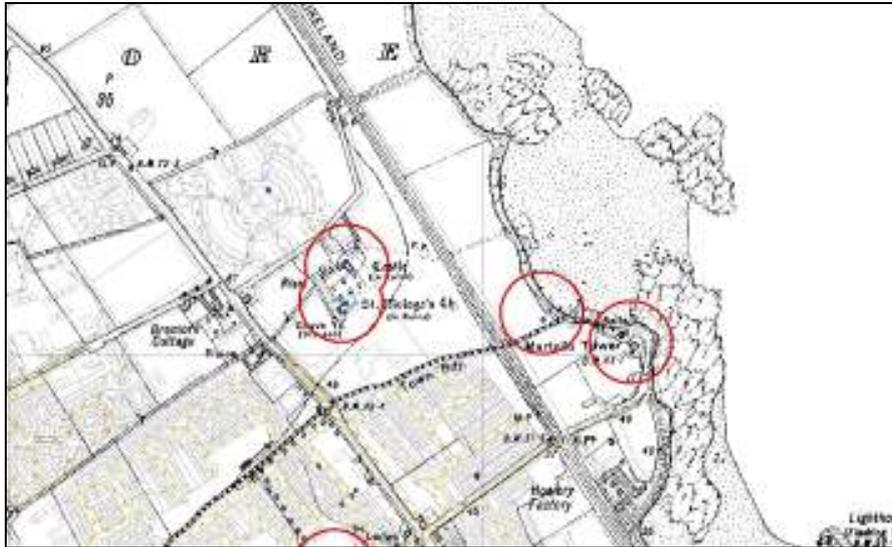
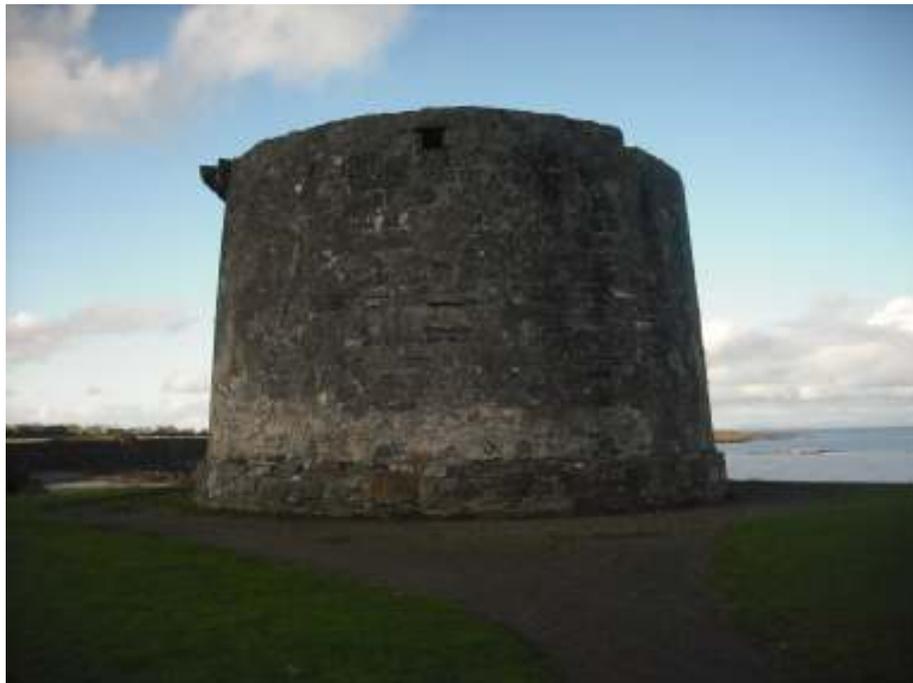
**Location:** Kings Strand, Bath Road, Balbriggan

**FMA Report:** Top removed in 1920s-stone used for houses on Main St. opposite Texaco garage (M. Lynch pers comm.). No access and some graffiti.

**Structural Survey 2011:** The construction of the tower is so robust and massive that it has considerable resistance to decay. In the longer term it may be vulnerable, depending on the level of protection provided to the roof when the top was removed.

- Possible water damage

- As the site is within the ownership of FCC, Ministerial Consent will be required PRIOR to the commencement of ANY works. Consent will require a detailed plan of works to be undertaken.
- Establish source of water damage

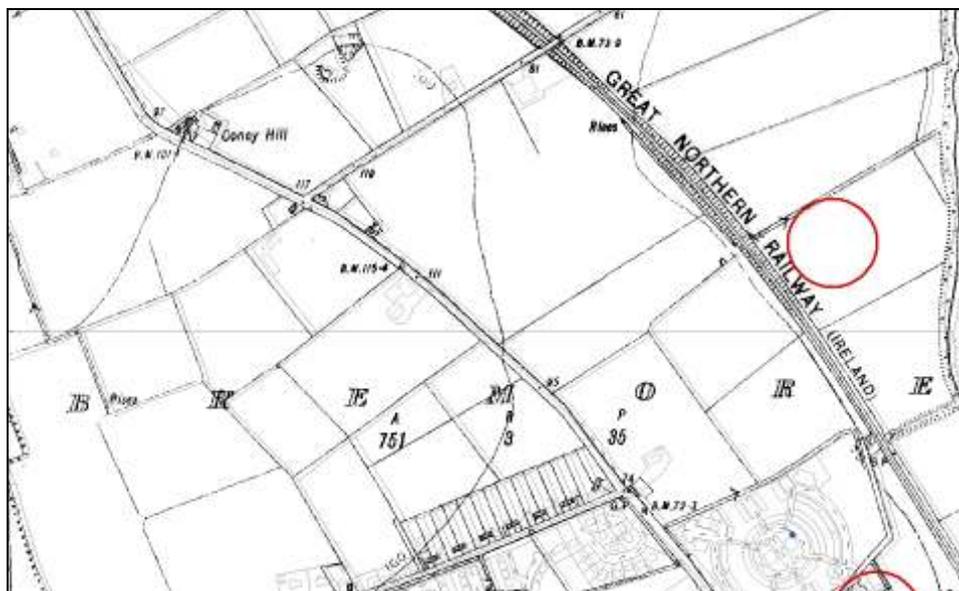
**Location:** East of railway line, north of Bremore castle complex

**FMA Report:** Possible sub-surface remains. Within council openspace scheduled for proposed coastal walkway.

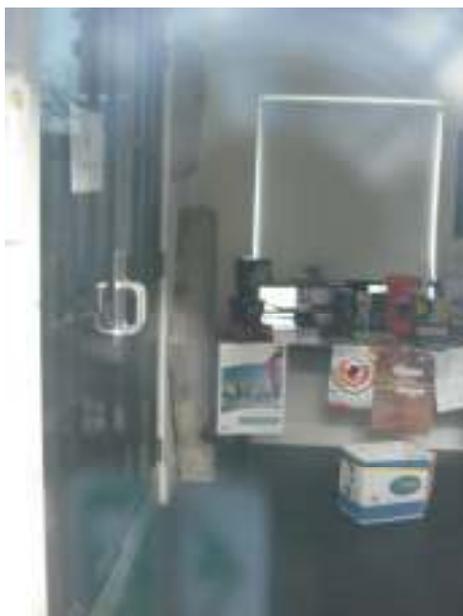
**Location:** Garristown Library

**FMA Report:** Two parts of the effigy are now on display in Garristown library-the whereabouts of the third piece is unknown.

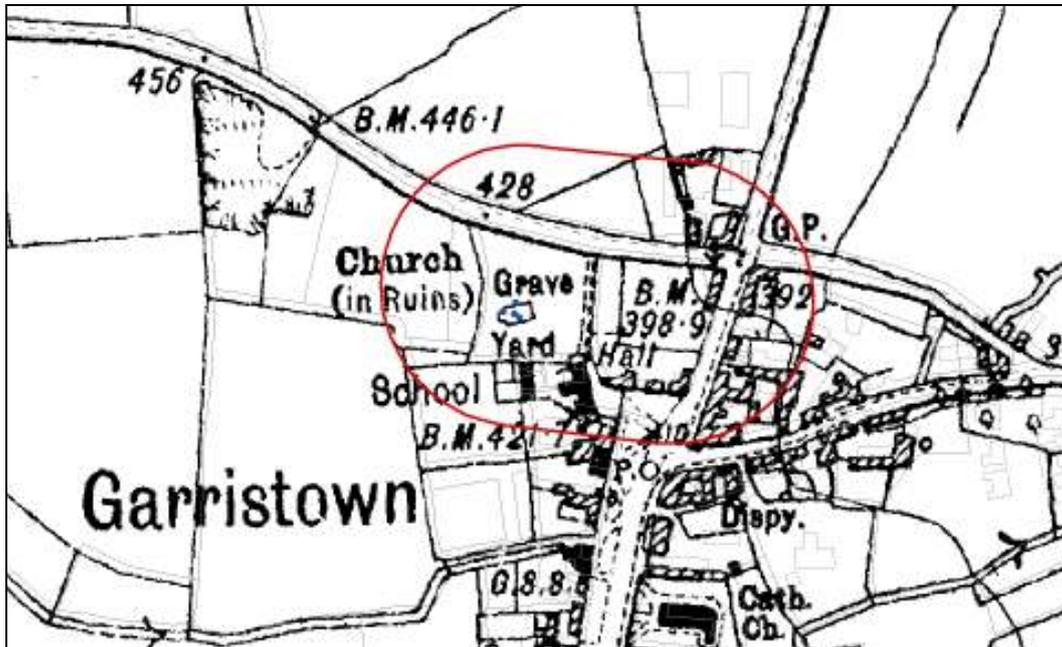
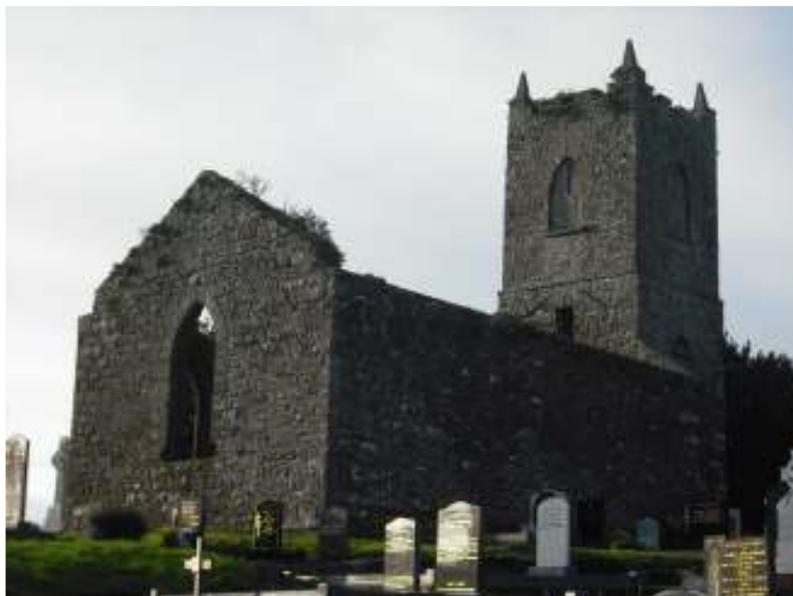
**Location:** Garristown Village, west of R130.

**FMA Report:** Church as described on RMP: Belfry being used for dumping graveyard detritus. The ubiquitous ribbon pointing in evidence. Located almost at top of E facing slope with extensive views.

**Future Objectives:** Information signage.

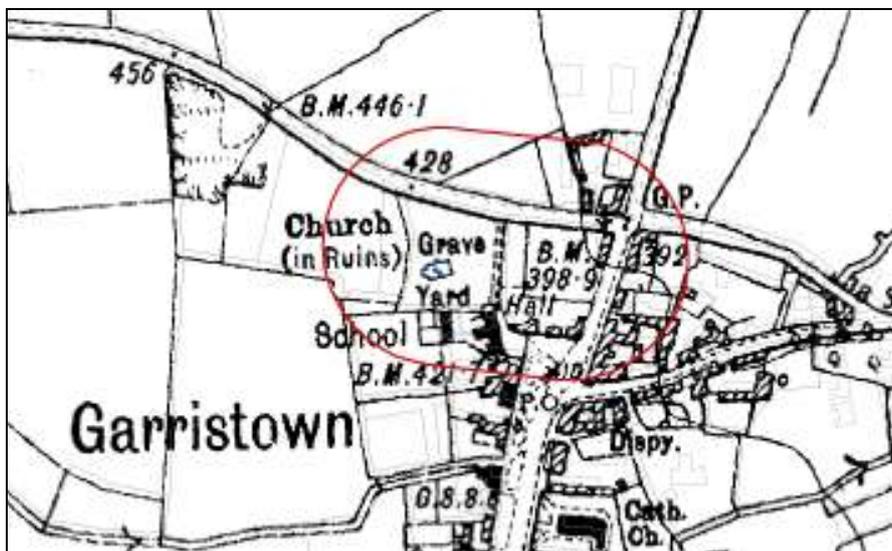
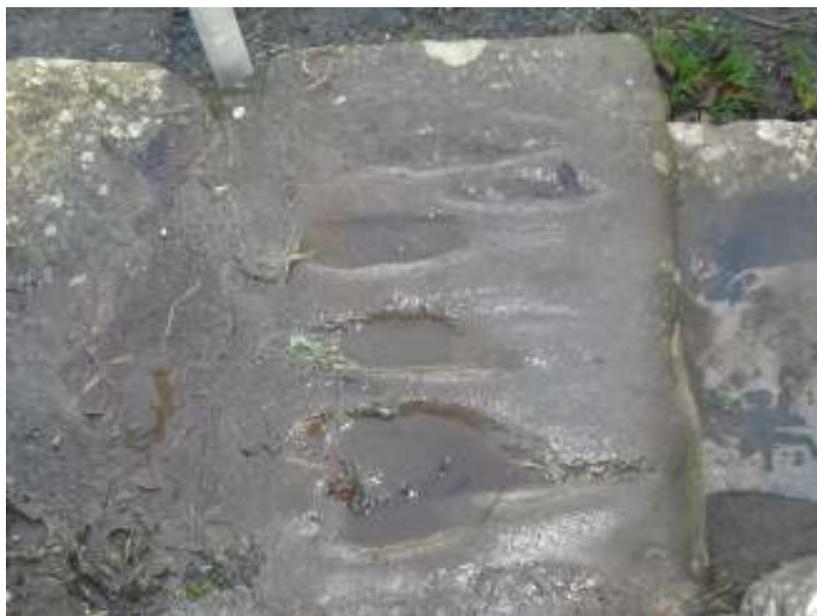
**Location:** Garristown Village, west of R130.

**FMA Report:** Its position on a stile will result in wear. Railings have been inserted at stile but did not damage stone.

- Damage and erosion through use
- Weathering-water tends to pool within the features of the whetstone.
- Lack of awareness to its presence and significance

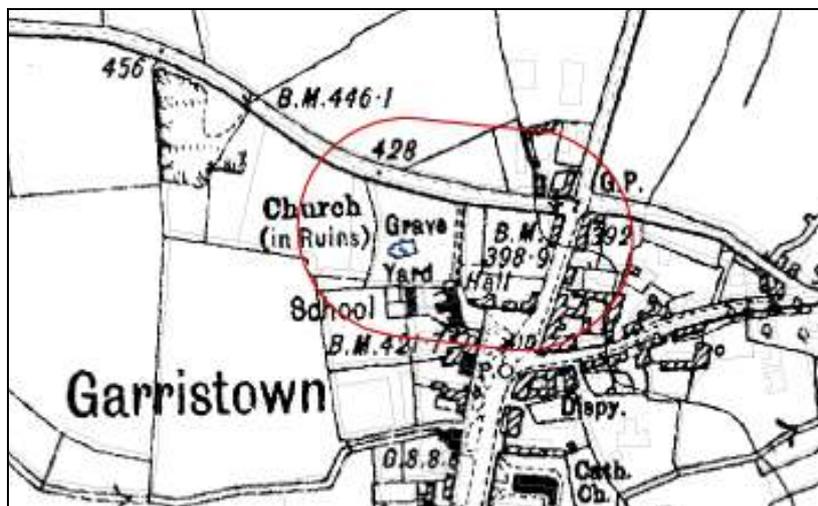
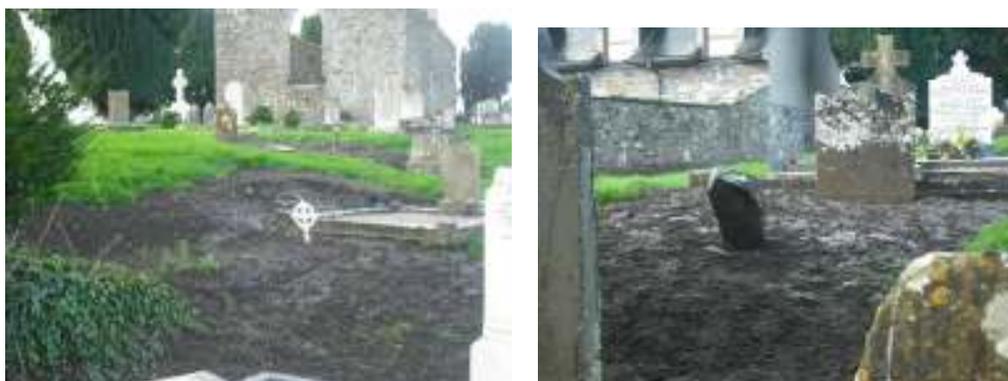
No.13                      **GARRISTOWN Graveyard**      DU003-011--03

**FMA Report:** Contained by modern stone wall. There appears to be a terrace/boundary? in field immediately to E. Graveyard has been extended to W. Gravestones a mix of modern and some earlier gravemarkers. Eileen Brosnan with the Garristown Historical society have produced a leaflet about the gravestones Road is to the N and new builds adjacent to graveyard wall to the S. Extensive use of weedkiller has resulted in denided spreads of mud.

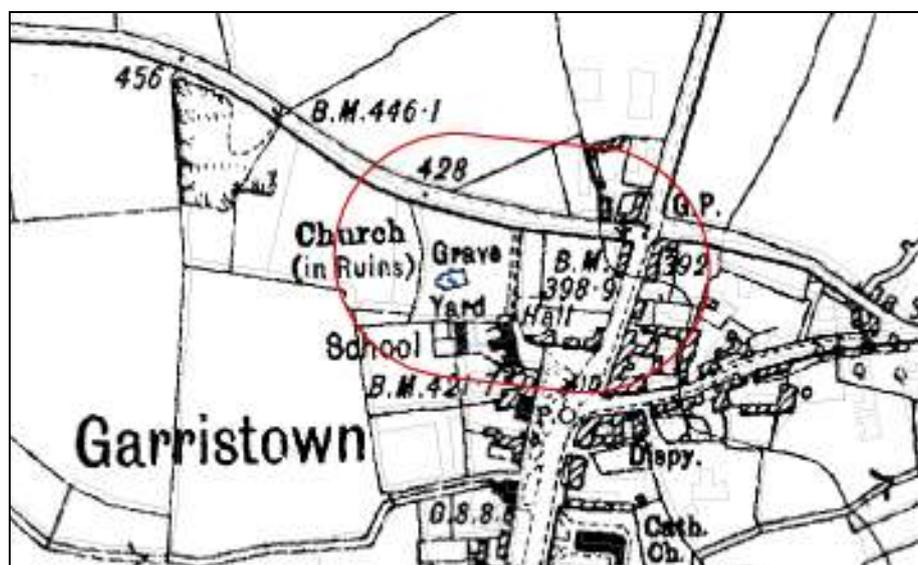
No.14 GARRISTOWN Tomb fragment Original Location DU003-011--04

**FMA Report:** Mary McMahon undertook to supervise the lifting of the slabs in 1990. Slab A - female effigy fragment Slab A measures 1.18m long by 1m wide and consists of the lower half (below the waist) of a female figure. Her heavy woollen skirt falls in regular parallel folds to her feet. The front is raised to reveal a smock underneath. Her feet rest on a tasseled cushion. The skirt measures 0.39m wide at the top and 0.7m at the bottom. There is a raised band, c. 100 mm wide, along the right margin of the slab, but there is no sign of an inscription on it. The lower left corner of the slab is broken away. Slab B- side slab of a tomb chest Slab B, which is broken at one end, measures 1.6m long by 0.64m wide.

**Future Objectives:** Information board to indicate significance.

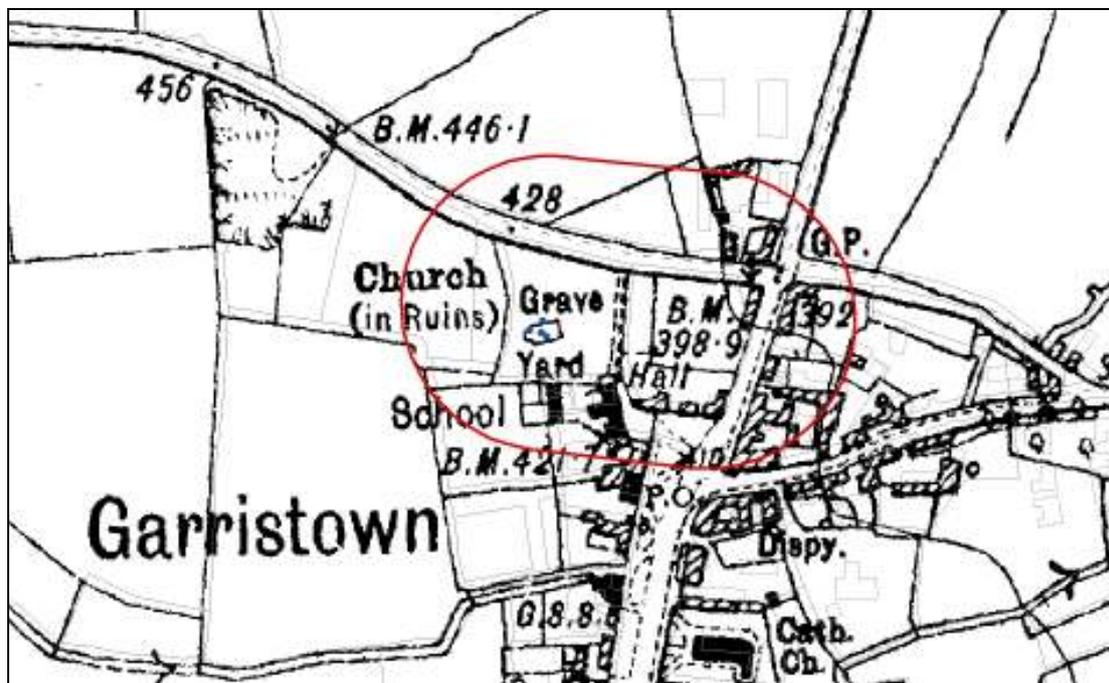
**Location:** Within the graveyard.

**FMA Report:** Located using GPS-no evidence of sink hole or slop stone

**Future Objectives:** Information board to indicate significance.

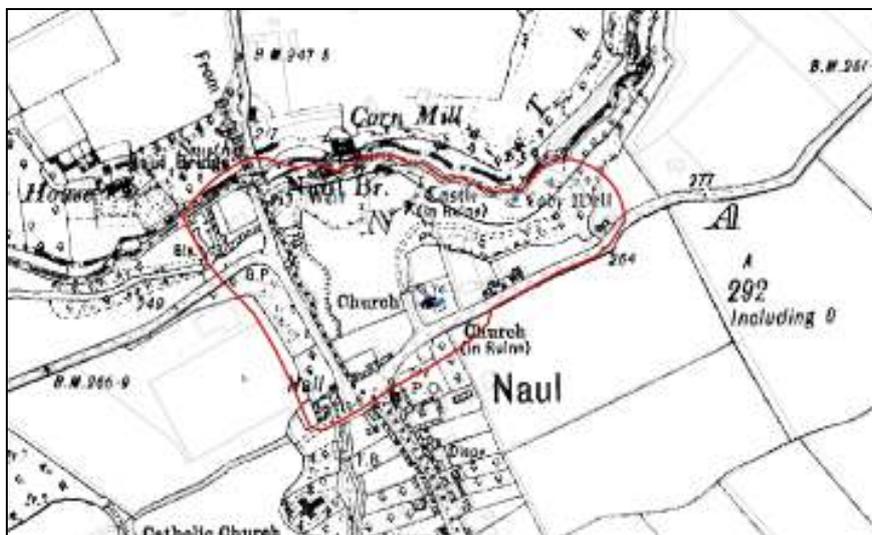
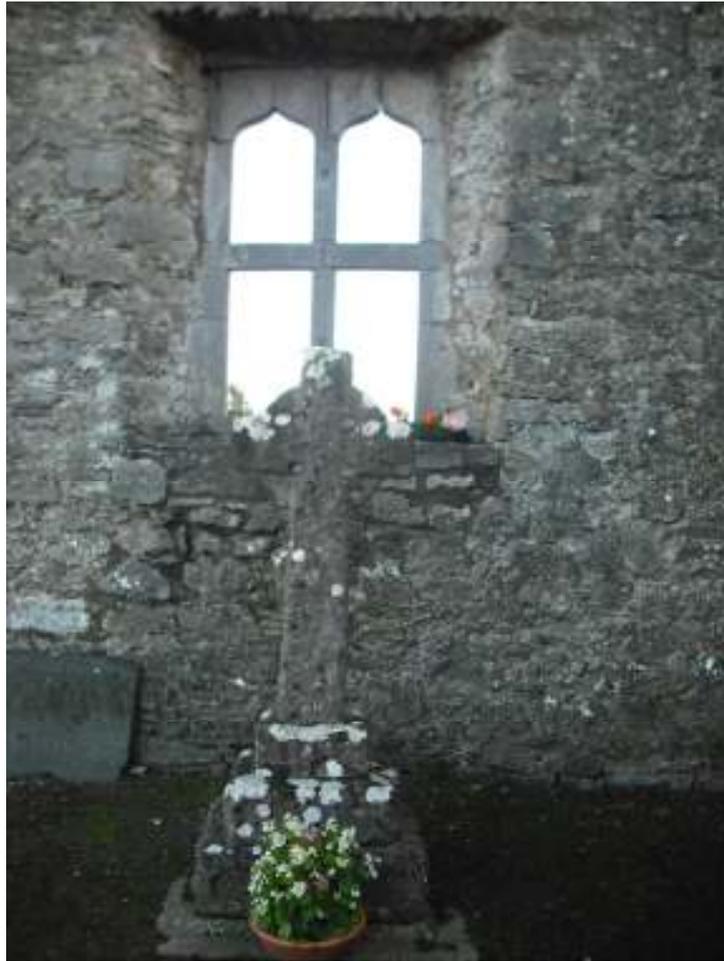
**Location:** Naul Village

**FMA Report:** Located on high ground on Eastern approach to the village, SE of the Black Castle. Double ogee-headed window in eastern gable. Shield in sill. Plaque above northern door. Proportions of the upstanding remains are all wrong-supposedly the northern wall never built. Cross in interior. Light vegetation growth along tops of walls.

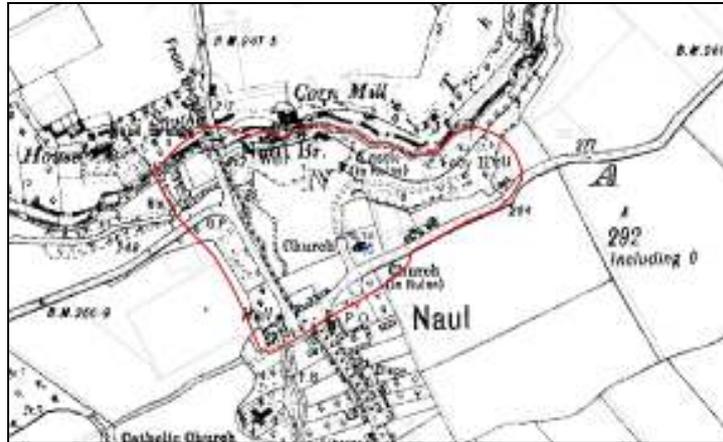
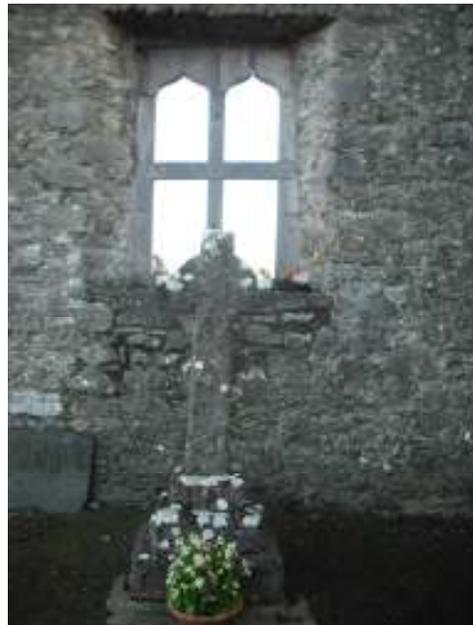
## NAUL Church DU004-010-02

**FMA Report:** Cross in interior. Some lichen growth.

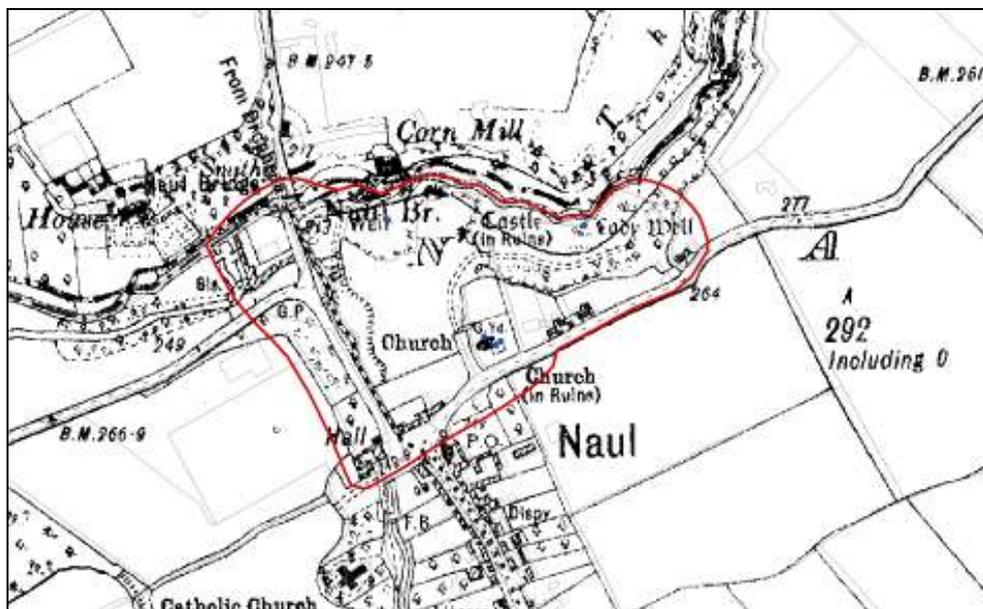
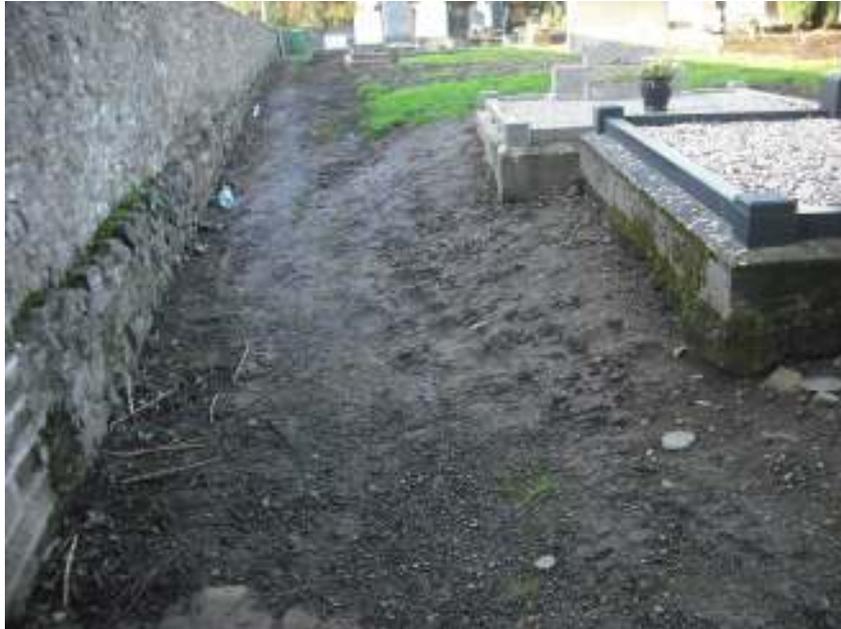
**Location:** Naul Village

- Overuse of weedkiller has created extensive denuding

- Stop use of weedkiller

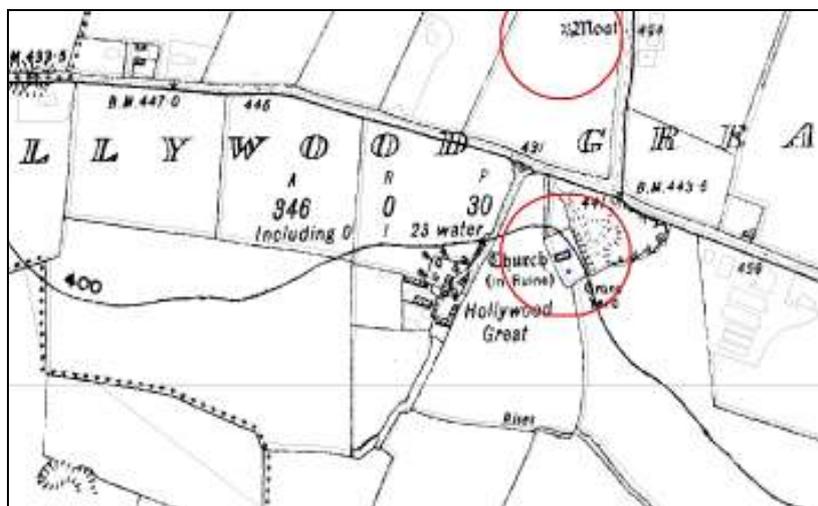
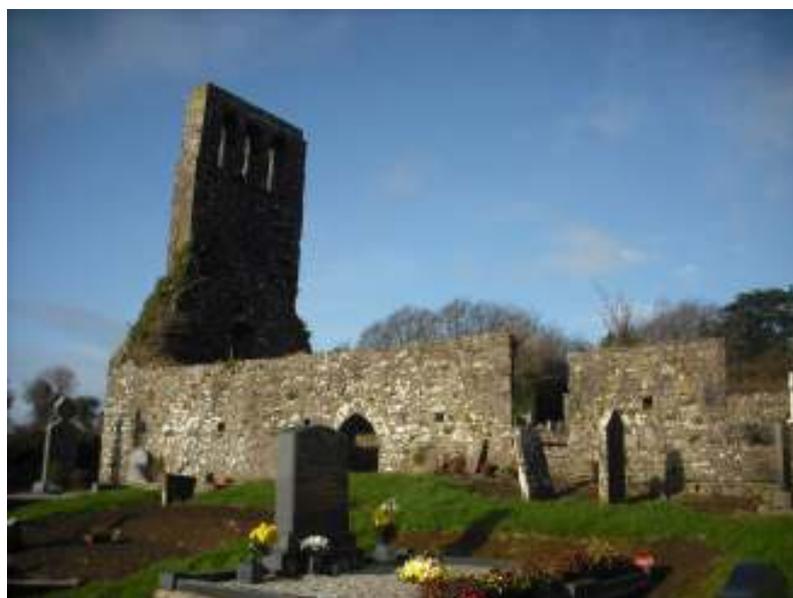
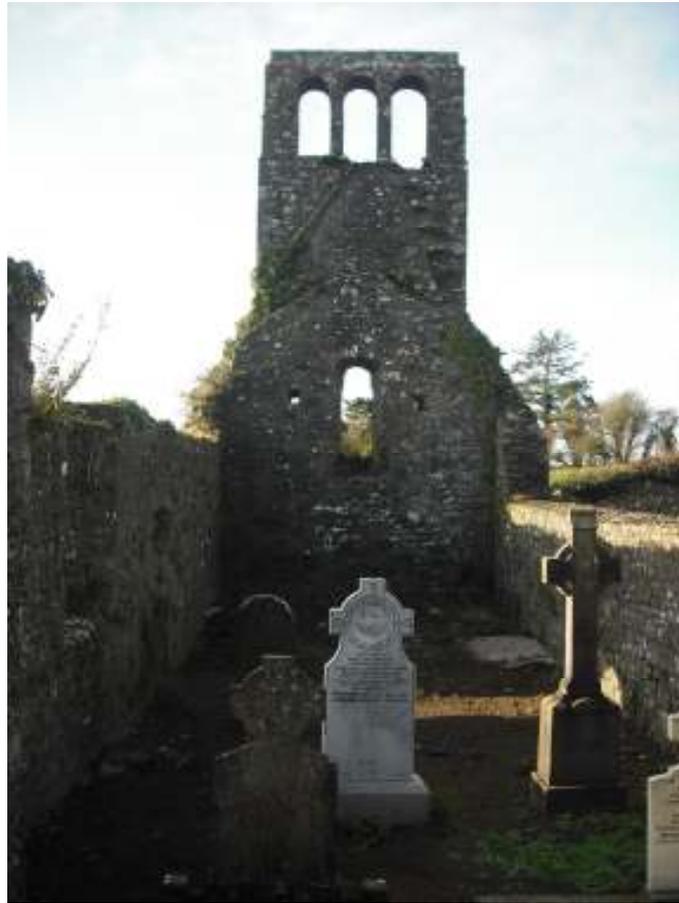
**Location:** Hollywood Great, Naul

**FMA Report:** Located towards the base of a steep slope with extensive views S. to the Dublin Mountains. Has been "improved", the dreaded ribbon pointing much in evidence. Aligned EW, triple bellcote at W gable. Internal burials. Dated to 1275 and belonged to the Priory of Llanthony. Some wash-out of mortar at base of west gable. Vegetation growth in mortar and long top of walls and gable.

- Vegetation
- Mortar wash-out

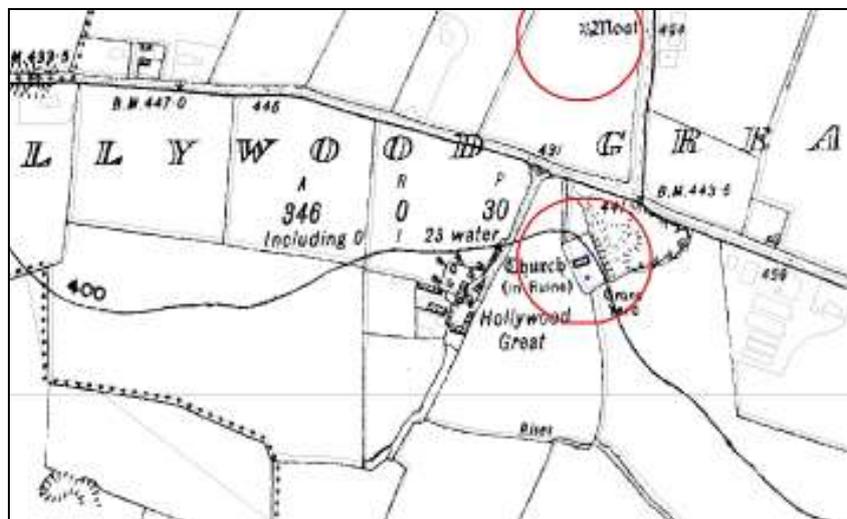
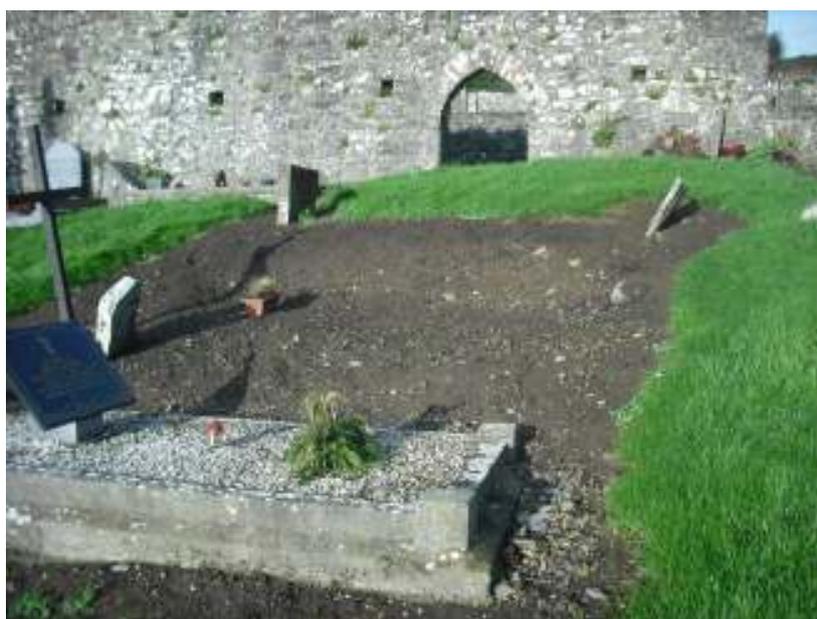
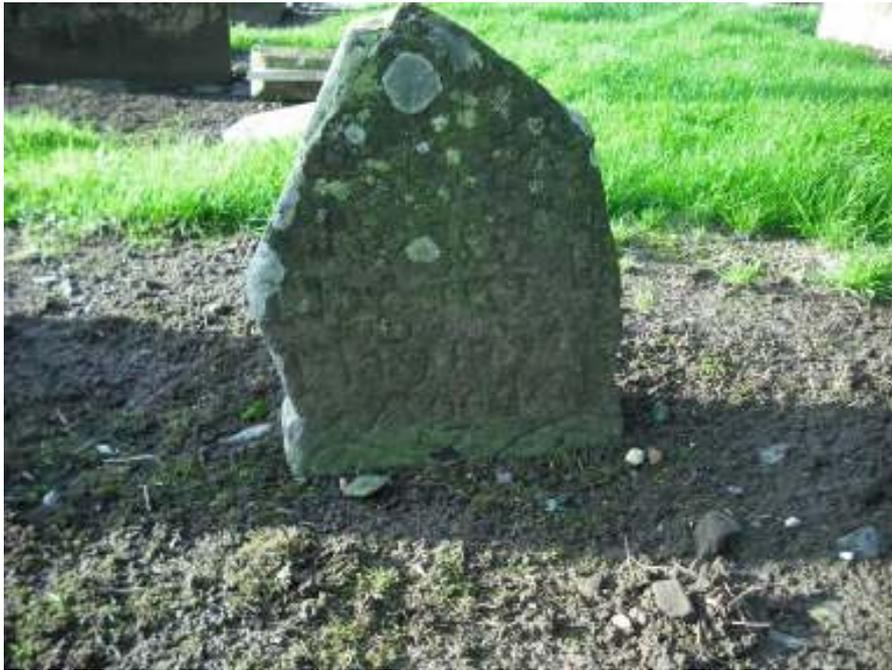
No.19 **HOLLYWOOD GREAT Graveyard** DU004-023-02

**FMA Report:** Graveyard Square in plan, defined by substantial stone wall. Ground slopes down from N to S, (church located c. half way), and slopes down into SW corner. Entrance NW corner-lane to road defined by stone wall to E and hedgerow W. Vast swathes of slope have been subject to weedkiller and have become denuded.

- Denudation caused by extensive weedkiller

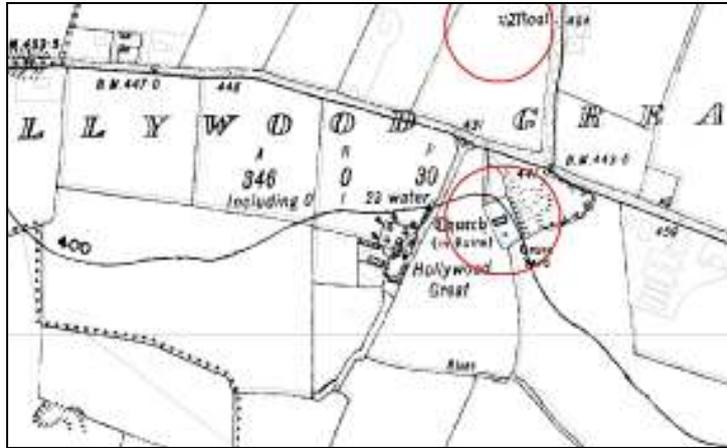
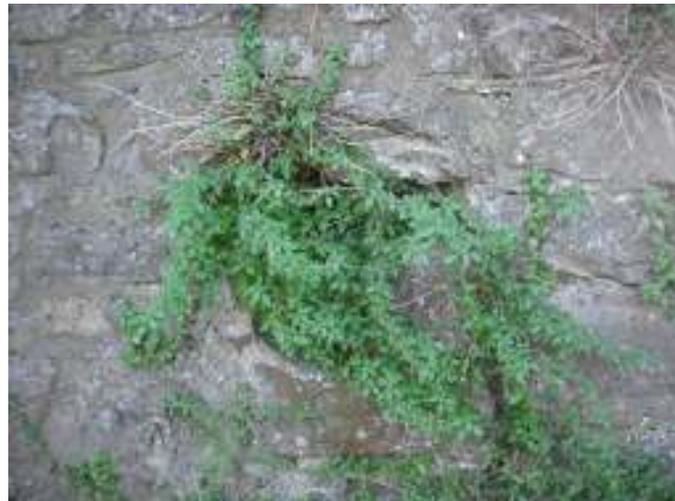
**Location:** East of doorway, interior of southern façade.

**FMA Report:** The stoup has been reset-cement visible 0.31m in height x 0.42m in width. Overgrown.

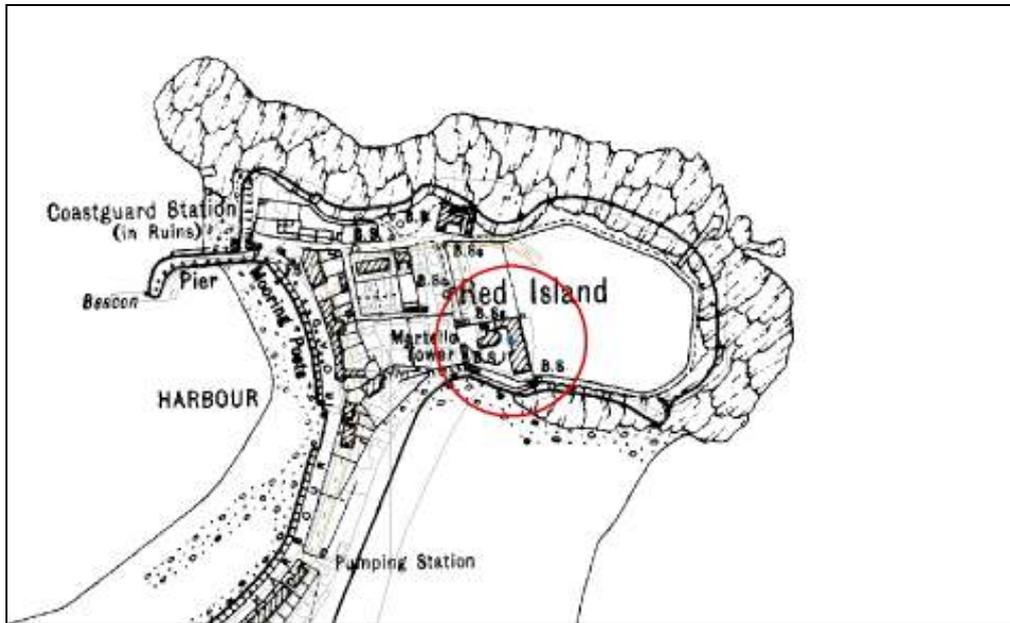
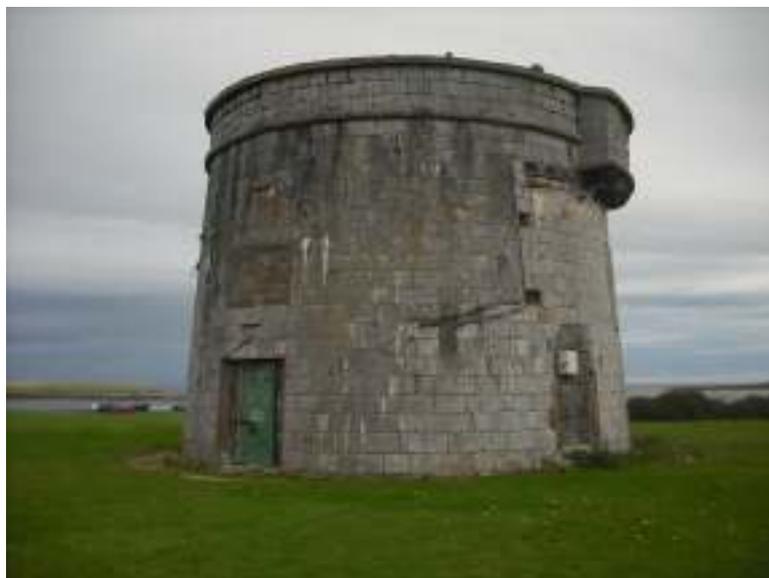
**Location:** Red Island, Skerries

**FMA Report:** Elevated position has been surrounded by a stone faced wall-adjacent to Red Island carpark. Maintained grass in immediate vicinity and door secured. Some gaps in concreted in windows. Grass growth on roof.

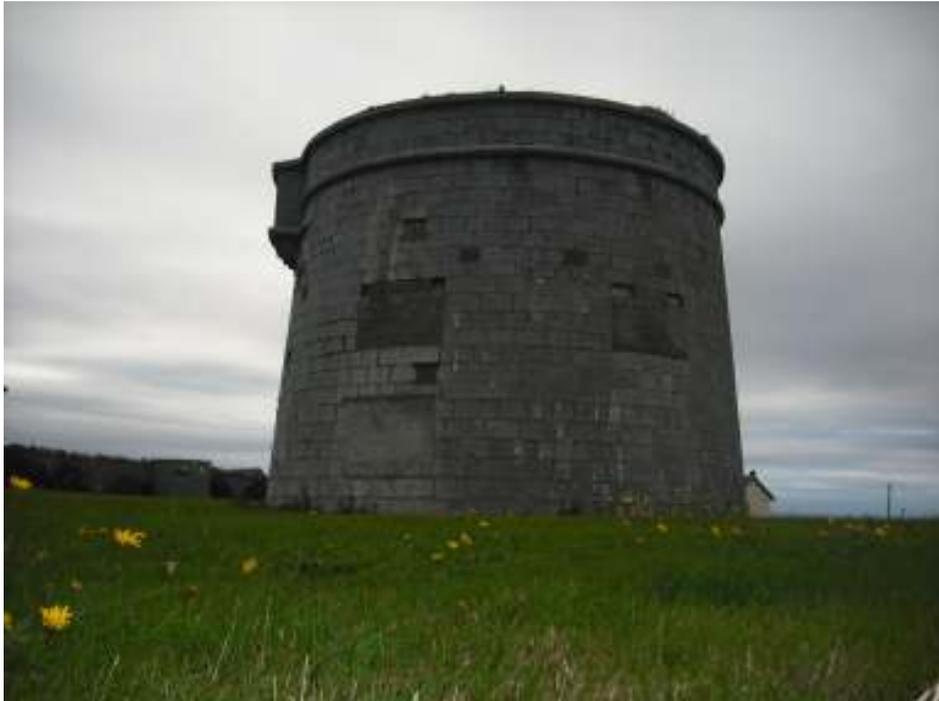
**Structural Report 2011:** At high level there is moss growing in the joints which is evidence of dampness of the walls.

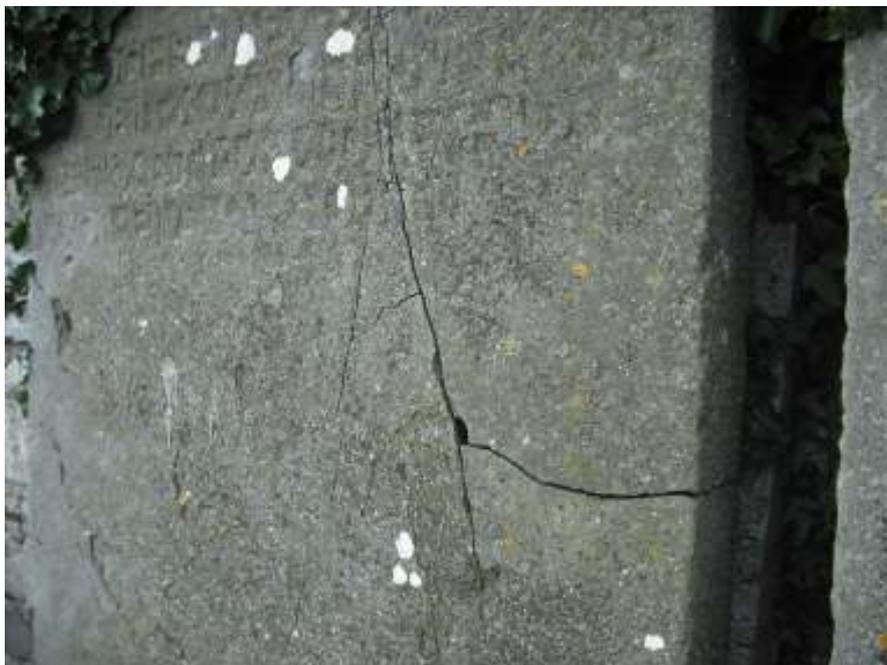
**FMA Report:** Peter Mann (e)1520. Located to set in concrete against S wall of bell tower. Some lichen growth and weathering but in relatively good condition. Peter Mann one of the last priors of Holmpatrick. Stone slab with cross inscribed *Hic Jacet Petrus Mainn Olum Prior Huus Dominus Cuis Anximae Propicitur deus qui Obit Anno Christi MVXX*. Translated by Rev. William Carrigan CC 1907.

Here lies Peter Mann formerly Prior of the House on whose soul God have mercy. he died in the year of Christ 1520. Delahoyde (Delahide) stone 1587. Located adjacent to the Mann stone. TV Steele in 1893 found that the stone was lying below 2ft earth and he had it dug up and cleaned. Two shields to the right of which is a hole. Described by stone cutter in 1893 as a 'wart-hole'. he remembered a time when people of Skerries would put their hands therein in order to cure warts. Manne stone is in good condition. Delahide stone has cracks of unknown origin that have not undergone remedial works and have spread. Ivy growth has become established.

- Vegetation
- Cracking and weathering
