*Managing Fingal County Council's  
Archaeological Resource*

Christine Baker  
Field Monument Advisor

March 2012

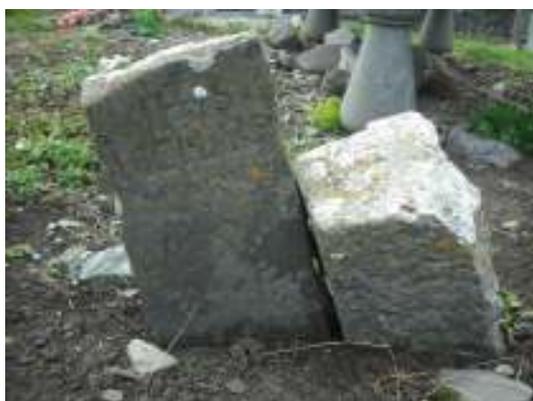
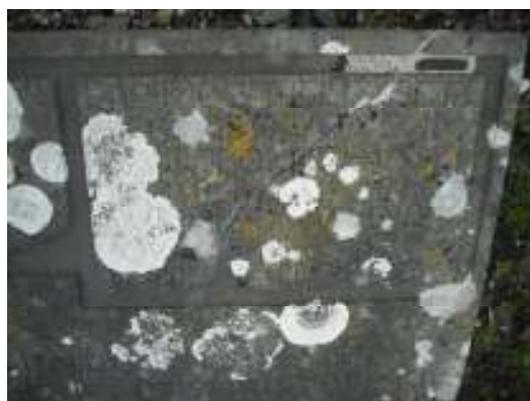
**RMP Report:** Hussey stone 1577. Large table tomb set on a modern pedestal north of bell tower. Inscribed *Hic Jacet Elizabeth Finglas quindan uxor Thomae Hussei de Holmpatrick generosi que obit xxvii die November AD 1577 Quivis air ppciatur.* Arms of Hussey impaling Finglas and initials T.H and E above. Stonecutter 'improved' the description in c.1940s. Only upper quadrant of the graveslab occupied by 1577 inscription-remainder Grimes family. Richard Farrell 1691. Located west of the Hussey tomb. Good condition.

**FMA Report:** The Hussey stone was 'improved' the description in c.1940s. Only upper quadrant of the graveslab occupied by 1577 inscription-remainder Grimes family. Extensive use of weedkiller around the Farrell stone.

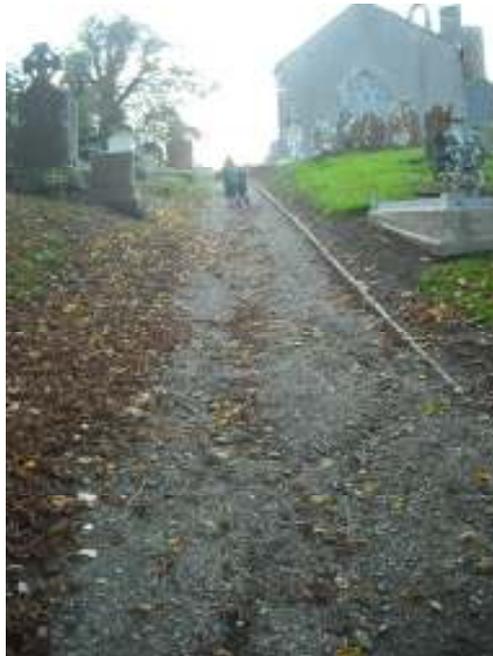
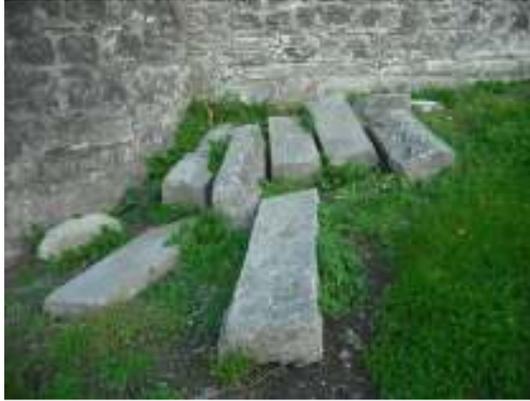
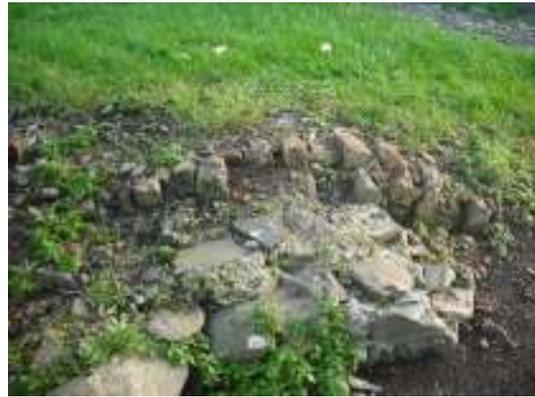
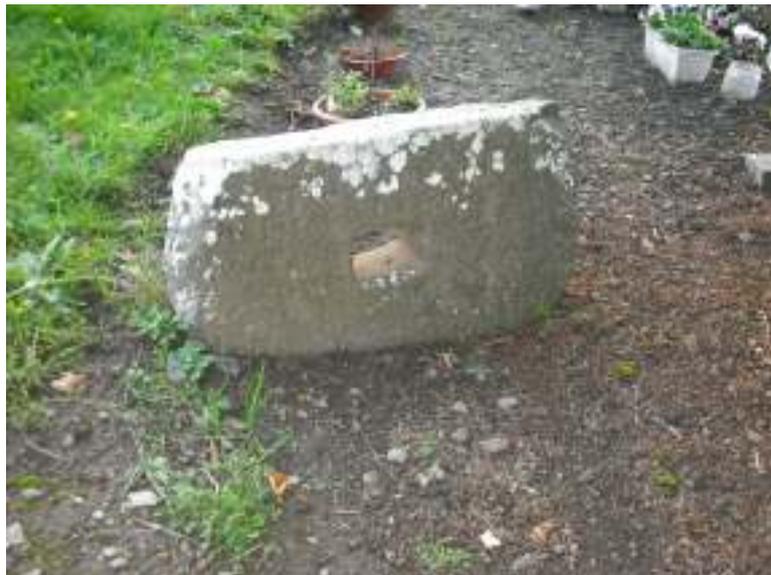
**FMA Report:** Slopes down to W, N and E. Extension made to the Northern limit by Fingal County Council-geophysical survey carried out prior to works. Graveyard contains a mix of 18th century to modern gravemarkers. Excavations to the south (1999) uncovered burials beyond the present line of the graveyard wall. Steep path up to church has suffered degradation from water drainage uncovering tree roots. Stone dumped to the rear of the tower. Hamilton crypt to the north of the church becoming uncovered. Extensive use of weedkiller has created unsightly earthen patches.

- The access path is dangerous.
- Over use of weedkiller
- Exposure of crypt

- Appropriate remedial measures on footpath
- Stop use of weedkiller
- Returning of crypt

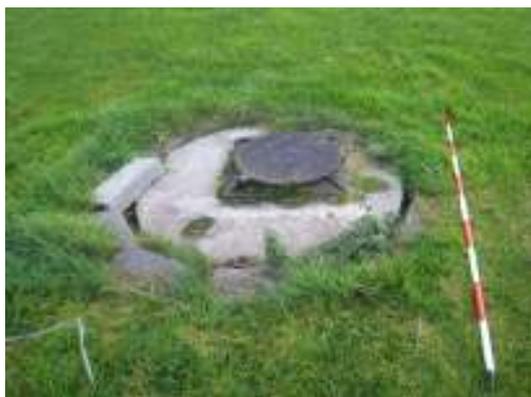
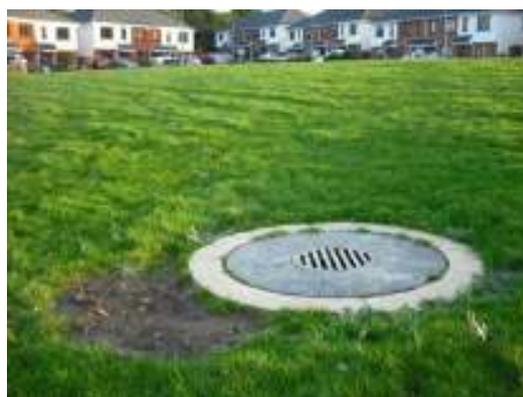
**FMA Report:** Holy well located within a field of enclosures. During the housing estate construction the well covered in with concrete capping—ash tree also removed. A new cover has been installed.

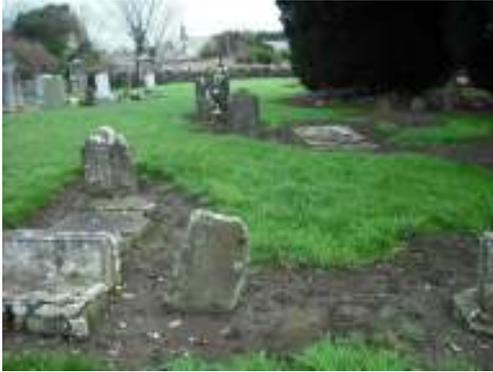
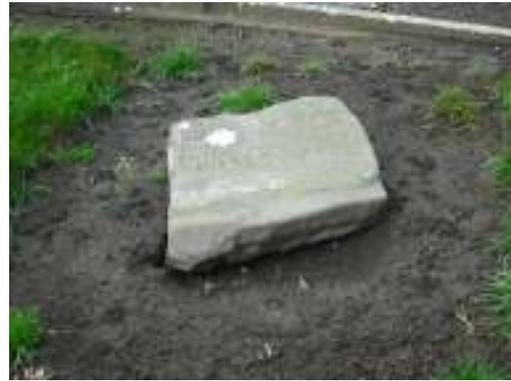
**FMA Report:** Graveyard defined by stone wall, square in plan. Significant drop to surrounding land to W and S. Interior perimeter path. Possible architectural fragment to Se corner of graveyard adjacent to Smith grave. Overall mix of gravestones 18th century-modern. Remains of stone wall/building immediately N of graveyard wall-may have reused stone from Church. Use of weedkiller has created muddy expanses between concrete path which is very cracked in place and the graveyard wall which is showing evidence of mortar wash out.

- Trees and ivy have become established along the east wall possibly causing destabilisation
- Washed out mortar from walls and possible external bulging.
- Uneven concrete paths may be indicative of soil shifting
- Use of weedkiller has created muddy patches

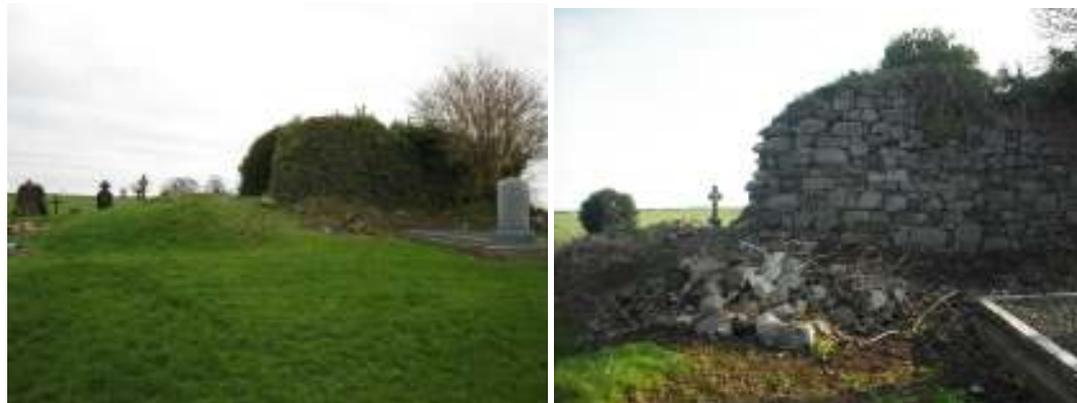
*Grallagh church facing north 2008 & 2011*

Church aligned EW at highest point in sub-rectangular graveyard. The east end of church contained by concrete wall - area of significant collapse which is contained by two courses of a dry stone wall to north. North and south wall defined by a rubble bank. One gravestone internally. West gable standing to base of window height. The gable was identified as being overgrown by ivy with signs of collapse in 2008. By the 2011 visit the ivy had been pulled from the gable removing masonry and there was a collapse internally. Part of the window noted by Walsh is now visible.

- Vegetation is destabilising the masonry of the remaining structure.
- Unmonitored ivy removal has resulted in masonry collapse.
- Use of weedkiller has exposed the earthen banks and caused slippage.
- The mounding of earthen banks and collapsed masonry obscured the walls of the church and their level of survival cannot be assessed.

- An investigation of the earthen mounding, its origin should be undertaken. If resources can be found an archaeological excavation would establish if the walls of the church have been obscured by the mounding of earth and masonry.
- The significance of the site should be highlighted with signage.

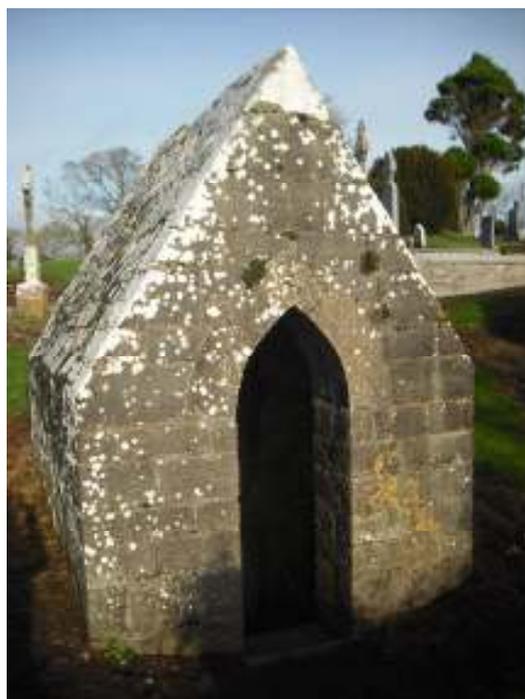
**FMA Report:** The well site has remained unchanged, other than being treated at the base with weedkiller and light vegetation growth.

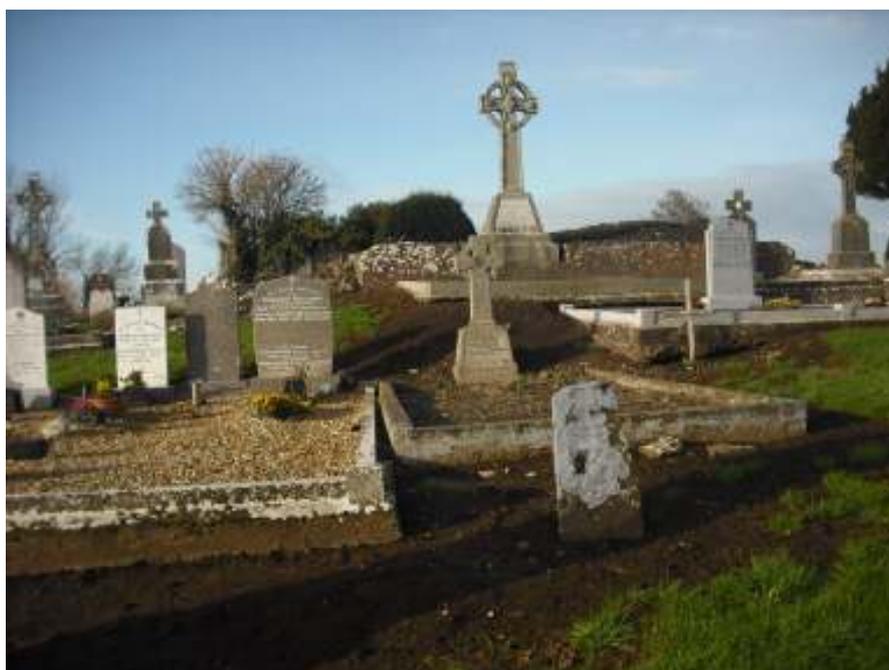
*Grallagh Graveyard 2011*

**FMA Report:** Graveyard defined by deep ditch to N,W, S and by wall along the roadway. Well established hedge line to W and S. Prominent area where church is located. Internal perimeter concrete path and lawn layout to west. Overuse of weedkiller has caused denuded patches.

- Extensive use of weedkiller has caused denudation within the graveyard especially around areas of steep slope
- Use of weedkiller can cause damage to gravestones.

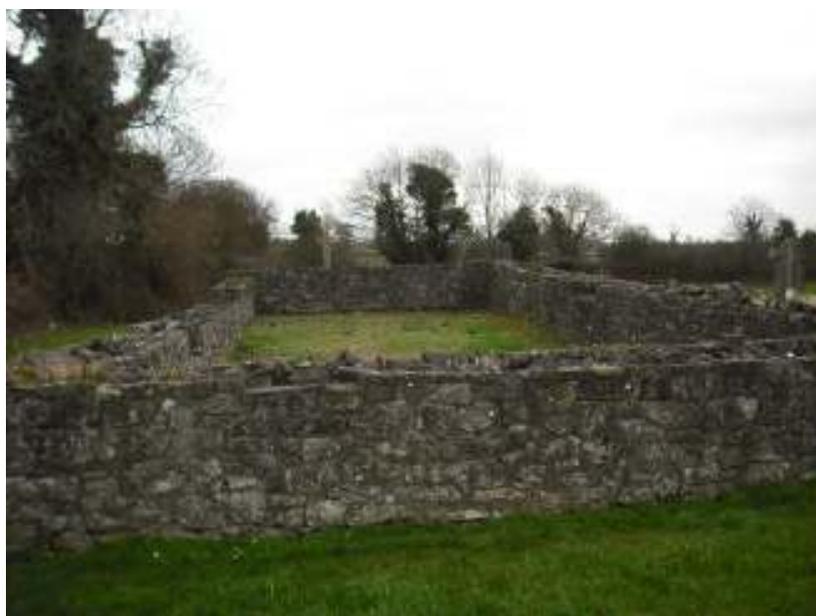
**FMA Report:** Located a field back from the Ballyboughil road. Church aligned EW-stands from 1m-2m in height c.1m wide walls. Base of 2 window openings along S. Chamfered doorway to N and large entranceway. High ground to S with NS undulations. Church on slightly higher ground with older gravestones in vicinity. The church has been ribbon pointed.

- The top of the walls are uncapped and the facades are pointed with concrete which may create internal decay.

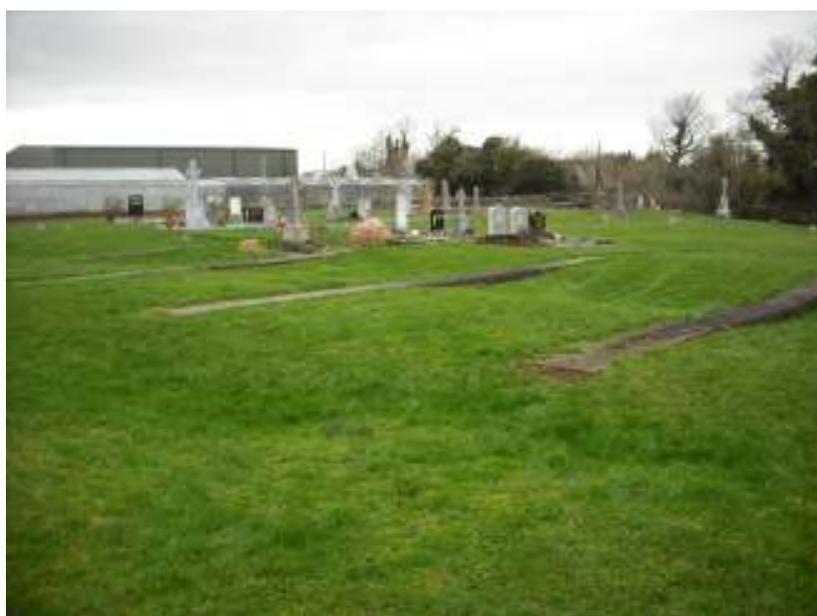
**FMA Report:** Located a field back from the Ballyboughil Road-access through Keogh's land. Church on slightly higher ground to north of graveyard. The graveyard has been expanded and is now rectangular defined by a low bank and well established hedgeline. To west one glasshouse. To north overgrown small field with modern bugalow beyond.

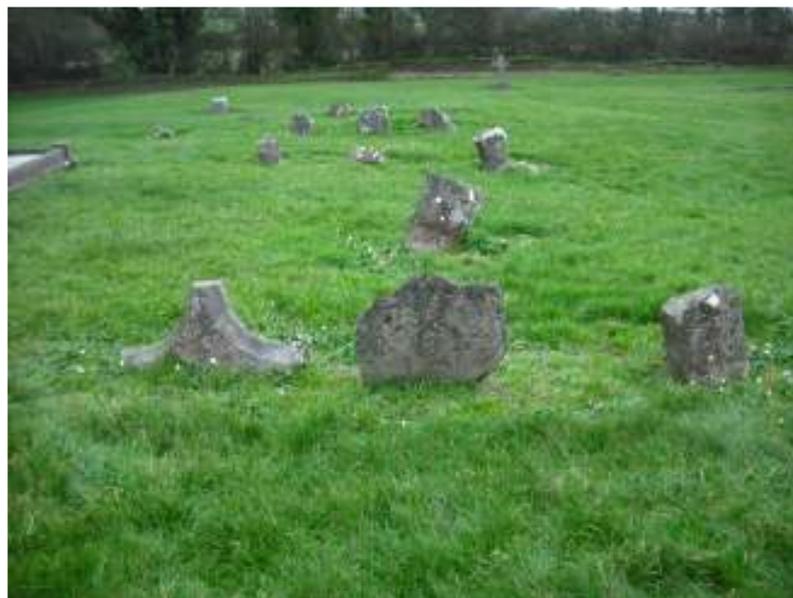
**FMA Report:** The architectural fragments have been placed in orderly rows south-east of the church.

- Damage from machinery used in grass cutting
- Removal

**Future Objectives:** A survey of the survey architectural fragments to provide an accurate record of their quantity, quality and current position.

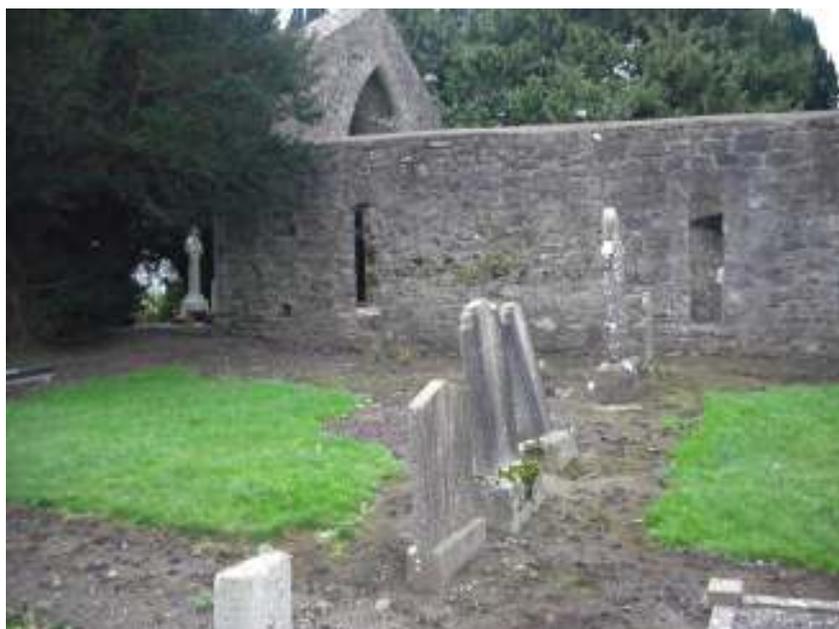
**FMA Report:** Graveyard entered by lane from main road. Church located in southeast corner of large expanded graveyard bounded by hedges, and wall at west perimeter. Graveyard slopes from north to south. Original line to west marked by a yew trees. External to the north is a playing pitch. There is a new headstone dedicated to the men of 1798 along south façade of church. Extensive use of weedkiller.

- Extensive use of weedkiller had created large muddy patches
- There are a number of broken headstones

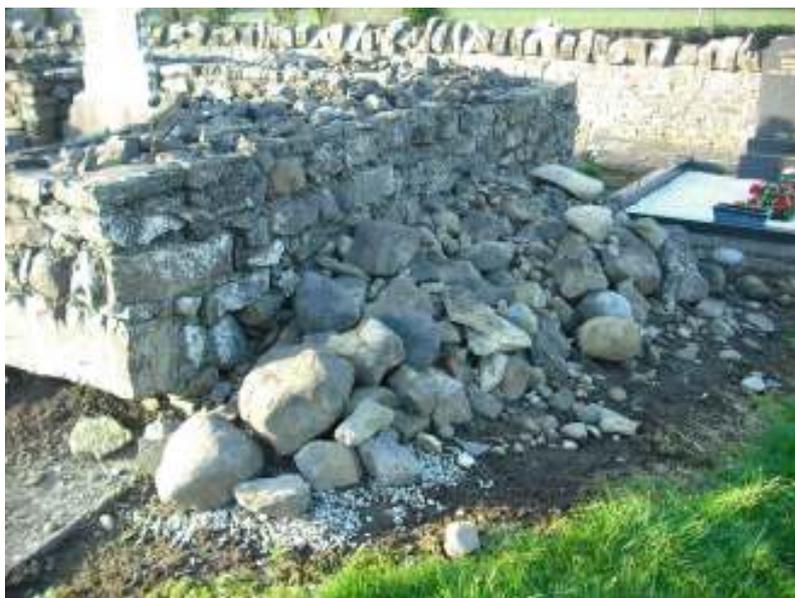
**FMA Report:** Church located at highest point within a circular walled graveyard. Survives in two parts divided by the insertion of modern gravesplots. W. limit-W gable to c.1m and NW possibly to door position. Rooney gravestone inserted into inner facade of wall (1906-1941). E limit:-E gable and N,S,E quadrants defined to W by more Rooney graves late 19th/early 20th century. Piling of stone to west and northwest of church.

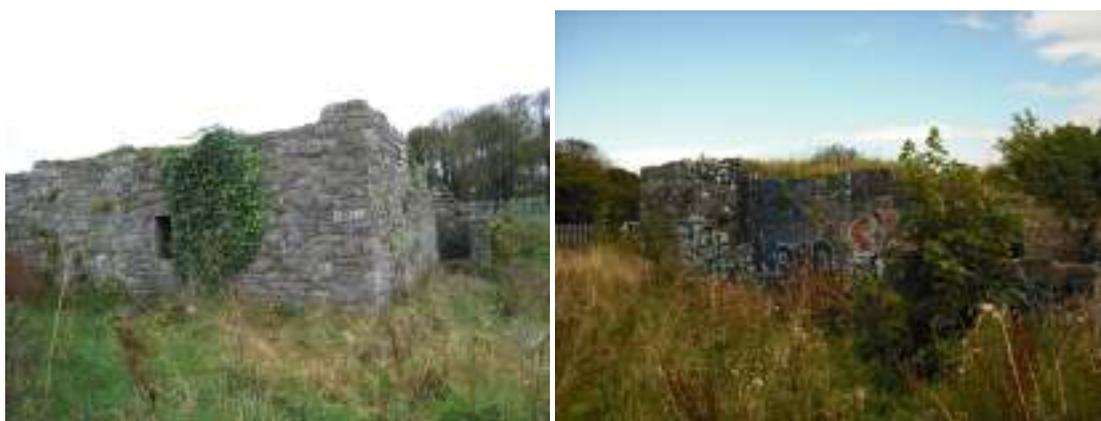
*Rush Tower House November 2007 and August 2010*

**FMA Report:** Currently surrounded by steel fence in open space outside St Catherines' housing estate. Fence has been vandalised and as such does not prevent entry. Lots of graffiti. significant ivy, grass, bramble growth. To north significant area of cut away. Internally the site has been used for anti-social behaviour, fires have been lit and it is strewn with bottles and graffiti.

**Structural Survey 2011:** The monument has been neglected and there appears to be a lack of ongoing maintenance. The extensive vegetation growth on the outside and the collapse of wall facings on the inside will lead to gradual degradation of the walls.

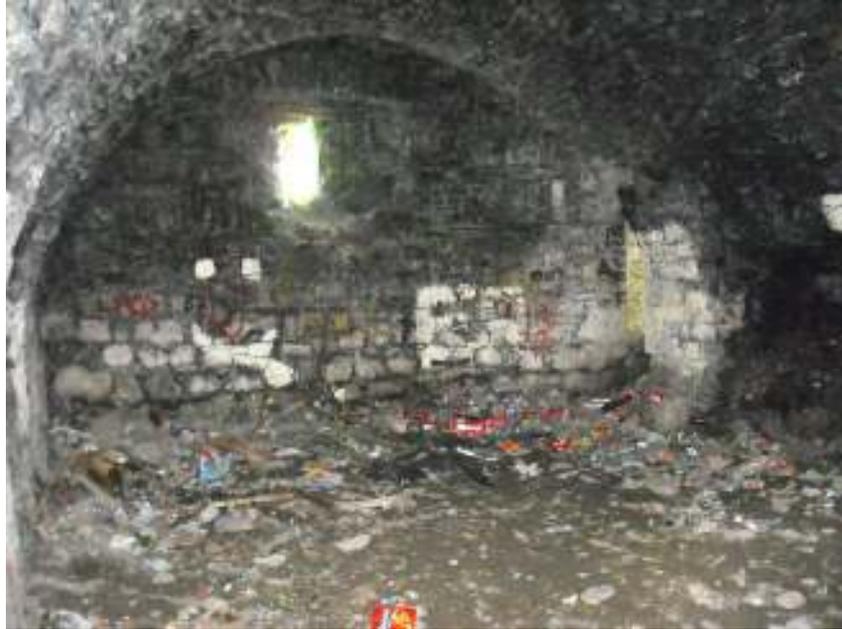
*Internal view Rush tower-house*

Vandalism-graffiti, fire and anti-social activity

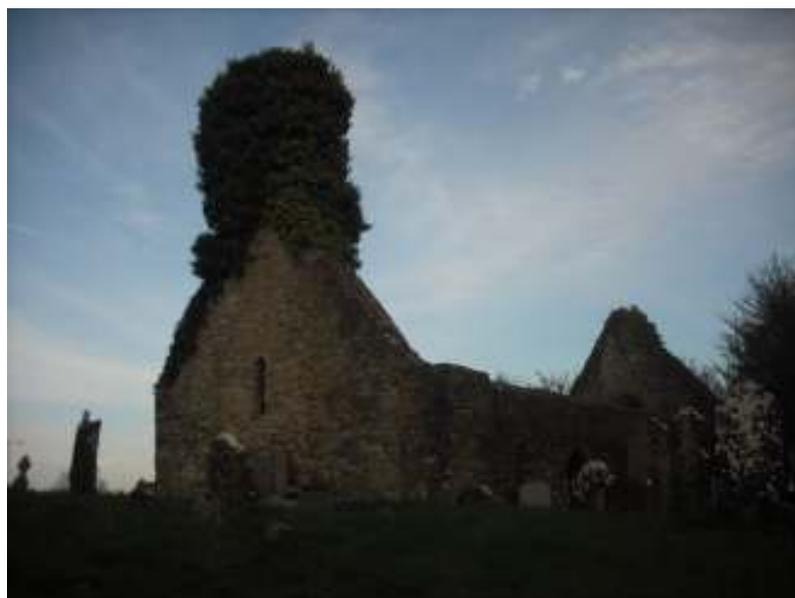
**FMA Report:** Currently the bellcote is completely covered in ivy. Doors and apses blocked with stone/brick except for S. door-secured by metal door-internal overgrowth.

**Structural Survey 2011:** There is evidence of a small area of wash out of mortar at the base of the north wall. There is extensive cracking on the west gable wall which is probably due to subsidence caused by the proximity of graves.

- As the site is within the ownership of FCC, Ministerial Consent will be required PRIOR to the commencement of ANY works. Consent will require a detailed plan of works to be undertaken.
- Removal of vegetation in line with best practice
- Re-pointing in line with conservation specialist recommendations

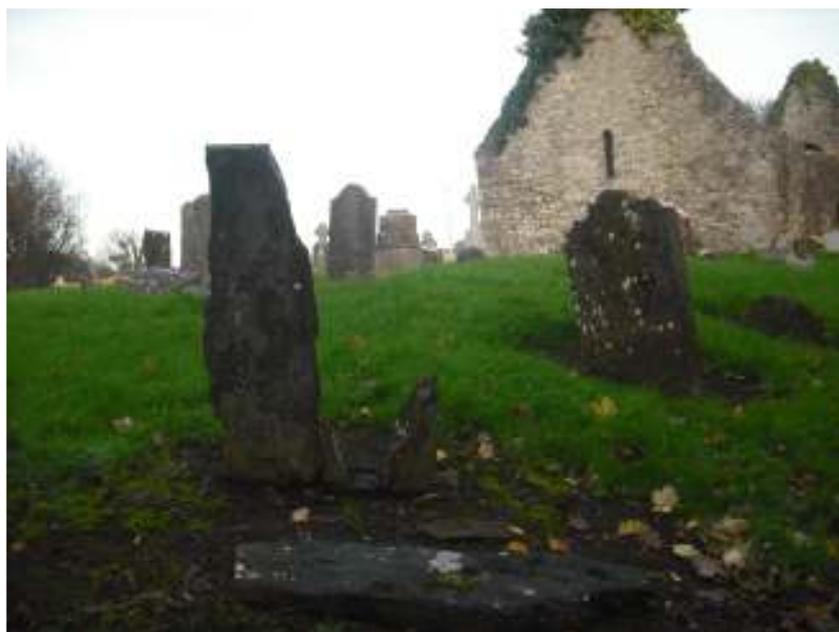
**FMA Report:** An oval walled graveyard that rises to a prominence where the church is located. Gravestones a mix of old and new. Contains the grave of Jack the Bachelor, 18<sup>th</sup> century smuggler. Use of weedkiller has created islands of mud around gravestones.

- Use of weedkiller
- Number of broken gravestone and a possible subsidence issue

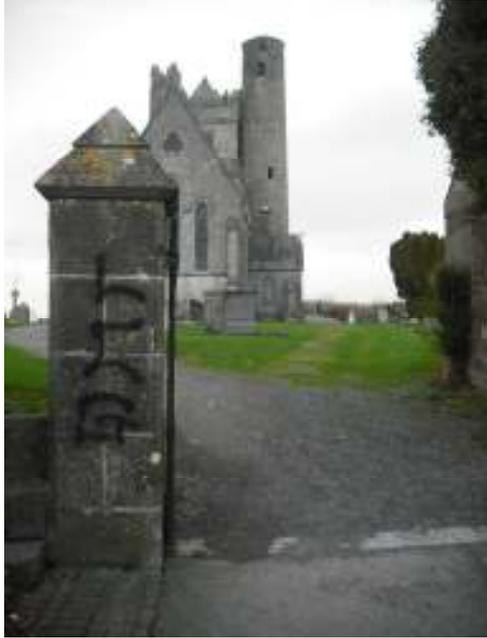
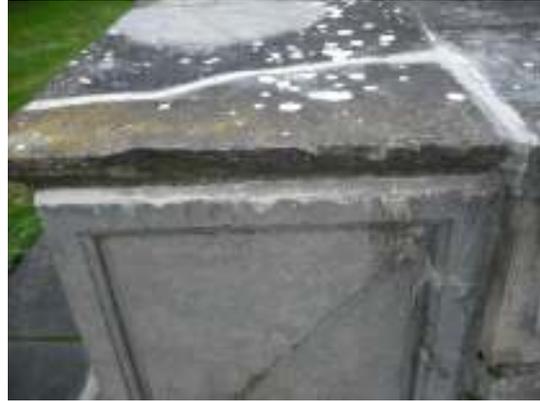
**FMA Report:** Vast swathes of the southern area of the graveyard has been denuded through the use of weedkiller. There is evidence of significant skeletal remains exposure. The Echlin tomb was vandalised and repaired. The graveyards is the scene of littering and anti-social behaviour.

- Vandalism
- Denudation

- Stop use of weedkiller
- Regrass denuded areas

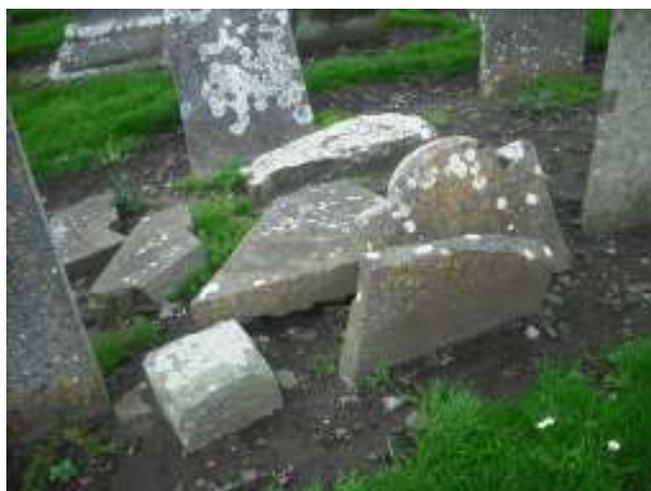
**FMA Report:** Located adjacent to Rush-Lusk Road. Bounded by walls of various date-mostly modern. Church on highest point as are oldest graves-some plain grave markers near road. Majority of graveyard substantially landscaped and modernised. Use of weedkiller has created denuding. Greater than average amount of broken headstones.

- Overuse of weedkiller has possibly caused destabilisation of headstones.

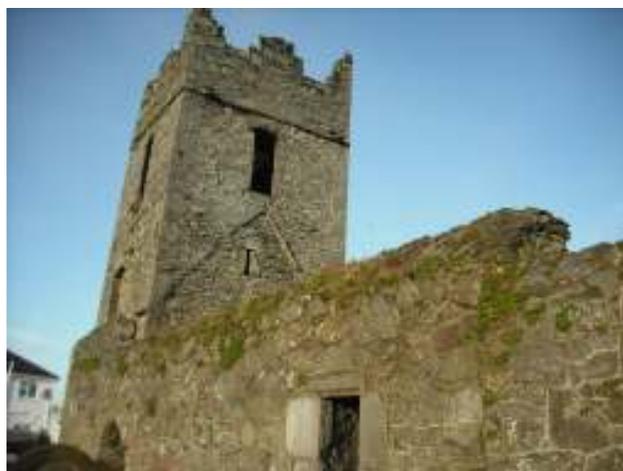
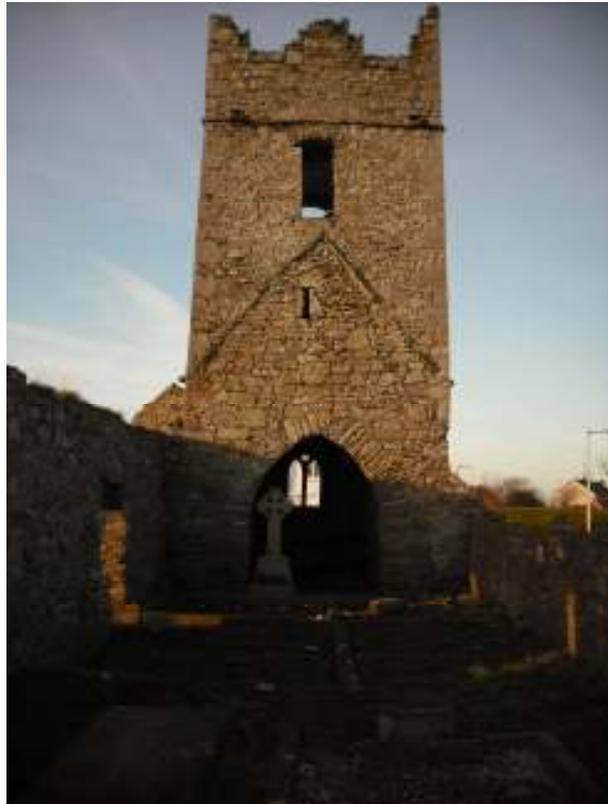
**FMA Report:** Church walls have suffered from overenthusiastic ribbon pointing. Internal burials-gravestones have been vandalised. No sign of stoup within the tower. There is another carved head in a similar position on the northern façade of the tower. Internal burials. Evidence of anti-social behaviour on site. Vegetation is beginning to re-establish itself along the nave walls with ivy on the north wall.

- Mortar wash out
- Vegetation
- Vandalism

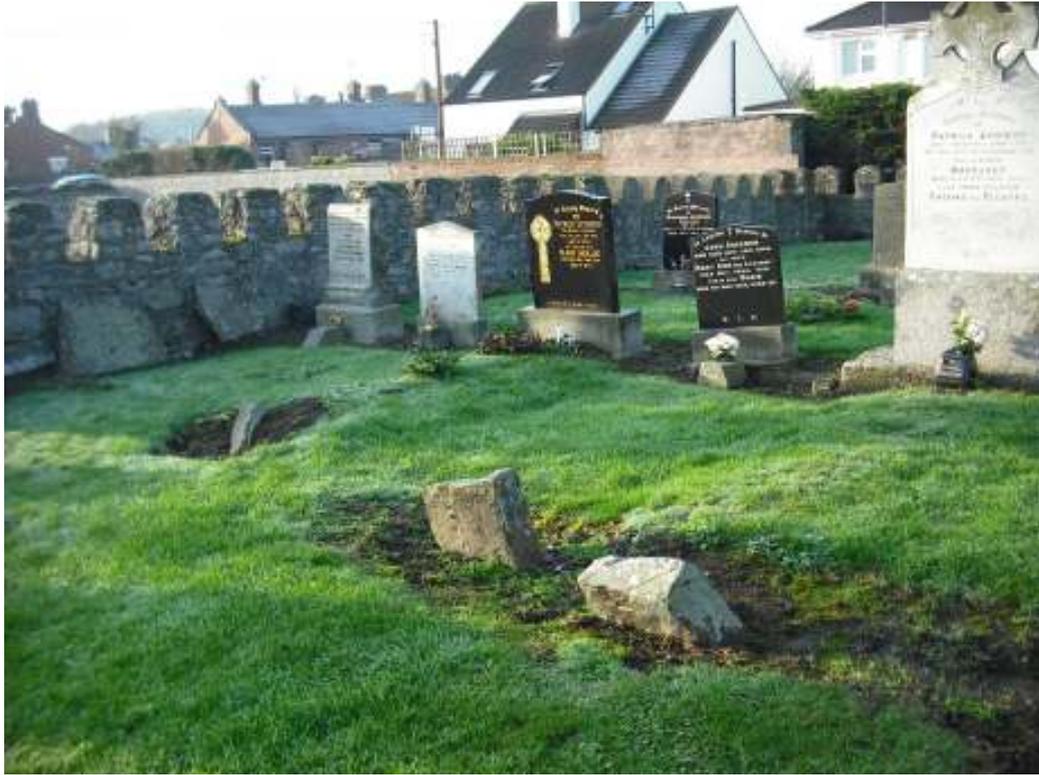
Use of weedkiller has created patches of earth around gravestones

- Stop use of weedkiller

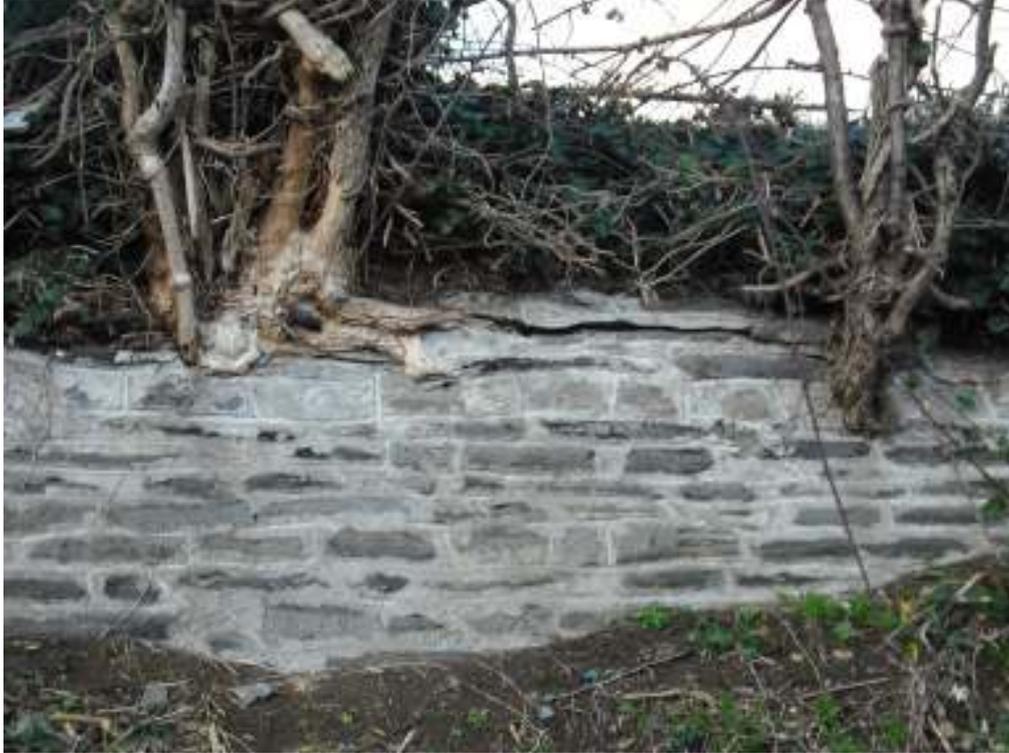
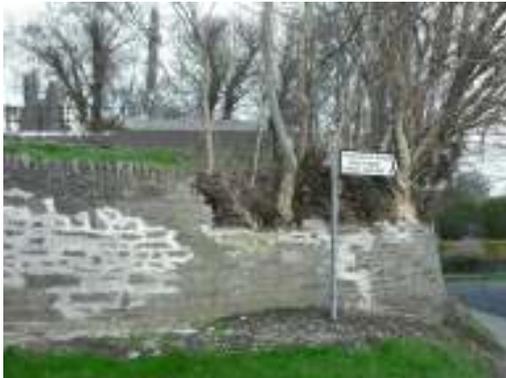
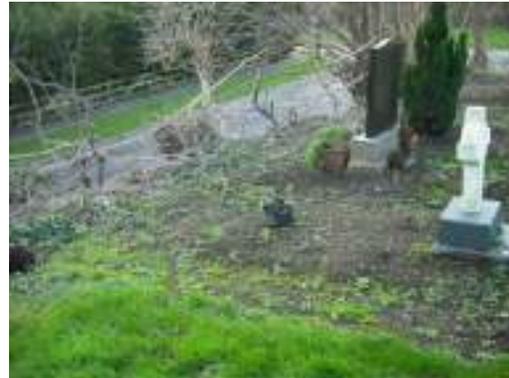
**FMA Report:** Located on high point within Rowlestown village. Bounded by curved road to E and houses & gardens to W. Distinct drop down to N where there may have been a bank-now features as N limit of graveyard and is tree lined beyond which is a steep drop down to the river where dwelling DU011-057 is located. Stone and gated entranceway to SE beside which is a stile which has a graveslab cemented in place at an angle at top. Interesting grave marker to NW (W of yew tree). Concentraion of older grave markers to E of Church. Church has been stabilised and repointed. The eastern graveyard wall is threatened by tree root growth which is exacerbated by the extensive use of weedkiller on the plots above which has denuded a large area. There is significant potential for slippage and collapse. There has also been significant ugly cement repointing which will damage the stonework.

- Tree roots are destabilising graveyard wall and could lead to collapse
- Inappropriate cement pointing will destabilise stonework
- Use of weedkiller has created large areas of earth which could lead to slippage

- As the site is within the ownership of FCC, Ministerial Consent will be required PRIOR to the commencement of ANY works. Consent will require a detailed plan of works to be undertaken.
- Removal of tree roots as a priority
- Remedial stonework
- Stop use of weedkiller
- Return denuded area above destabilised wall

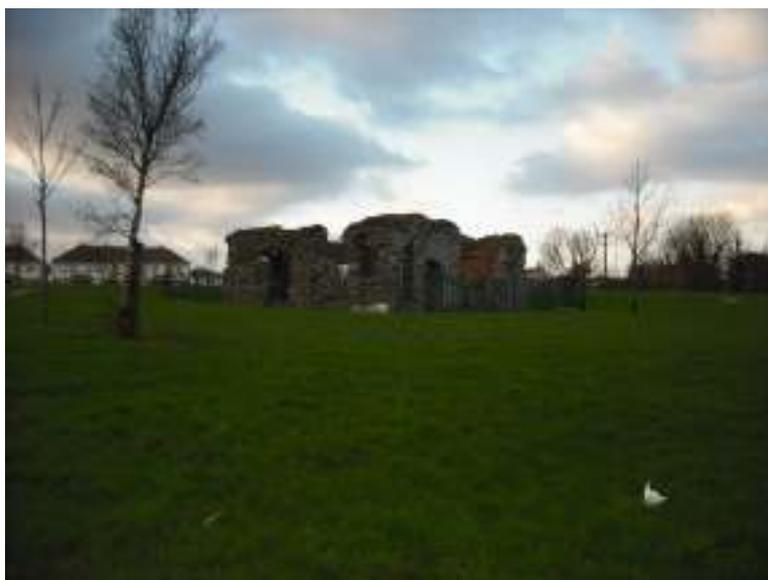
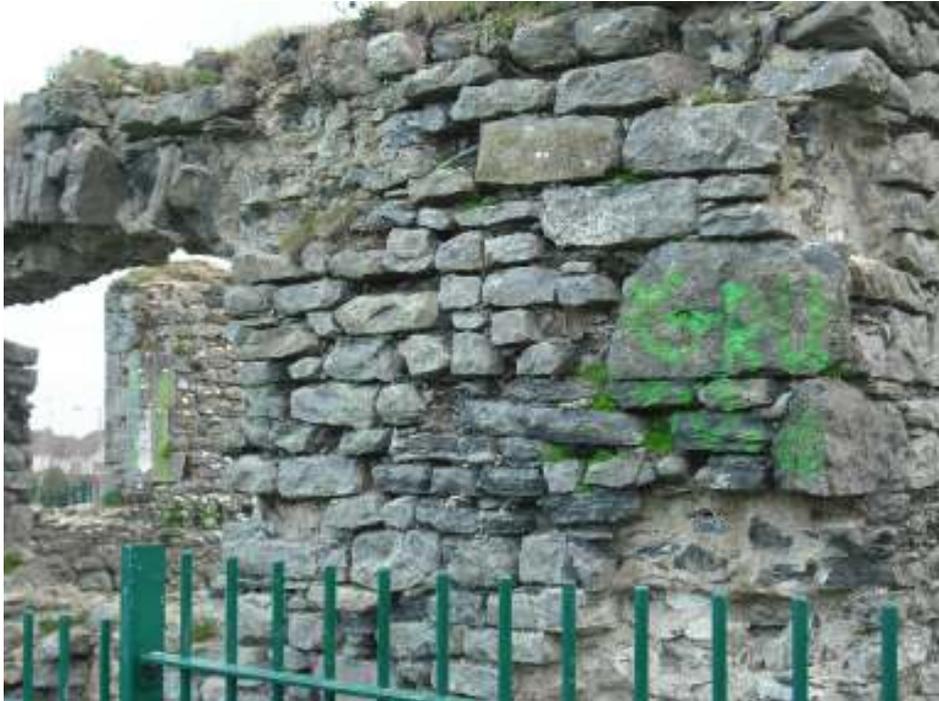
**FMA Report:** Historical evidence suggests that this is not the location of Glasmore Abbey, which, according to the *Martyrology of Oengus*, is situated to the south of Swords. In landscaped hollow-prior to building of housing estate would have had extensive views up to the Naul. Now railed off and gravelled. Has been subject to vandalism-inserted medieval window jamb extensively graffitied. Extensive wash out of mortar which is resulting in structural destabilisation and loose stone collapse. Litter dumping internally and vegetation growth, internally and the tops of walls.

- Wash out of mortar has lead to destabilisation and some collapse
- Vegetation
- Vandalism

- As the site is within the ownership of FCC, Ministerial Consent will be required PRIOR to the commencement of ANY works. Consent will require a detailed plan of works to be undertaken.
- Survey and structural engineering assessment of condition of standing remains
- Remedial works to stabilise structure
- Removal of vegetation in line with best practice
- Removal of graffiti on advice of stone conservator

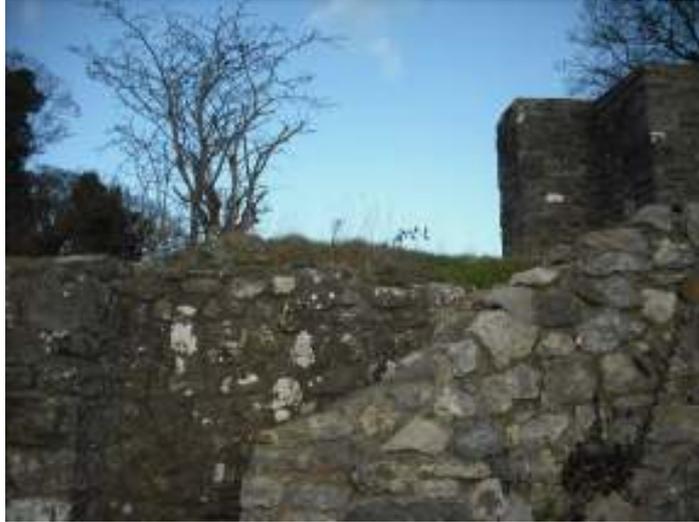
- Vegetation
- Mortar wash-out and destabilisation of mortar.

- As the site is within the ownership of FCC, Ministerial Consent will be required PRIOR to the commencement of ANY works. Consent will require a detailed plan of works to be undertaken.
- Removal of vegetation in line with best practice
- Re-pointing in line with best practice.

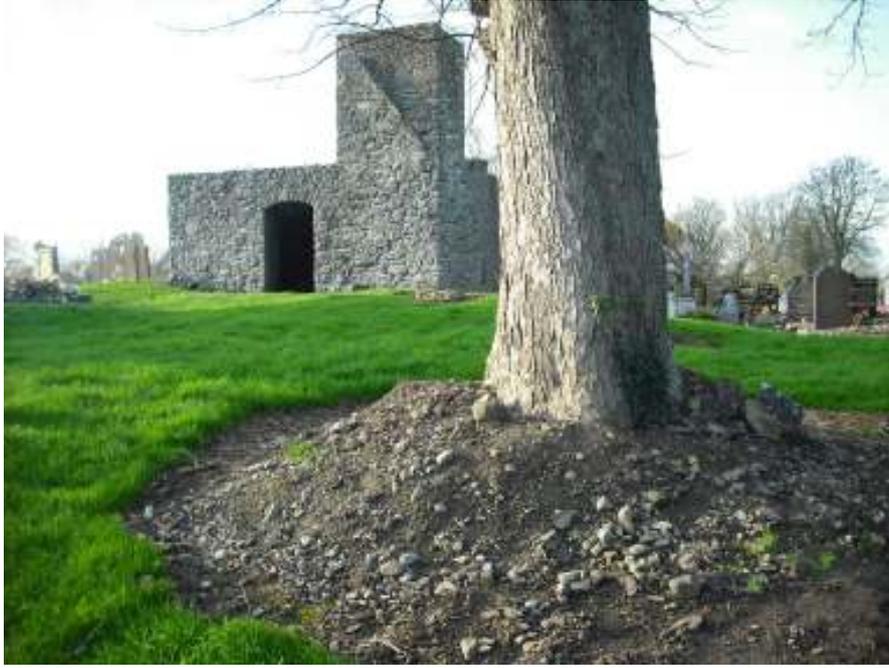
**FMA Report:** Ground slopes steeply down to E and S. Bounded by square concrete wall-house immediately to S, farmyard to W. Graveyard has a definite bend to SW which may reflect earlier enclosure. A desktop was carried out in June 2008 on c.130 acres site immediately west of church & graveyard-identified areas of high potential. Some of the 18<sup>th</sup> century stones are suffering lamination.

- Use of weedkiller has created earthen patches around gravemarkers
- Exposure of skeletal material

- Stop use of weedkiller
- Appropriate disposal of exposed skeletal material
- Remedial measures on gravestones

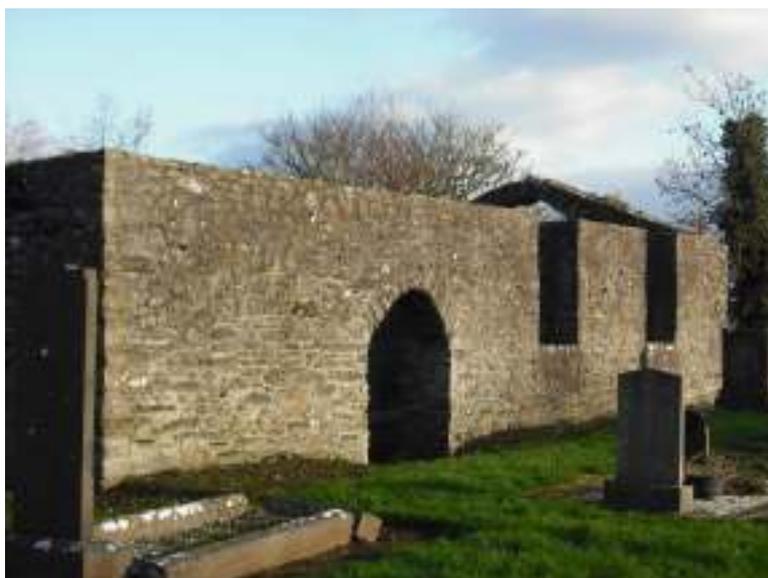
**FMA Report:** Located at high point and aligned EW. E facade large arch. W facade survives half way to windows. Has been subjected to ribbon pointing. N wall built up 4-6 courses to make wall height even.

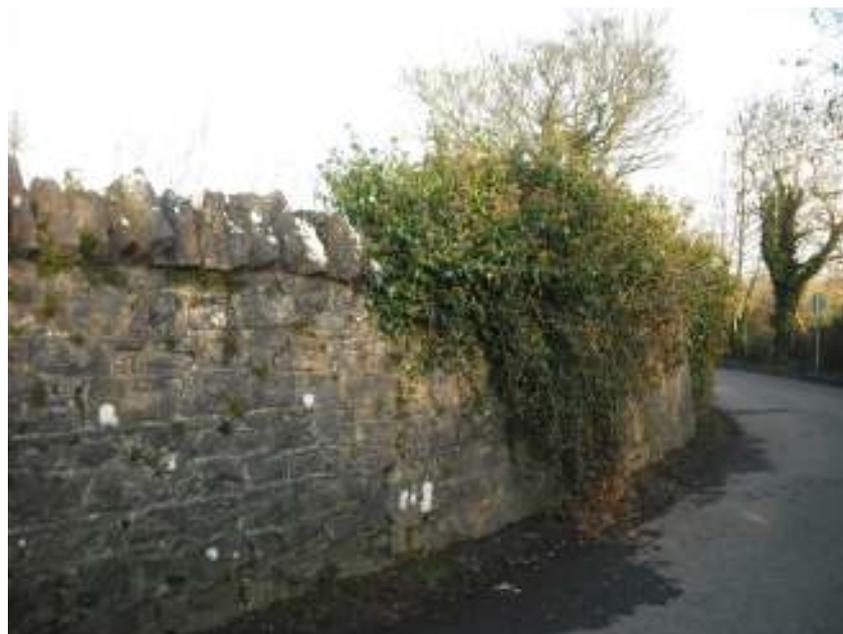
**FMA Report:** Located within oval graveyard defined to E and S by curving road and to N and W by hedge. Interior concrete pathway. There is a significant differential in land level internally and externally to the graveyard. Extensive use of weedkiller.

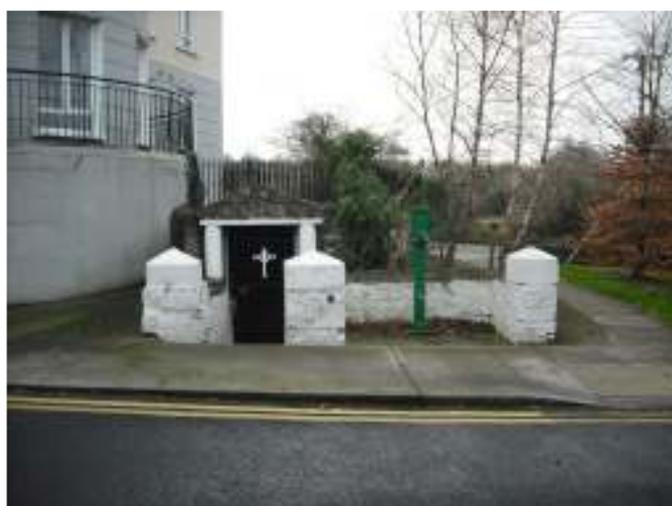
**FMA Report:** Located on curved road within view of St Columbas church. Enclosed with steps (8) leading down from street level. Plaque erected within gate by Historical society 'in 590AD ST Colmcille blessed the well of clear water thus naming 'Sord Cholmcille'. Waterpump located immediately north of well.

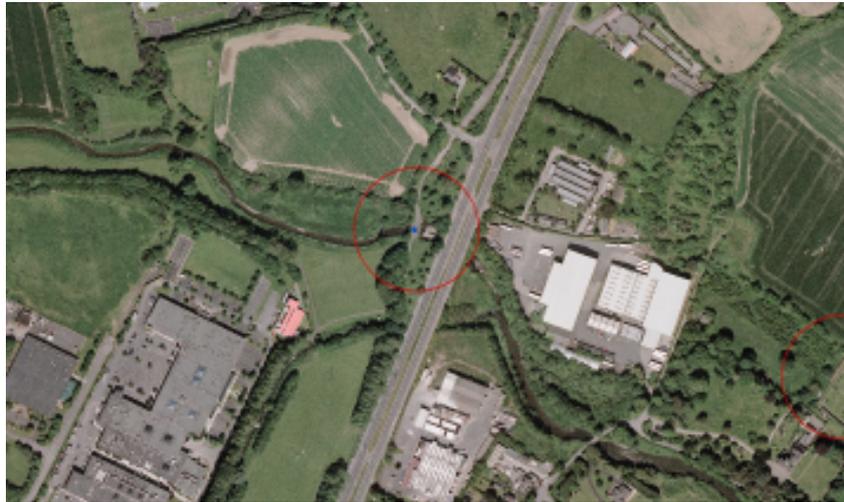
**Lissenhall Bridge DU011-081 RPS#340**

**RMP Report:** A five- arched off Dublin-Belfast Rd. and N of Swords. Bridge marked on Down Survey. Mortared limestone masonry. Three abutting sections. Middle slightly pointed arches with wattle marks. Upriver cutwaters are triangular with semi pyramidal cutwater cappings. Dated to 1450-1550.

**FMA Report:** This was the Old Coach road. Some repairs to E facade of bridge-bad ribbon pointing. Capping is becoming loose and overgrown. Proposed that Metro North be carried across the bridge but project currently suspended. Some graffiti.

- Vegetation
- Vandalism

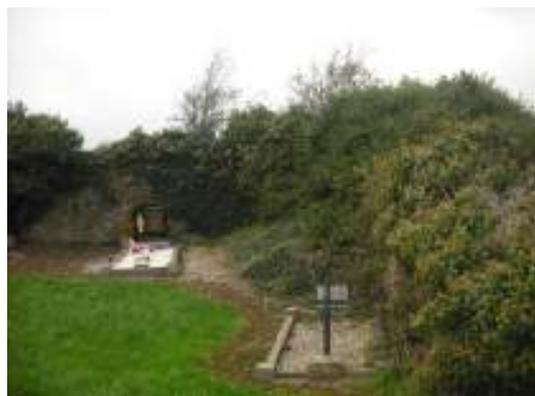
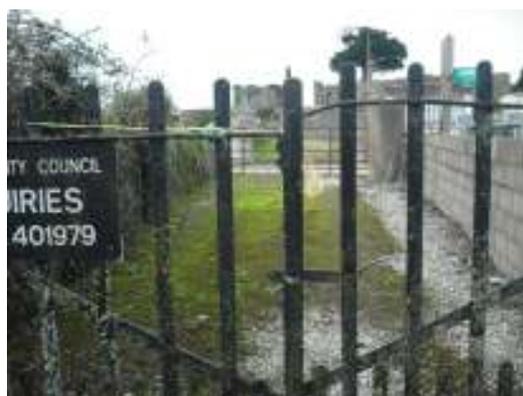
**FMA Report:** Graveyard surrounded by stone wall sub rectangular in plan. Ground slopes steeply from south to north. Contains a number of 19th century mausoleums. Overuse of weedkiller has resulted in large earthen patches and slippage.

- Excessive use of weedkiller
- Extensive ivy growth on graveyard walls

- Stop use of weedkiller

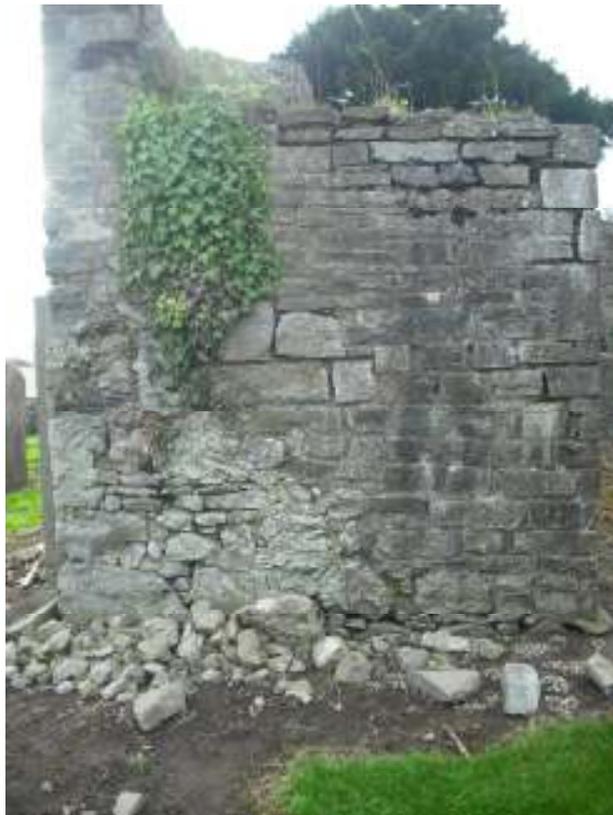
**FMA Report:** Located immediately N of 'old church'. Chantry church contains burials and big tree internally and ivy overgrowth. Some rebuilding of wall.

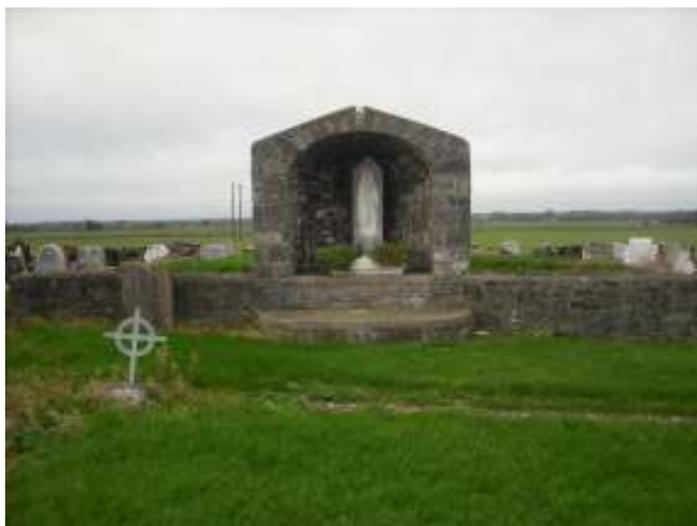
## Ward Lower Church DU011-039-01

**FMA Report:** Church has been considerably "improved". Defined by a rectilinear stone wall with grass ramp built into S wall and return in N wall with a stone built concrete roofed alcove in E wall. Wall stands to 0.75m-1m in height and is extensively ribbon pointed. 16m x 6.5m (8m). Presumed enclosure of original mound remains. Difficult to say if any of the stone original to the site. Possible remnants (or stone dump) overgrown immediately from SE corner. No sign of reused window jamb.

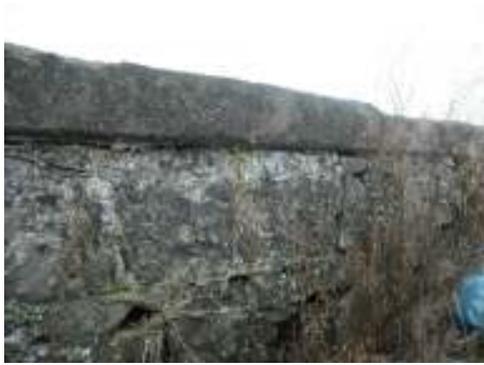
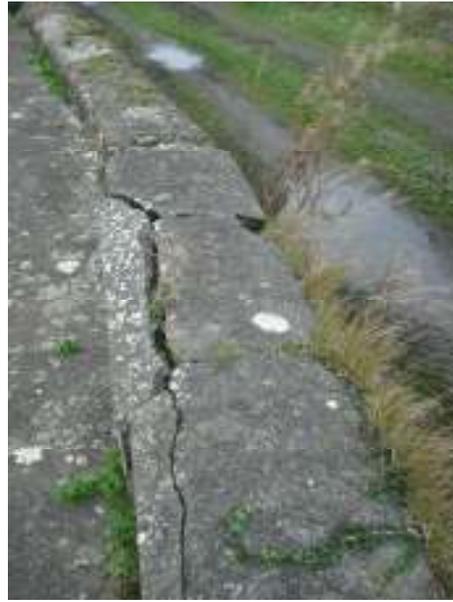
## Ward Lower Graveyard DU011-039-02

**FMA Report:** Subrectangular graveyard adjacent to curve in Ward Road. Would probably have been circular/oval in plan before improvements. Entrance pillared and gated to E. Majority of headstones extremely modern 80s to present- three older to Se of church. Located within a tillage field with new N2. Difference in ground level from interior of graveyard to surrounding tillage field. The graveyard walls have deteriorated and show signs of collapse.

- Collapse

- As the site is within the ownership of FCC, Ministerial Consent will be required PRIOR to the commencement of ANY works. Consent will require a detailed plan of works to be undertaken.
- Urgent remedial works to stabilise graveyard wall
- Ongoing monitoring of stability of graveyard wall

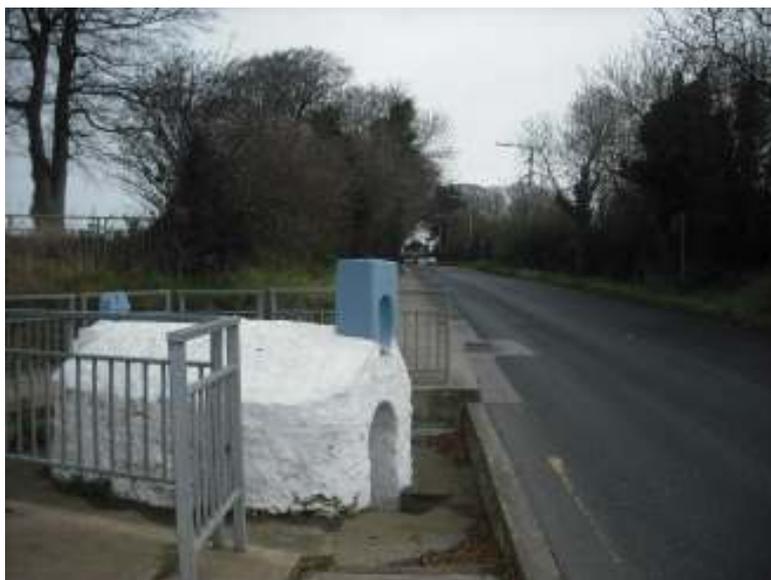
**FMA Report:** Roadside holy well-no longer surrounded by a wall but by a kerb and railings. Aligned WNW/ESE it has two finials-eastern inscribed IHS and O blessed Mother and Ever Virgin Queen of the World make Intercession...May Praise thee O sacred Virgin and thy...; Western cross inscribed. In good condition-maintained and painted but with some internal rubbish build-up.
