*Managing Fingal County Council's  
Archaeological Resource*

Christine Baker  
Field Monument Advisor

March 2012

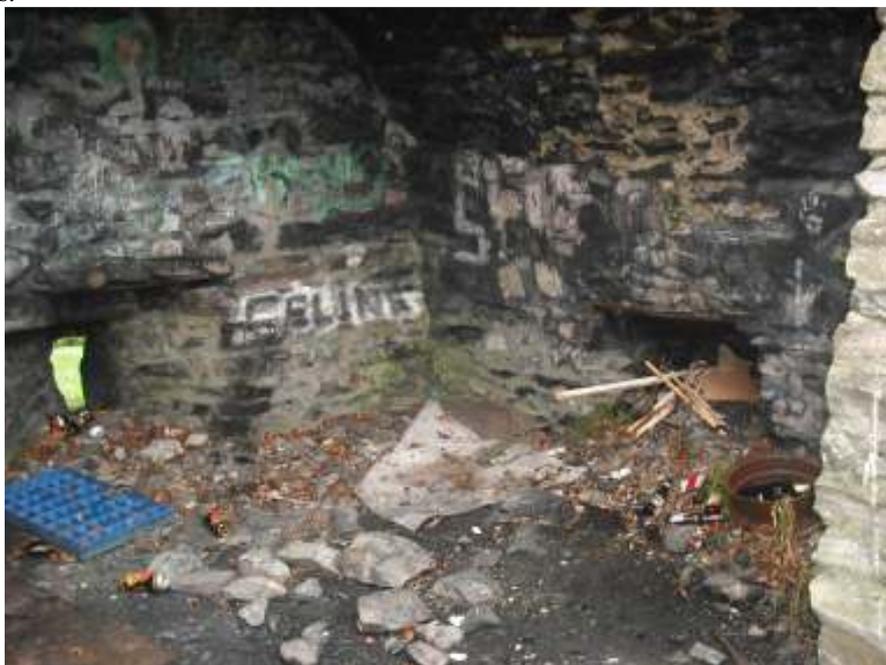
**FMA Report:** Church located at highest point. West gable exterior has two mouldings for plaques-upper empty, lower a damaged Commins & Warren 1675-1740s. Window in south facade of tower-appears to have been reinstated badly! Door survives in N facade. Eastern limit only survives to less 1m in height max. and is overgrown with ivy. Arch of residential tower subject to burning and graffiti. Gravestones present in interior of church.

**Fingal Historic Graveyards Project:** Church first mentioned in early 15th century on the incorporation of a guild 'the guild of the fraternity of Our Lady St Mary of the Church of Mulhuddart' (Ball 1920, 44-46). The site appears to be subject to anti-social behaviour as some graveslabs are paint covered and fire has been set in the tower interior which has damaged the walls and vaulting.

- As the site is within the ownership of FCC, Ministerial Consent will be required PRIOR to the commencement of ANY works. Consent will require a detailed plan of works to be undertaken.
- Paint and fire damage should be removed from church ruins by a specialist stone contractor.
- The stone plaque should be appropriately pointed to prevent further deterioration.
- Vegetation removal may be necessary and should be done in accordance with best practice and to avoid any destabilisation of the medieval fabric.

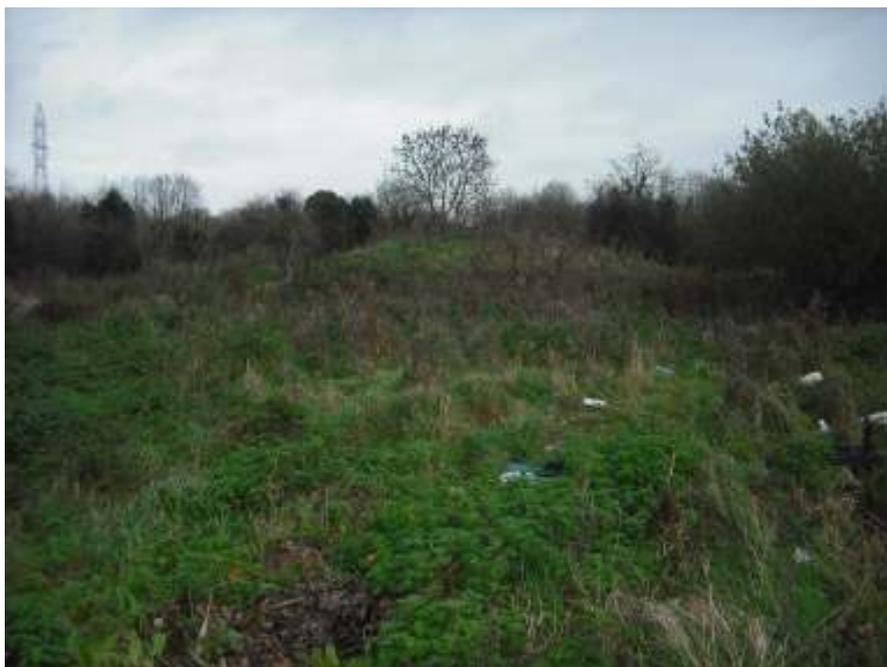
**FMA Report:** Now located at east end of open space of a housing estate. The tributary of the Tolka is fenced to the north. Completely overgrown and inaccessible. Evidence for dumping (construction and domestic) in the vicinity.

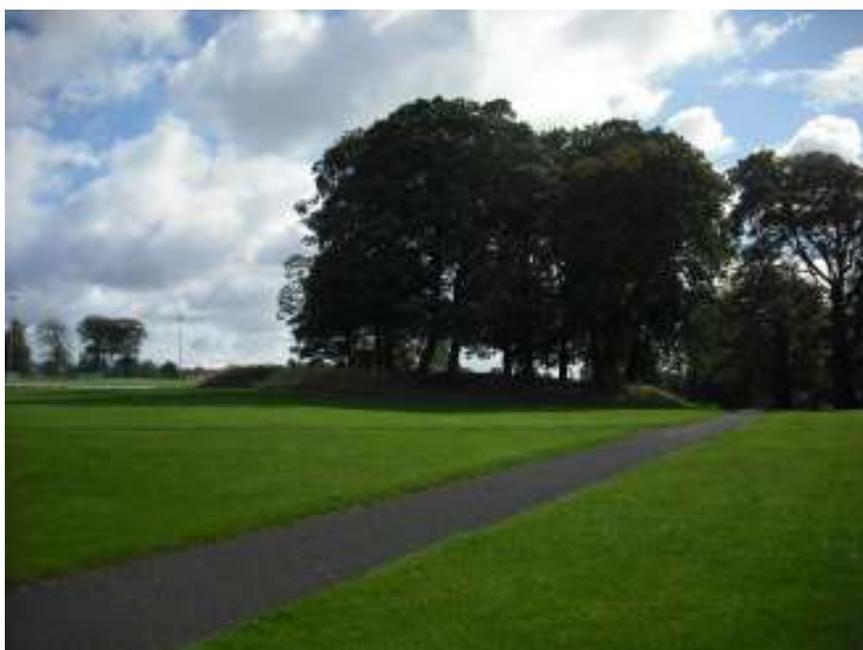
*Corduff ringfort*

**FMA Report:** No longer located in dense tree cover but in green space abutted by two playing pitches. Remains of well established trees edging and upon mound which is defined on its top edge by large boulders. Criss-crossed by pathway-grass reduced to muck-possibly used for biking. Rises up in the middle. Some denuding along SW from water. By second visit substantial regrowth but denuding expanding. Also being used for anti-social behaviour.

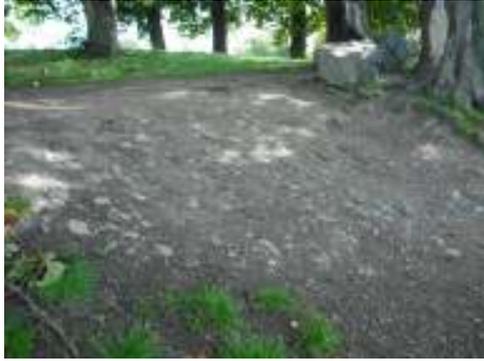
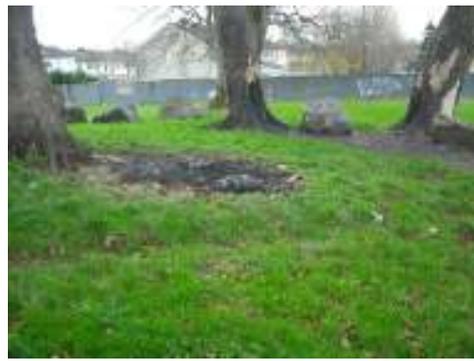
*Denudation and vandalism Corduff ringfort*

- Archaeological monument but is not recognised as such.
- Site of anti-social behaviour including burning of trees.
- Continuing denudation along south-west of bank.

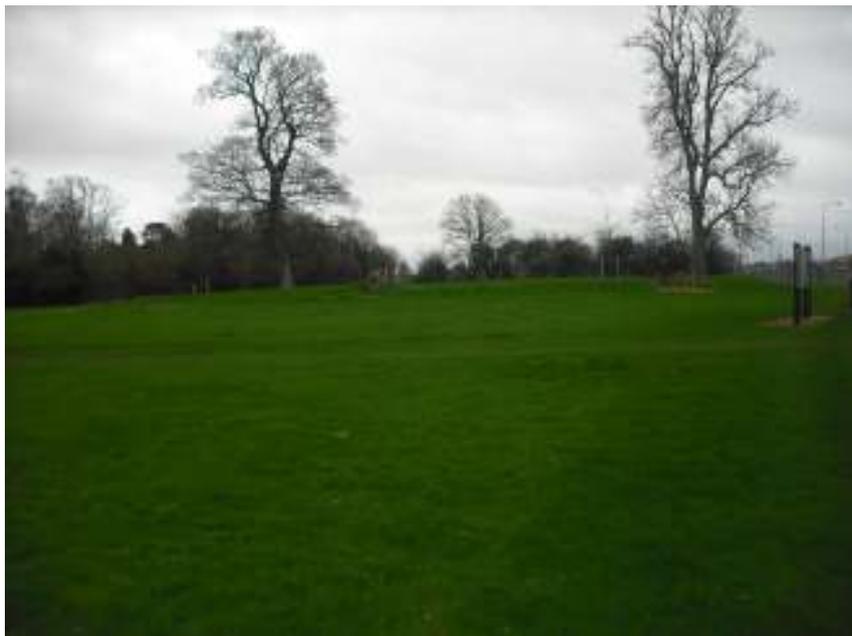
**FMA Report:** Now contained within the Blanchardstown Millenium Park off Blanchardstown to Clonsilla Road. Mound survives as uneven and grassed over within open space with gravel path to the W. Two trees mark E limit and SW quadrant. Two stumps line NW quadrant. Geophysical survey for the Metro Westt shows survival of ditch and masonry but to the west of the mound.

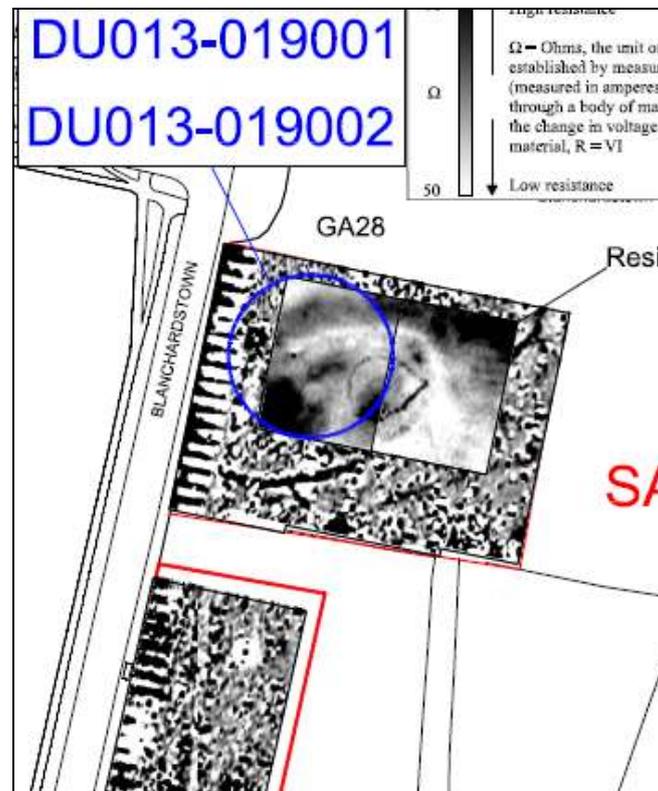
*Metro West Tallaght to Dardistown Archaeological Geophysical Survey 2010 Drawing 2310. Target  
Archaeological Geophysics 09R195*

**Context:** The co-ordinates as given in the RMP are incorrect as shown by the geophysical survey meaning the zone of potential extends further than previously shown.

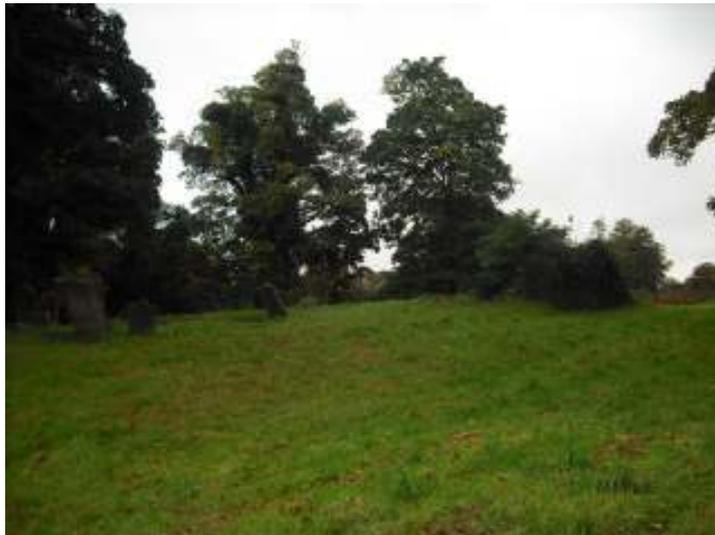
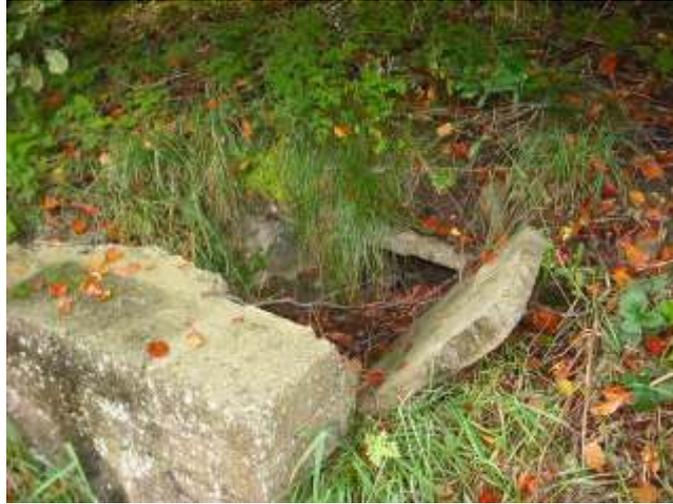
**FMA Report:** Church located on high point within graveyard. Part of the north and west walls survive but completely overgrown with ivy. Aligned east-west some window opening survive with internal graves. Holy well appears to be located east of a large oak tree 309228/238829. Appears to have been blocked at east end by concrete but flag has since collapsed. Stone passage c.1m wide that extends westwards for at least 2m. No sign of water.

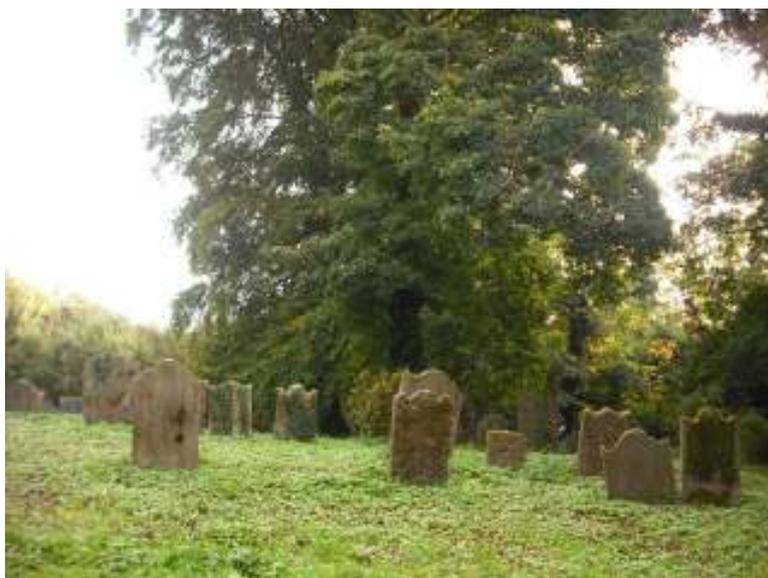
**FMA Report:** The sub-circular graveyard is enclosed by a stone built wall (19th century?) which has been extensively ribbon-pointed. To the north, the wall has been replaced by a concrete wall. To south and west is a wide deep fosse, water filled at base, with a well established tree line. Number of grave stones are ivy clad and appear to have been subject to rubbing-lots of chalk. Abbotstown graveyard formerly under maintenance of FCC. However when the old main road was closed off eight years ago with the construction of the M50 there was no longer access and the site became overgrown. Now the staff from the State Labs keep the grass down with a tractor around the edges and a strimmer across the top.

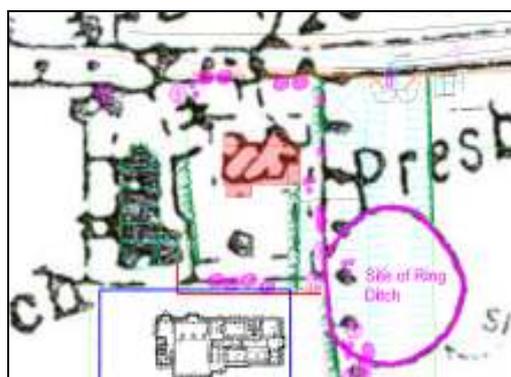
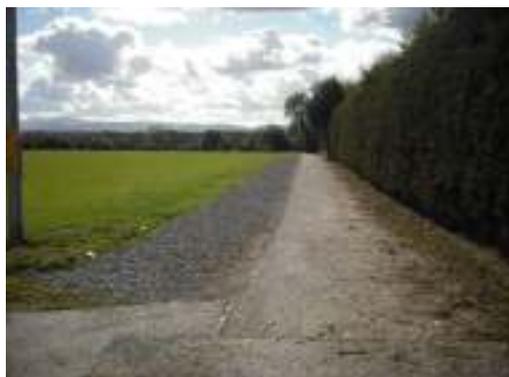
**FMA Report:** Excavations in 1988 identified a wide (2.5m-3m) ditch and interior postholes that yielded Bronze Age pottery. Geophysical survey revealed the ditch extends into the playing pitches of the adjacent park to the west of the NS boundary, a well established hedgerow. On subsequent visit it was noted that a sports club had been constructed further south, being accessed by a pathway that traverses the site. It is unknown if insertion of services had any effect.

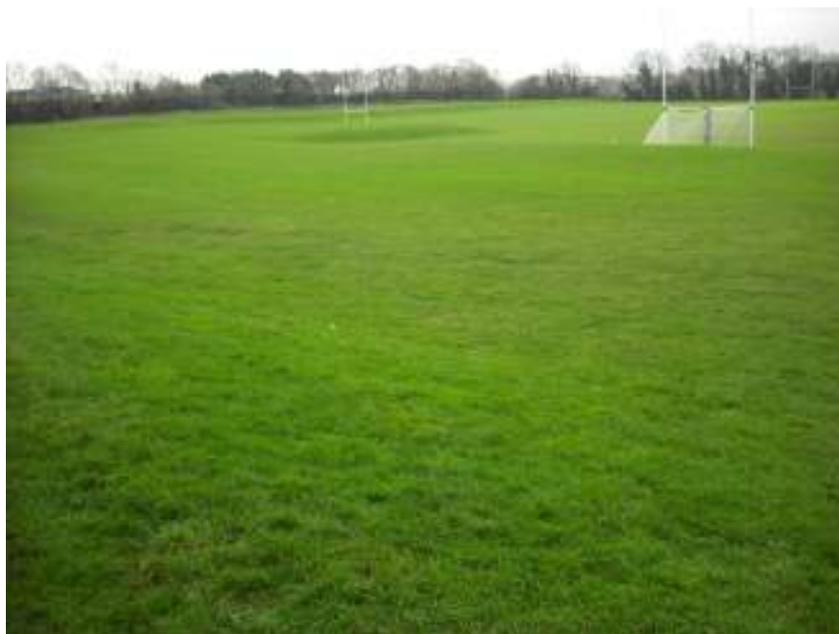
**FMA Report:** Now a large rectangular field which encompasses two playing pitches. The eastern and northern limits are c.2m higher and roll down to the playing pitches indicating extensive landscaping.

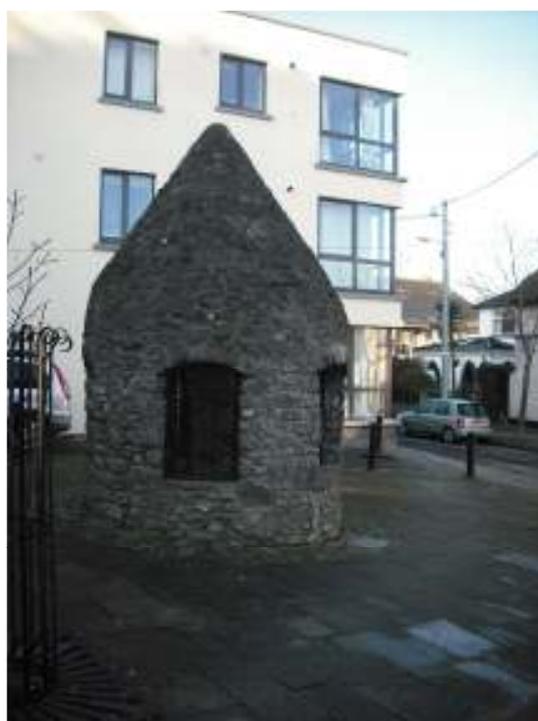
**FMA Report:** Well of the Blessed Virgin/Sunday well/St. Sylvester's well-located to the rear of St. Sylvester's church. Annual Marian pattern day 15 August when a statue of the BVM was displayed at the well which was circled 7 times. After reciting the rosary the people went to the Abbey graveyard to clean the graves. a custom existed until 1890s of inserting an eel into the water for purity. Well has been restored and plaque with : St Sylvester's Well ca. 430AD, restored 2001. Context and setting altered by the development of apartments immediately to the west.

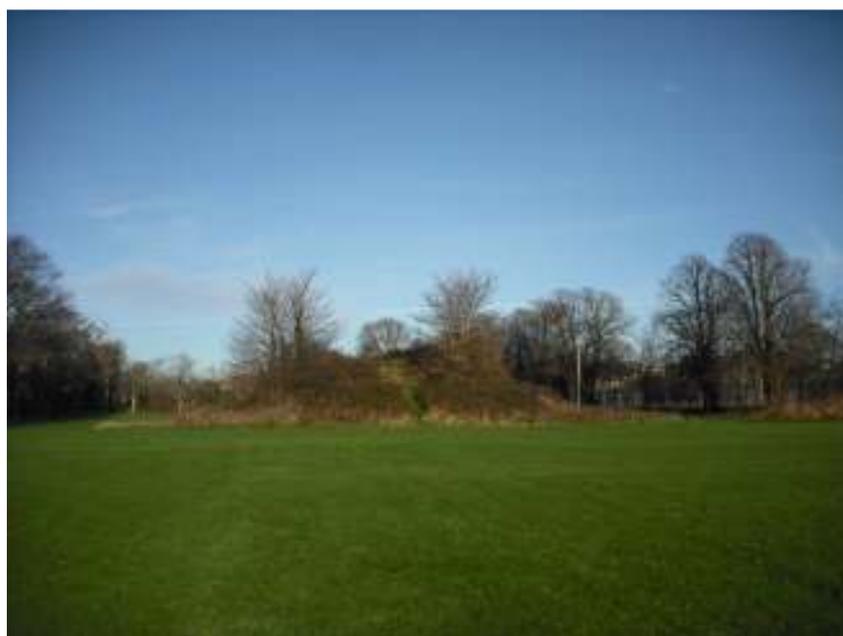
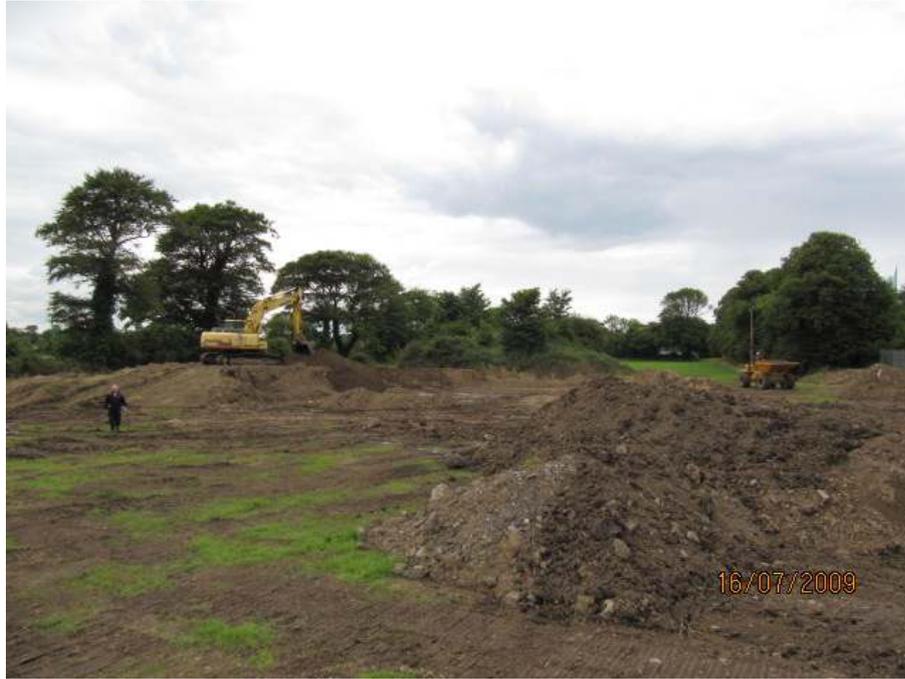
**FMA Report:** Fingal County Council leased the area to Naomh Mearnog GAA who made a new playing pitch to the south east. The field surrounding the motte has been landscaped and put under grass right up to the fosse. Area to the south, the presumed site of the bailey is still somewhat uneven but it had been used for dumping spoil during playing pitch construction. The playing pitch has been fenced off with a steel fence although there is proposed access from the walled garden currently under negotiation. The fosse has recently been cleared out. Access to the top of the mound but sides overgrown with branches and trees. McDowell's who formerly owned the land retain the motte as they had people scattered there but the bailey is in the remit of FCC.

- As the bailey site is within the ownership of FCC, Ministerial Consent will be required PRIOR to the commencement of ANY works. Consent will require a detailed plan of works to be undertaken.
- Geophysical survey should be undertaken to establish the full extent of the archaeological remains and ascertain the level of damage accrued during landscaping works.
- This can inform any access or fencing works that may be proposed in relation to the upstanding motte.

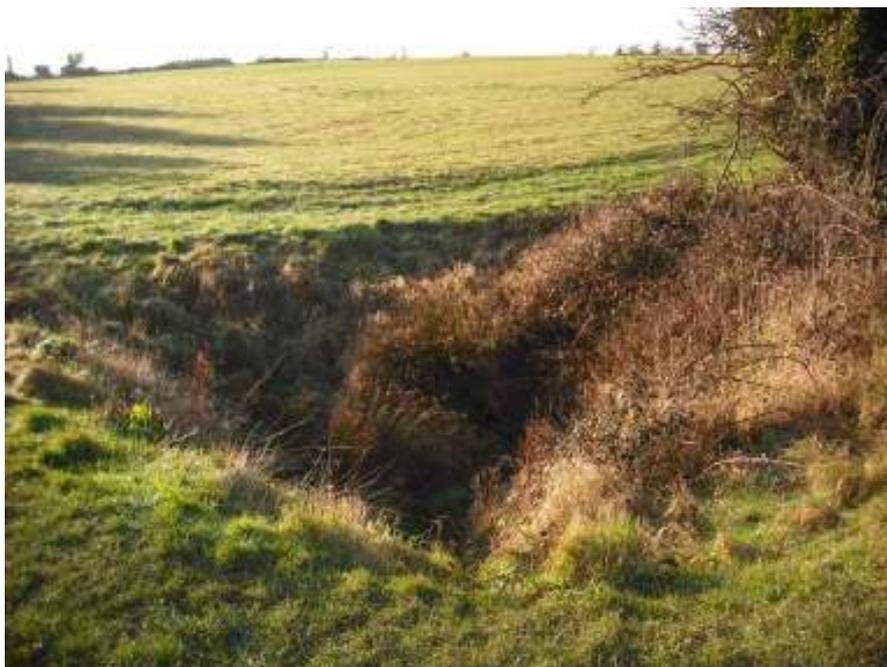
**FMA Report:** Located at the terminus of a field boundary 324396/245069-the remainder probably removed during landscaping and insertion of footpaths. Deep area with some large stones and muddy residue visible. However there is the sound of flowing water. Very overgrown towards field boundary. Excellent views east to Lambay.

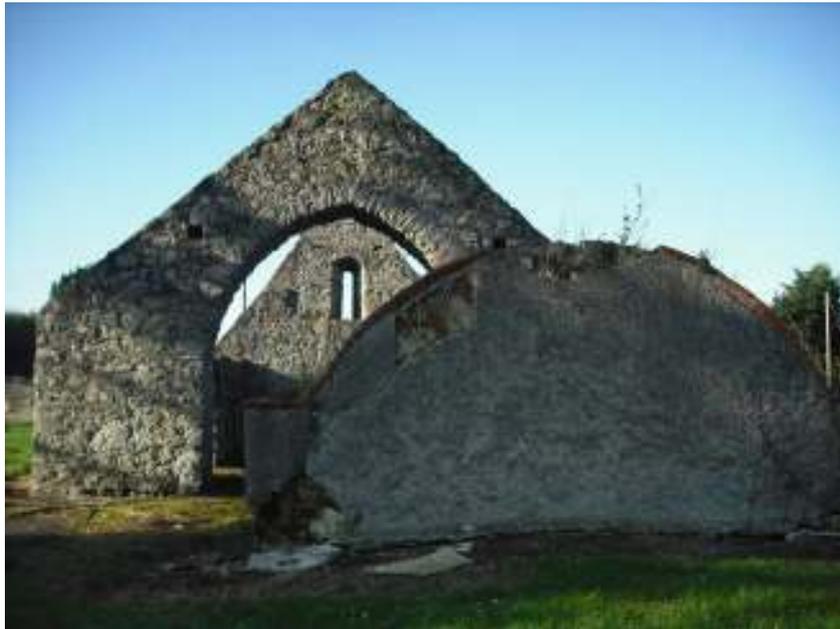
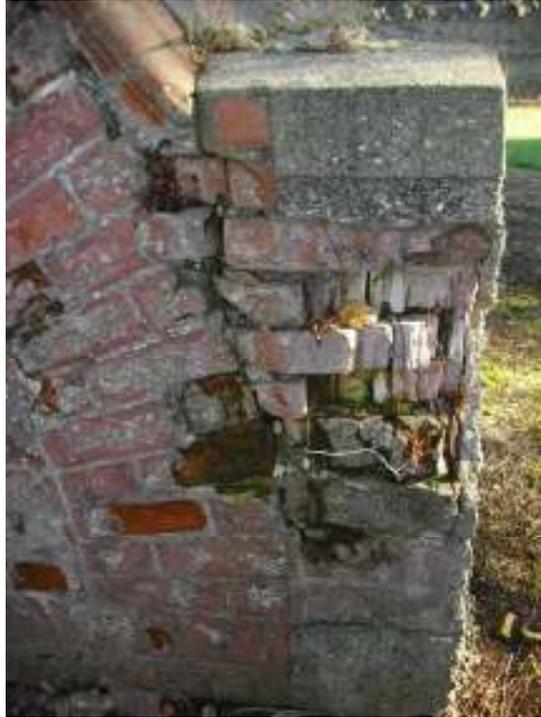
**FMA Report:** Church located centrally to spacious stone walled graveyard. Church aligned EW with double bellcote to W and door in south facade. Austin Cooper's tomb at north-east corner-red brick and had been rendered-render chipped off with concrete roof. The exposed redbrick is beginning to disintegrate.

- Repair Austin Cooper's tomb

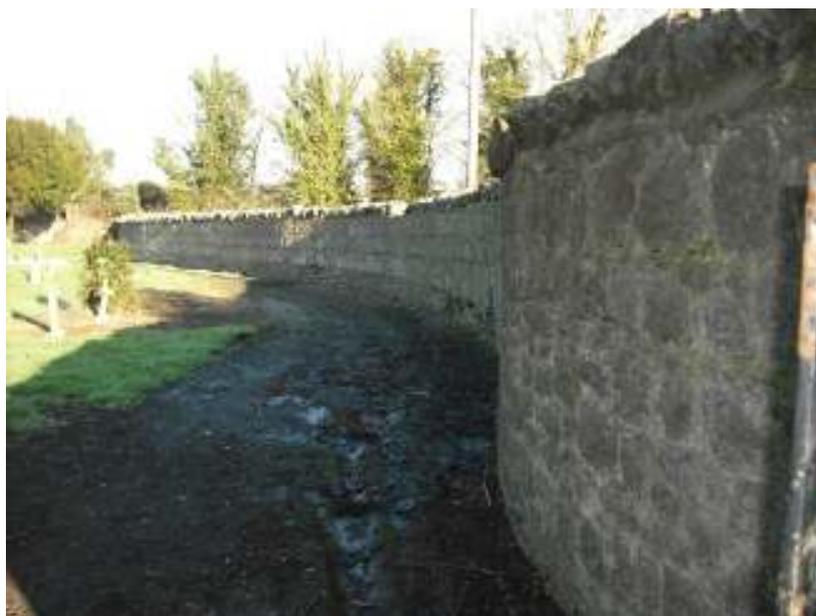
**FMA Report:** The expansive graveyard is bounded by a high stone wall. There is a kink in the wall which may indicate an earlier date of origin. The mausoleum of antiquarian and former owner of Abbeville, Austin Cooper is located within the church but is in deteriorating.

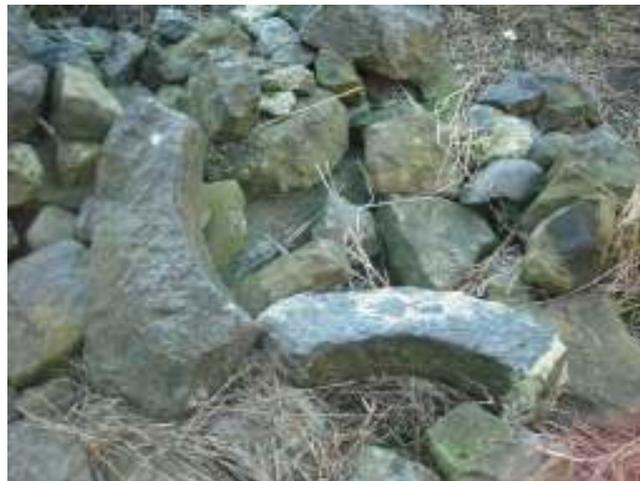
- 'improvements' undertaken without archaeological advice or supervision have destabilised the building fabric
- Attempted removal of tree bowls have uncovered skeletal material.
- Lintel in the west gable appears to be cracked and disintegrating.
- Vegetation has re-established itself

- As the site is within the ownership of FCC, Ministerial Consent will be required PRIOR to the commencement of ANY works. Consent will require a detailed plan of works to be undertaken.
- Removal of vegetation in line with best practice
- Recording of the cut stone removed during unauthorised improvements
- Repair the cracked lintel stone.
- Stabilise the structural elements of the church in accordance with best practice

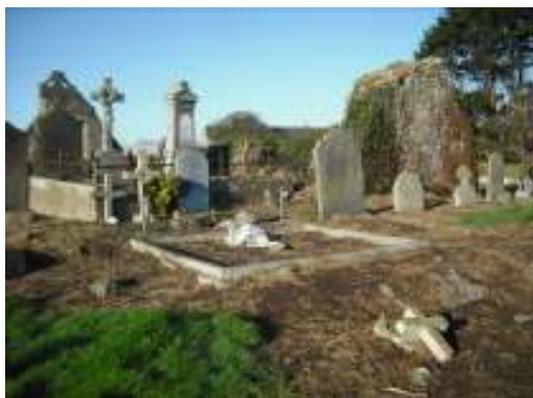
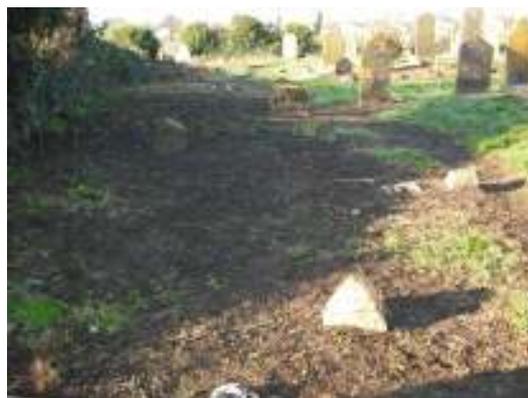
**FMA Report:** The graveyard on the occasion of the first visit in 2008 was under long grass but had been relatively undisturbed for a decade or more. As such it was haven for wildlife. In the intervening period the local Lion's club at the behest of the local priest and against advice issued to them by FCC undertook a graveyard cleanup. This involved the use of lawnmowers, tree cutters, strimmers and weedkiller. The Spring of 2010 has meant there has been some recovery of growth but as a consequence of the clearance a number of plots have been defined by stone and infilled with gravel as well as the insertion of new headstones all of which has had an impact on the graveyard.

**Future Objectives:** Advise local community on appropriate grave furniture for an historic graveyard.

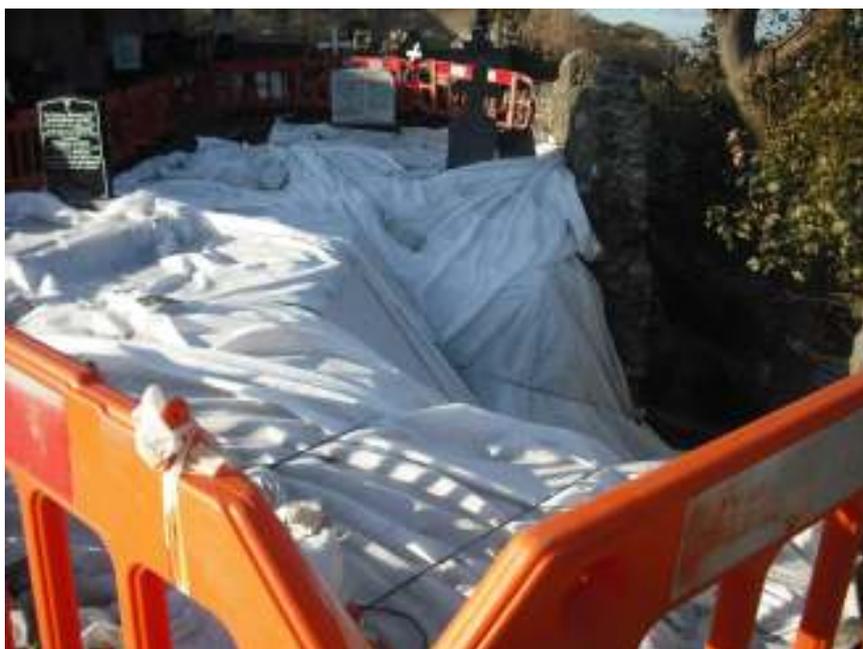
**FMA Report:** Graveyard square in plan entered from south-west corner where it drops down significantly from street level. Houses to south and west, including Howth College, Abbey Rd. to east and sheer drop to north. Reuse of medieval graveslabs, including one as kerbing. Unusual crenallated perimeter wall depicted by Beranger in 18<sup>th</sup> century. After torrential rain in October 2011, part of the northern perimeter wall collapsed causing extensive collapse and coffin exposure. A programme of removal and reinstatement is currently underway.

- Reinstatement of the graveyard wall

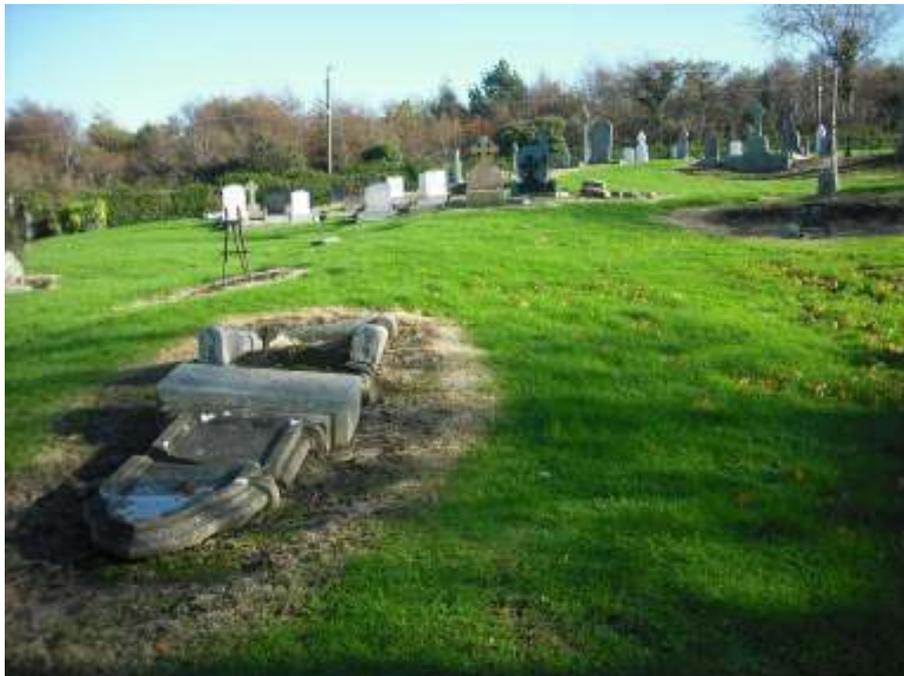
**FMA Report:** Enclosure survives as a flat topped bank but with grave plots dug into it. Overuse of weedkiller has denuded areas of the bank.

**Future Objectives:** Raising awareness among maintenance crews and the public as to the significance of the enclosure.

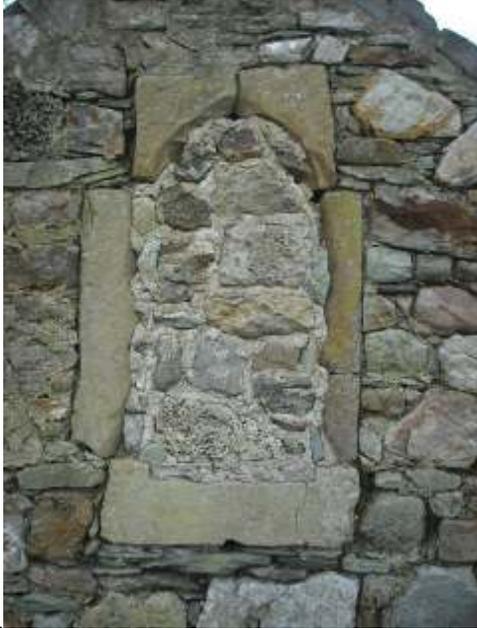
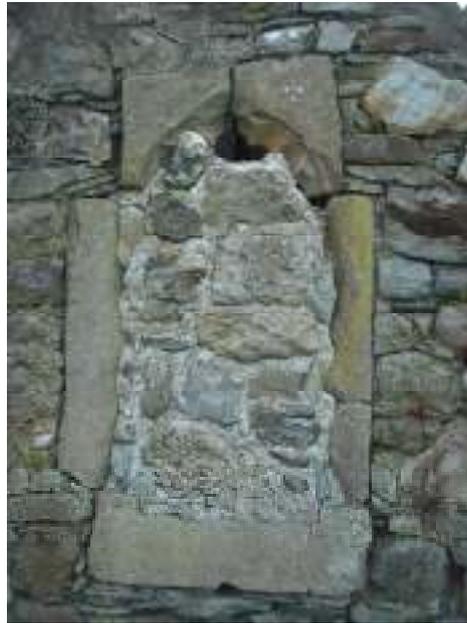
*St Fintan's window ope 2007 and 2010.*

The sept-foil moulded window in E wall has been inexpertly blocked up. Metal grilling added to roof and door. The Bellingham graveplot also defined by railing is immediately adjacent to the church on north. Recently it has been noted that the E window infill has started to fall out thus destabilising the original window fabric

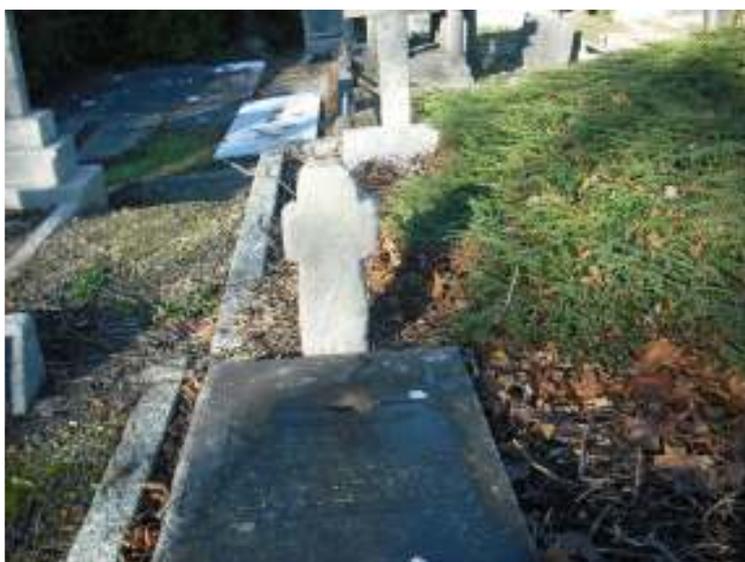
**FMA Report:** In danger of being encroached by vegetation from adjoining graveplots.

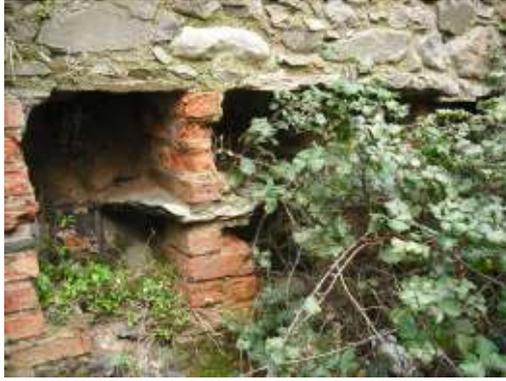
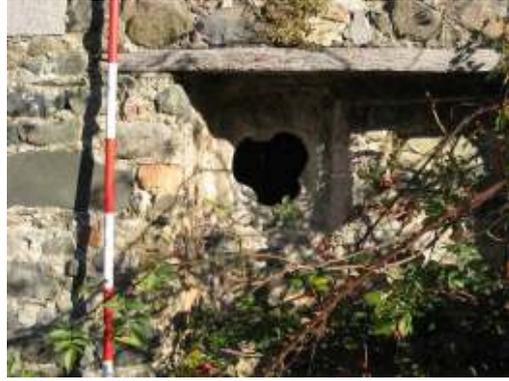
**FMA Report:** Now at 5 storeys with various decorative features, embellishments and turret-made by those employed on Fás course. Bremore Castle has been undergoing 'improvement' for over 10 years now. Lately the nature of these improvements have caused concern. There is currently no overall plan for the future development access and use of the site. An archaeological assessment undertaken as part of a ministerial consent resulted in a site visit from the DoE. Concern centres around the effects of the new build on the limited original remains. The site is to undergo a Conservation plan. New boundary walls and gatepost are currently being constructed. There are important archaeological and architectural fragments in the outbuildings that should be protected.

**Future Objectives:** Currently the subject of a Conservation Plan.

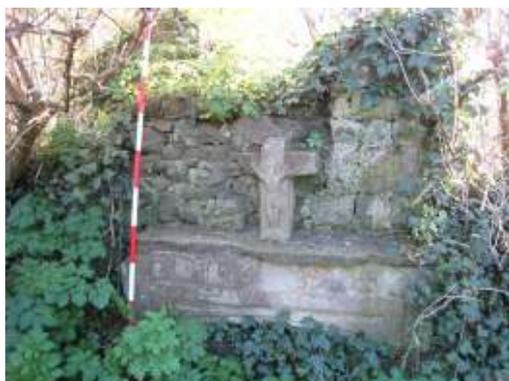
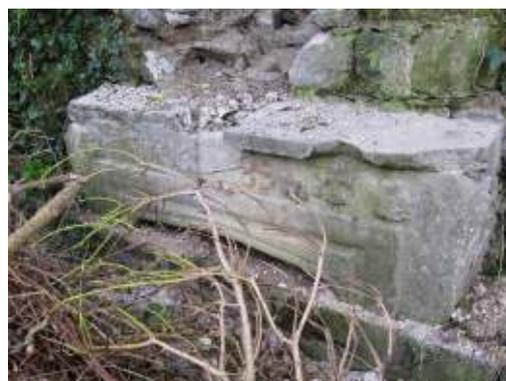
*Cross and lintel 2007 and 2010*

**FMA Report:** This cross was affixed to a chimney lintel that had been set along the north face of the church remains. It was removed in 2008 to Ardgillan Castle for safekeeping.

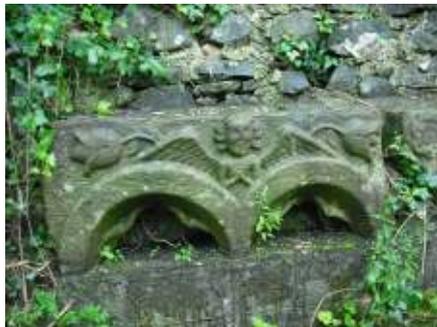
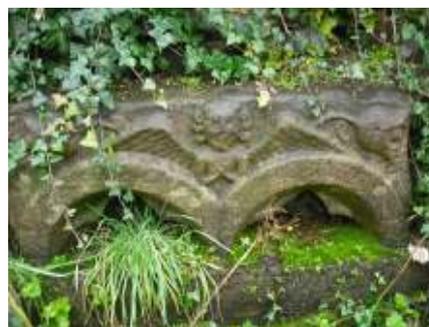
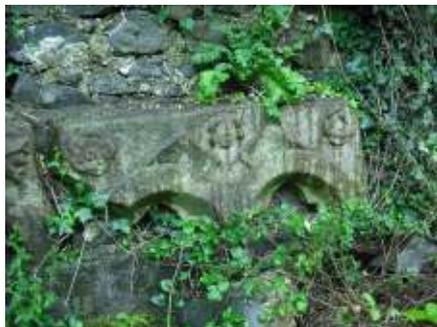
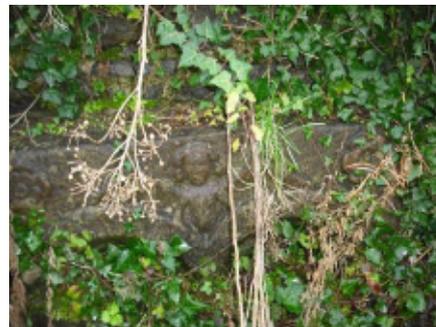
**FMA Report:** Remains of two double ogee headed windows with curly headed angels depicted at arch. E has tulips, W rosettes. Decoration similar to that on 1689 architectural fragment (DU002-002-06). Both set on a concrete plinth adjacent to N end of church. Their condition has deteriorated since 2010.

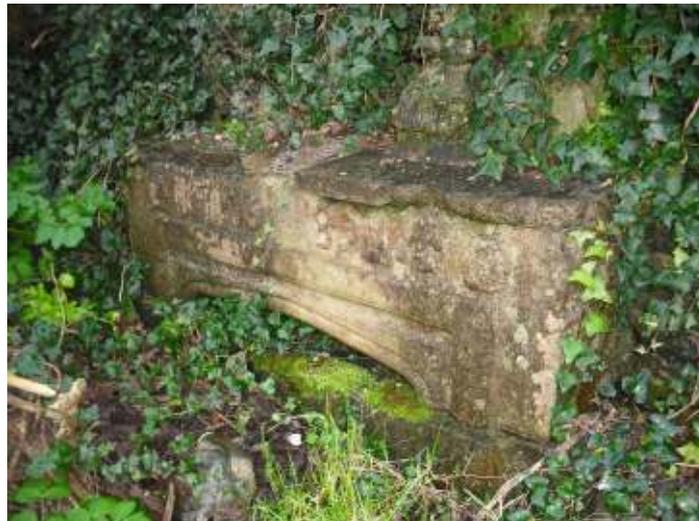
**FMA Report:** Chimney piece inscribed with angels/figurines set against the north wall of church on a concrete plinth-east of the windows pieces (DU002-002-05). The crucifixion piece has been removed and is reportedly in Ardgillan Castle. Vegetation is encroaching. There is a second chimney lintel located in grass just outside the entrance way to the graveyard that is deteriorating.

**DO** Take cognisance of recommendations of Conservation Plan

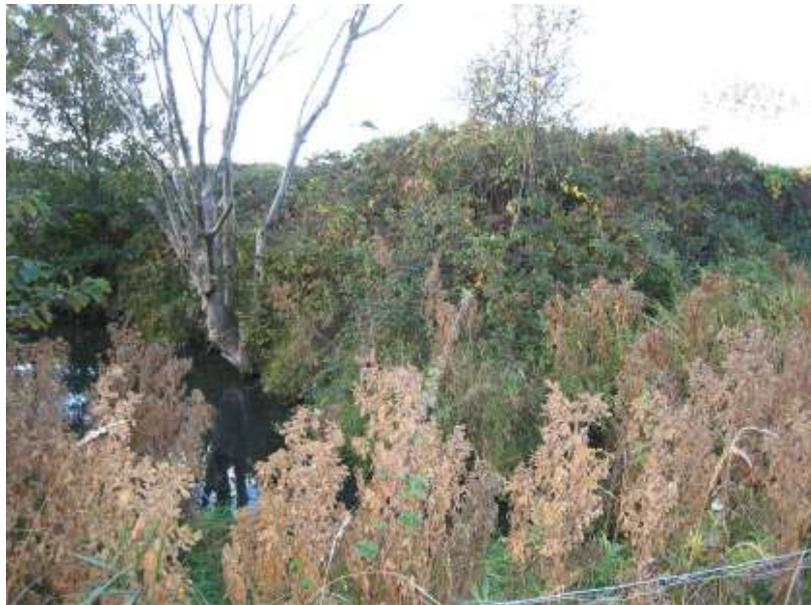
**FMA Report:** Site formerly a hockey pitch that was always subject to flooding-allowed to return to a pond and is currently a bird sanctuary. The Kybe well is located to the north-west corner of the pond but is completely inaccessible. Marked by a dead tree to the north of which is a manhole cover. Fenced off from road to the west from road entrance to the Mill Complex carpark.

- As the site is within the ownership of FCC, Ministerial Consent will be required PRIOR to the commencement of ANY works. Consent will require a detailed plan of works to be undertaken.
- Assessment of condition-has insertion of drainage damaged well? Has flooding of area covered/removed remains. Requires archaeological assessment.

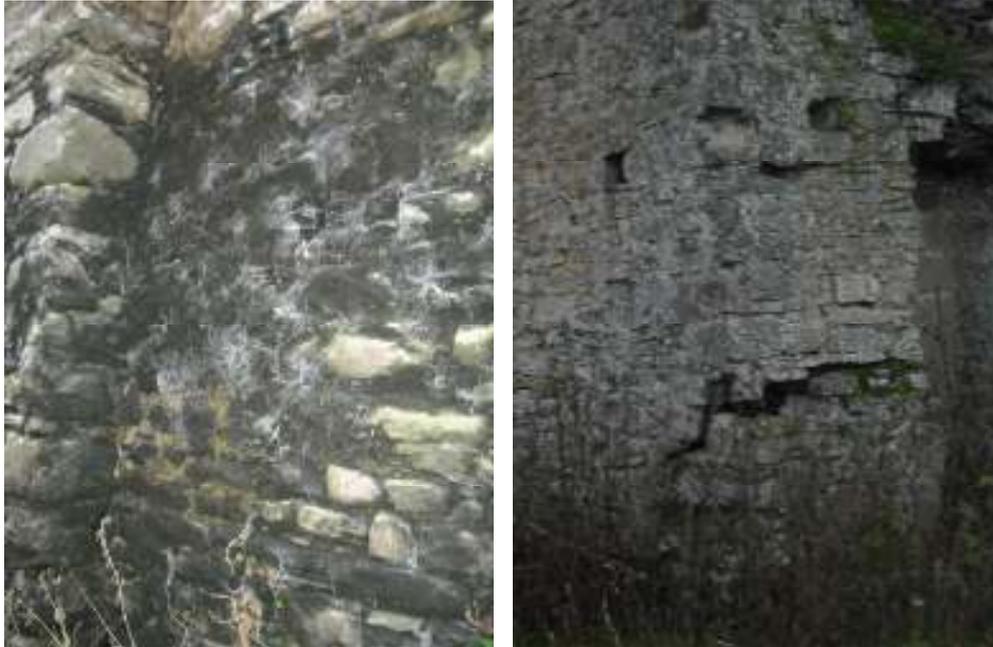
**FMA Report:** Located within S. entrance of Newbridge Demesne, in parkland. Gable of removed buildings visible on E facade. W. facade subject to burning. Damage to SE corner. Also sporadic ivy growth damage. All opes in filled with brick and concrete. Castle had been used as a cattle shelter for many years..residence of the landowners of Lanistown and probably dates from the time of the Bathe family who first possessed the lands in 1376. A 1776 survey shows large single storey residence to E-used into the 19th century when Cobbe family purchased tenants (John Grace) interest in surrounding lands and demolished house in c.1820. John O'Donovan told by Charles Cobbe in 1830s that there were extensive buildings to N and E of castle prior to demolition. Ruins of St Colman's Church which stood near castle seen by O'Donovan. On return visit appearance of ivy having been removed from N & NE corner has uncovered significant damage including area of stairwell. Base of SE corner has significant cracks. The blackened area on the eastern façade is covered in a white substance-could this be a fungus?

**Structural Survey 2011:** The monument is vulnerable at present because there are structural problems which could lead to a collapse of sections of masonry if they are not addressed.

- Vegetation growth, its removal and subsequent re-establishment have destabilised masonry.
- There are significant cracks in the masonry at the south-east and north-east corners of the tower.
- Area of the rear façade which appeared blackened is now covered with white matter-is this a fungus?

- As the site is within the ownership of FCC, Ministerial Consent will be required PRIOR to the commencement of ANY works. Consent will require a detailed plan of works to be undertaken.
- A structural survey and recording of the original fabric remains should be undertaken by a suitably qualified practitioner prior to the undertaking of any works.
- Stabilisation of masonry, suitable repair and conservation.

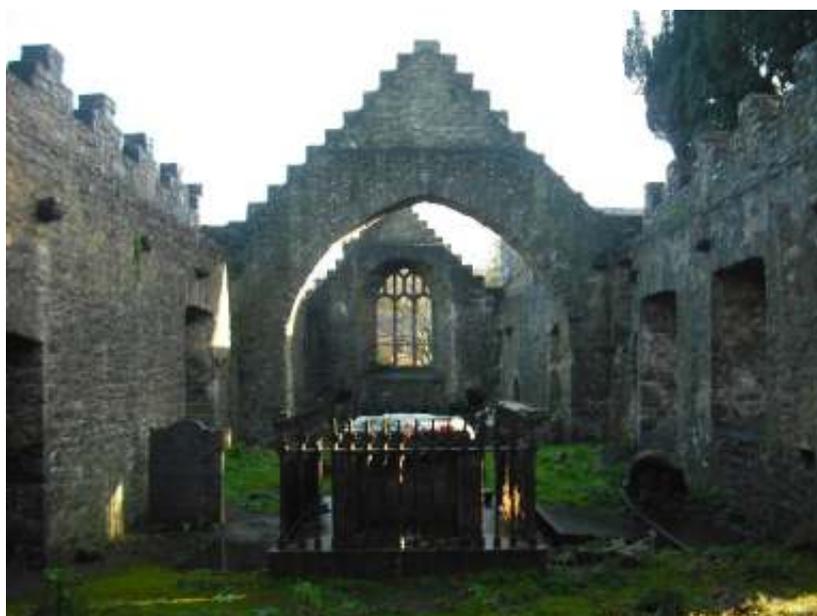
**FMA Report:** Church aligned EW with triple bellcote and three ogee windows in W gable and tracery arch. Two storey sacristy attached to SE corner of the church-upper floor 3 windows and fireplace and chimney. Lower floor barrel vaulted-step down from interior of the church. Access to upper floor via external steps. Uneven clay interior within church with a mix of recumbent stones and box tombs. In 2010 the tree and vegetation growth which dominated the south of the church has been removed which

opens up the entire south facade. By 2011 there is significant small vegetation growth on all facades of church. There also appeared to be significant leaking of water into 'sacristy'.

**Structural Survey 2011:** The church is in stable condition at present and appears to be well looked after. Fairly small works will ensure its sustainability into the future.

- Vegetation growth on fabric of the building
- Extensive moss growth within interior of the church
- Sacristy roof leaking

**DO** Assess the sacristy roof for leaks

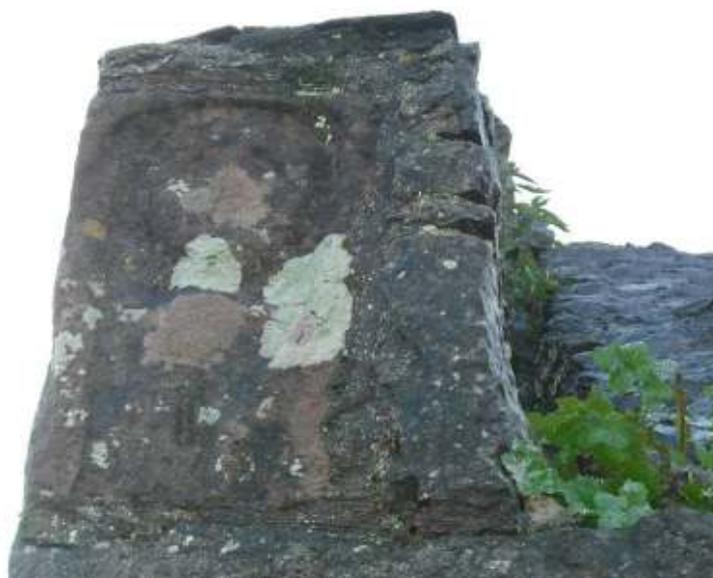
**RMP Report:** Quoin at NE angle of chancel of church comprises a framed seated figure carved in false relief on red sandstone block-large shapeless head, short neck, and squashed body.

**FMA Report:** Lichen growth is beginning to obscure the sheela-na-gig and although not as weathered as that on the eastern gable the nature of sandstone means it will decline.

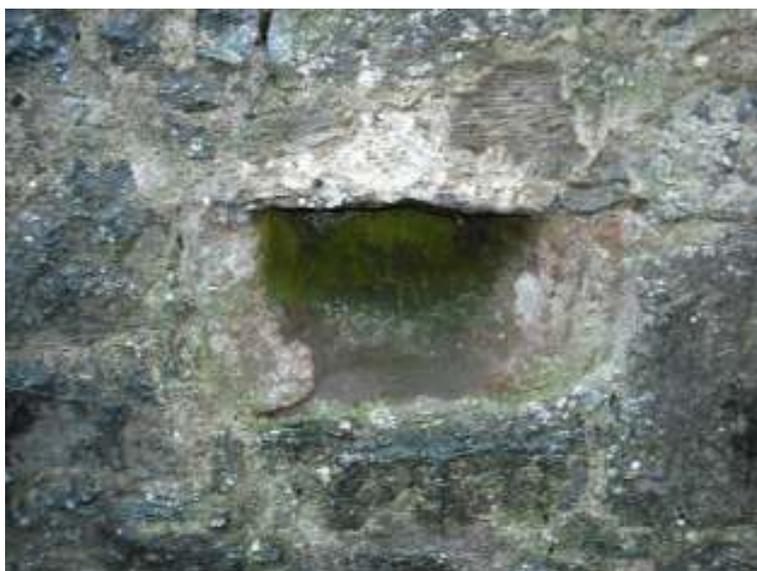
**RMP Report:** Interior red sandstone stoup-secured to south wall of church

**FMA Report:** Stoup located to east of south door.

- Currently in good condition but the nature of sandstone means its condition will decline.

- Monitoring of condition
- Appropriate protection from the elements

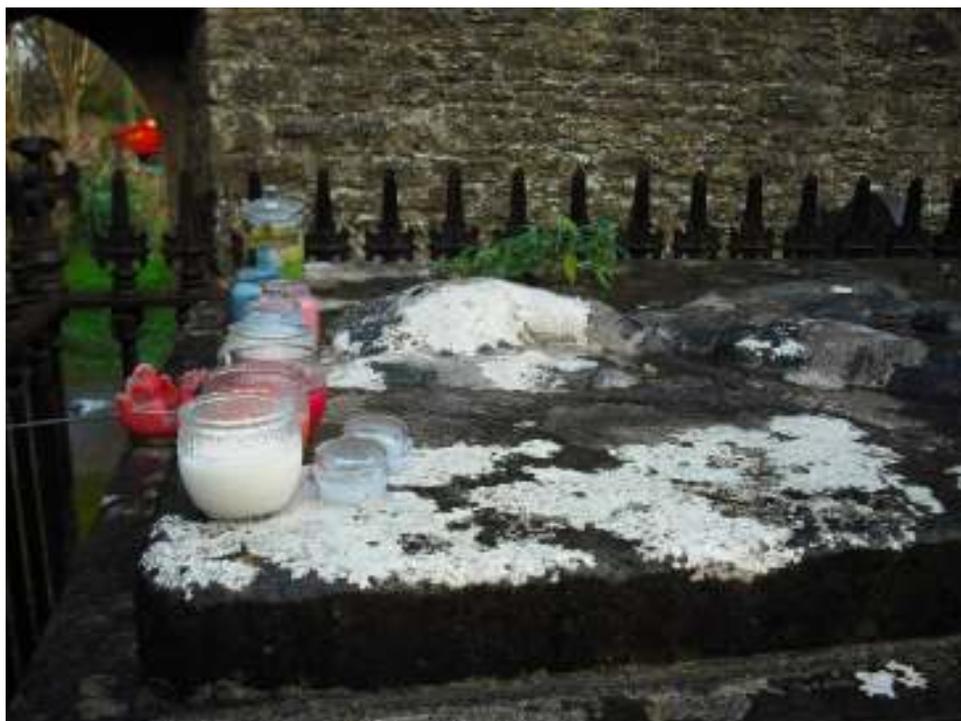
**RMP Report :** Altar tomb dedicated to Maud Plunkett d.1494-recumbent effigy of female figure with horned cap.

**FMA Report:** Effigial tomb surrounded by decorative iron railing. West end (N and E) corners have been modified and consist of brick supports. East corner looking fragile, north-east broken. Base decorated with Plunkett shields. Effigy set in thick slab (w end has been damaged and repaired).By return visit vegetation had become established in north-corner of tomb. Significant lichen growth. Mostly recently candles have appeared on the tomb.

**Structural Survey 2011:** Consideration should be given to repairing Maud's tomb by reattaching pieces of masonry which have broken off and repairing cracks to the ashlar.

- Supporting slabs of the effigy have deteriorated and fragments have broken off.
- Vegetation

- As the site is within the ownership of FCC, Ministerial Consent will be required PRIOR to the commencement of ANY works. Consent will require a detailed plan of works to be undertaken.
- Repair to the tomb will require specialist assessment and advice
- Lichens to be assessed for damage potential

**DO** Repair Maud's Tomb with specialist Conservation advice

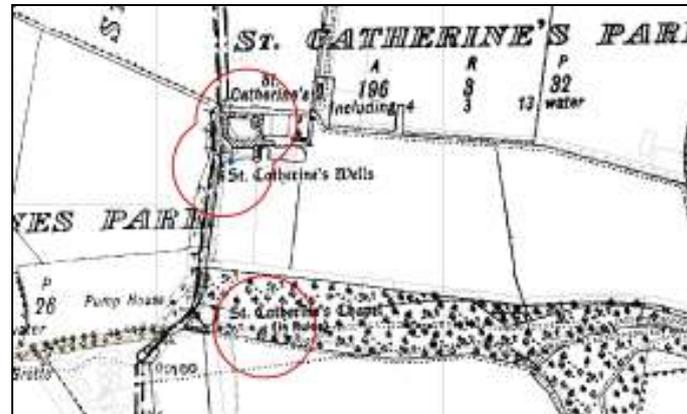
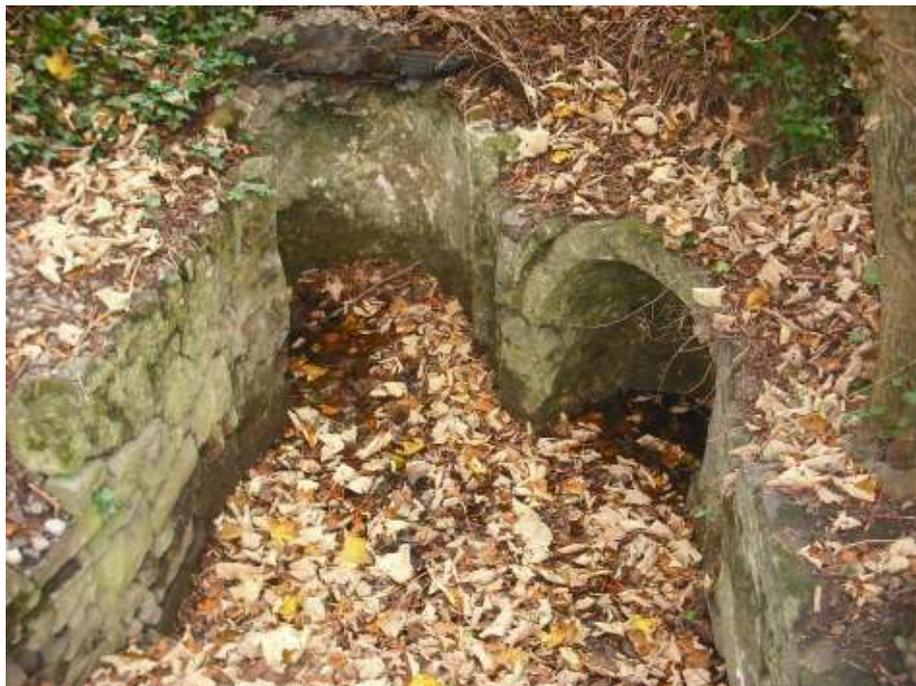
**RMP Report:** Located along side entrance on E side, two wells side by side with arched coverings, one in N higher than other. Lower well has hollowed out granite facing at base. In 1958 carved stone head was fixed to higher arch (Rep Nov p.82). No longer present. Tradition of water from wells curing sore eyes. No longer venerated. Concrete culverts have been erected W end of well and pipe runs into lower well.

**FMA Report:** Located at the base of wooded slope and adjacent to tarmaced pathways. Steps down into wells. The upper well has since disimproved from the last visit-the arched covering has fallen been broken off-shows in section as corrugated iron and possible asbestos rendering.

- Either repair or complete removal of well covering.
