*Managing Fingal County Council's  
Archaeological Resource*

Christine Baker  
Field Monument Advisor

March 2012

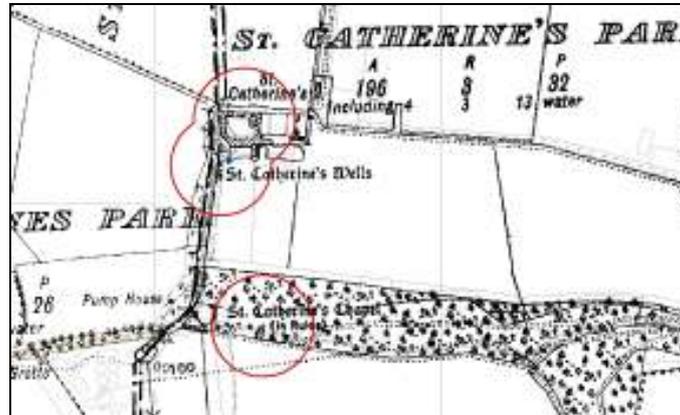
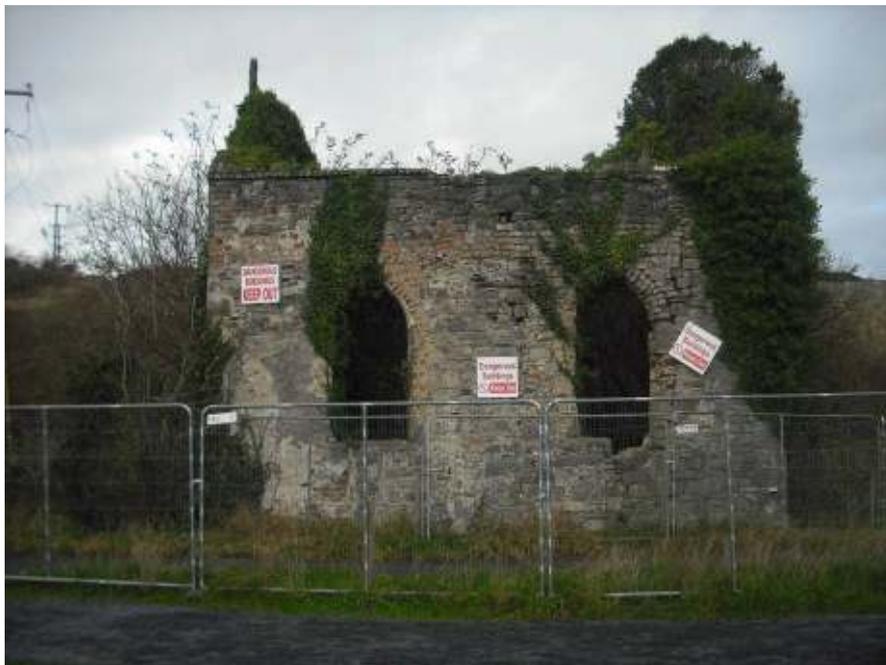
Located at the base of a hill by tarmaced walkway within St Catherine's Park. Belonged to Dr Stephen's hospital at one point. Squareish building survives to roof height. Two pointed gables, brick-lined. Rough limestone with red brick inserts. Completely overgrown internally and ivy growth on three facades. Accompanied on return visit by Con Manning (2010). He believes W gable not to be original.

Damage to fabric around E window ope where be used for entry. Internal plasterwork falling. The site has continued to deteriorate and is now fenced off.

**Structural Survey 2011:** The structure is very vulnerable and decaying rapidly. It is a good example of the damage that can be inflicted on buildings by uncontrolled vegetation.

- As the site is within the ownership of FCC, Ministerial Consent will be required PRIOR to the commencement of ANY works. Consent will require a detailed plan of works to be undertaken.
- A structural survey and recording of the original fabric remains should be undertaken by a suitably qualified practitioner prior to the undertaking of any works.
- Dependant on the result of above and advice of the Conservation Officer, a programme of consolidation and repair should be instigated.
- Removal of vegetation in line with best practice and with advice of the Conservation Officer.
- No groundworks should be undertaken within or in proximity of the church without an archaeological assessment.

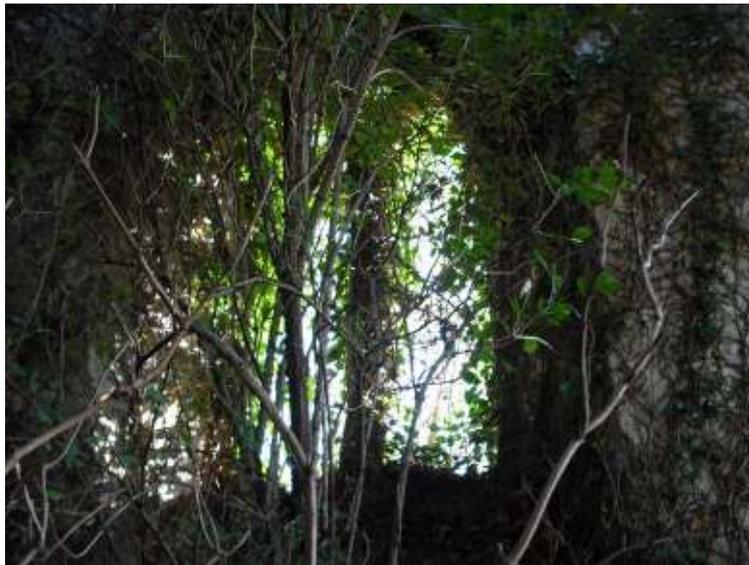
*14<sup>th</sup> century window mullion*
