Core Hole Investigation Steel Sheet Pile Survey - Supplement Skerries Pier

Project Title:	Core Hole Investigation
Location:	Skerries Pier
Document No:	21-018/UI02

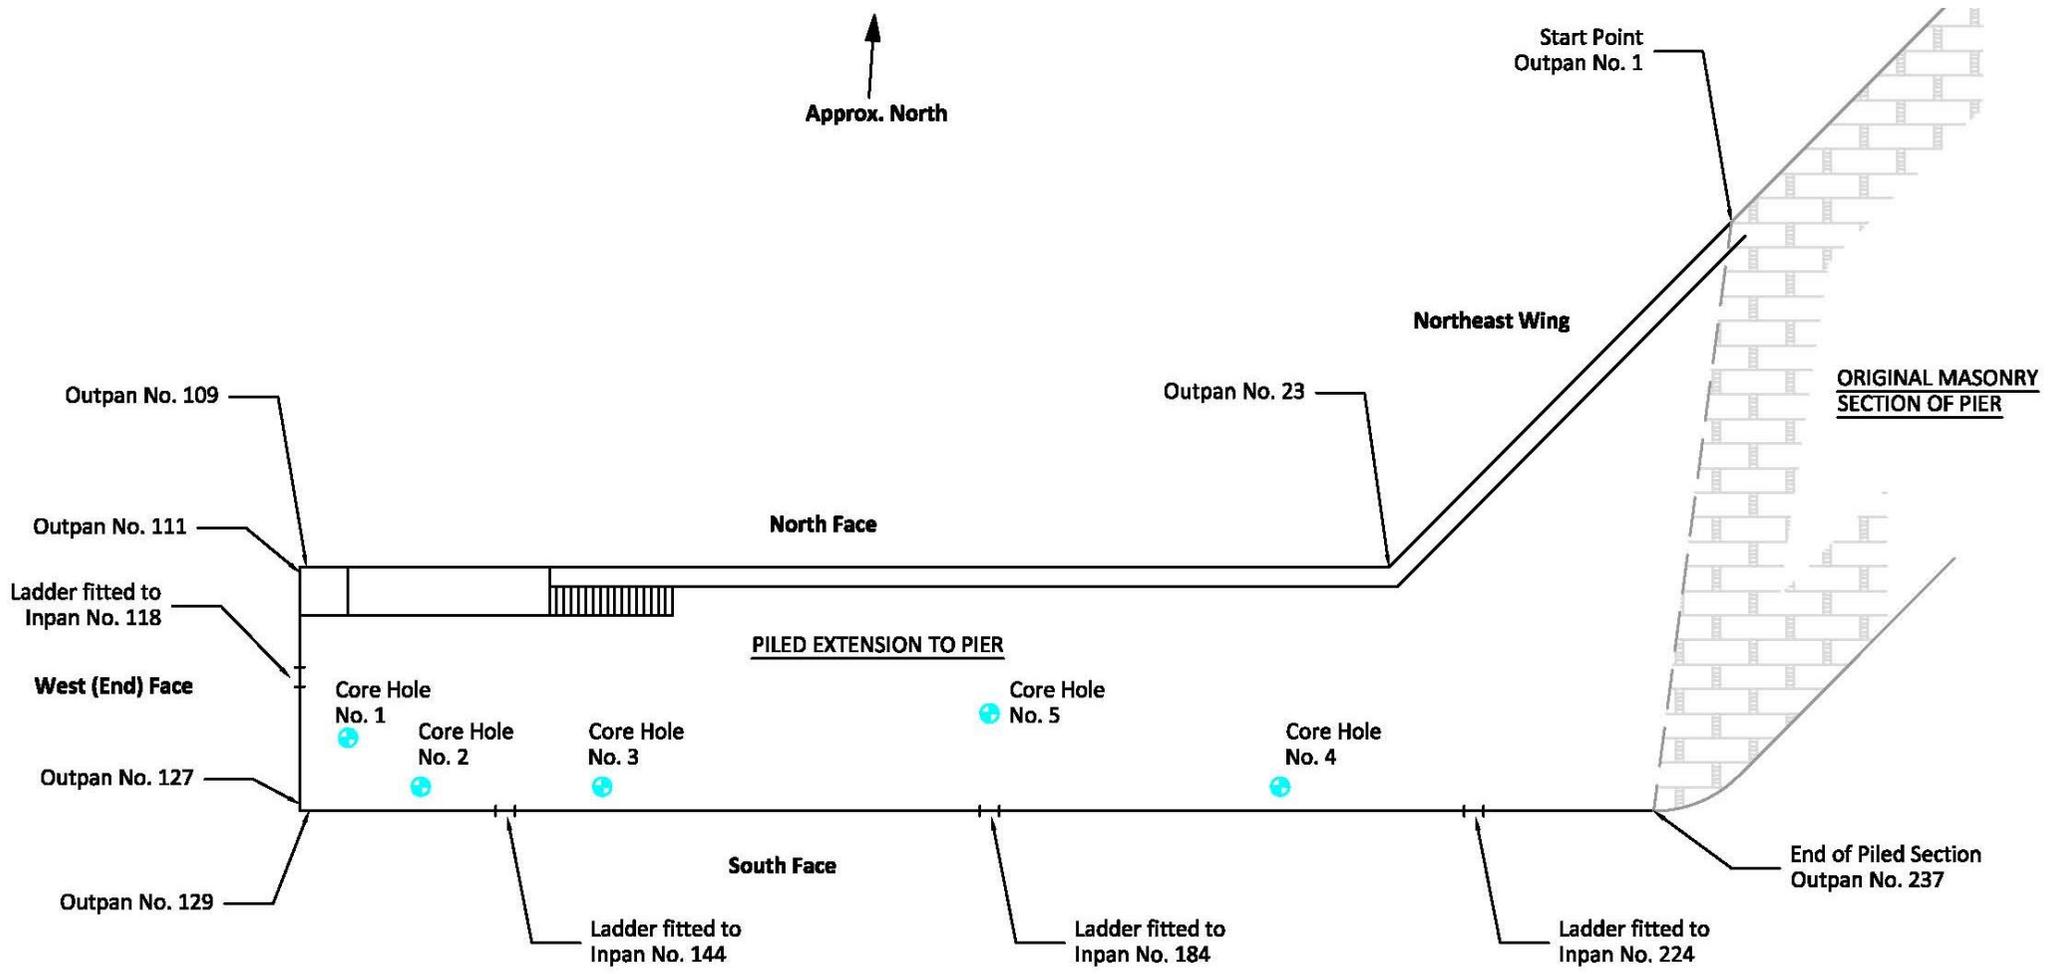
Fig A1 – Core Hole Location Layout

The locations of the core holes were selected and marked on the pier surface, to correspond piles where defects were previously found.
