# Record of Conservation Works at St. Columba's, Swords, Co. Dublin

CMF23-1-DF001

Finola O'Carroll

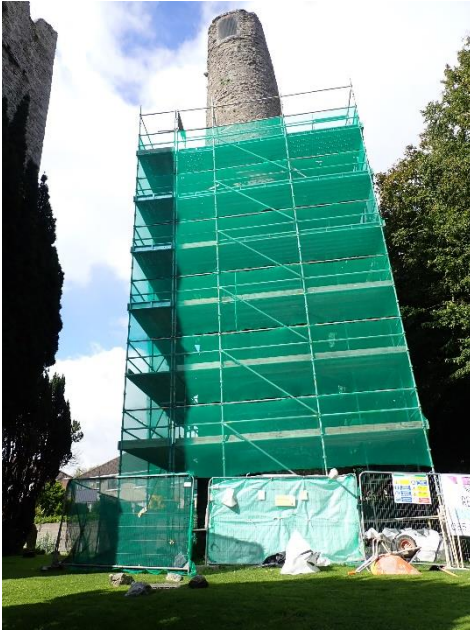
The scaffolding was erected to a height of about 15m around the round tower and in use by the second week in August. Specific areas had been highlighted for re-pointing, notably the southeast side and part of the west side, starting midway between the levels of the south and north windows extending down to ground level.

Plate 1: the tower with scaffolding in place

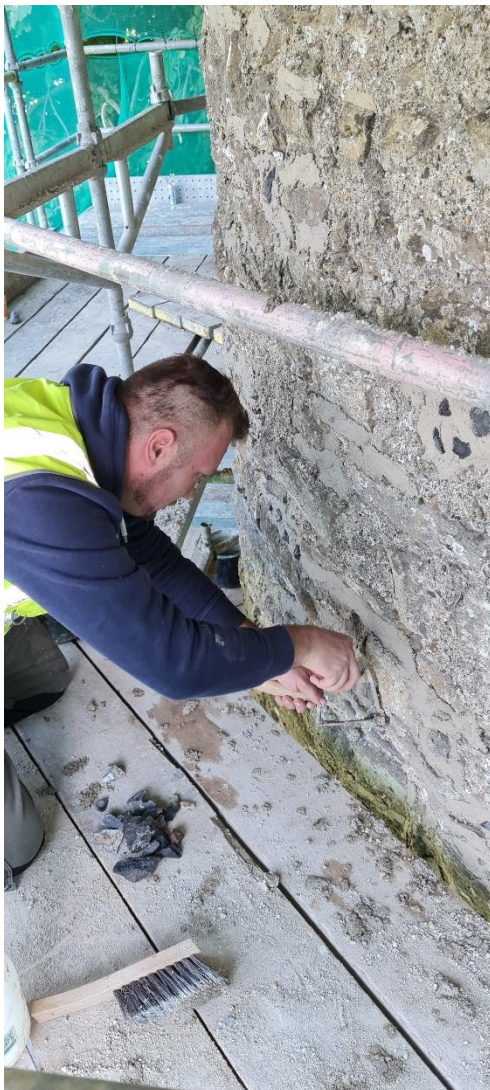
Plate 8: a stonemason at work

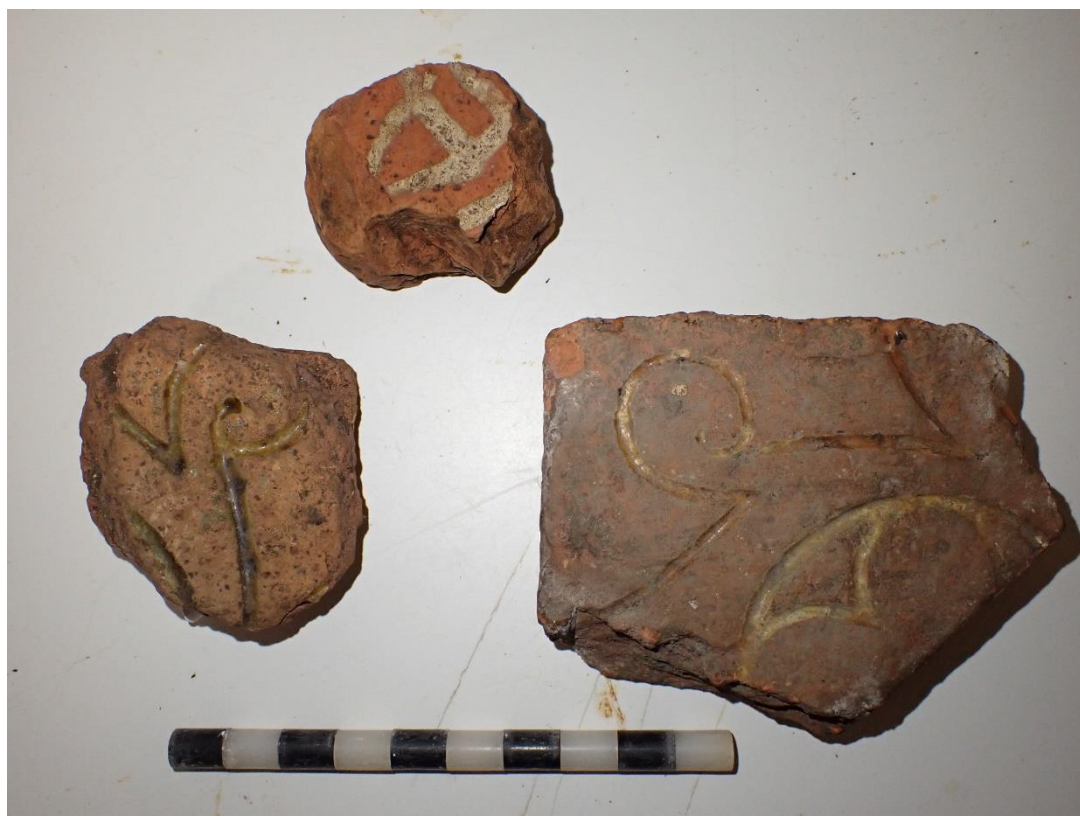
Plate 32: Line impressed tiles of pattern L46 (bottom) and unidentified two-colour tile (top)

A second fragment of the same pattern of line impressed tile was also found by him. These tiles have been found before in Swords Castle and recorded by Eames and Fanning (P. 34) and from Lusk in Co. Dublin, as well as from various sites in Dublin city. Mr. Mierocha also found a small fragment of a two-colour tile. This is too small to identify the pattern with any accuracy. Only one two-colour tile is known from Swords, T59, a four-tile design with lion's face in a circular band, but this fragment does not appear to fit with this pattern. Tiles of this type were found in Swords Castle (Baker 2022<sup>2</sup>) but not illustrated.

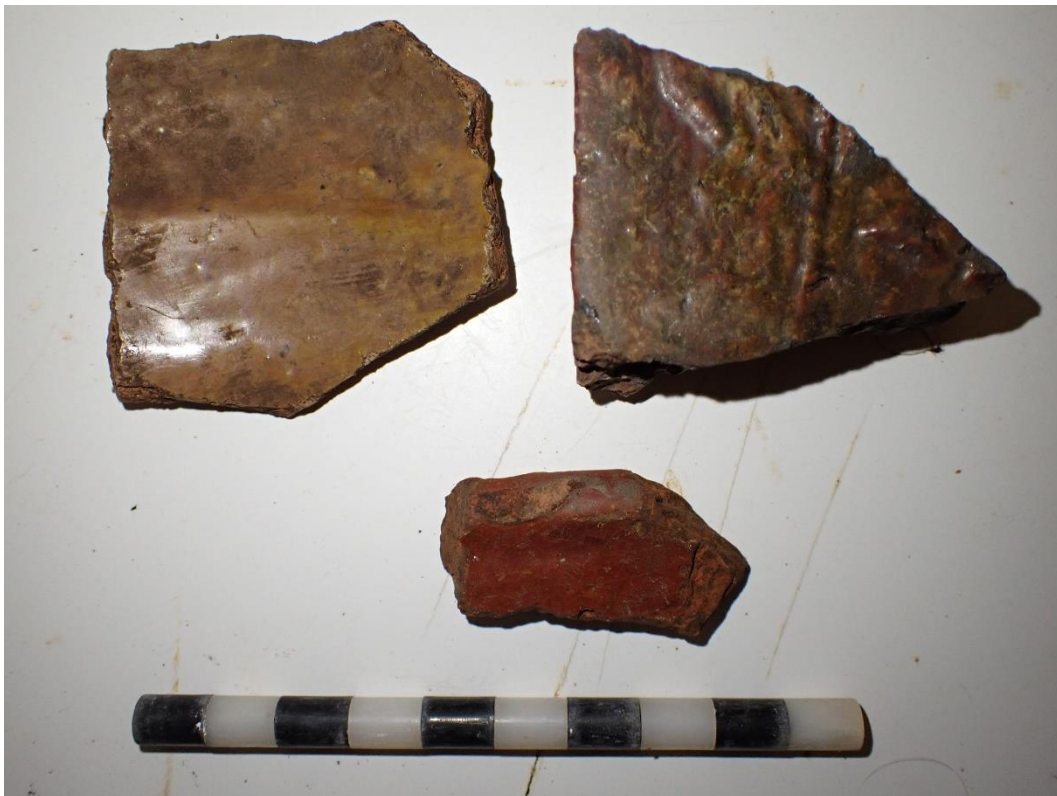
In addition to these medieval tiles, he also found a relief tile of possible late medieval to early post-medieval date. This appears to be of the tile pattern R87, known from Dublin Castle (Kieran Campbell, pers comm). According to Eames and Fanning such tiles were rarely in use in Ireland until the late fifteenth century, (ibid p. 57).

Plate 33: Fragment of relief tile (top right) with two fragments of post-medieval pottery
