**Tower House
at
Glebe South
Balrothery, Co. Dublin
Archaeological Oversight Report**

CMF23-1-DF003

RMP No. DU005-057006-

License No. 23E0833

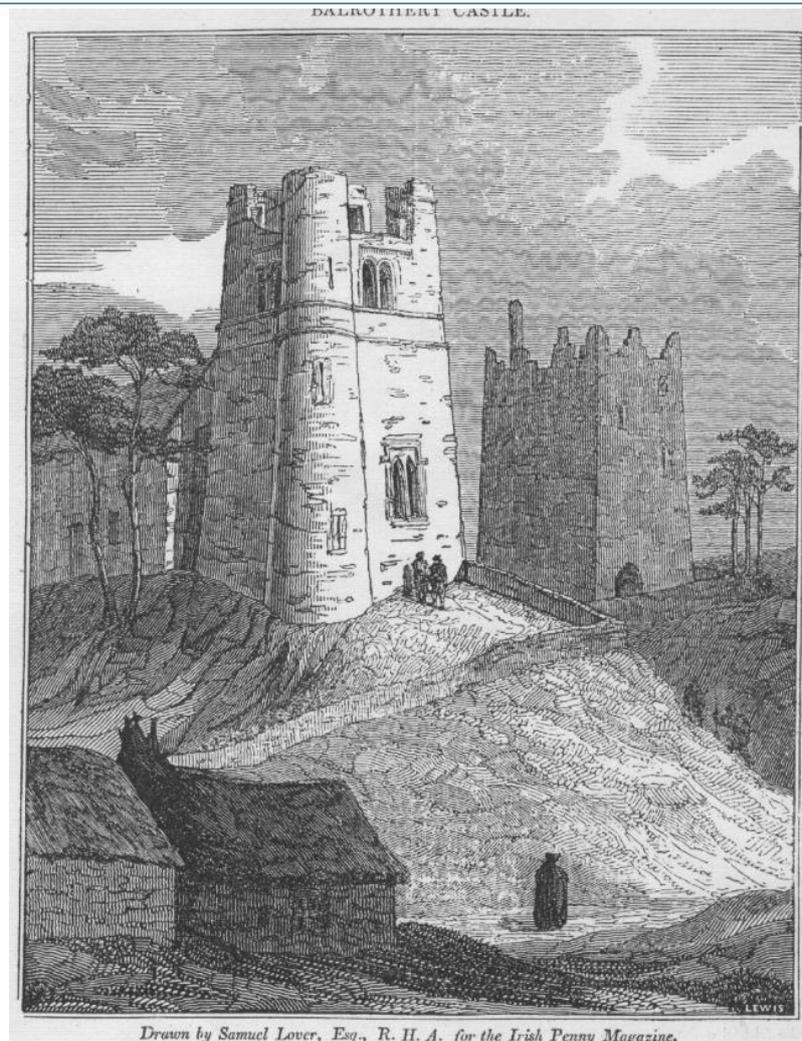
Plate 31: Illustration from the Irish Penny Magazine of Balrothery church and tower house by Samuel Lover, 1833.

The chimney rose high above the roof and parapets as can be seen in this 19th century illustration, although the shape of some of the crenels is inaccurate.
