Conservation Management Plan

**Mulhuddart Church (St. Mary's)
Church Road
Buzzardstown
Dublin 15**

Community Monuments Fund CMF23-2-DF001

05 March 2024

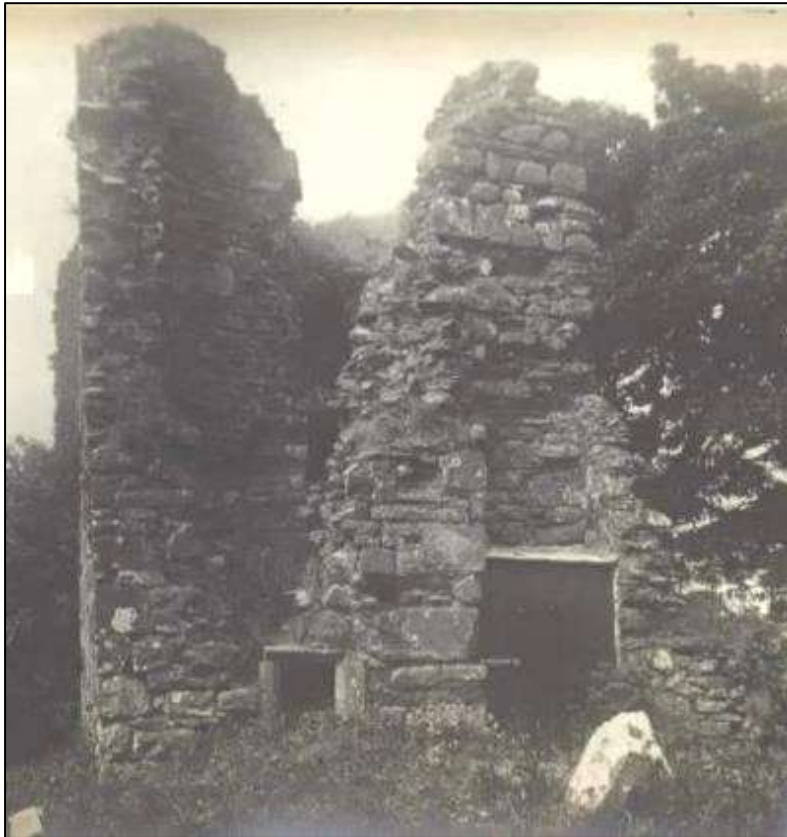
Figure 8 Image of tower from north c.1900 (NLI)

The extent of the modern repair is abundantly clear from a comparison of the available images; where a view of the interior of the tower was possible c.1900, that is no longer the case (Plate 10). The string courses which are present in the earlier image are likewise not present today and the modern repairs have served to obscure the location of the entrance doorway which is present in the historic photographs of the tower (Figures 7 & 8). Likewise, the extent of the modern repairs mask where the southern elevation of the tower would have met the western wall of the church, to the point where the relationship between the two is no longer apparent. The blocked window ope at waist height in the southern elevation is partially obscured by brambles in the earlier image, but it is possible to discern that it was not blocked at that point in time and that it was bordered by the same chamfered cut stone blocks as it is today, blocks which were poorly reinserted to the point where the glazing bar holes now face in an implausible direction (Plate 11). Also present, in both the historical and modern images, above this ope are a number of stone voussoirs above the lintel.

Today no trace remains of the doorway which was present on the early images (Figures 8 & 9), the modern repairs have been too thorough in that respect and the location of that ope is completely without evidence on the southern elevation of the tower at present. The access to the interior of the tower would have been through that door, with a doorway immediately on the left upon entry which would have accessed the stairs to the upper floors. The basic massing of the structure suggests the former possible location of this staircase (Plate 19), with the massing of the western wall (Plate 20) also suggesting it may have accommodated a stair of its own, possibly starting from a higher floor or from the end of the southern wall staircase. Something which was documented by Austin Cooper in his 1781 account which noted the remains of a staircase in the southwest corner of the tower.

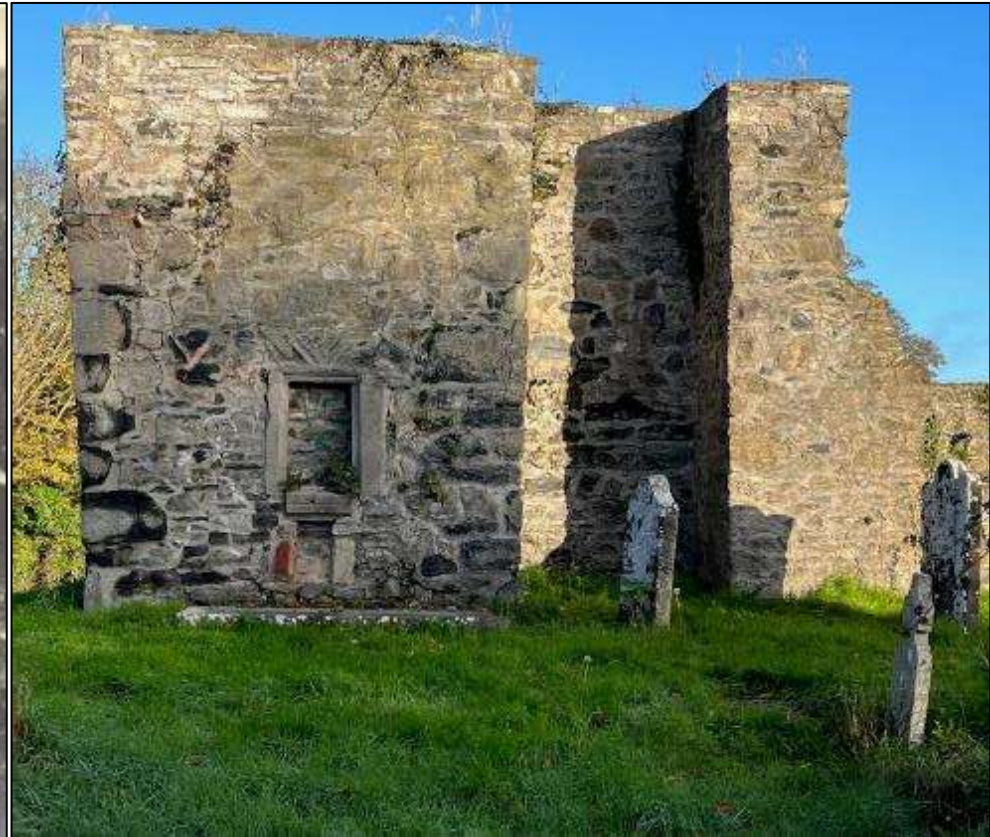
Plate 10 Image of tower from north (present day)

Southern elevation (Plate 10)- the extent of the modern repair with the late twentieth century strap pointing which afflicts much of the tower and church has served to obscure the location of the entrance doorway which is present in the historic photographs of the tower (Figures 8-10) and additionally it masks where the southern wall of the tower would have met the western wall of the church, to the point where the relationship between the two is no longer apparent. A blocked window ope at waist height in the southern elevation is bordered by some chamfered cut stone blocks, which have been poorly reinserted to the point where the glazing bar holes are facing in an implausible direction (Plate 11), this ope may have illuminated the start of the staircase, which was possibly contained within a mural gallery in this wall, as suggested by the massing (Plate 19).

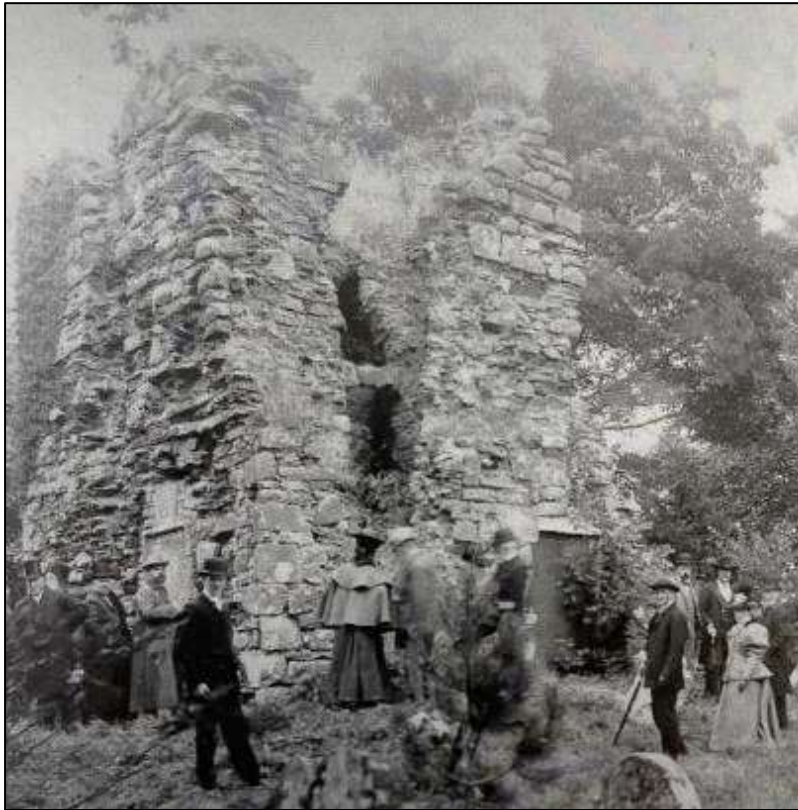
Figure 9 Lantern slide of tower from northwest, 1897 (RSAI)

A comparison of the 1897 lantern slide (Figure 9) and the modern images (Plates 12 & 16) of the western elevation is interesting in that they again evidence the extent of the previous modern interventions to the tower. The 18th century mural tablet on the exterior of the west wall

of the tower was at shoulder height, judging by the gentleman pictured beside it in 1897. Today it is sadly illegible from ground level as the modern interventions appear to have moved it to a higher location on this elevation, rendering the script indecipherable from ground level, although some of the inscription was recorded previously, during the Fingal Historic Graveyard Survey. The mural tablet and its smaller companion (Plate 13), which is located above it, are today both surrounded to either side and above by a rolled moulding, which would appear to be original to the larger mural tablet, but from the historic photos, is not original to its smaller neighbour above. On the current height of the wall is the base of a rectangular window ope, which would have been at first floor level and curiously at ground level a further, semi concealed, window ope type feature is present in the wall, something which suggests that the surrounding ground level and indeed that on the interior of the tower is higher than it formerly was, presumably thanks to the extensive collapse from the upper levels. The western elevation again exhibits the extensive modern repair with the late twentieth century strap pointing which afflicts much of the tower and church.

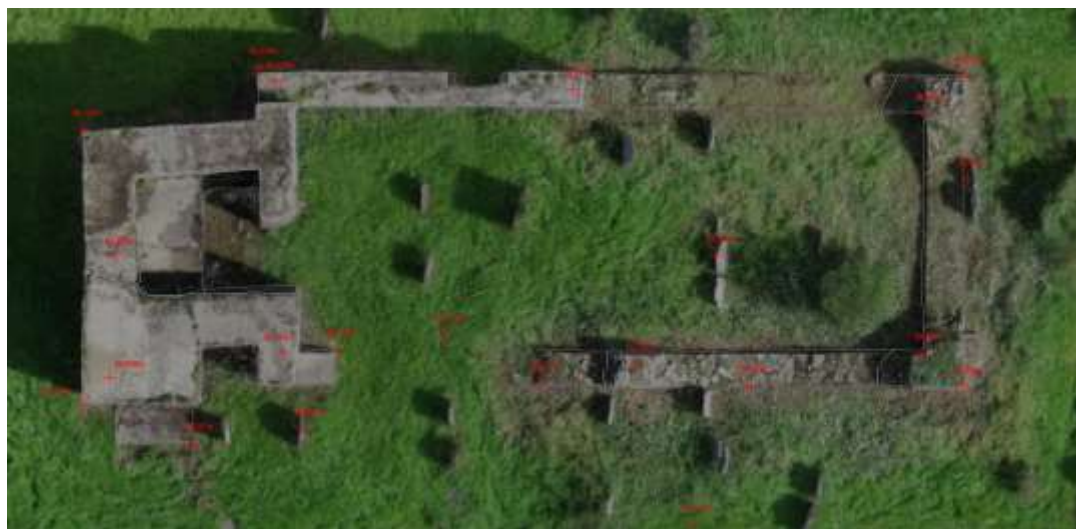
The large nave is long roofless, likely from the mid 17th century and most of the walls are now quite insubstantial excepting the west end of the north wall which rises to approximately 2.2m for an 8.0m length. This section seems relatively robust and has received repairs albeit cementitious pointing in the recent past. There is also a stub of the south wall attached to the residential tower that has been repaired as part of previous repair works to the tower.

The rest of the nave walls are in a very poor state and have attracted some poorly conceived repair attempts which are now failing.

Footprint of the upstanding remains – Archer 2023

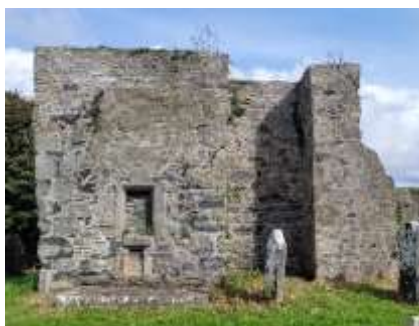
South elevation of Tower.

The condition of the tower walls is enigmatic. There are many vertical cracks that appear to tell the storey of the previous iterations. The infill stonework now appears to be unravelling. Picking this apart might lead to a substantial tranche of work and therefore restraining the tower as is should be considered as perhaps a more pragmatic approach.

There is much recent cementitious pointing, and it appears as if this may be leading to issues with moisture movement through individual stones and erosion of the stones.

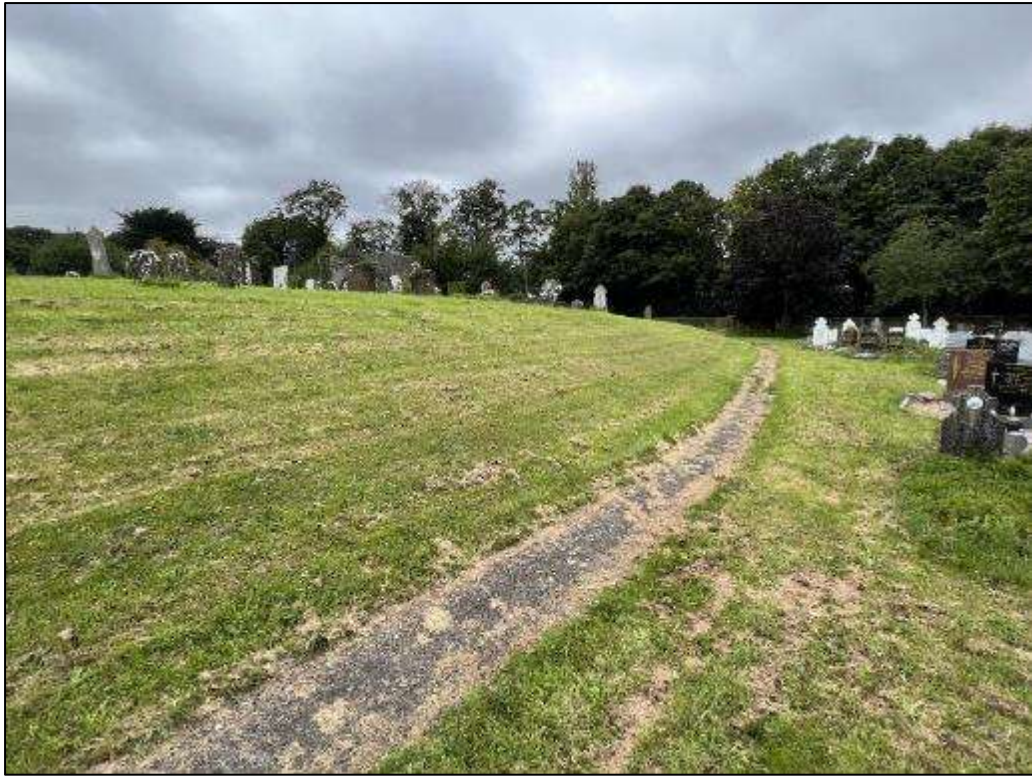
Located immediately at the base of the rising ground of the mound slope is modern a curvilinear path at approximately 85m OD, which mirrors the curving line of the edge of the mound (Plate 3) and it is suggested that this feature may inadvertently represent the line of a possible former enclosing element to the mound/church site (Figure 13).

Plate 3 Curvilinear path on north side of mound, facing west

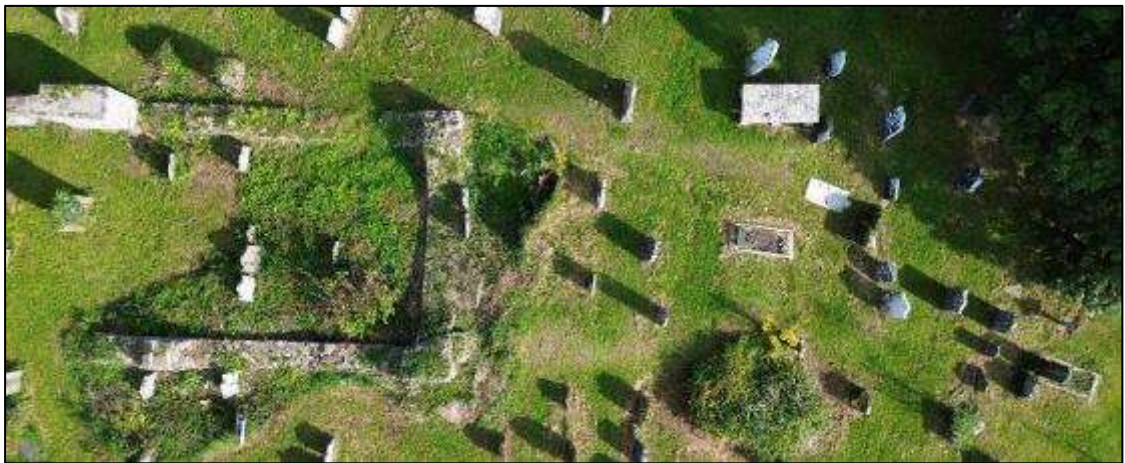
The subsurface remains (Plate 6), leading east from the current eastern gable of the church are intriguing; although it has not been confirmed, the aerial photos and evidence on the ground appear to point to the foundations of the north and south walls of a slightly smaller structure extending eastwards from the current location of the eastern gable of the church, possibly suggesting that the full footprint of the church may have been adjusted over time (Plate 21). The subsurface remains enclose a rectangular area 11.5m east-west and 6.5m north-south, which would represent a stone built structure of considerable size. One interpretation of these remains might be the former presence of the nave/chancel arrangement mentioned by Ronan (1940), of which only the chancel remains upstanding today. Whilst the elements of upstanding masonry (Plate 22) present close the southern end of the eastern gable's exterior elevation might be construed as the remains of a batter, the fact that it is present on the shorter, and therefore generally more stable gable wall would seem to rule that interpretation out. An alternative interpretation could be that the feature represents an *Anta*; such features are described by Ó'Carragáin (2005) as "*pilaster-like projections of the side walls beyond the gables that, most authors agree, are translations into stone of the corner posts of timber prototypes*" in other words the stone mimic of a timber feature or skeuomorph. Ó'Carragáin states that most of the Pre-Romanesque churches with *antae* are located in the east of Ireland and whilst the presence of such a feature is not in keeping with the late 13th/early-14th century construction date of the upstanding remains, it is tempting to suggest that there may have been an attempt by the medieval builders of St. Mary's to recreate a feature of the early church in their later build. That suggestion might be scoffed at but when one considers Ó'Carragáin's statement that East Munster & West Leinster were the only substantial areas where *antae* remained ubiquitous until well into the twelfth century, knowledge of this type of feature might not be that farfetched. However, it is suggested by the author that the most likely interpretation of this piece of masonry is that it is the only above ground manifestation of the below ground remains of the walls of the former nave of St. Mary's.

Plate 6 Aerial view of possible gallery extension, east from the church

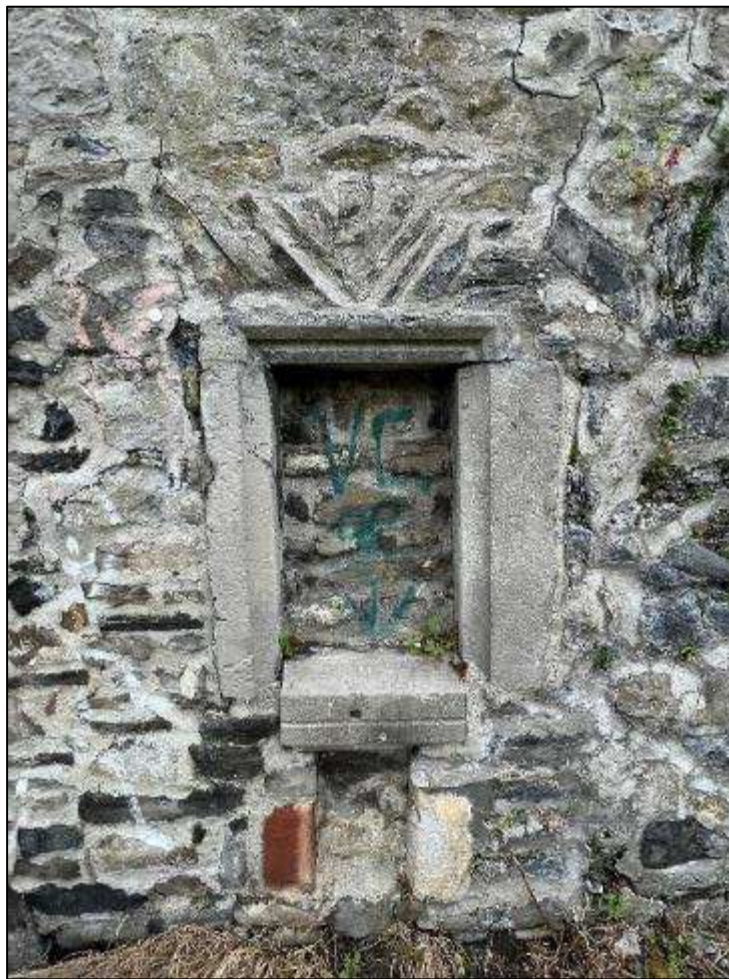
The previous window opening to the south elevation is now blocked up and although having to do little structural work the well-being of these carved stone elements needs addressing.

Plate 11 Blocked window opening on southern elevation, facing north

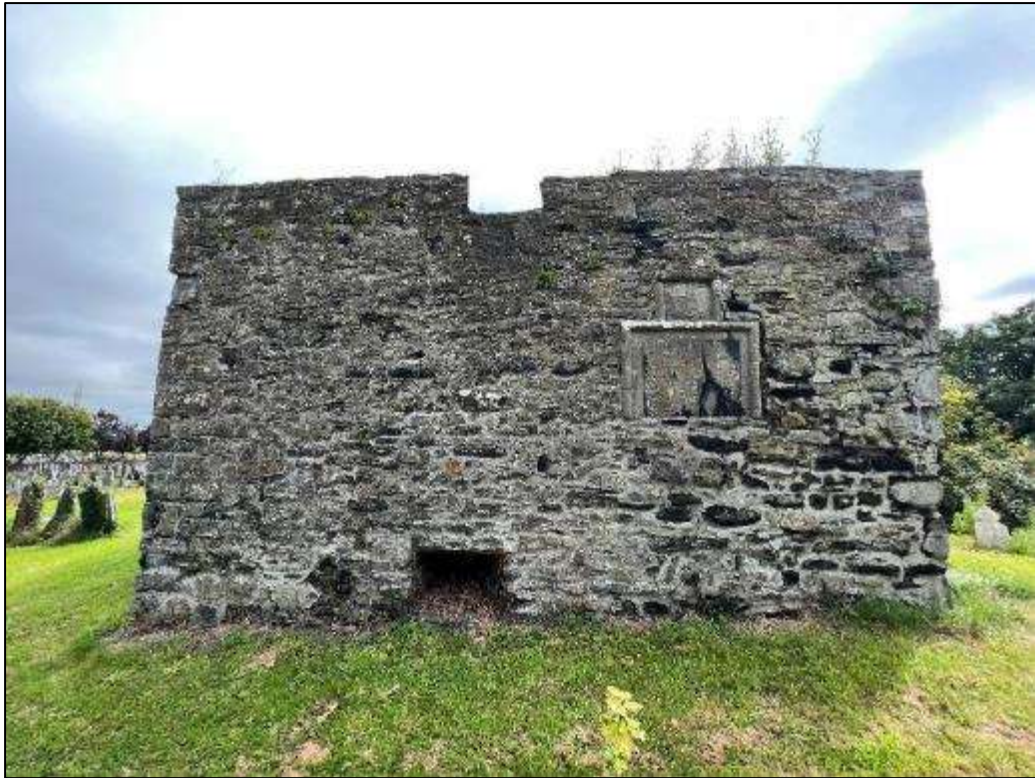
Plate 12 Western elevation of residential tower, facing east

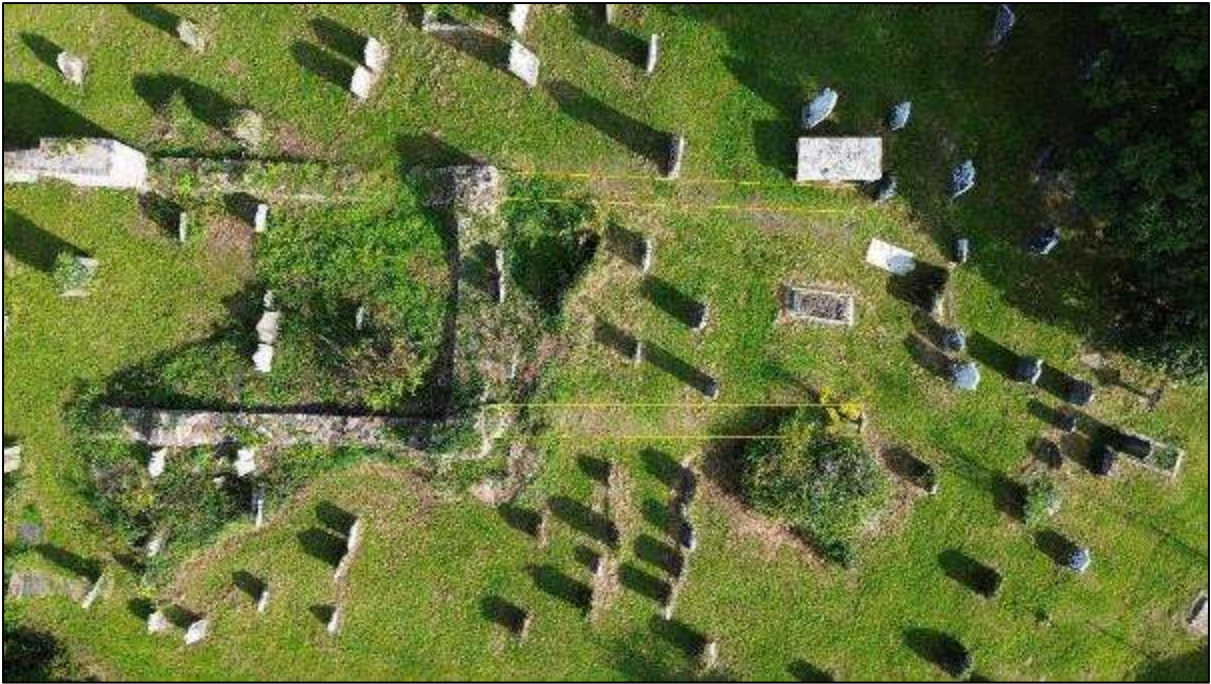
Plate 21 Approximate lines of possible former nave/earlier church outlined in yellow

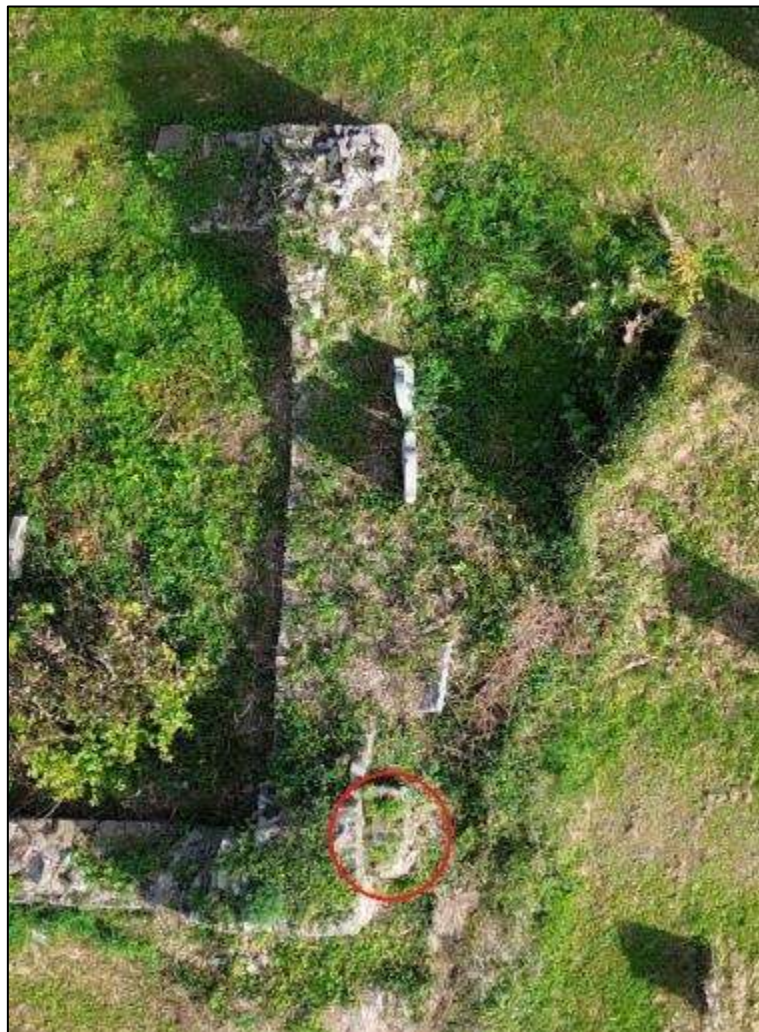
Plate 22 Aerial view of eastern gable, with masonry remains circled in red
