Site: Lanistown Castle, DU012-004

Address: Donabate, Co. Dublin

Report on Archaeological Monitoring of CMF Conservation  
Works (CMF24-1-DF004) under Ministerial Consent C00141

Date: 11<sup>th</sup> February 2025

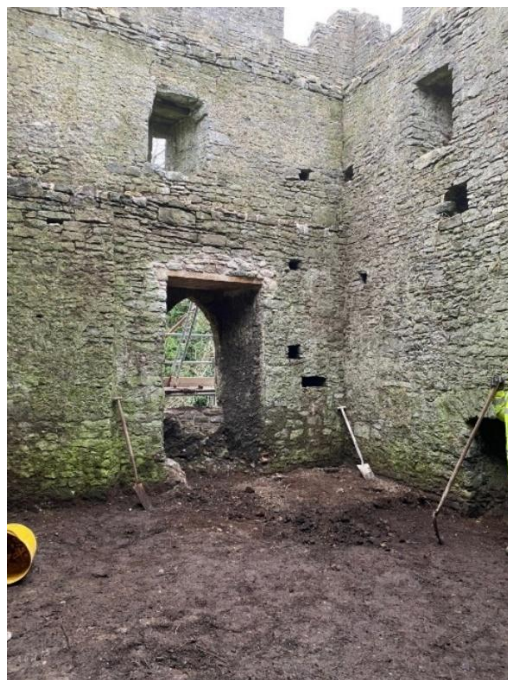
The stone vault covering the ground floor rooms and forming the first floor level in the castle had been open to the elements for a prolonged period of time. During this time a deposit of hummic material had accumulated, providing a fertile environment for plant growth (Plate 10). Significant woody saplings were present at the outset of the project and the conservation works provided for the removal of the plant growth, removal of the hummic material and installation of a layer of compacted puddle clay to be capped by a thin layer of grassed sod that could be easily maintained through regular mowing. The hummic material was removed by hand under archaeological supervision (Plate 11). No artefactual material was encountered apart from a plastic shotgun cartridge and a scalloped edged fragment of tin-glazed earthenware (Plates 12 and 13).

**Plate 11:** Hand removal of soil overlying vault, with replaced western lintel visible, facing west

Prior to the installation of the puddle clay, the lintel over the western ope was replaced with timber beams and a hole in the floor over the western intramural stairs was covered with a salvaged stone slab (Plates 14-16).

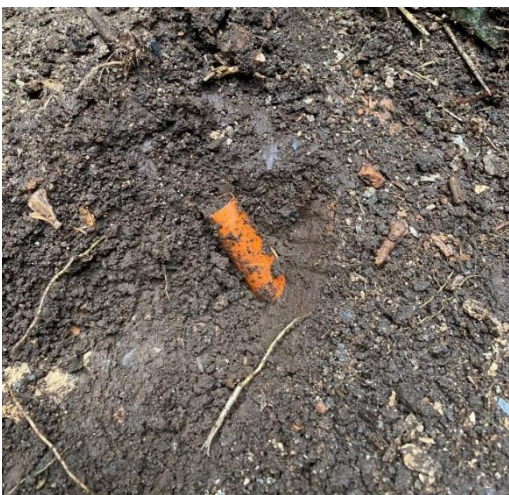
**Plate 12:** Plastic shotgun casing in soil overlying vault

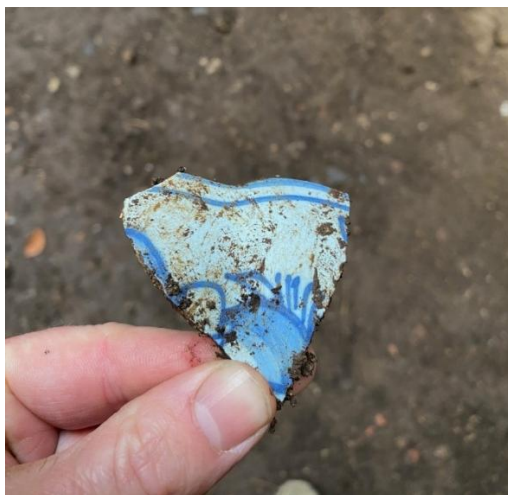
**Plate 13:** Tin glazed earthenware from soil overlying vault

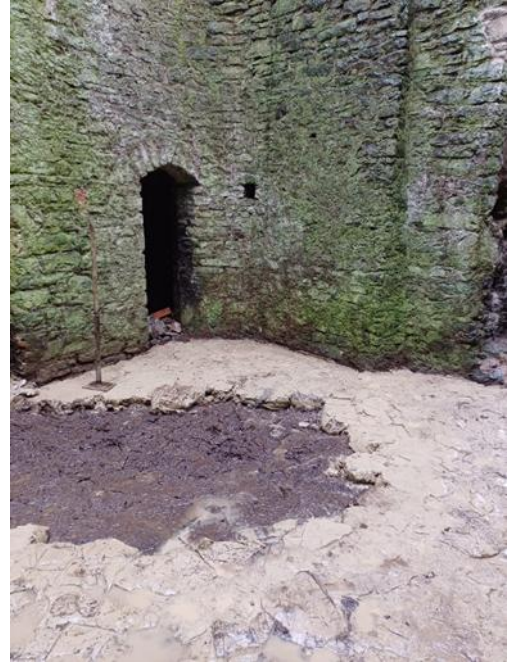
**Plate 15:** Installation of puddle clay art first floor level, facing northeast

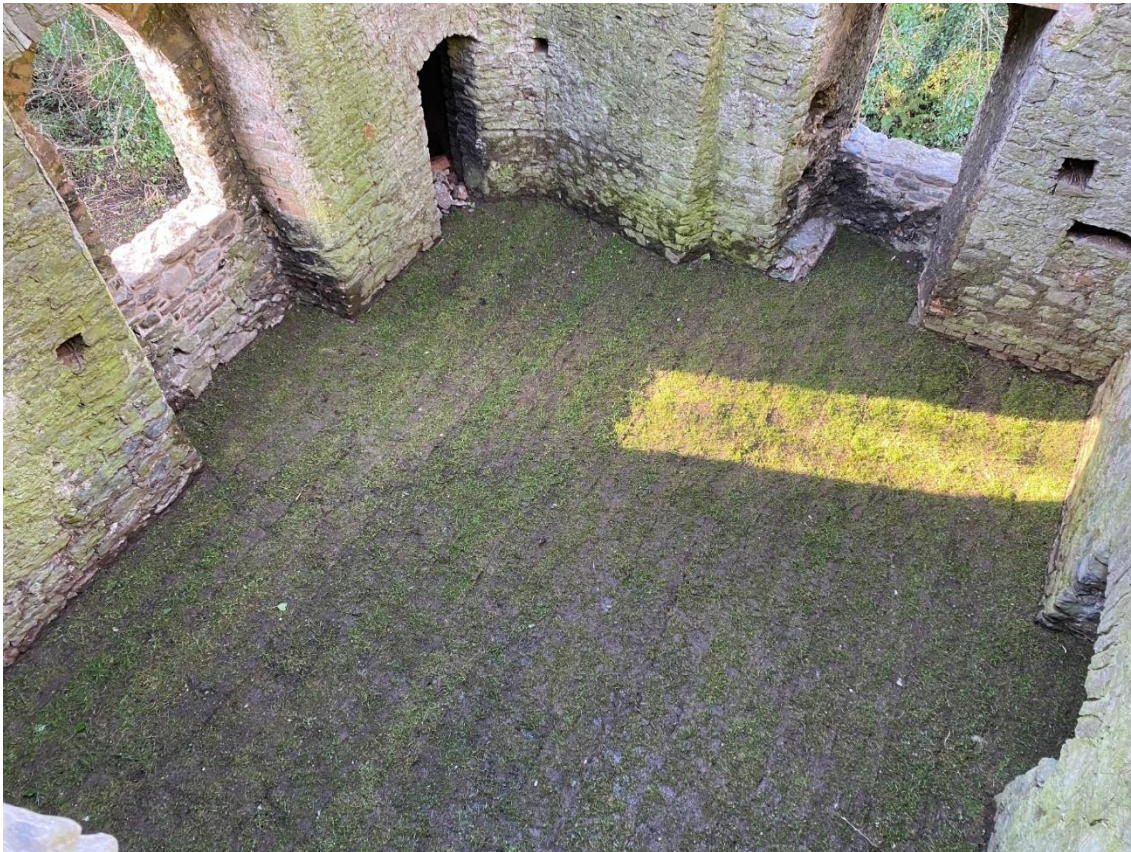
**Plate 16:** Grassed sod installed over puddle clay at first floor level

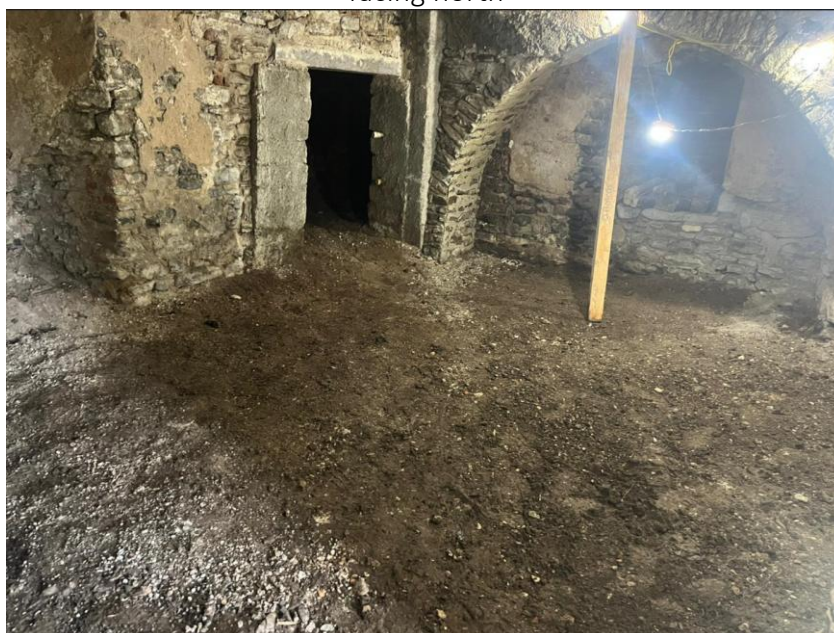
**Plate 18:** Ground floor interior following reconstruction of arch and removal of muck and stone

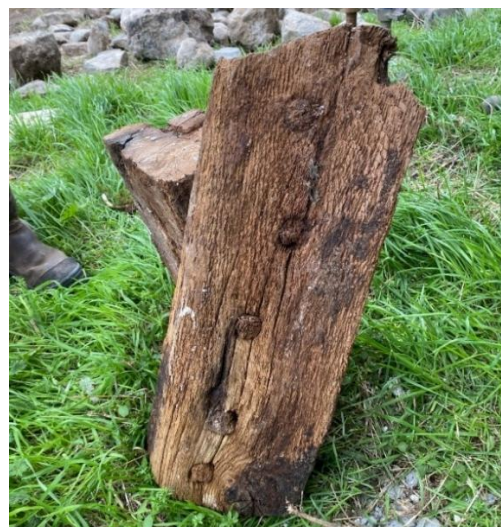
During these works, a post-medieval fireplace that had been inserted into the southwestern tower was cleaned out and degraded iron bars and a rotting timber that spanned the concrete sides of this opening, were removed (Plates 21-2). The timber was inspected following removal and was found to exhibit several dowels that may indicate it is of some antiquity. The timber was examined by Dr Ellen Ocarroll and confirmed to be oak. The sample was identified as a very fast-growing specimen with c. 30 tree rings evident. For this reason, it is not feasible for dendrochronological dating.

**Plate 22:** Dowelled timber beam from the post-medieval fireplace

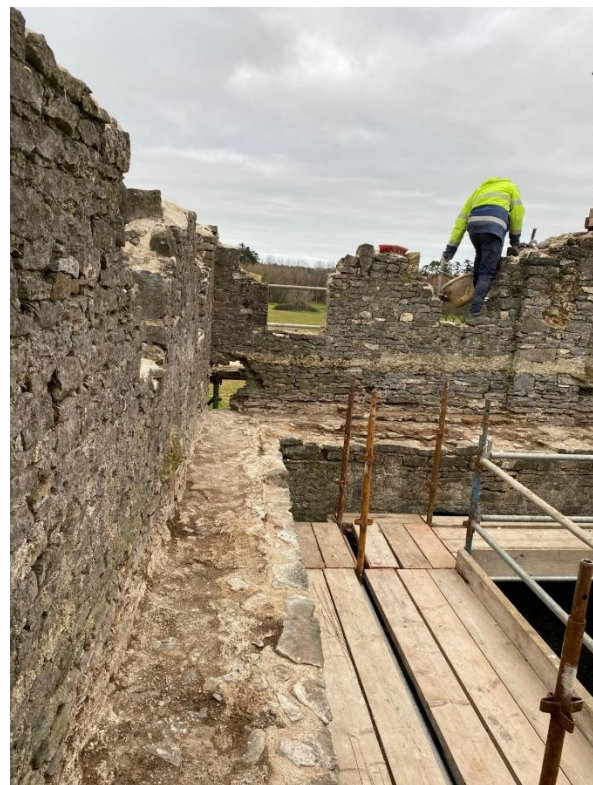
Significant water pooling, collection of hummic material and vegetation growth was evident on the wall walks at the outset of the project. The vegetation was removed and overlying hummic soil and it was found that loose redbrick dating to the 18th century phases of the site was cluttering the top of the wall walks providing pockets within which vegetation growth was encouraged. These bricks were removed under archaeological supervision, collected and stored in the ground floor room for future use.

**Plate 25:** Western wall walk following removal of brick

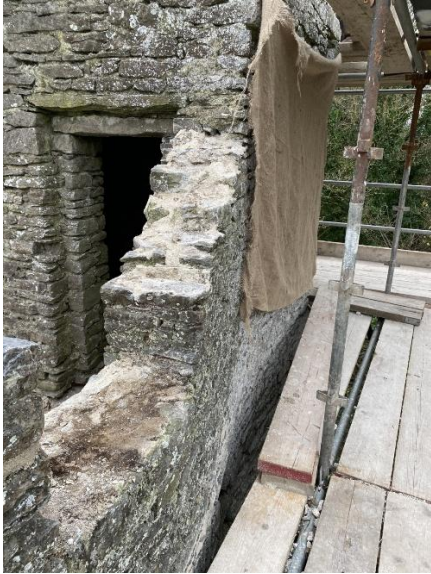
**Plate 25:** Flaunching on western wall top

The tops of the wall walks were then rough-racked with lime mortar and stone salvaged from the site (Plates 23-5). Lime mortar flaunching was applied to the tops of the crenelations all around the upper levels of the castle (Plates 26-7).

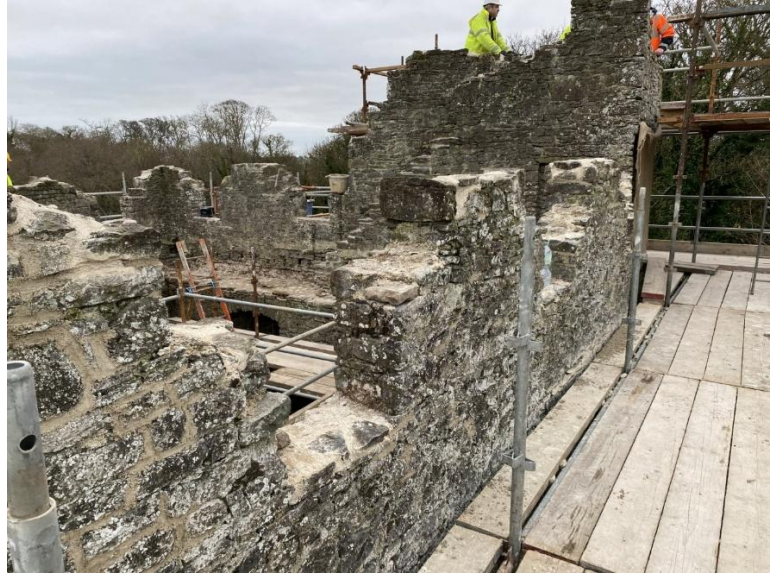
**Plate 26:** Flaunching on eastern wall top

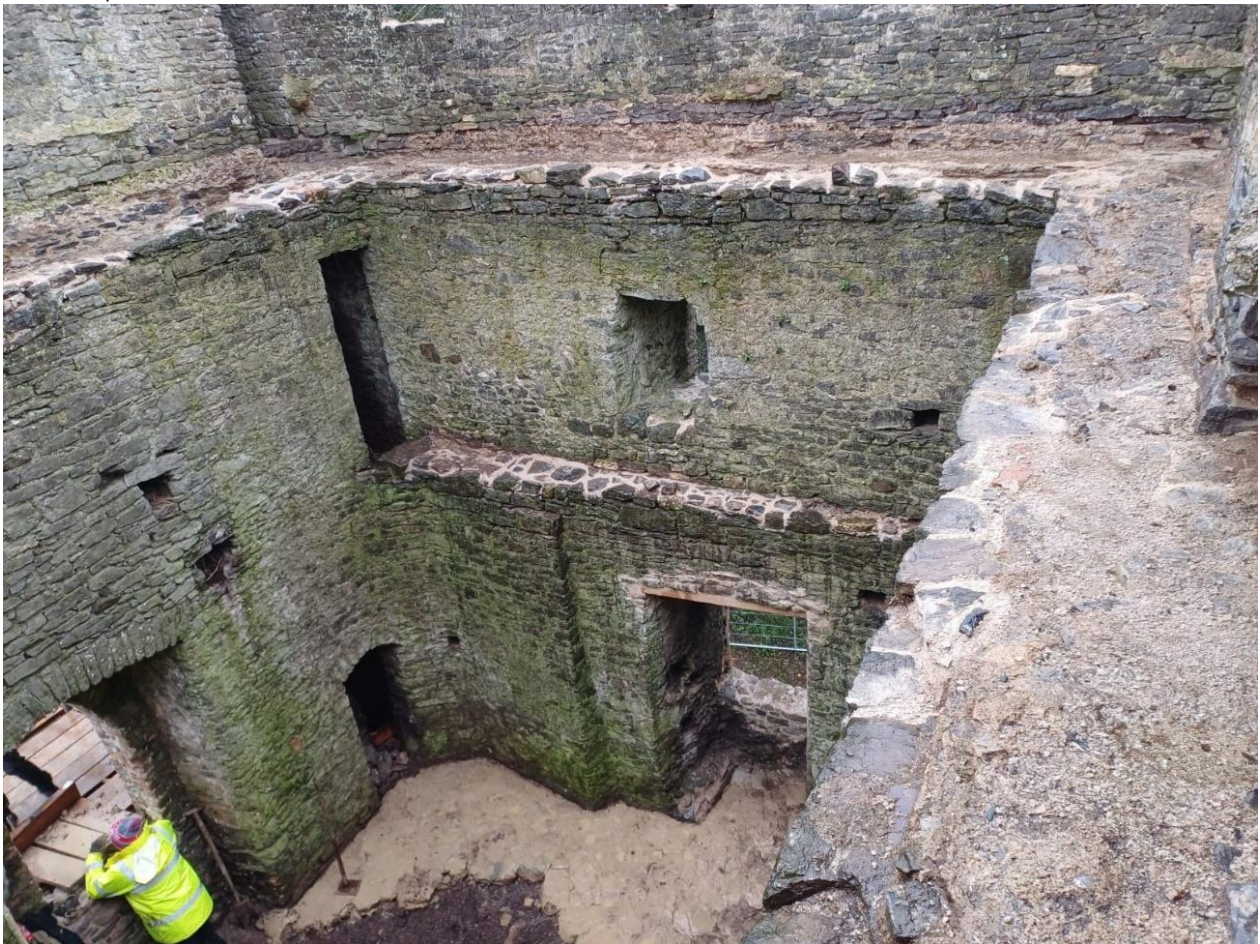
**Plate 27:** Rough racking on wall walks, facing southwest

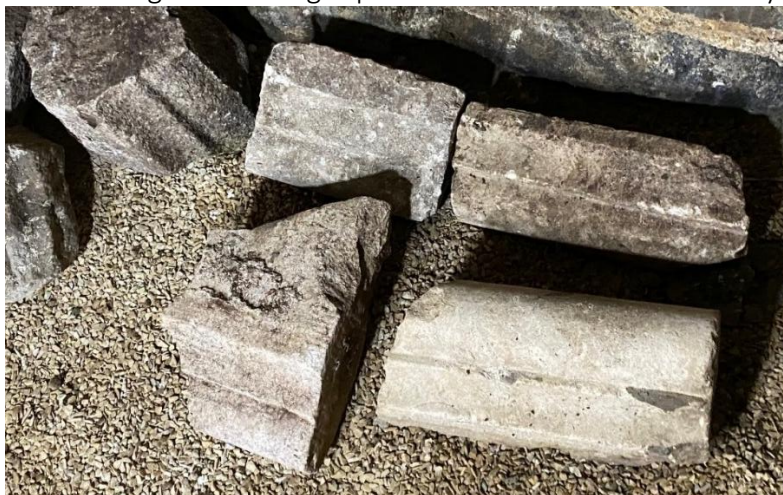
1. 4 x Moulded white imported limestone (probably Portland Stone) and including two jambes from a window or door surround of likely 18th century date and two coping stones of the same decorative programme. A close inspection of the stonework surviving at Newbridge House might prove valuable in further identifying these fragments.

**Plate 34:** Moulded limestone fragments

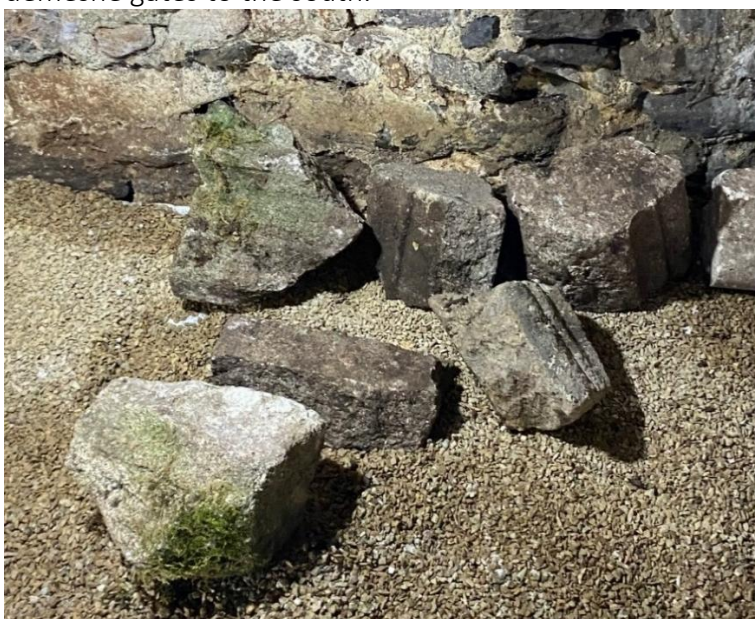
2. 6 x Moulded granite pieces. The moulding on these pieces is of the same type as the fragments above with large rolls similar to Neo-Classical decoration. One of the fragments, a flat fragment is an exact match for the capping stones on the original demesne gates to the south.

**Plate 35:** Moulded granite fragments

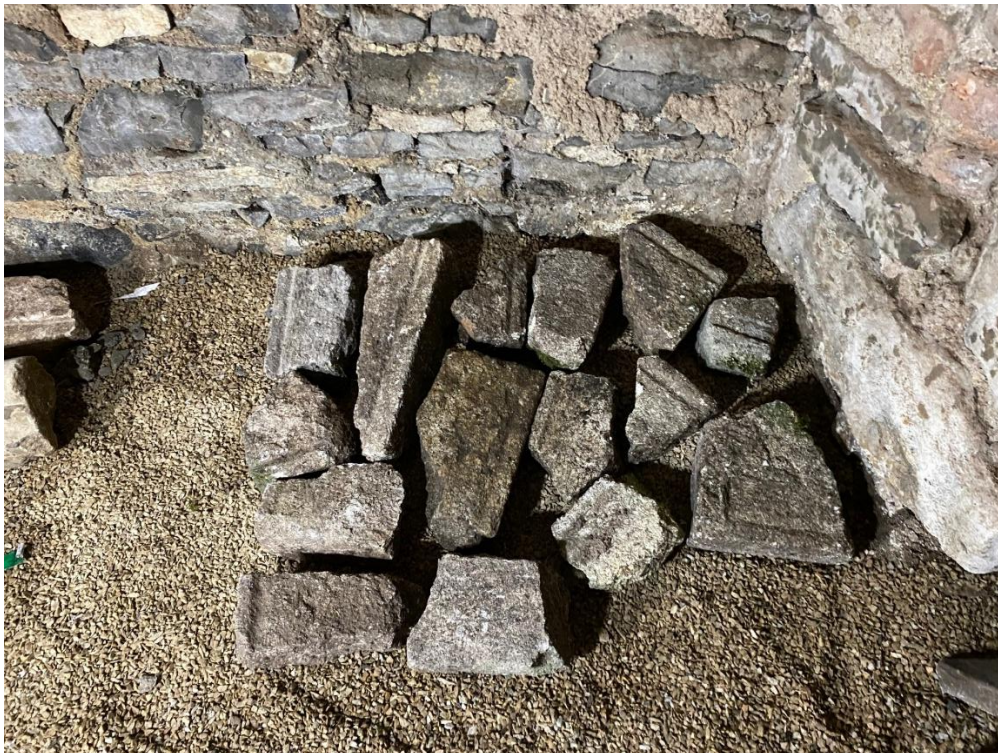
3. 15 x Flat granite fragments with edge moulding. These fragments are most likely belonging to decorative cladding or façade on 18th or 19th century date.

**Plate 36:** Fragments of granite cladding

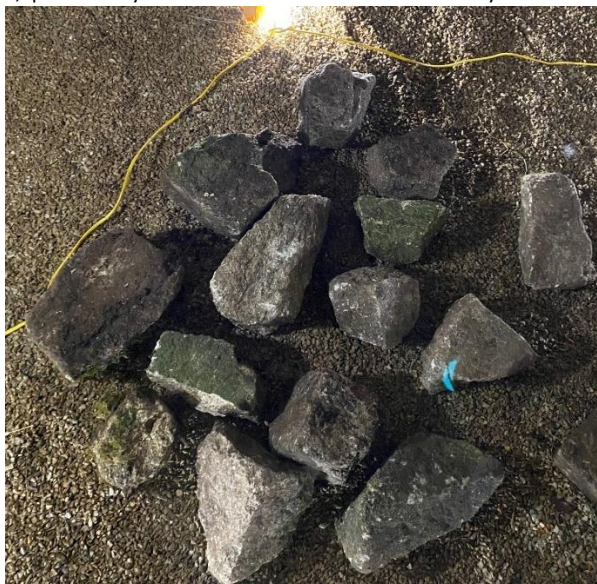
4. 14 x Undressed/broken granite fragments. While these fragments are not architectural, bearing no dressing, moulding or ornament, granite is not local to this area and was brought to the site, probably in the 17th or 18th century.

**Plate 37:** Granite cladding

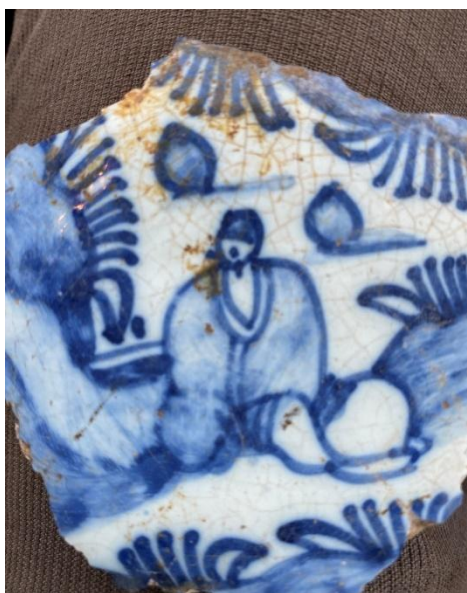
The works also involved the removal of a deep layer of twigs and debris (largely from birds nesting) from the ground floor level of the southeastern tower. This tower had been converted into a chimney in the 17th or 18th century. A single fragment of ceramic was retrieved from this material – the base of a footed tin-glazed earthenware plate decorated with the motif of the Chinese scholar, a figure common on late 17th century English pottery (Grigsby 2000, 2:140; Plate 11). The shell-edged fragment retrieved from the hummic layed on top of the vault would appear to be from the same vessel (see Plate 13).

**Plate 38:** Base of a footed tin-glazed earthenware plate decorated with the motif of the Chinese scholar
