Newbridge Demesne, Donabate, Co. Dublin

Woodland Inventory & Management Plan, 2022 – 2041

13th July 2022

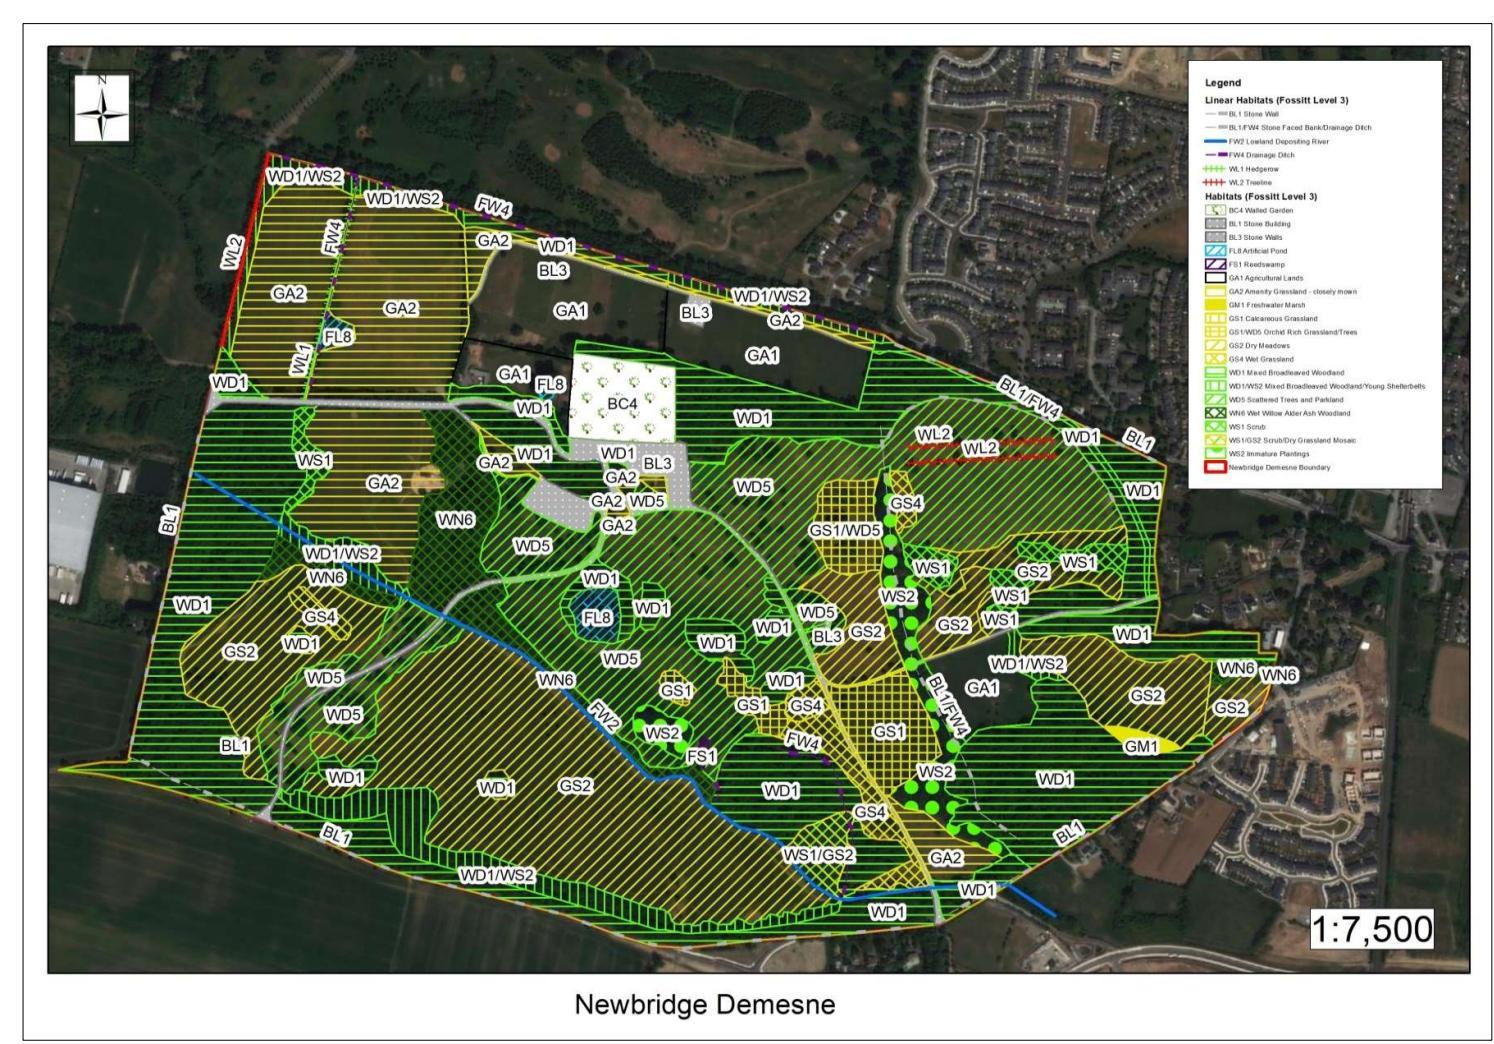
Figure 15. Woodland habitats were mapped as part of the wider ecological survey of Newbridge Demesne in 2021 Wilson *et al.* (2022).

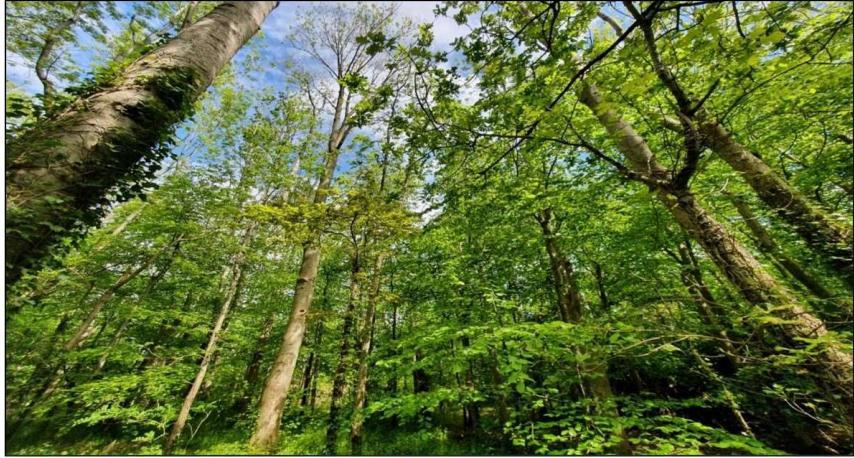
Plate 2: Dying ash tree, with depleted crown due to ash dieback disease and oak waiting to fill space.

It is recommended that a bi-annual summer survey of healthy ash trees not displaying ash dieback symptoms be carried out and that these are recorded and mapped and protected in any thinning operations.

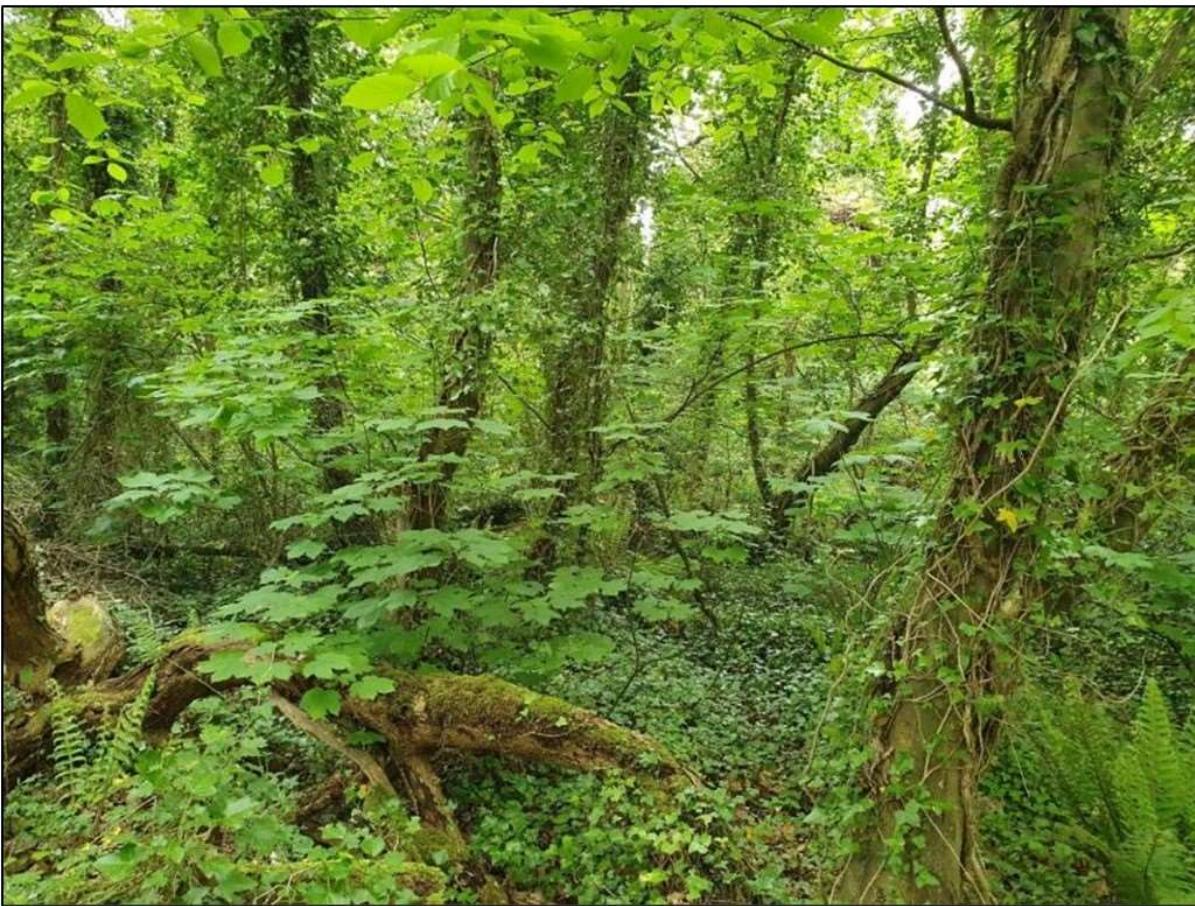
Plate 3: Example of sycamore rapidly colonising the entire understorey of the forest. This will result in low levels of light reaching the forest floor, impacting on the potential for regeneration of other, more desirable species.

- Where mature sycamore are dominating the canopy, they are selectively felled or ring-barked to create favourable conditions for regeneration of more light demanding species. Ring barking involves the removal of bark from the tree for approximately 5cm-10cm around the entire tree. This stems the flow of water and nutrients from the crown to the roots and will result in the death of the tree over several years.

- Where semi-mature sycamore are co-dominant with other species, that they are selectively felled or ring-barked to allow crown development of the other species.

- Where dominating natural regeneration, that they are selectively removed by manual cutting or breaking, in favour of competing other species.

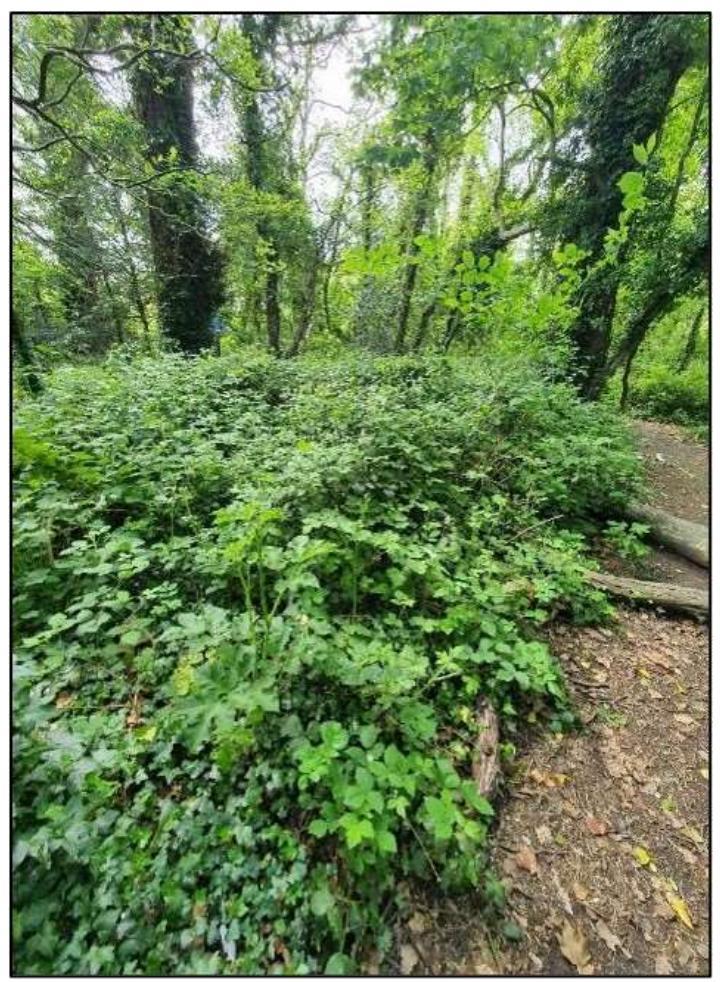
Plate 4: Area of dense briars which should be cleared and replaced with enrichment planting.

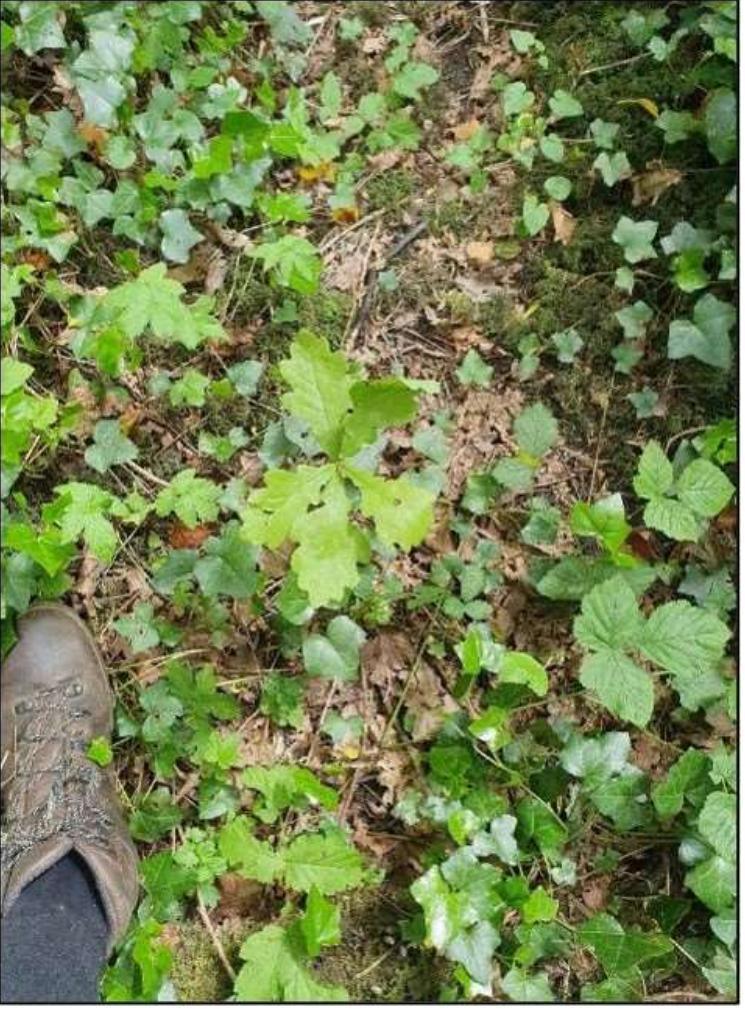
Plate 5: Oak seedling regenerating where there is adequate light and favourable conditions

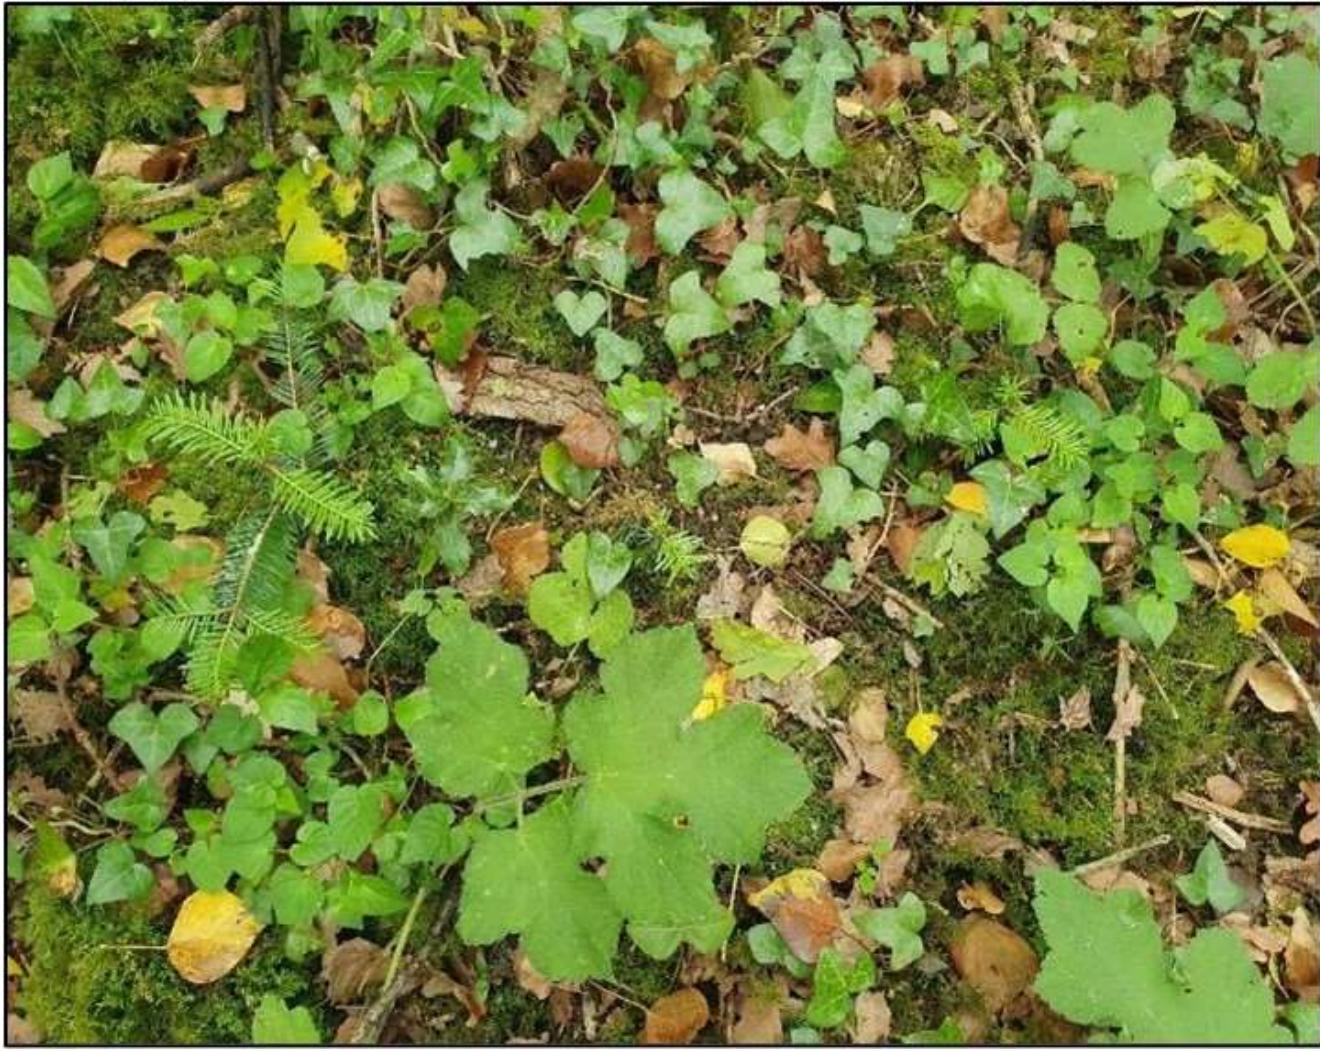
Plate 6: Silver fir naturally regenerating in suitable conditions.

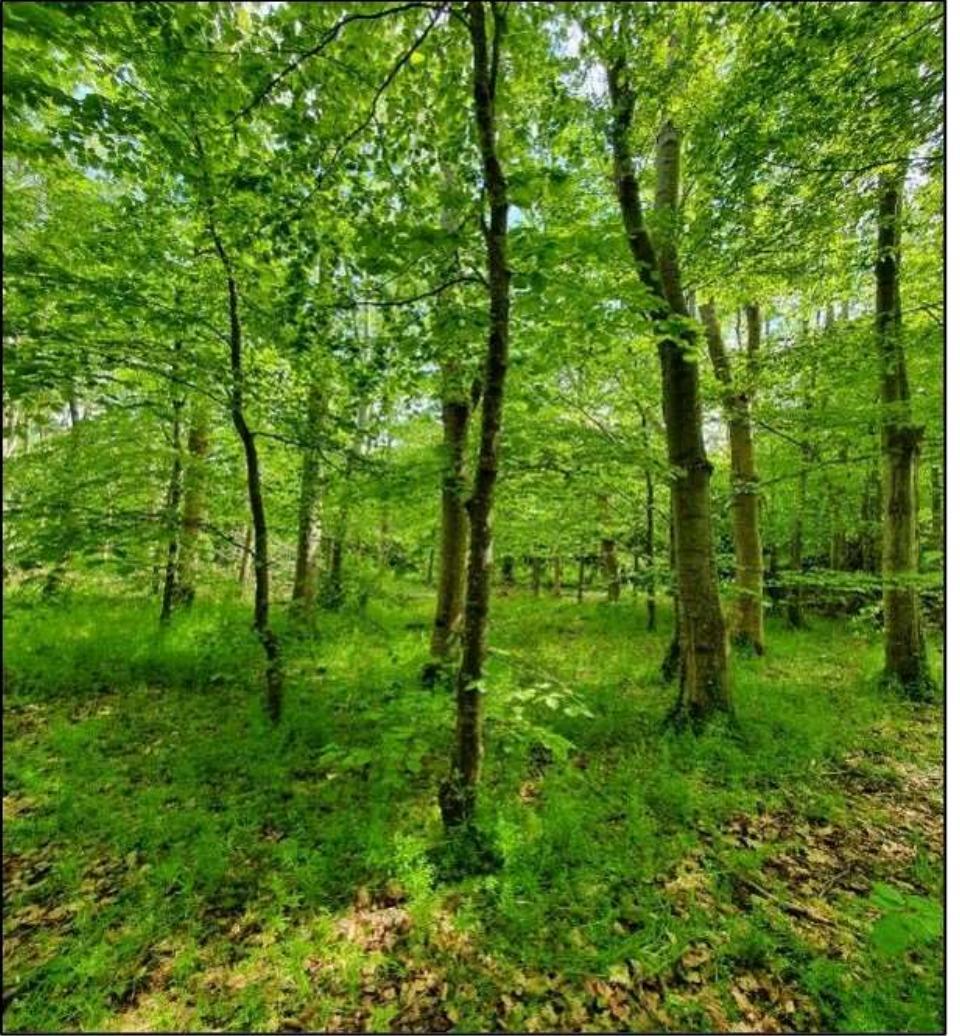
Plate 7: Area of beech with good structure and range of tree sizes, no invasive species in the understorey

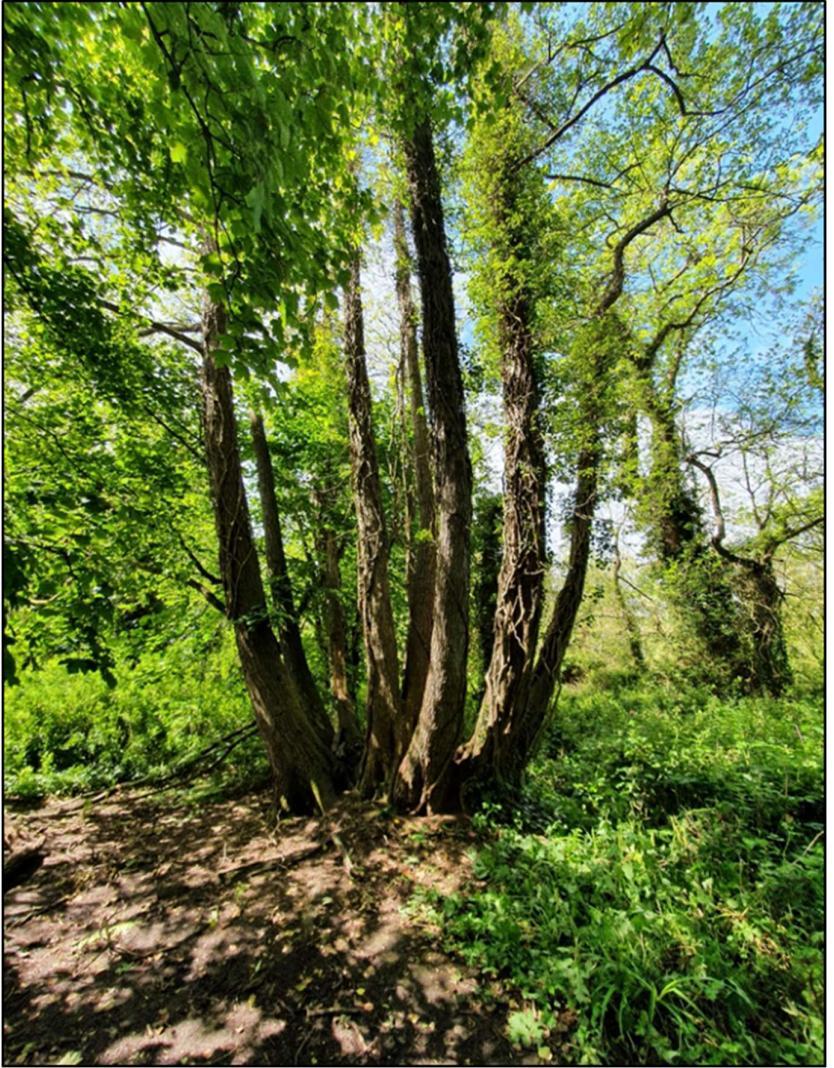
Plate 8: Compartment 1, Multi-stemmed Alder tree with high biodiversity value – note trampling pressure.

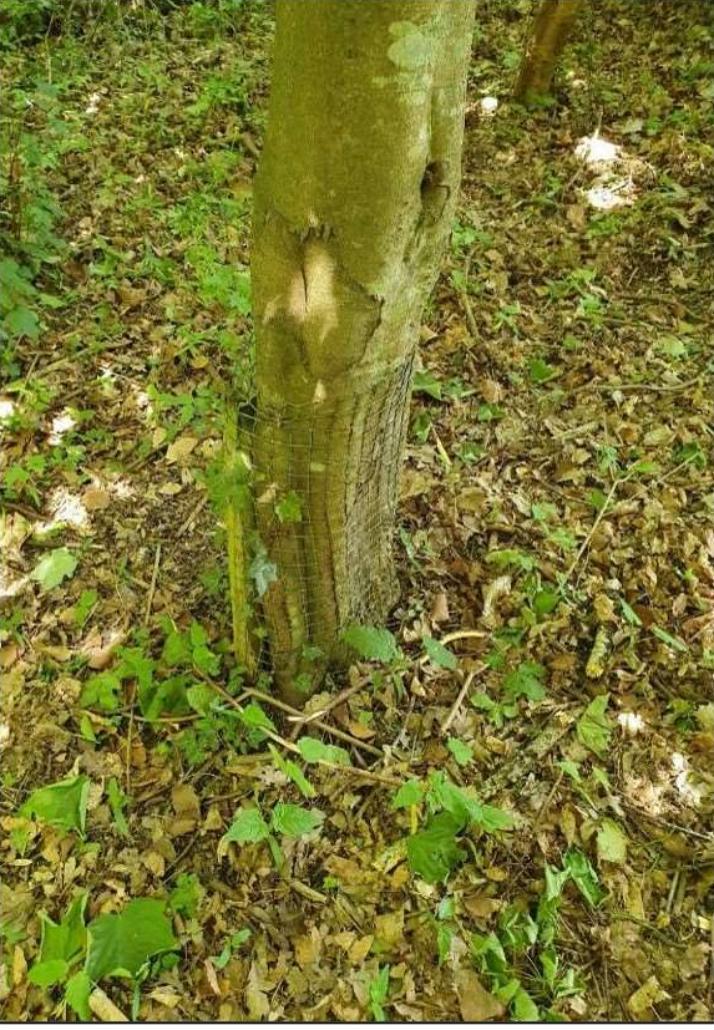
Plate 9: Tree guard which needs to be removed from the base of the tree, there are several trees with these, mainly found in Compartment 6
